1988/21. Investigation of a cracked house in Windermere Road, East Tamar.

W. R. Moore

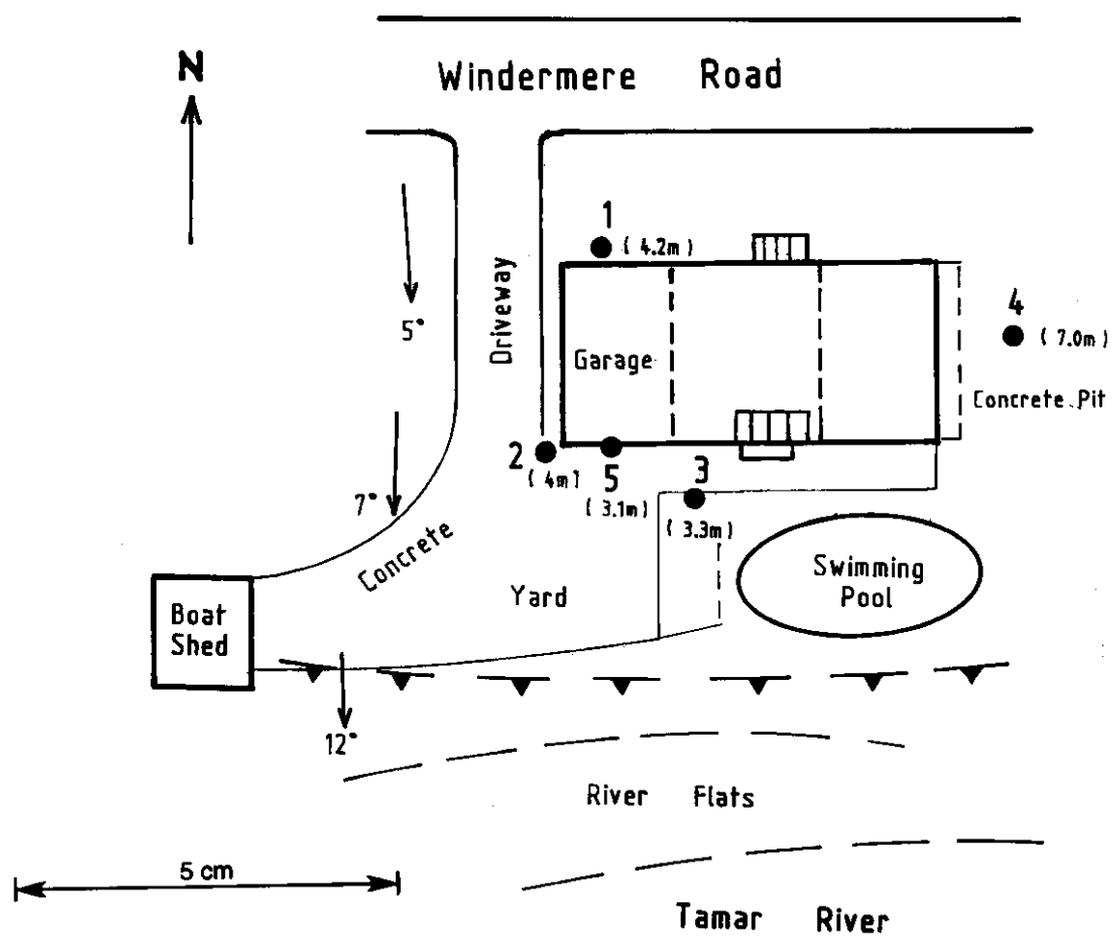
Figure 1. Sketch location plan of bore holes

The lithological logs of the five drill holes are given in Appendix 1 and the location of these drill holes is shown on Figure 1.

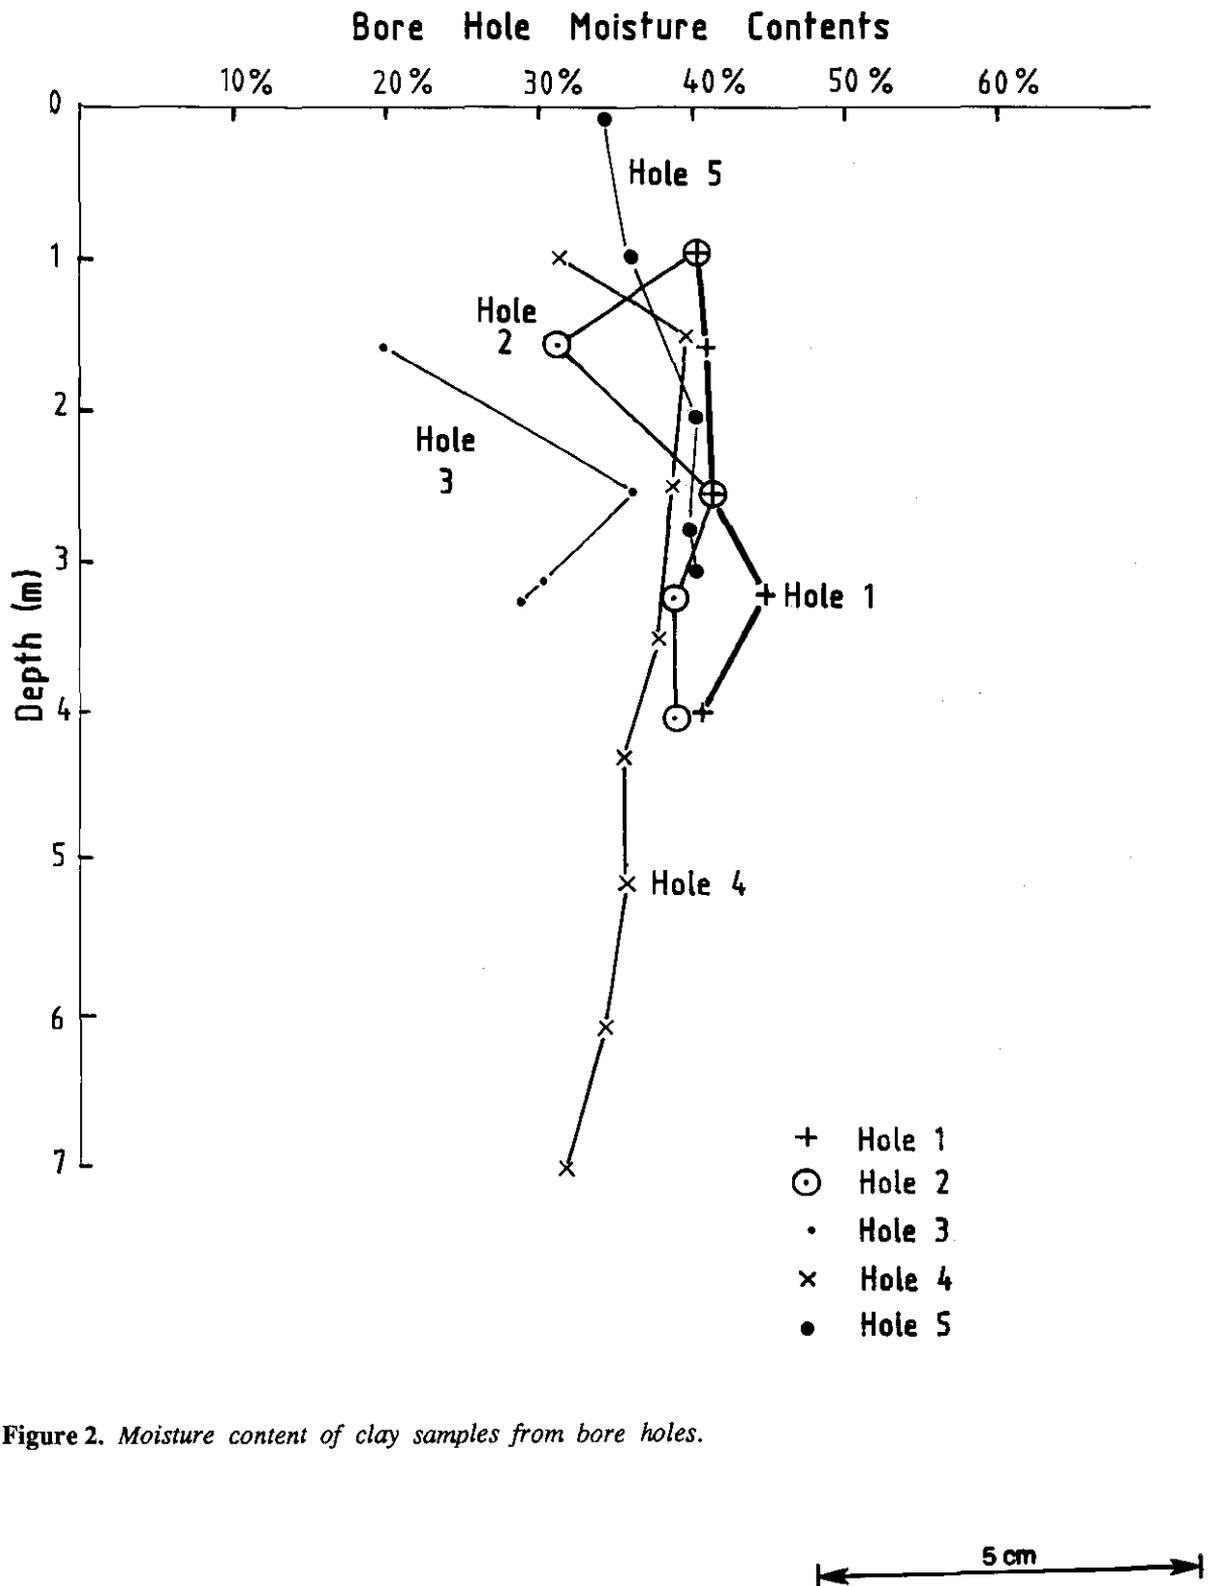
Figure 2. Moisture content of clay samples from bore holes.

Clay samples from all five holes were tested for moisture content, and the profiles of these are shown in Figure 2. With the exception of Hole 3, all moisture content profiles show only minor fluctuations and are in the range of 35-45%. Hole 3 clay is noticeably drier but this is a factor of the location being near the concrete yard and partially under shelter.

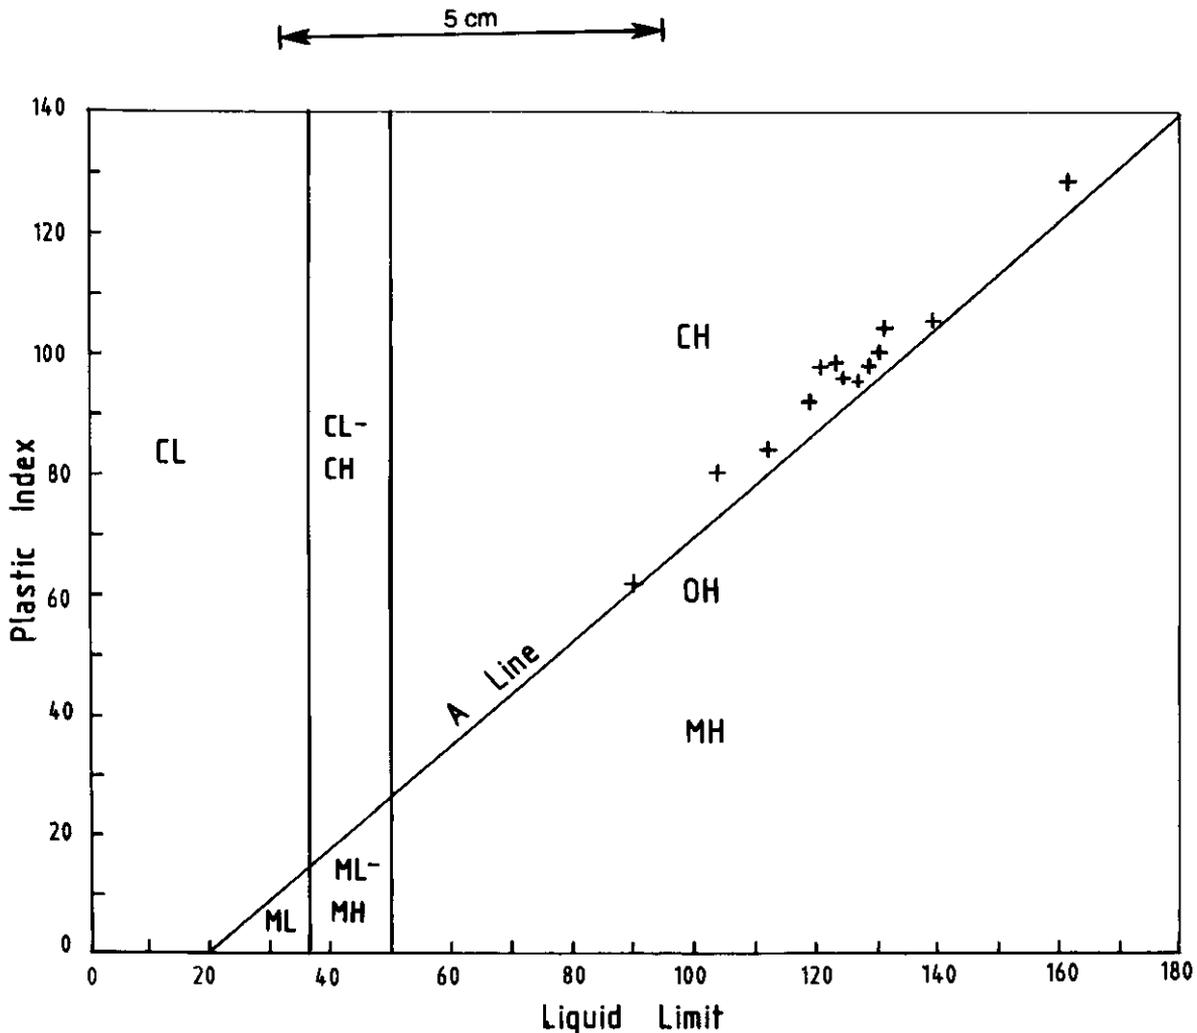
Figure 3. Unified Soil Classification of clay samples

The clay from all holes, both from field and laboratory tests, is highly plastic (CH). By the Australian Standard Classification 2870-1986 the clay would now be classified as extremely reactive (E) with plasticity indices ranging from 63-128, with an average plasticity index of 97.5. Because of the likely landslide risk the location is classified as a problem site (P).

Reflecting these very high plasticities, the clay has high linear shrinkages of 20-27%, with an average of 23.6%. Given that the seasonal and longer cyclical term (drought) soil moisture content profile fluctuates to a depth of between 3-4 m, the theoretical total movement could be as high as 140 mm, with differential movement of 70 mm. These values are similar to those established elsewhere at Windermere and in the Tamar Valley in the thick clay soils of the Launceston Beds of Tertiary age.

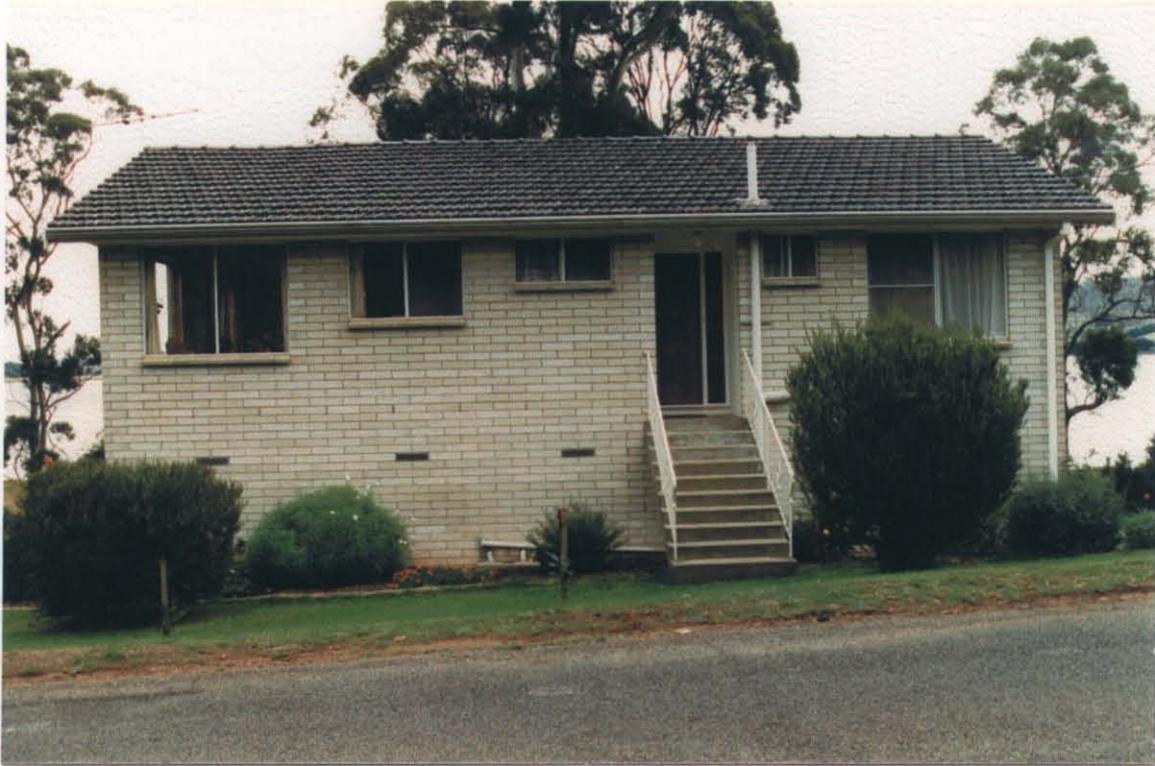
Plate 1a. *North and east walls of house.*

The house is situated on the river side of Windermere Road, on a 5° slope which steepens to 9° and 12° down to the river flats. The two storied brick-veneer house is located close to the road, with an extensive concrete driveway and courtyard on the west and south. The north and east sides of the property are mainly in lawn (Plate 1).

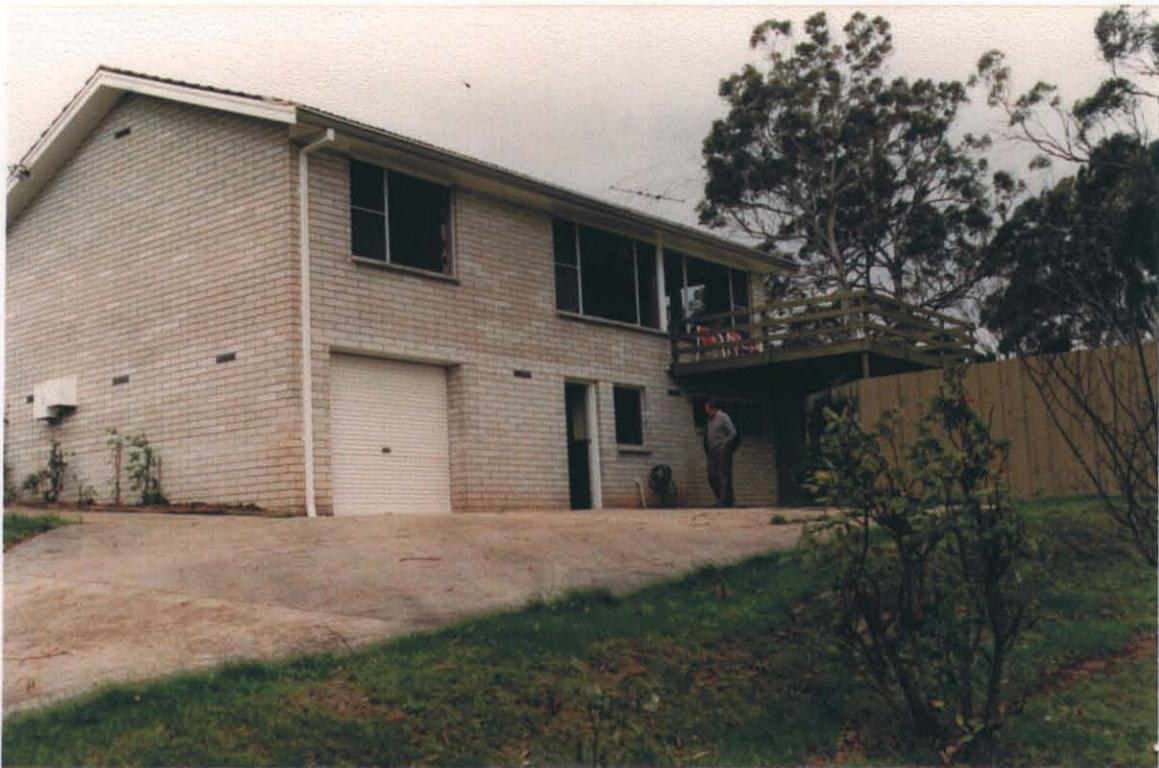
Plate 1b. *West and south walls of house.*

The extensive concrete driveway and courtyard along the western and southern walls may have stopped cracking of these walls. With such expansive clays, it is surprising that more cracking is not present on this house. This is possibly because the Aspinall's keep lawns and gardens regularly watered.

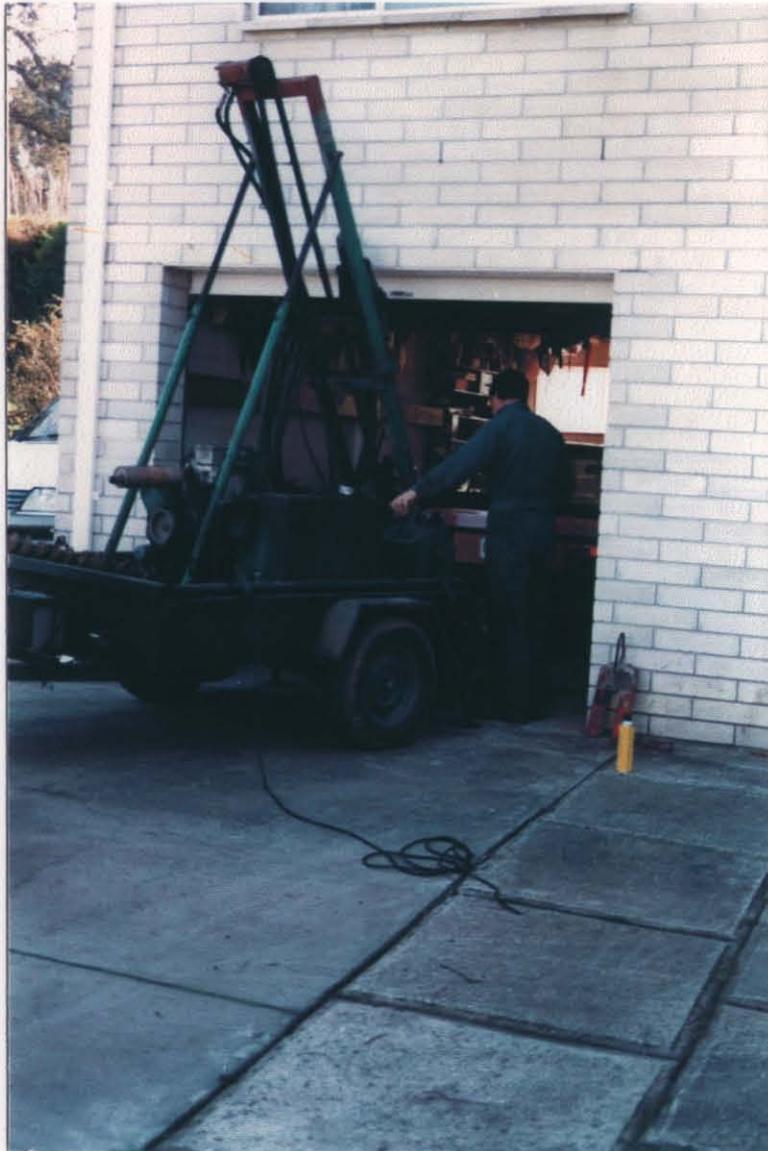
Plate 2. *Drilling angled hole, garage floor, south wall.*

Hole 5 was drilled through a hole in the concrete floor from the garage doorway (Plate 3), at an angle of 60°. The orange-brown and brown clay were stiff to very stiff, with a soft zone at the bottom of the hole. This hole was dry and made no water. Surprisingly no steel mesh was found in the concrete in the hole made in the garage floor. This was confirmed by Mr Aspinall, who tested the garage floor of the house using the Department of Mines Garrett ADS 'Deep Seeker' metal detector.

- (8) No steel mesh was found in the garage floor when Hole 5 was drilled. A metal detector survey indicated that no steel mesh is present in the concrete floor of the garage. In contrast steel was detected by this instrument in the concrete driveway and courtyard, where it was known to be present by the owner.

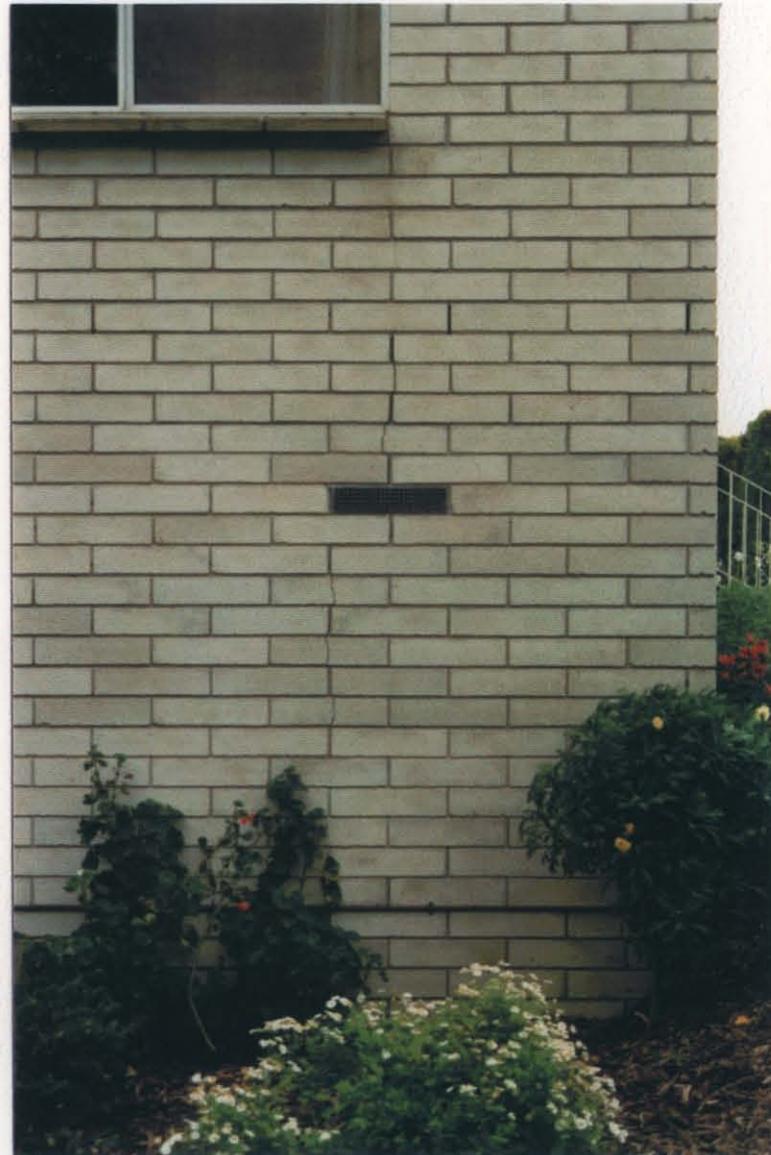
Plate 3. *Cracking in east wall.*

The exterior of the house has only slight damage, with a major vertical crack present down the east wall (Plate 2). This crack cuts some bricks but is mainly confined to the mortar. The major damage occurs on the concrete ground floors of the garage and billiard room. Here the cracking is widespread and, in some areas, severe. Measurements on these cracks by the owner indicated some doming was occurring beneath these floors.

- (4) A concrete border be placed along the eastern and southern walls of Aspinall's house with waterproof sheeting underneath this concrete.
- (5) The garage and billiards room floors be re-concreted with adequate steel-reinforced mesh in the concrete to withstand the vertical movements of the expansive clay.
