Investigation of a proposed dam site at Nubeena

by W. L. Matthews

Abstract

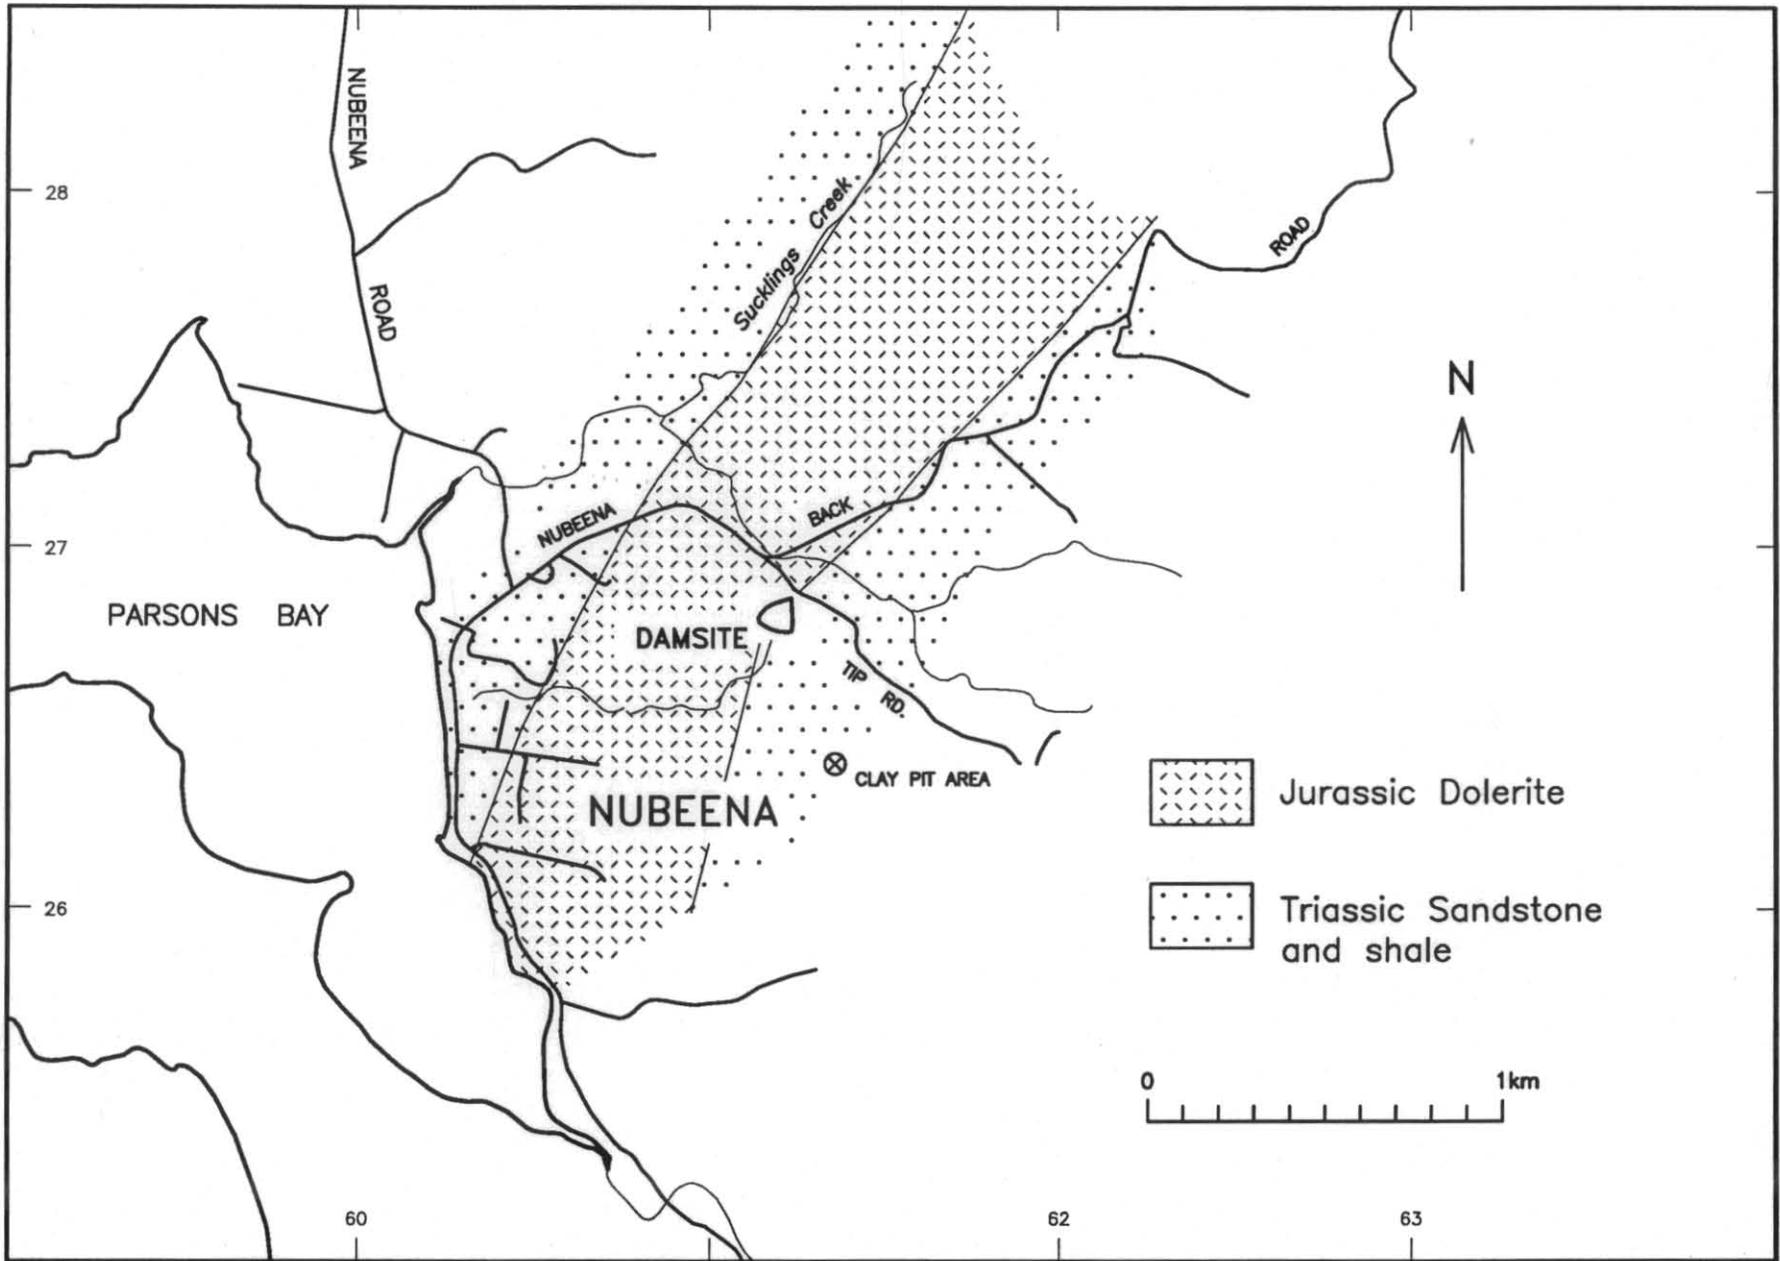
Figure 1. Location of dam site and clay pit areas, Nubeena.

The dam site is on the eastern contact between a northeast-trending body of dolerite about 500 m wide and Triassic aged sandstone and siltstone. The general geology of the area is shown in Figure 1.

A possible source of clay for the construction of the dam had previously been located to the south-east of the dam site (fig. 1). A test pit in this area had indicated considerable depths of clayey material which had been tested as being suitable for the core of the dam. The area

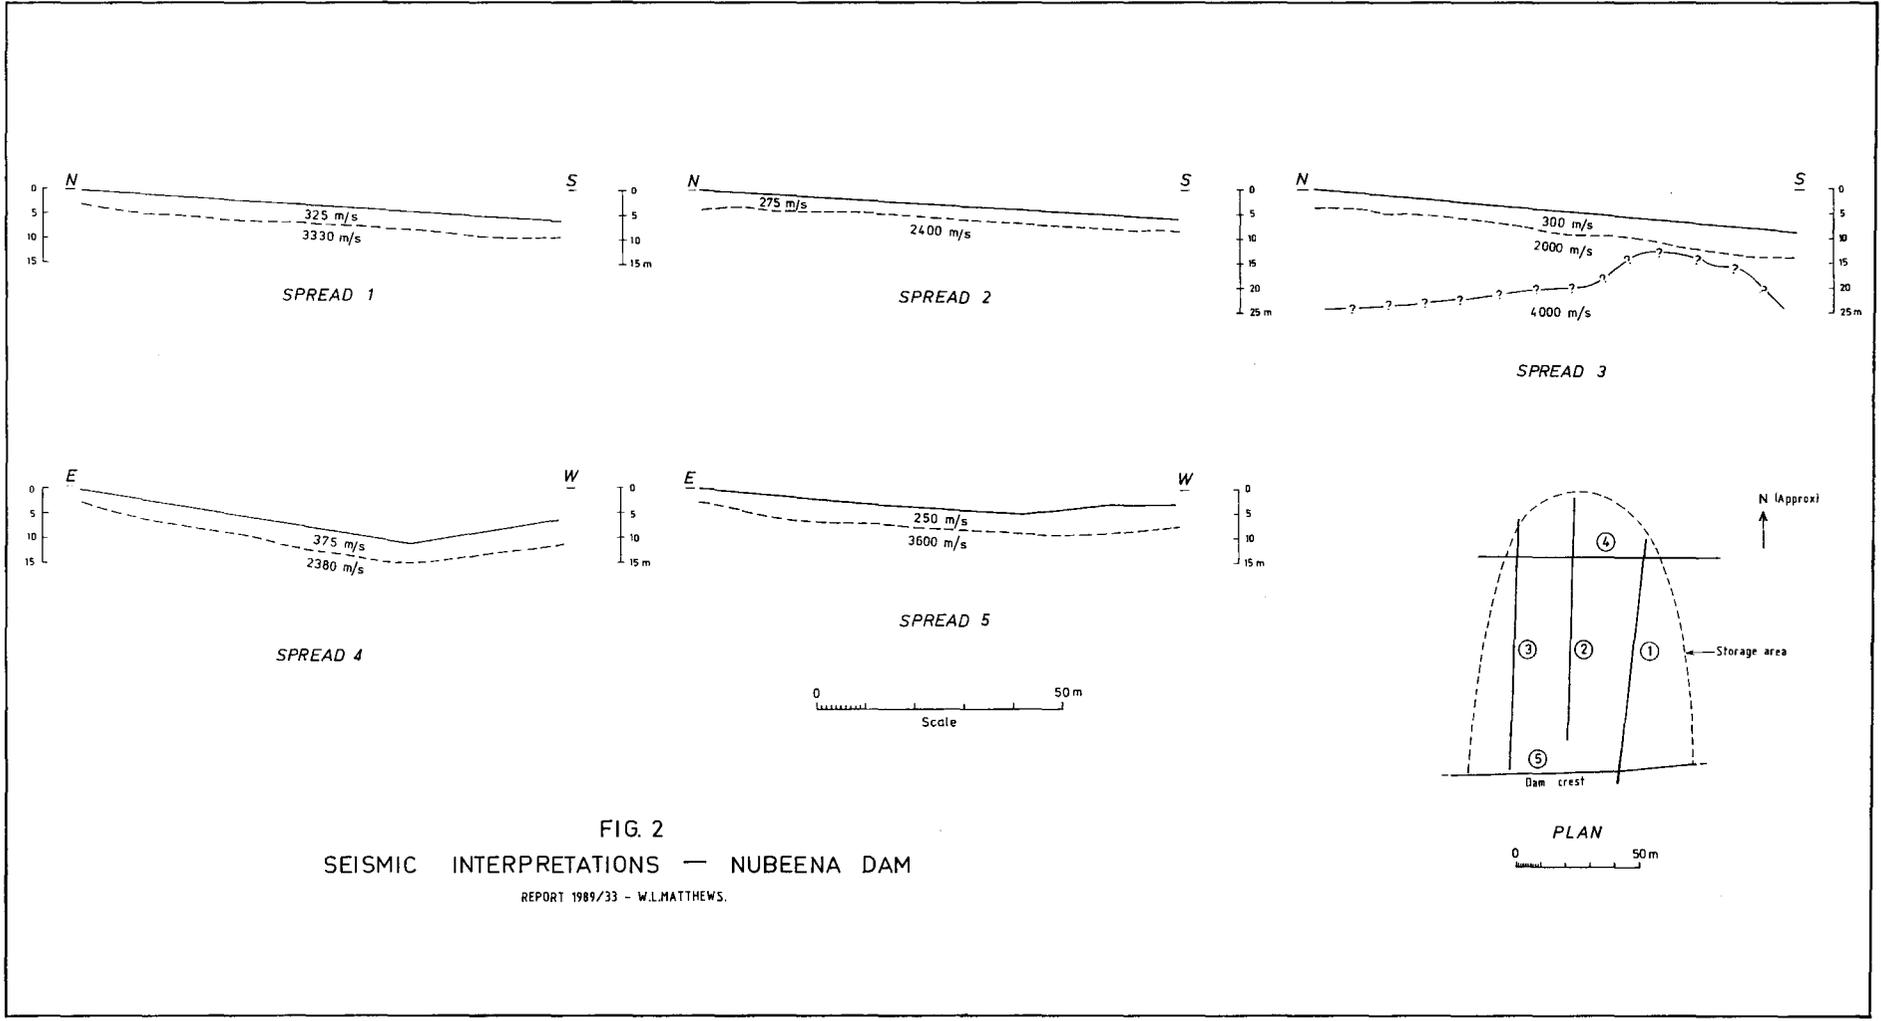
FIG. 2
SEISMIC INTERPRETATIONS — NUBEENA DAM
REPORT 1989/33 - W.L.MATTHEWS.

The interpreted profiles under the spreads are shown on Figure 2. Under each spread there appears to be 2–4 m of soil and loose material (seismic velocities of 275–375 m/s). Under Spreads 2, 3 and 4 the surface material is underlain by material with a seismic velocity of 2000–2400 m/s. This probably represents weathered rock (Triassic sediments under Spread 2 and part of Spread 4, and dolerite under Spread 3 and part of Spread 4). Material with these velocities should be rippable.

At deeper levels under Spread 3 material with a velocity of 4000 m/s was indicated, at depths ranging from 14–18 m with questionable depths outside this range under both ends of the spread. Rock with this velocity is probably unweathered dolerite.

The minimum depth to material with seismic velocities of 3000 m/s under Spreads 2 and 4, and most of Spread 3, is ten metres. Sandstone or dolerite with this velocity would be difficult to rip.

Spread 1 is underlain by material with an interpreted velocity of 3330 metres/second. This probably represents relatively unweathered Triassic sediments, which would be difficult to rip.

Spread 5 is underlain by relatively high velocity material at depth; this material may be partly sandstone and partly dolerite, or all dolerite.

The western end of Spread 5 and the southern end of Spread 3 have extremely low velocity material near the surface. This may indicate loose dry sand.

Removal of the material to make the storage will probably expose fresh rock, which may have moderate permeability. If this is the case, the storage area would need sealing with clay. The higher velocity material under Spread 1 may be difficult to rip.

The material under the proposed dam wall needs to be examined. This could be done by drilling with an auger drill and/or digging pits with a backhoe. The western end is of particular concern.

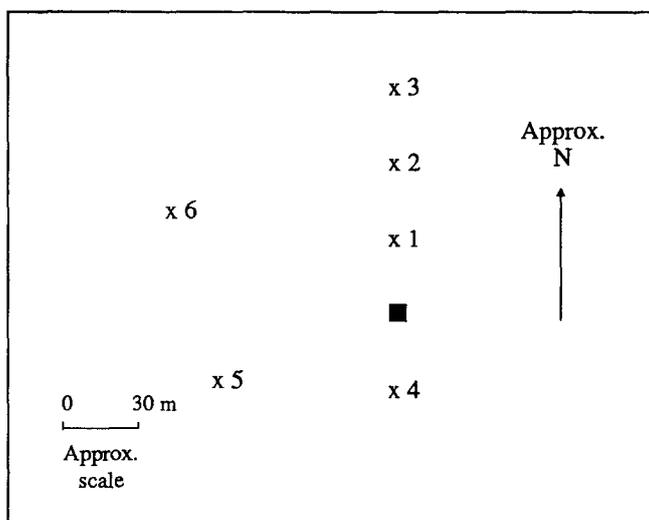
Sketch plan of auger hole locations - clay pit area.

A series of six auger holes was drilled around this test pit. The logs of these holes are given in Appendix 1. Most of the holes, even those close to the test pit, encountered much less clayey material. As the material remaining around the test pit had a different moisture content than that produced from the auger holes, some sizing analyses were undertaken (Table 1). The amount of sand, as opposed to clay and silt-size material, was determined approximately by wet sieving, i.e. the samples were separated using a 63 µm sieve.

The distribution of material with a high clay and silt content is very irregular, and only Holes 1 and 6 indicated useful depths of material similar to the test pit. Further investigation into clay resources would be required to establish reserves.

Sufficient clay reserves for the dam construction have not been established, and further work is required to locate these reserves.
