River bank instability in the Deviot area

by W. L. MATTHEWS

An area where slumping has occurred along the River Tamar shoreline at Deviot in recent times has been examined at the request of the Municipality of Beaconsfield.

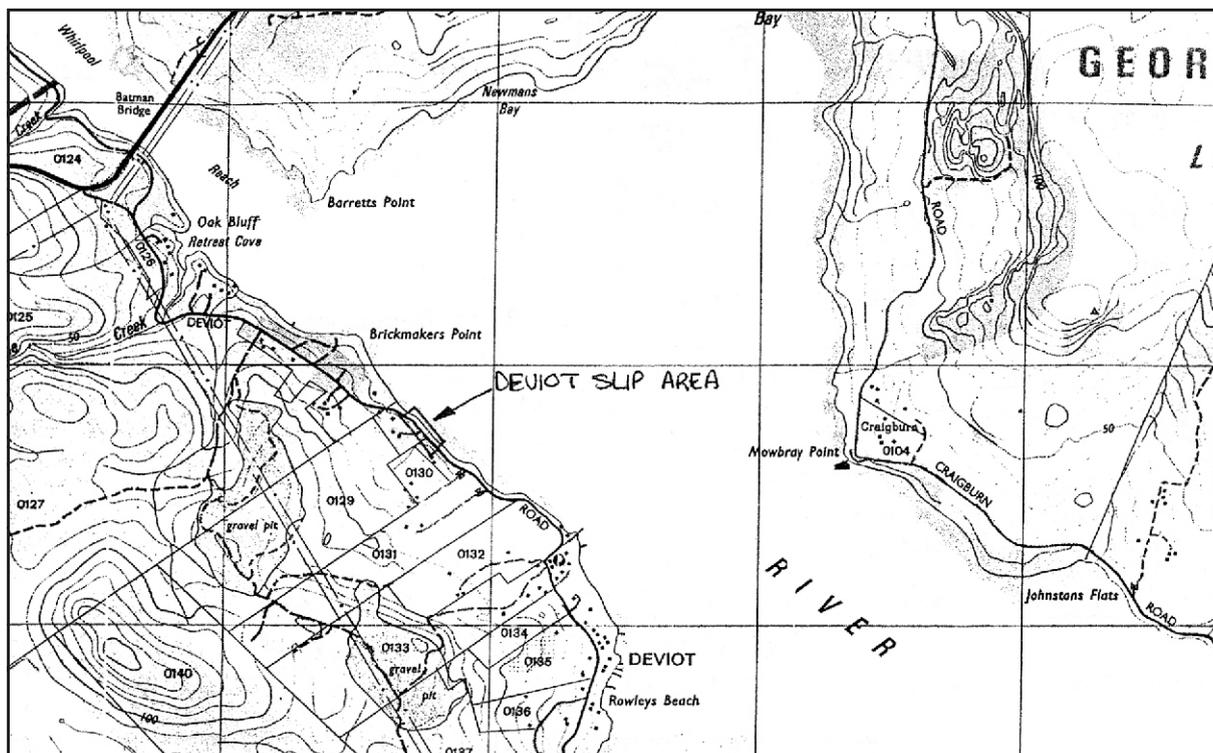
Slumps involving some tens of cubic metres of material have occurred in the higher parts of the embankment along a 50 m or so length of the river edge. Red and grey mottled clay of Tertiary age is exposed in the embankment. At shore level this material has intensive seams and networks of iron oxide seams.

The probable cause of the slumping is because of undercutting of the embankment at high tide levels and perhaps wave action at the same time. Slumping due to this cause is probably more prevalent when recent rains have saturated (and softened) the lower parts of the slope.

Prevention of the undercutting action of high tides and wave action will probably only be achieved by constructing a wall (or barrier) of some kind so that the river water is not in contact with the embankment. The process of undercutting, slumping and removal of material by the river and wave action is likely to continue over time until the road itself is affected as it was further to the north.
