## Subsurface investigation of land at Leam Road

by B. D. WELDON

A subsurface investigation of a property at Leam Road, Hillwood, was undertaken in relation to a proposed subdivision of the property. The investigation involved sinking three test pits and laboratory tests on a sample of clay taken from one of the test pits. A stability analysis was performed using the results of the laboratory tests.

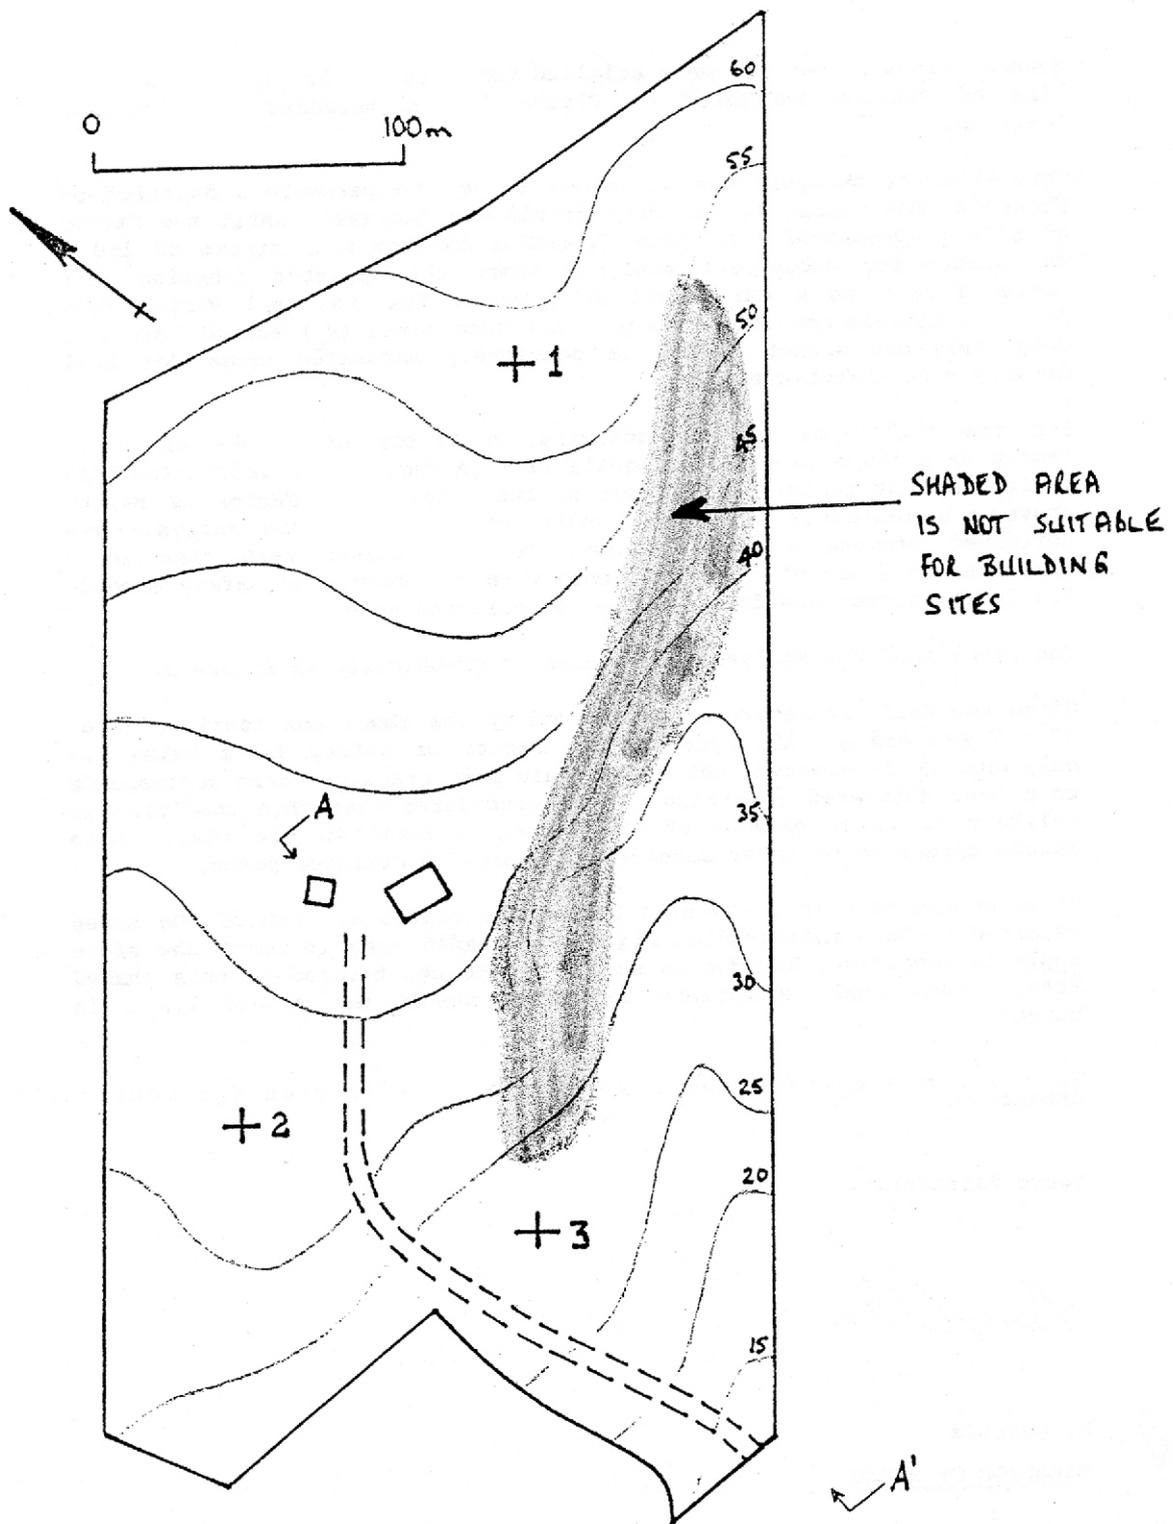
Test pits 1 and 2 were located on uniformly sloping ground and encountered stiff to very stiff clays. Spheroidally, extremely weathered boulders of dolerite were encountered at 1.4 m in test pit 1, while a cemented gravel and sand occurred at 1.55 m in test pit 2. These sites do not show anything extraordinarily suggestive of a high landslide risk.

Test pit 3 was located in an area where the morphology suggested past landslide movement.

It is concluded that a suitable house site exists at each of the sites examined. Figure 1 shows a shaded area in which the slope angle is excessive, and residences should not be constructed in this shaded area. Unsupported excavations and fills should not exceed 1.5 m in height.

Location of test pits and section line

It was recommended that development on the proposed lot with a frontage to Leam Road be restricted to the flatter lying country such as near the site of the test pit. Excavations into the slopes on this proposed lot should not exceed one metre in depth.

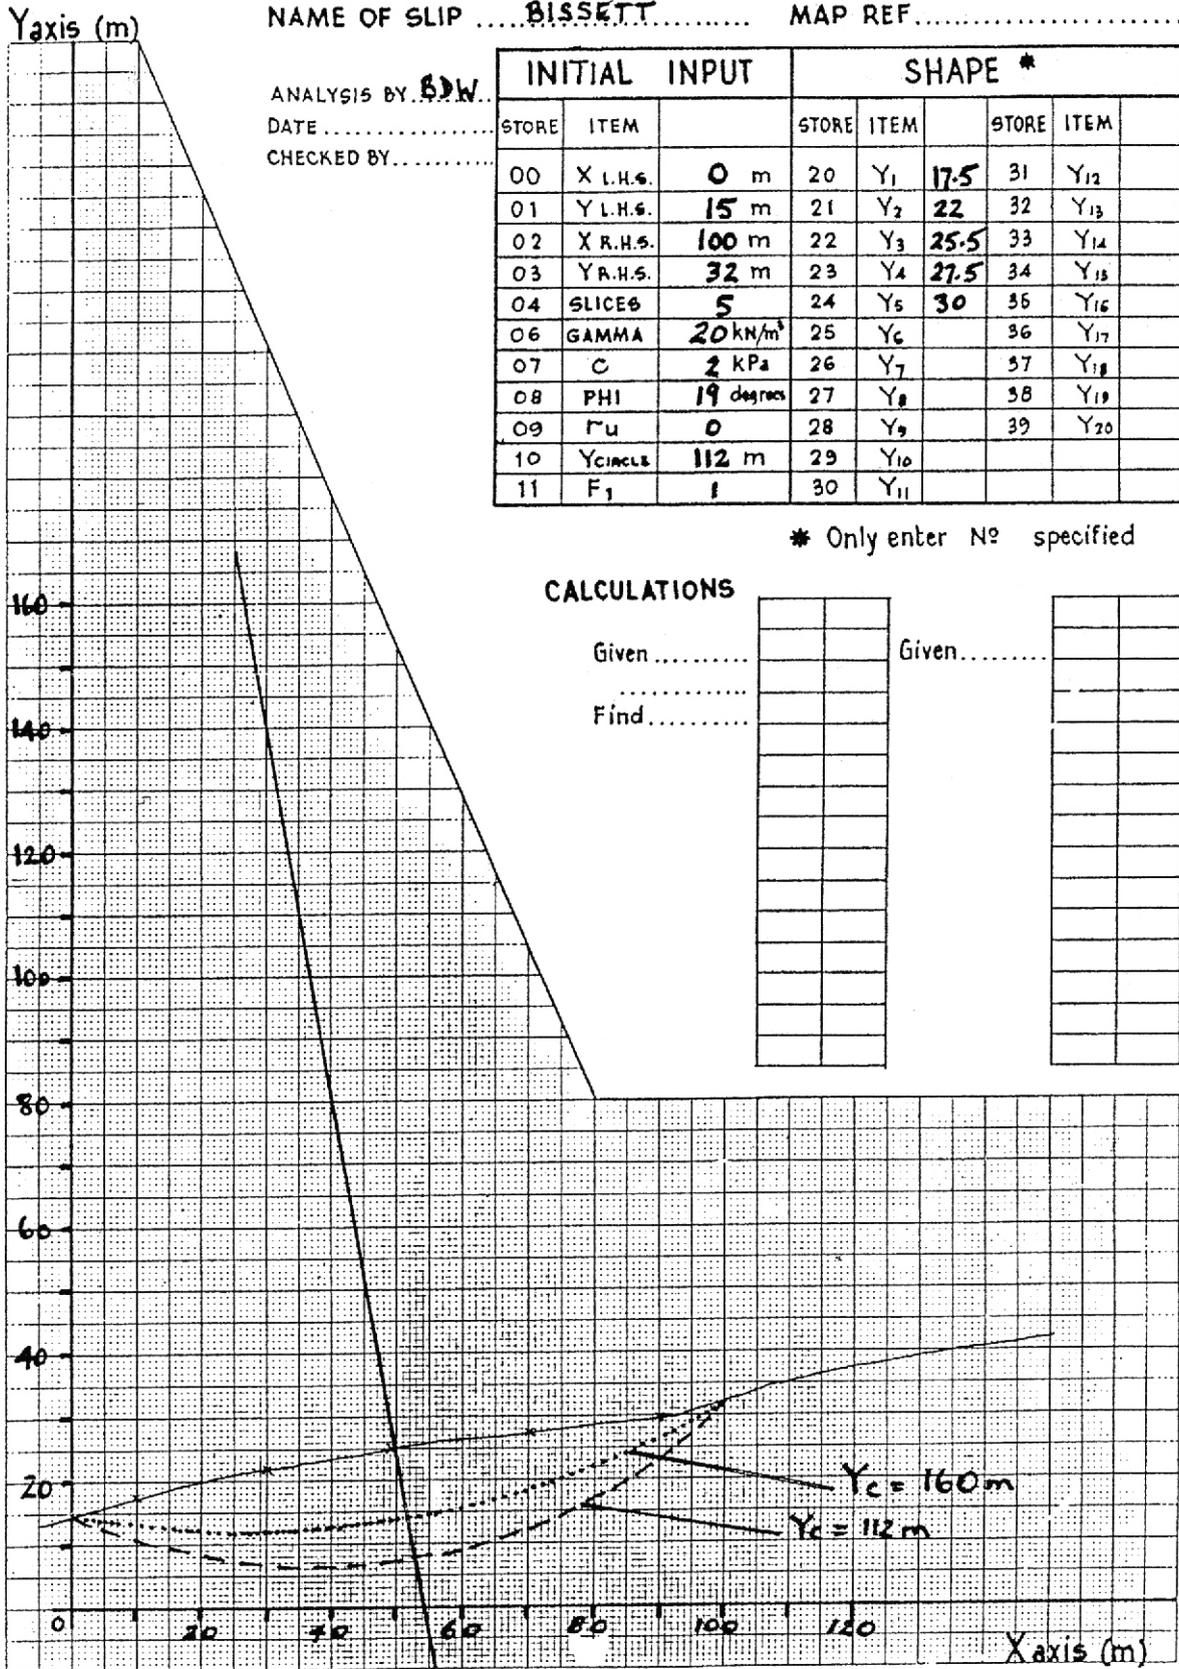
Figure 2  
 Cross section analysed for slope stability

Initially, an analysis was performed using the parameters detailed on Figure 2. The radius of the slip circle was increased until the Factor of Safety approached a minimum. A radius for the slip circle of 160 m was chosen for subsequent analysis where the apparent cohesion ( $c'$ ) varied from 0 to 6 kPa, angle of internal friction ( $\phi$ ) varied from  $16^\circ$  to  $22^\circ$ , and where the pore pressure ratio ( $r_u$ ) ranged from 0 (a completely dry slope) to 0.5 (a completely saturated slope for soil density = 20 kN/cubic metre).

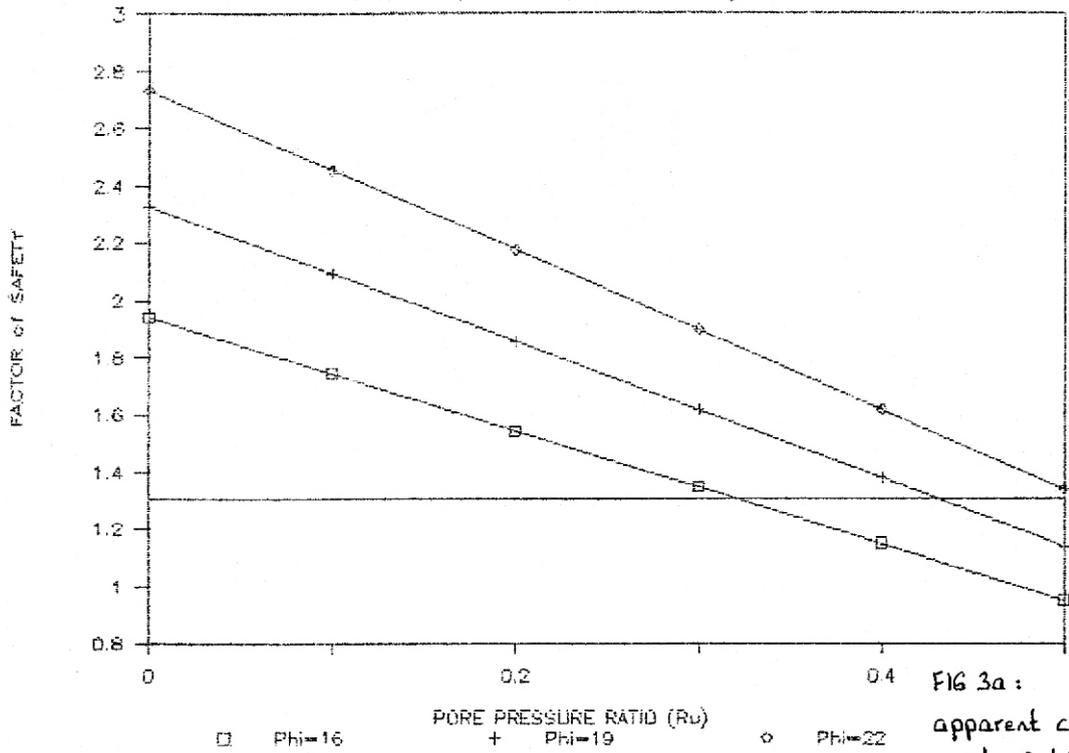
FIG 3a:  
apparent cohesion  
 $c' = 0$  kPa

Given the soil parameters as determined by the shear box testing, (i.e.  $c' = 2 \text{ kPa}$  and  $\phi = 19 \text{ degrees}$ ), the Factor of Safety falls below 1.3 only when  $r_u$  is greater than 0.473. This pore pressure ratio corresponds to a near saturated condition. It is considered that this condition is unlikely to arise because of the lenses of sand in the clay. These lenses appear to be interconnected and provide drainage paths.
