Further subsurface investigations of land at Leam Road, Hillwood

by W. L. MATTHEWS

An inspection of land at Leam Road, Hillwood, has recently been undertaken. This land was examined previously (Weldon, 1989).

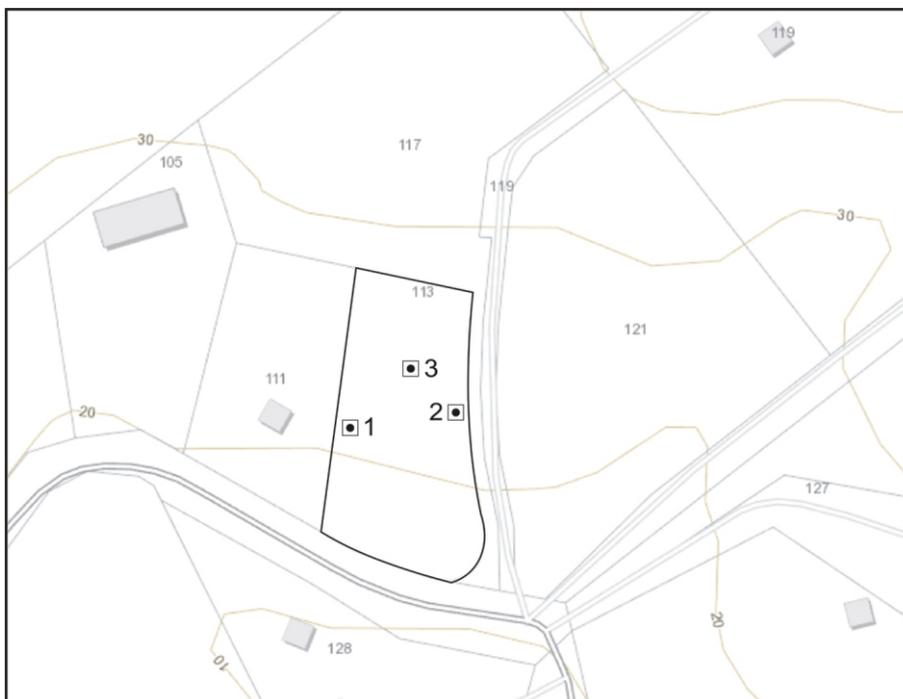
Figure 1

Three test pits were dug on the lot. Each pit encountered quite stiff fissured clay, with laterite fragments and clay showing a remnant igneous texture (deeply weathered dolerite).

*Approximate locations
of test pits.*
