Investigation of water seepage at Beauty Point

by *W. L. MATTHEWS*

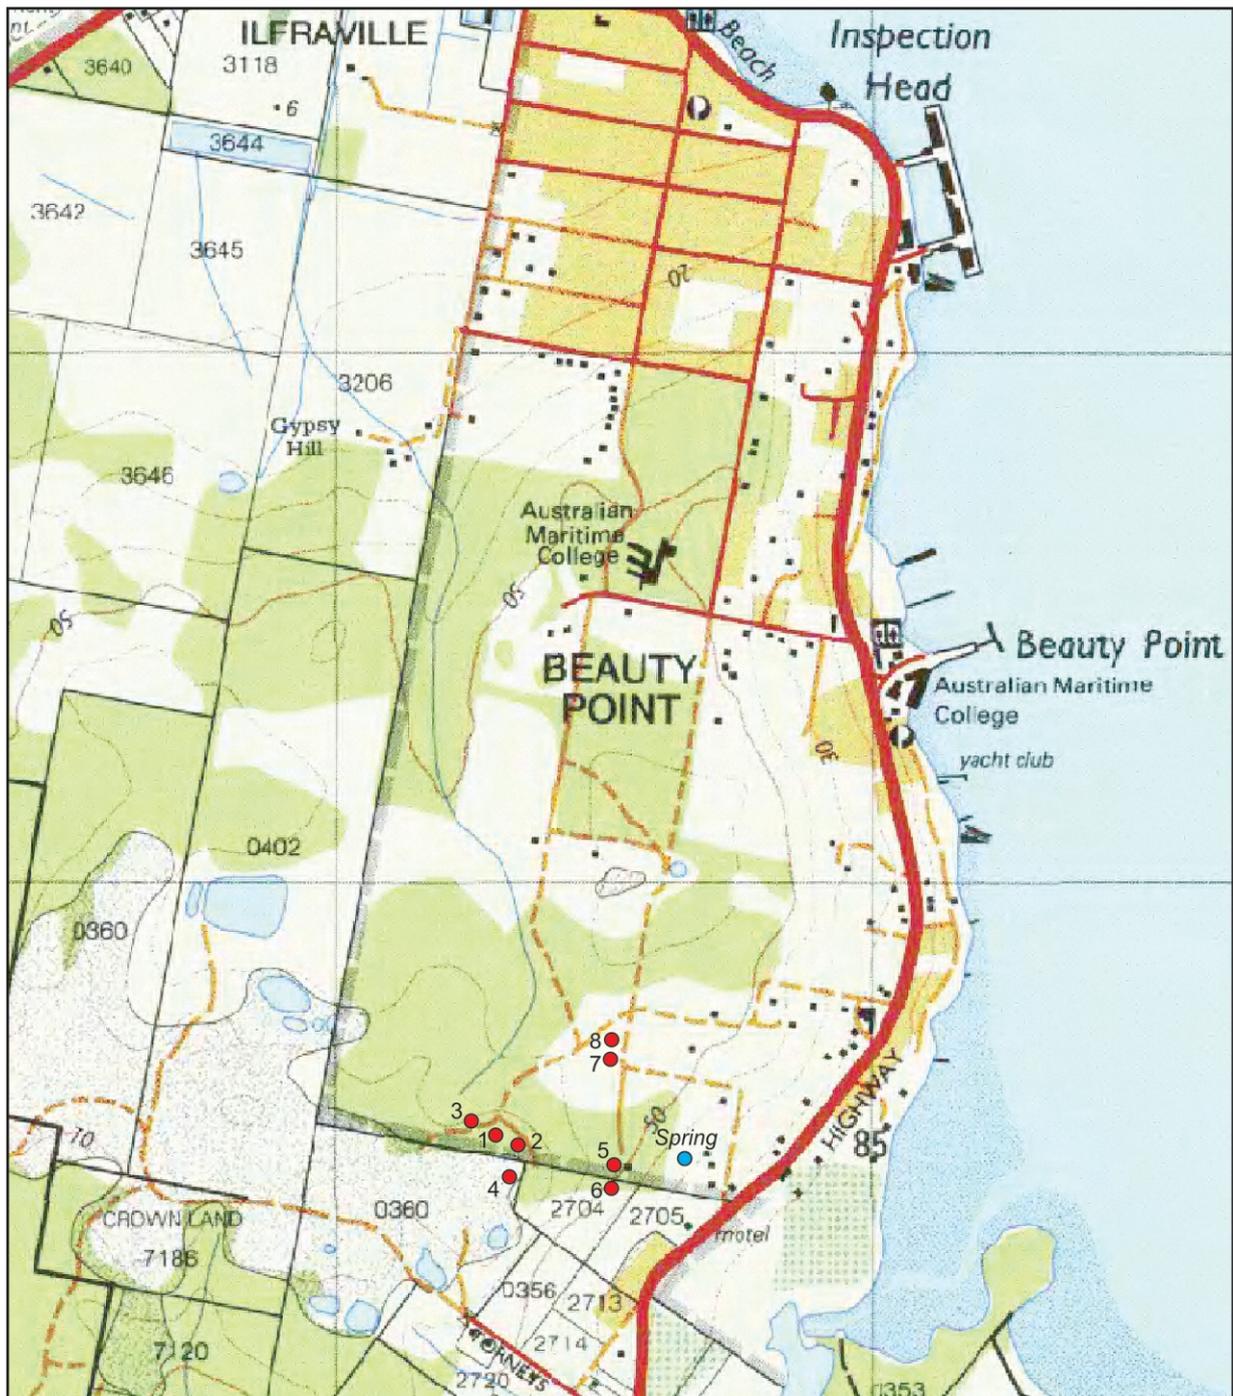
Figure 1

The Department of Mines undertook shallow drilling around the north-eastern margin of a sand pit to the west of Beauty Point following some concern that seepage water may have been coming from the pit. The land, part of a sand mining operation by Stornoway Hewitt Pty Ltd, and the surrounding properties were examined in June 1988 and eight holes were augered in the area surrounding the pit to the east and northeast. Stand pipes were installed in the holes. The logs of the holes are given in Appendix 1, with the approximate positions of the holes shown on Figure 1. It is proposed to survey these positions more accurately at a later date.

Location of auger holes and spring
