Landslips at Blackwall Road

by *W. L. MATTHEWS*

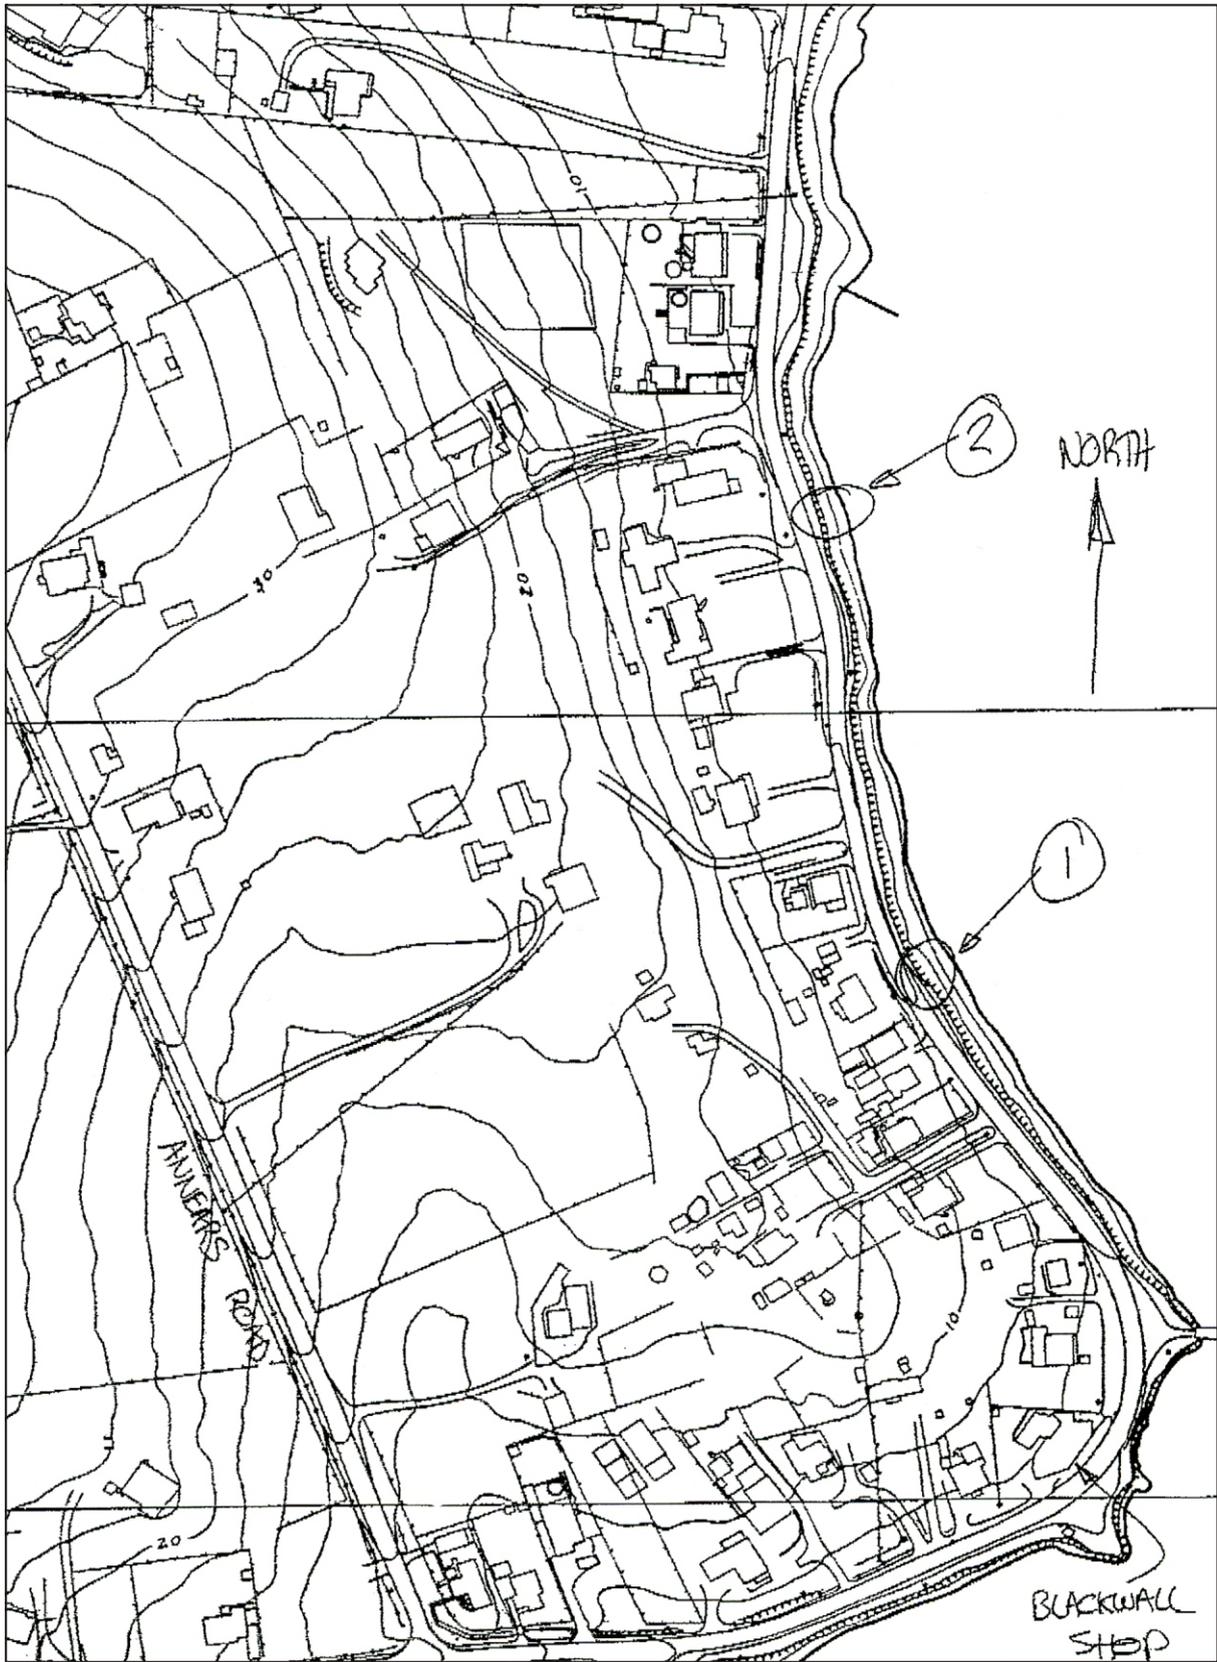
Figure 1

A brief inspection was made of two recent landslides that have occurred on slopes to the River Tamar and are affecting the edge of the road at Blackwall (fig. 1). Landslides have taken place on the embankment to the river previously.

The most southerly slip intersects the road edge and material has slumped about 1.5 m, leaving a steep scarp directly below the road. Some 30–50 cubic metres of material has been involved in the movement. Some of it comprises material from a recently excavated sewerage trench that was placed along the road edge.

The slope from the road edge to the river is steep and some 5–6 m high. Recent rains and drainage across the road have saturated the slope causing the clay to soften (a brown plastic clay is exposed in the heel of the slip) resulting in the slump.

The northern slip has much the same form but is smaller and similar treatment will probably be required.

Drainage should be prevented from flowing into the heel of the slip. At present water can flow across the road and enter the affected area. Piling or buttressing the slope with rock will probably be required to stabilise the area with the latter being the cheaper solution.

Traffic should be kept away from the road edge in the areas of the slip as further collapse is possible.
