## Division of Mines and Mineral Resources — Report 1990/17

# Examination of a proposed subdivision at Huonville

by B. D. Weldon

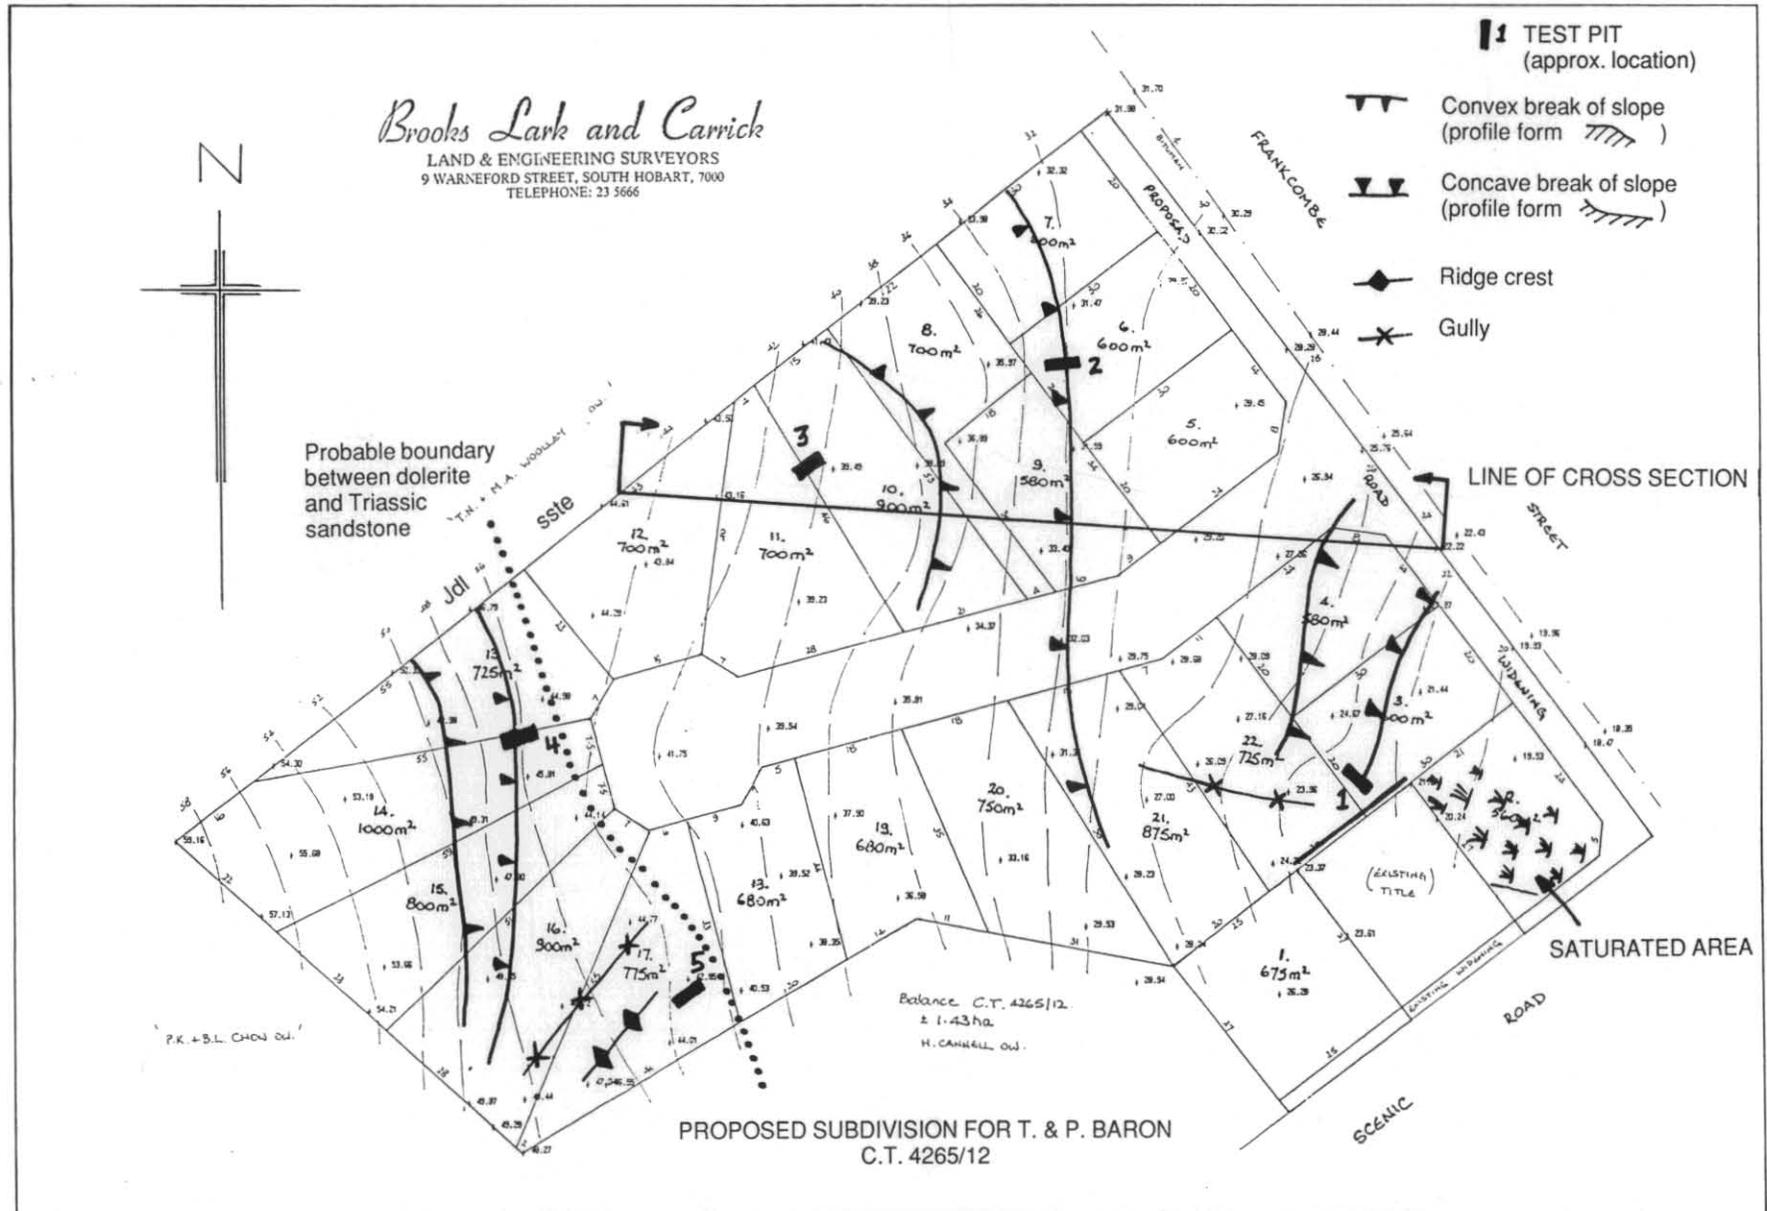
Figure 1. Site plan showing slope morphology, approximate test pit locations, and line of cross section used for stability analyses.

Several back-hoe test pits were excavated at the approximate locations indicated on Figure 1. Slickensided sandy clays containing carbonaceous materials and boulders of sandstone were excavated in test pit 2. This test pit was located adjacent to a large sandstone boulder. These materials are considered to be ancient landslide debris.

At test pits 4 and 5 (refer Figure 1) the excavations encountered *in situ*, moderately weathered, closely jointed dolerite. The joints within the dolerite were sub-vertical in orientation and showed little infilling. The boundary between the dolerite and the sandstone may therefore extend further east than indicated on the published geological map. Alternatively, a feeder dyke of dolerite may have been encountered. The approximate eastern extent of the dolerite is

shown on Figure 1. *In situ* dolerite is usually not associated with potential landslide activity.

Lot 2 requires extensive drainage improvements before it can be built on. The ground is completely saturated in places. Part of the problem appears to be caused by an open drain which runs along the back boundary of the lot marked as "existing title" (refer fig. 1). The source of the water in the open drain is partly due to stormwater and sillage from existing houses along Scenic Road. The drainage may also be from natural seepage from a drainage line on lot 22. The open drain should be piped and the water diverted away from lot 2.

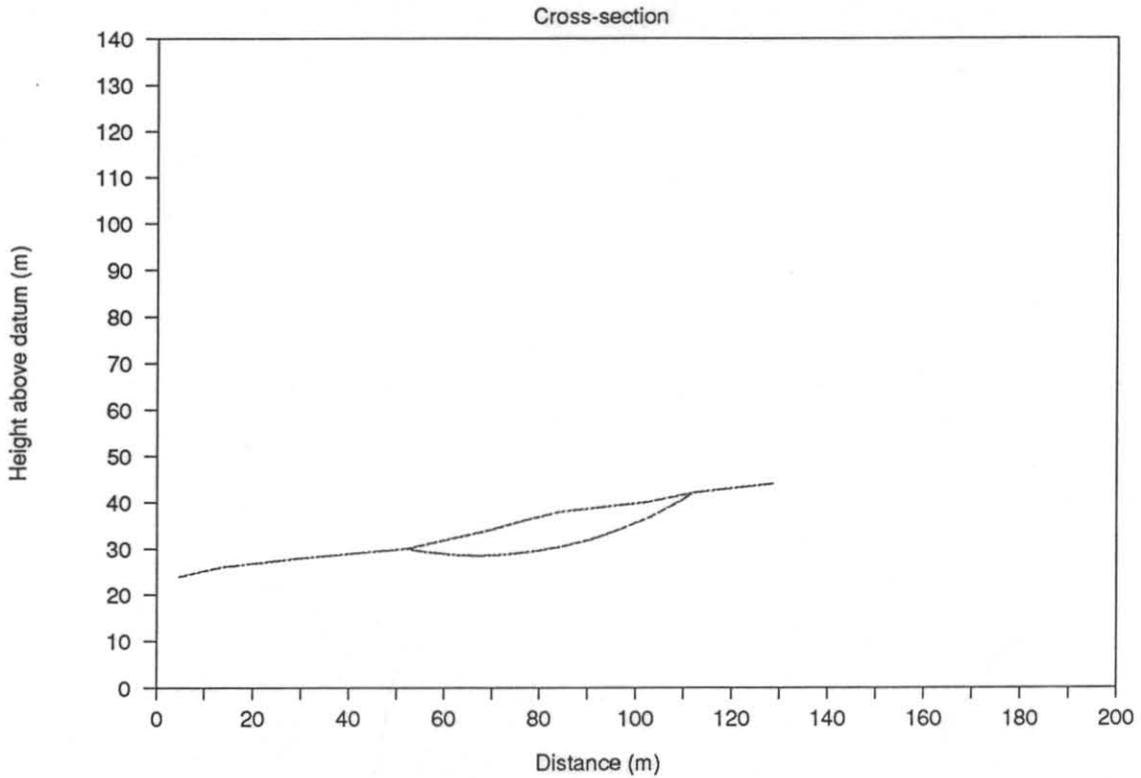
Figure 2. Cross section showing critical circular failure arc for stability analysis.

Stability analysis has been performed using SLIPCIRC (Weldon, 1987), a GW-BASIC program for Bishop's (1955) simplified slip circle stability analysis. The analysis has been performed on the slope profile shown on Figure 2. On this slope, an infinite number of potential circular failure arcs are possible. The end points of the failure arc shown on Figure 2 were carefully chosen after due consideration of the geology and geomorphology of the area. The failure arc shown on Figure 2 is the critical failure arc (i.e. the one which produces the lowest FS when all parameters other than the radius of the circular failure arc are held constant).

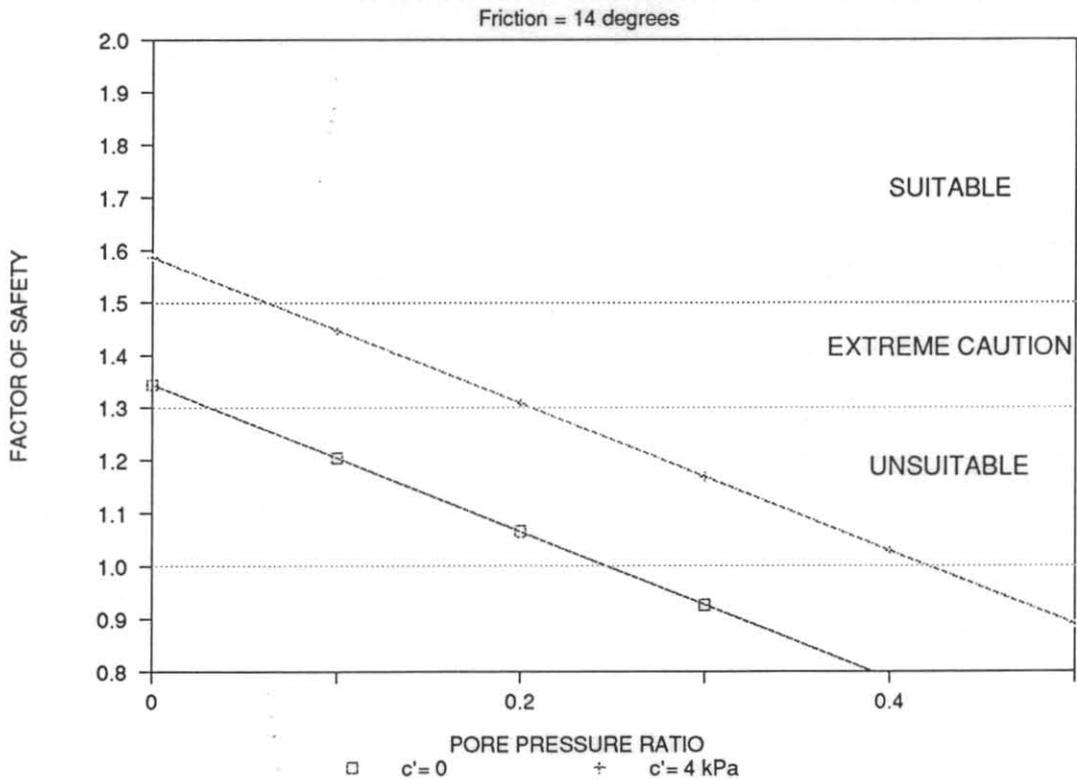
Figure 3. Results of stability analysis for critical failure arc at effective residual angle of internal friction, showing variation in factor of safety with pore pressure ratio at effective residual cohesion of zero and 4kPa.

Figure 3 shows the results of the stability analysis using the strength parameters as determined by the shear box test on sample 1. These results produce lower factors of safety than the results for sample 2. The results of the stability analysis are shown as Factor of Safety in relation to pore pressure ratio. A pore pressure ratio of 0.5 occurs when the assumed slide is totally saturated, a ratio of 0.25 occurs when the assumed slide is half saturated, and a ratio of 0.0 occurs when the assumed slide is fully drained.

The most conservative stability analysis is for an effective residual cohesion of zero. This type of analysis is used to determine the long term stability of a slope. The assumption is that small movements of parts of the potential landslide mass over long periods of time tend to reduce the internal effective residual cohesion to zero. Under these circumstances, for the critical failure arc shown on Figure 2, FS is always less than 1.5 at any pore pressure ratio for the laboratory determined strength parameters of sample 1. FS is equal to 1.3 when the pore pressure ratio is about 0.03. This is equivalent to a slope which is drained to a depth of 7.1 m at the point where the assumed sliding mass is thickest. In summary, drainage of the slope must be assured to a depth of 7.1 m below natural ground level if an FS of 1.3 or better is to be obtained.

The laboratory tests indicate that some effective residual cohesion is available in the short term to resist slope movement. In mobilising this effective residual cohesion, a FS equal to 1.5 occurs at a pore pressure ratio of about 0.06. This pore pressure ratio is equivalent to a slope which is drained to a depth of 6.6 m. If a less conservative approach is adopted where a FS as low as 1.3 is considered acceptable, the pore pressure ratio must not exceed 0.21. This is equivalent to a slope which is drained to a depth of 4.5 m below natural ground level.
