Division of Mines and Mineral Resources — Report 1990/18

A landslide investigation at the Pleasant Hills subdivision, Legana

by B. D. Weldon

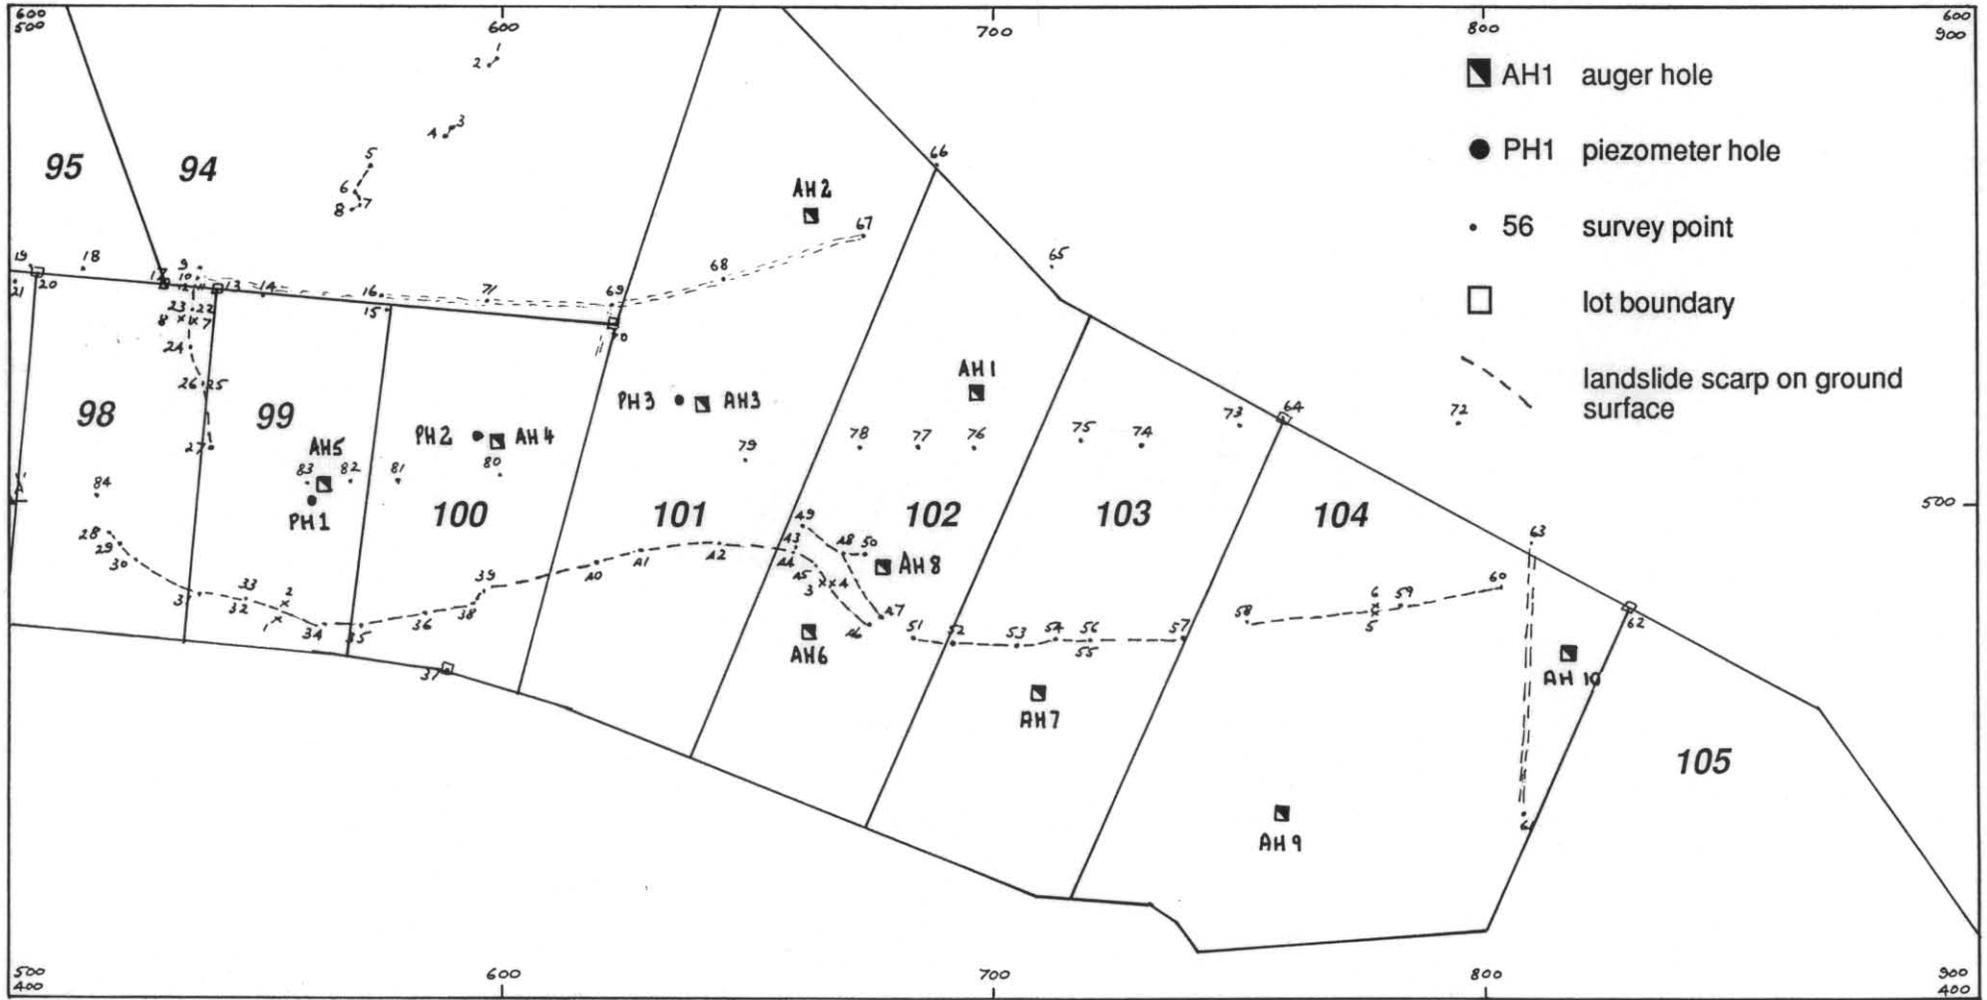
Following a period of high rainfall in mid-September 1989 a landslide of substantial proportions (fig. 1) developed on Stage III of the Pleasant Hills subdivision. The extent of the landslide has been delineated by survey. Investigations were conducted to determine the reason for the landslide.

A trailer-mounted auger drill rig was used to investigate the landslide area. In general, the auger holes (fig. 1) encountered grey-brown silty topsoil from the surface to about 0.4 m depth, yellow-brown clay to about 1.6 m depth, and brown clay to the maximum depth of investigation (7.5 m). Grey clay layers were occasionally intersected between 1.6 and 2.5 m depth. A limonite gravel was intersected at about 6.5 m depth. This was underlain by brown clay.

Figure 1. Extent of landslip area, Pleasant Hills subdivision Stage III, showing auger and piezometer holes and survey points.

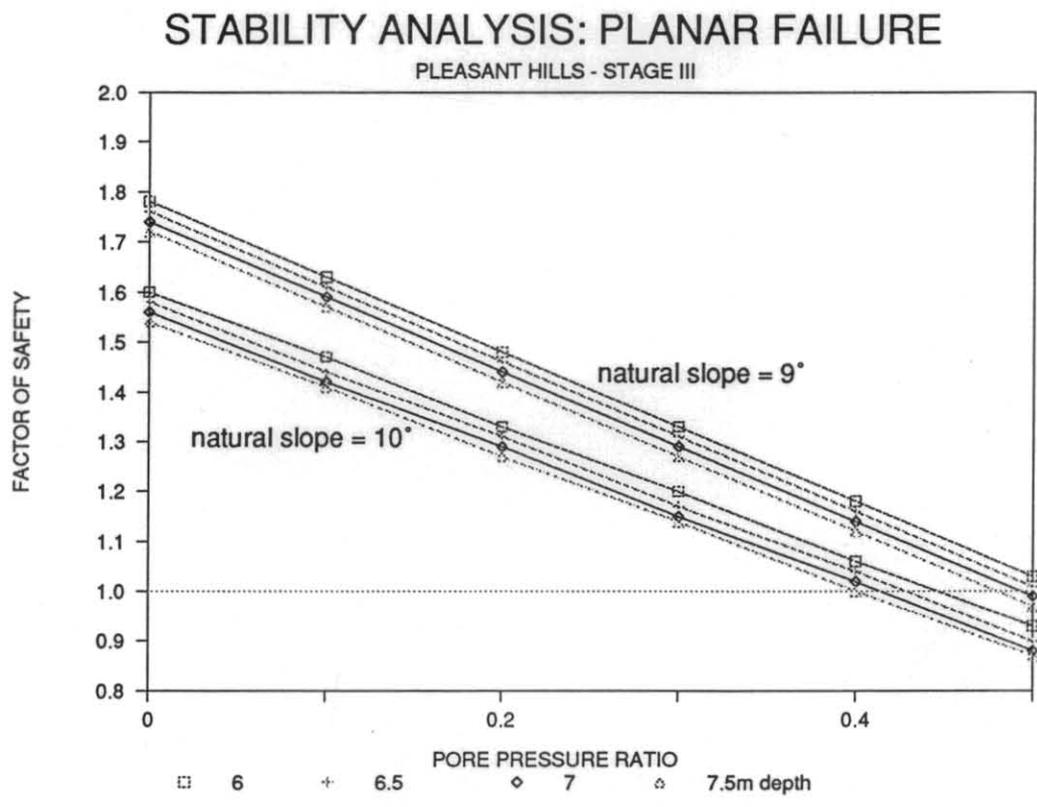
Planar failure stability analysis was performed using the computer program PLANAR (Weldon, 1989). The results for the parameters mentioned above are shown on Figure 2 as a plot of pore pressure ratio versus factor of safety. The pore pressure ratios at which failure occurs (i.e. FS = 1.0) are greater than 0.4. This is higher than that indicated by observation after the actual failure.

Figure 2a. Effective residual angle of internal friction = 13°, effective residual cohesion = 6 kPa.

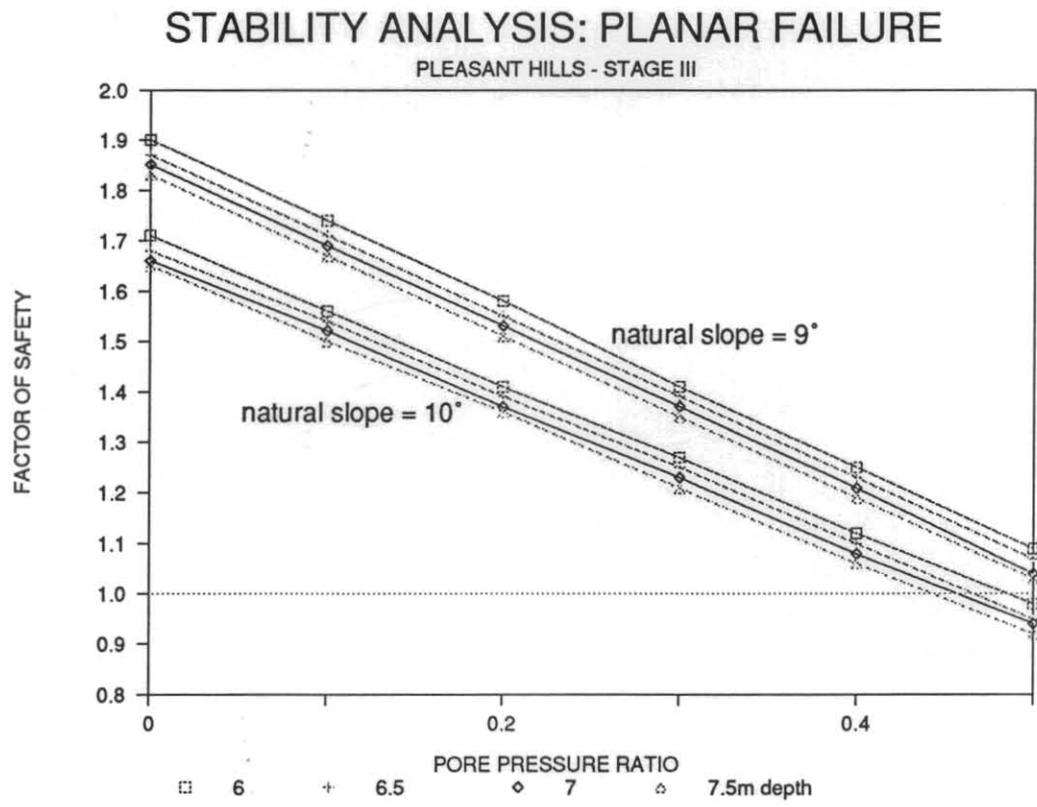
Figure 2b. Effective residual angle of internal friction = 14°, effective residual cohesion = 6 kPa.

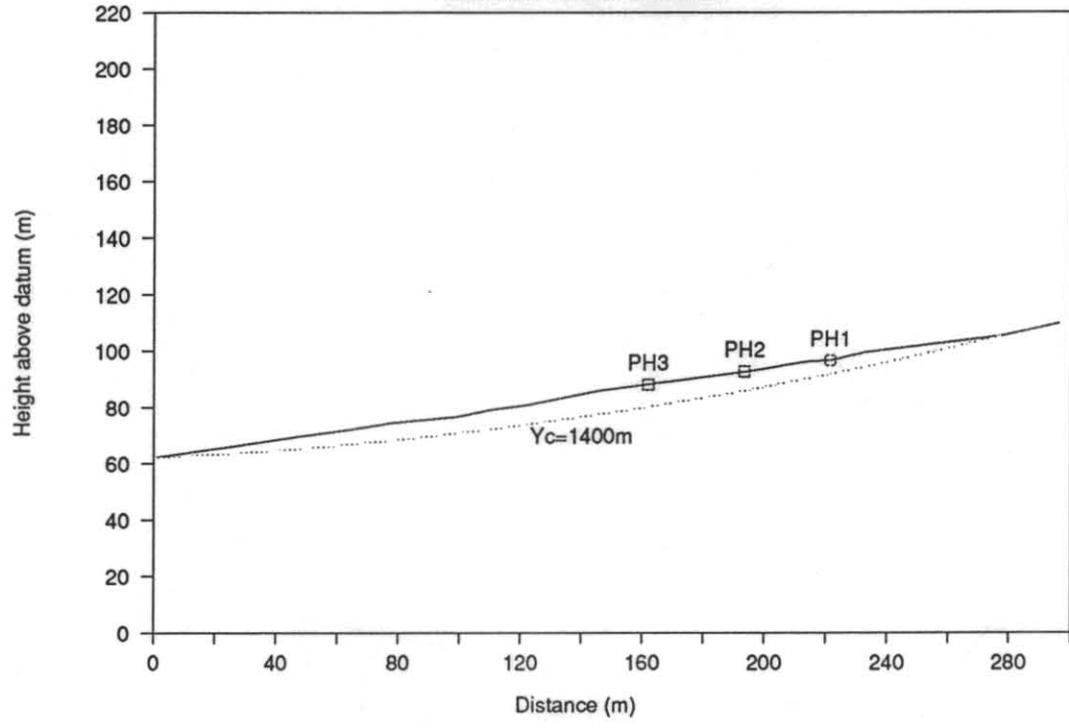
The depth to the presumed failure plane measured at piezometer holes 1–3, the head scarp, and the presumed toe (at the tributary of Muddy Creek) determines the position for any circular failure arc. A large radius circle (i.e. Yc in the range 1200–1400 m) is therefore required to meet these requirements. Figure 3 shows a long section selected for circular stability analysis using the computer program SLIPCIRC (Weldon, 1987b). The results of the analysis are presented in Figure 4 as a plot of pore pressure ratio versus factor of safety. For a fully saturated slope (i.e pore pressure ratio equal to 0.5), the FS with Yc = 1200 m is 1.09, and for Yc = 1400 m FS is 1.163.

Figure 3. Cross section for circular failure stability analysis. Approximate location of piezometer holes shown. Failure surface for $Y_c = 1400$ m is shown.

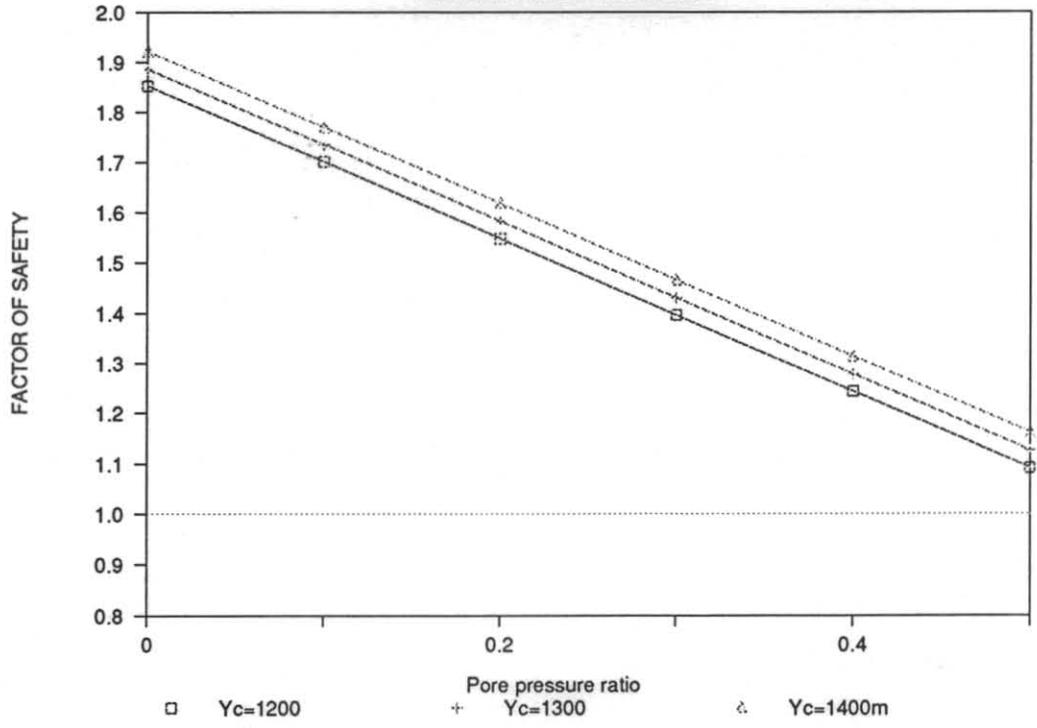
In summary, stability analysis shows that for the planar failure model, failure occurs at higher pore pressure ratios than that observed from field observations after the failure. The failure may have therefore resulted in a reduction of pore pressures after the event with some drainage occurring. The circular failure model technically does not produce failure (i.e. where FS is equal to or less than 1.0). This could be attributed to the fact that the tested samples may not have been from the actual failure zone. The failure zone may have been deeper than 7.5 m, the maximum depth of the auger holes.

Figure 4. Results of circular failure stability analysis plotted as pore pressure ratio versus factor of safety.
 Effective residual cohesion = 6 kPa
 Effective residual angle of internal friction = 13°
 Assumed density = 20 kN/m³

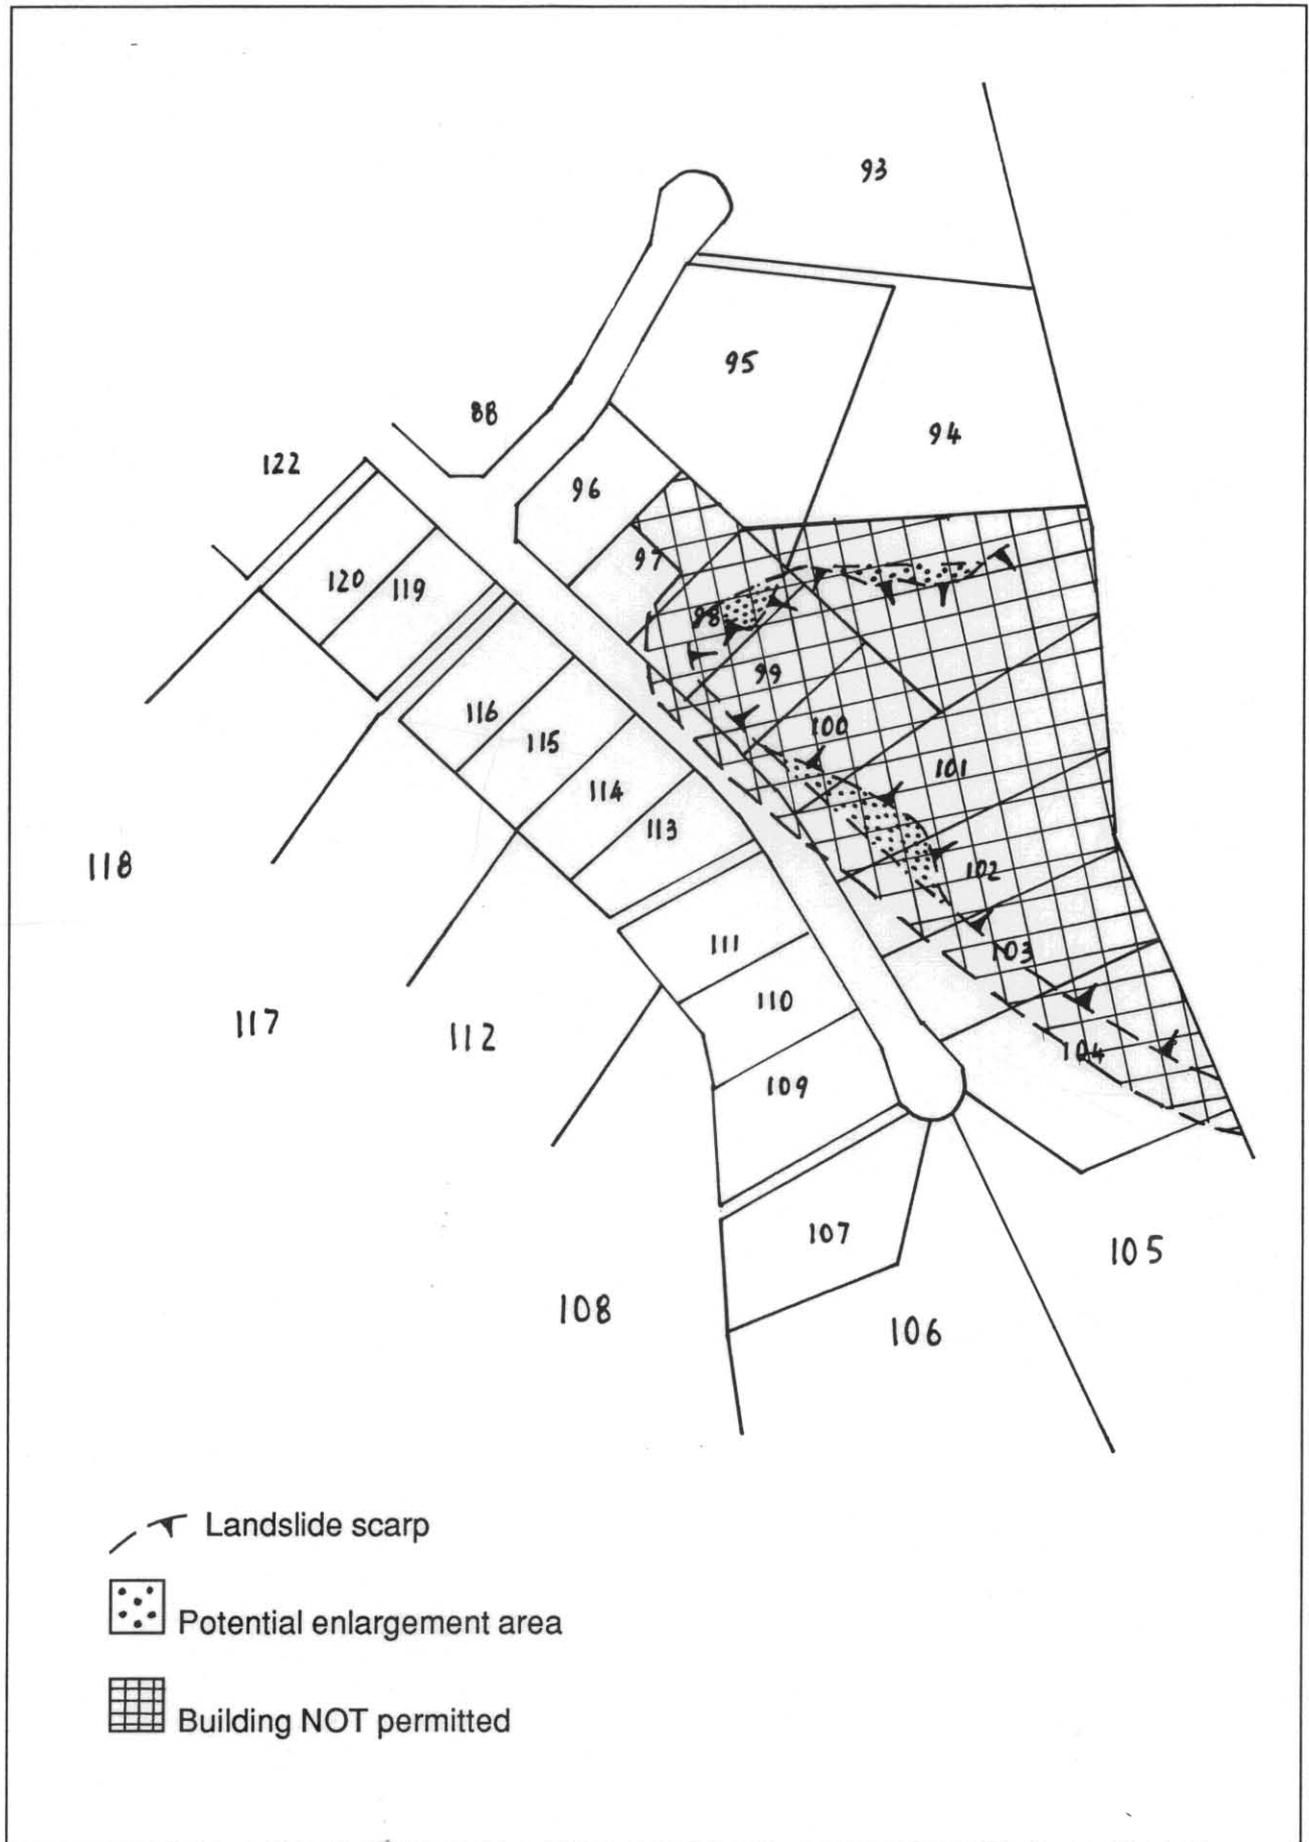
The landslide head and side scarps are outlined in Figure 5. Obviously building cannot be located on the mass which is subject to movement. Once failure has occurred there is a possibility of further movement, particularly in the head and side scarp regions. These regions have a risk of instability caused by removal of support previously provided by the materials which have now failed. There is also a possibility of increased pore pressure due to aquifer sealing caused by disruption of the gravel layer which contains the groundwater.

Due to the irregular nature of the landslide scarp, areas of high instability have been indicated as a dotted area on Figure 5. A buffer zone, 20 m in width, has also been delineated around the landslide area for reasons of potential instability described above. This buffer zone is a region where building should not be permitted, and is included in the hatched area shown on Figure 5.

Figure 5. Areas considered NOT suitable for building, Pleasant Hills subdivision Stage III.

It is therefore concluded that lots 98, 99, 100, 101 and 102 are unsuitable for development. There may be sufficient area on lot 103 to construct a dwelling. It is advised that the house be sited as close to the roadway as possible. Lot 104, although steeper than the land which has failed, can be built on in the area not hatched on Figure 5. Auger holes on the steeper part of this lot indicate that the underlying material is dolerite (which in this case is considered stable) and not the Tertiary sediments which have failed elsewhere on the subdivision.

Lot 94 is sufficiently large that suitable house sites exist on the lot. Preferred sites occur adjacent to the long access track. Building should not be permitted on this lot within the hatched area shown on Figure 5.

Test pits on lot 97 indicate that the risk of landslide is lower on the front half of this lot than the rear half. A house can be located on this lot provided it is not sited within the hatched area shown on Figure 5.

The developer has already mentioned the possibility of combining lots to form larger land parcels. Under no circumstances should building be permitted in the hatched area shown on Figure 5. Part of the hatched area could be given over to public open space and extensively planted with trees. This will have a stabilizing influence on the area.
