**Division of Mines and Mineral Resources — Report 1990/20**
**Investigation of a landslide,  
Hone Road – Officer Street, Rosetta**
*by B. D. Weldon*
**Abstract**

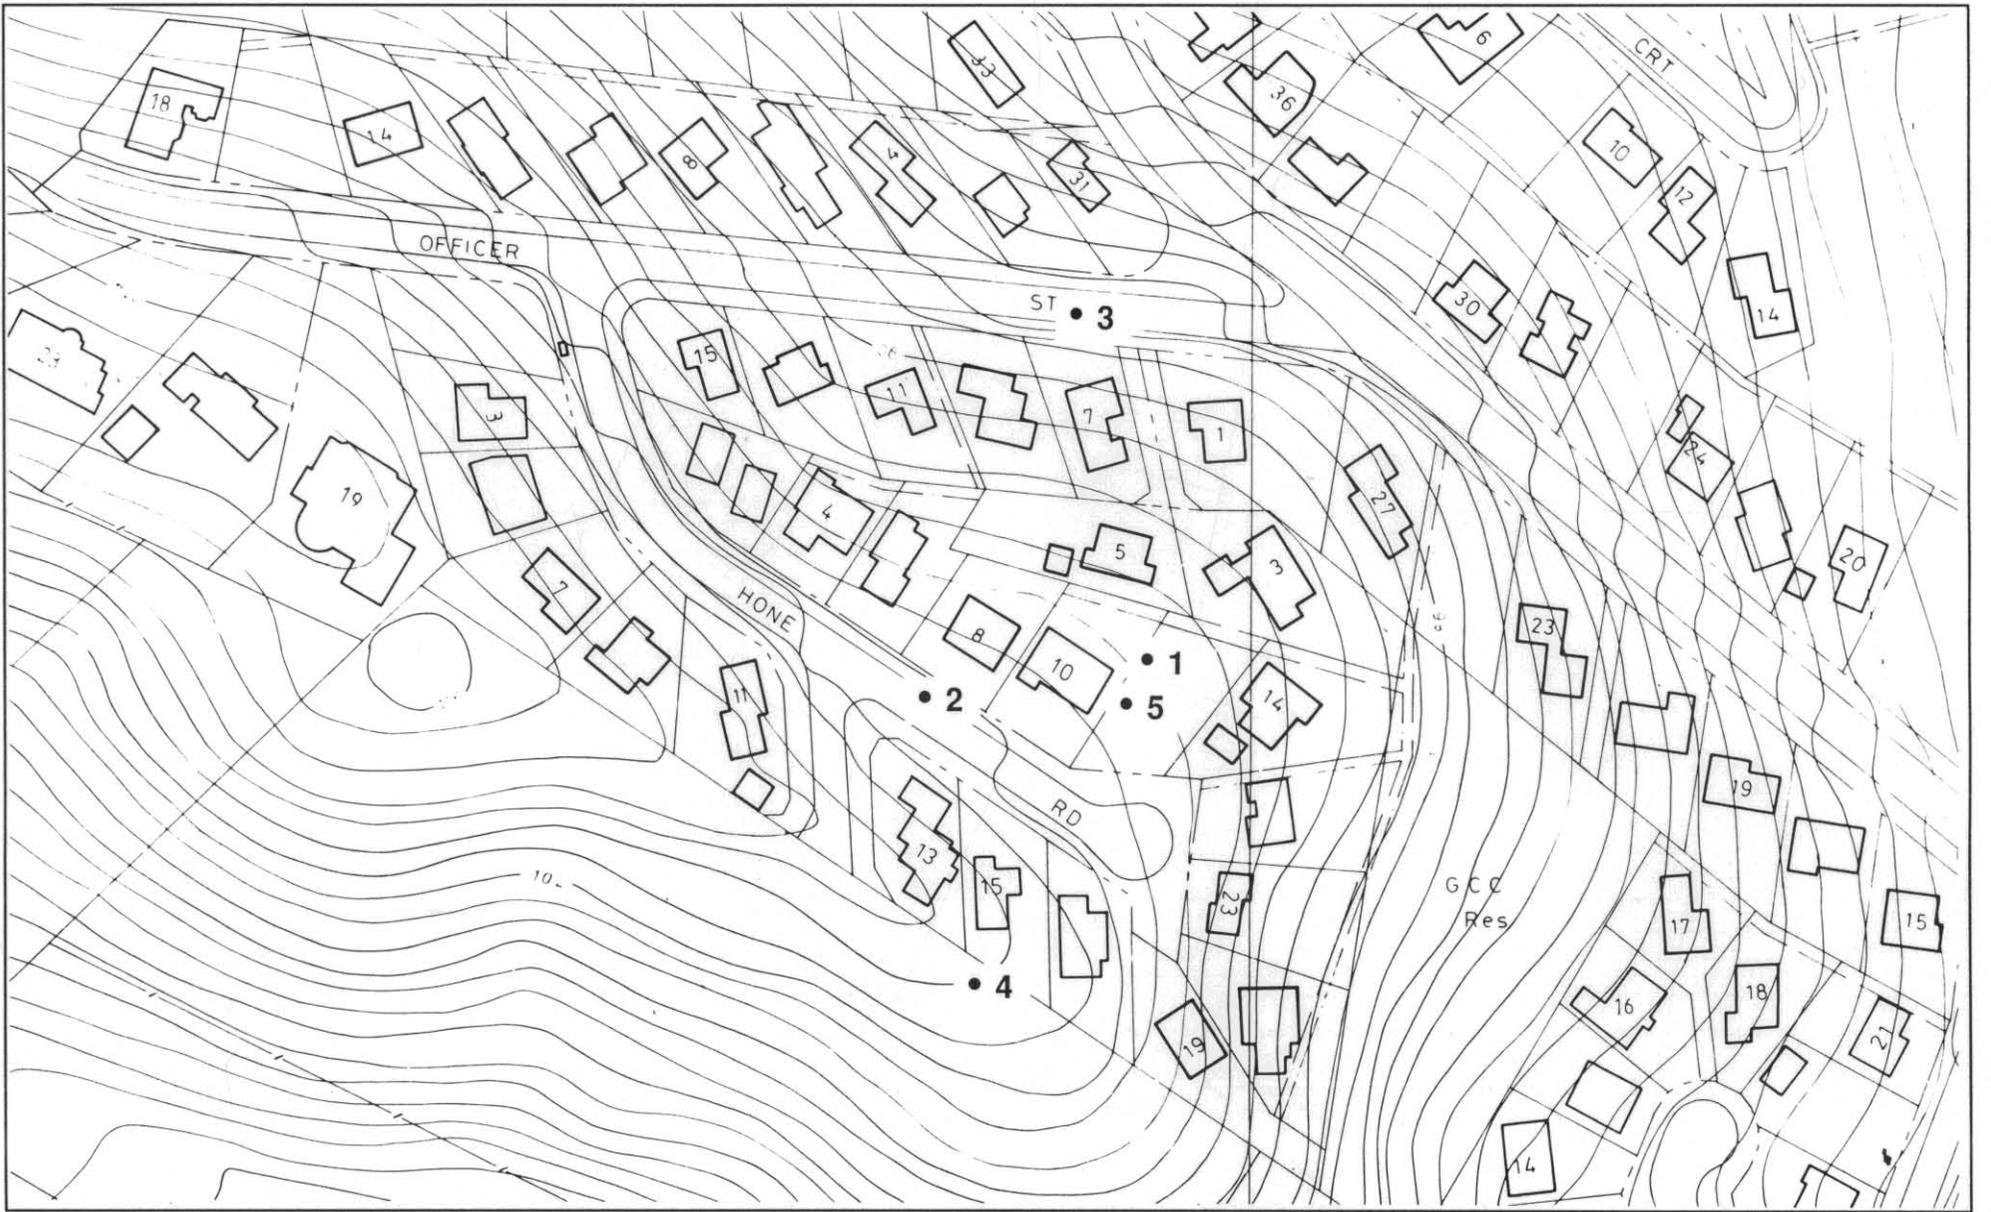
Figure 1. Location of boreholes, Hone Road area, Rosetta.

Five boreholes were drilled at the locations shown on Figure 1. A summary of the borings is provided in Table 1. Engineering logs are provided in Appendix A. Standard Penetration Tests (SPT's) were performed at 1.5 m intervals as the holes were advanced.

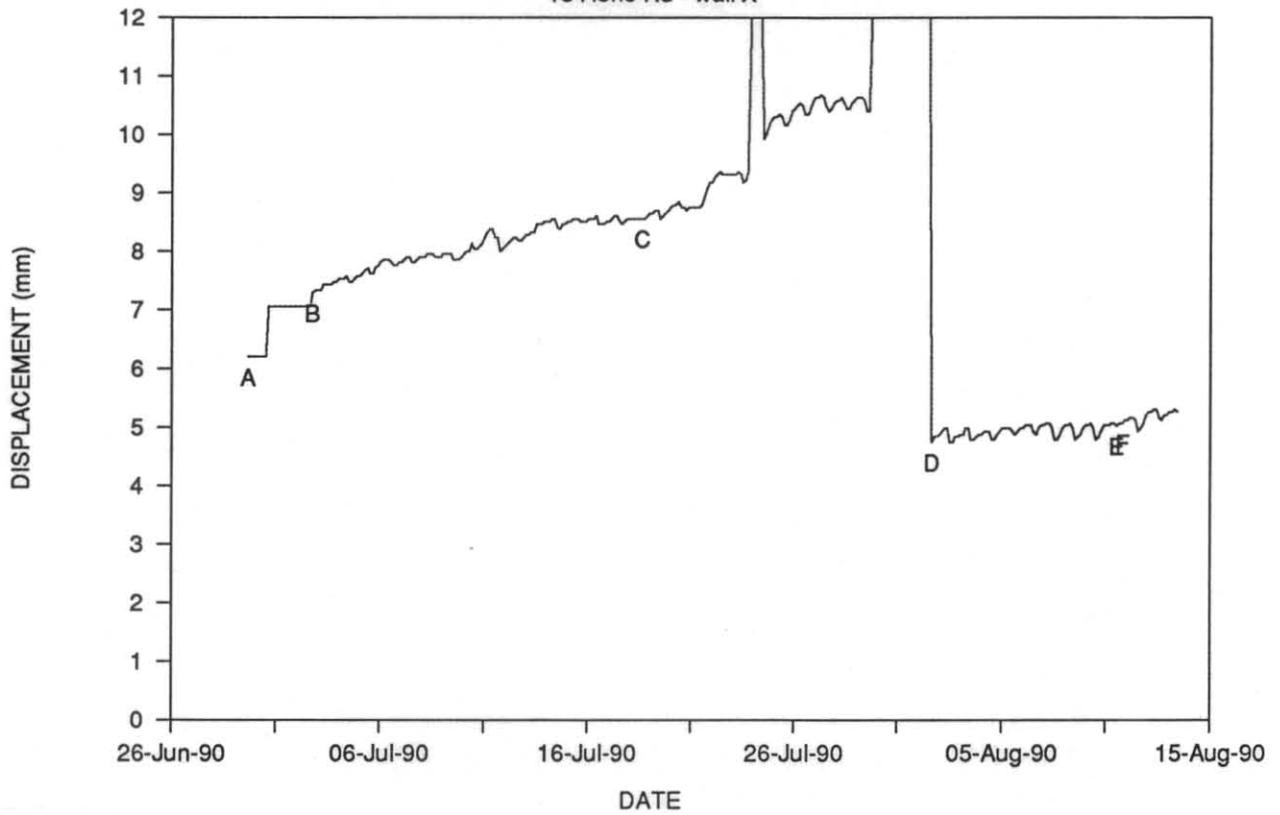
15 Hone Rd - wall X

The data collected to date is presented in Appendix B and graphically shows that movement is continuing to occur. The network of monitors will be completed in the near future to include a water depth sensor in Borehole 3. This will increase our ability to relate rainfall events, groundwater levels and rates of movement.
