**Division of Mines and Mineral Resources — Report 1990/26**

# Shallow subsurface investigations of a proposed subdivision at Newstead

by *B. D. Weldon*

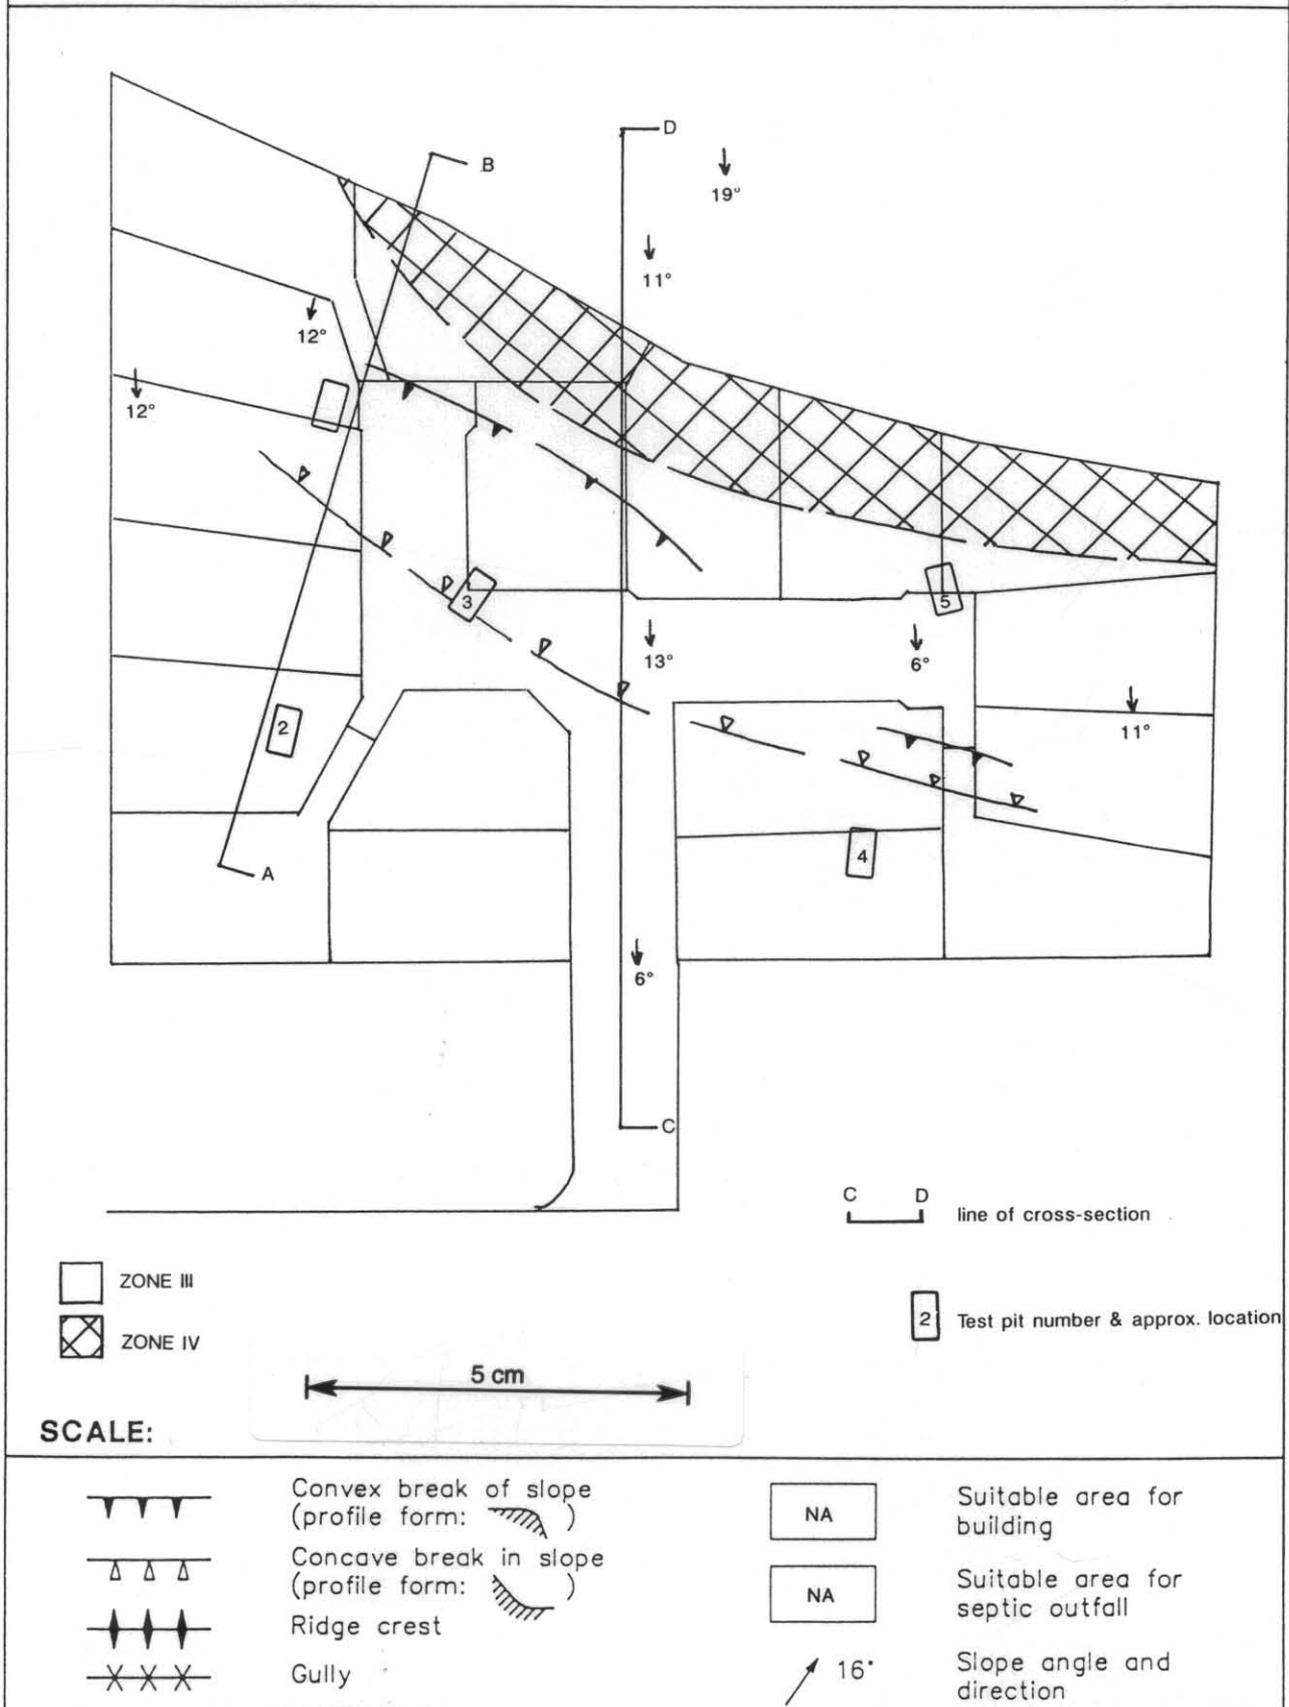
Figure 1. Proposed subdivision at Newstead showing approximate location of test pits, Tamar Valley advisory landslip zones, and cross-section lines used in stability analysis.

Several back-hoe test pits were excavated at the approximate locations indicated on Figure 1. The engineering logs are presented in Appendix 1. Slickensided high plasticity clay was encountered in test pit 1. The slickensides indicate prior mass movement of the clay. In test pit 5 a sand was encountered interlayered with clay. Sand was not encountered in any other test pit.

The morphology of the area suggests that ancient landslide activity has occurred, and part of the proposed subdivision has been zoned on the Tamar Valley advisory landslip zone map as zone IV (i.e. old landslides and adjacent areas). The balance of the proposed subdivision is mapped as zone III (i.e. potential landslide areas). A cautious approach is therefore warranted in assessing the impact of subdividing the area. For this reason, a factor of safety greater than 1.5 should be achieved over the land to be subdivided. The stability analysis indicates that this is only achieved by providing drainage to depths in excess of six metres.

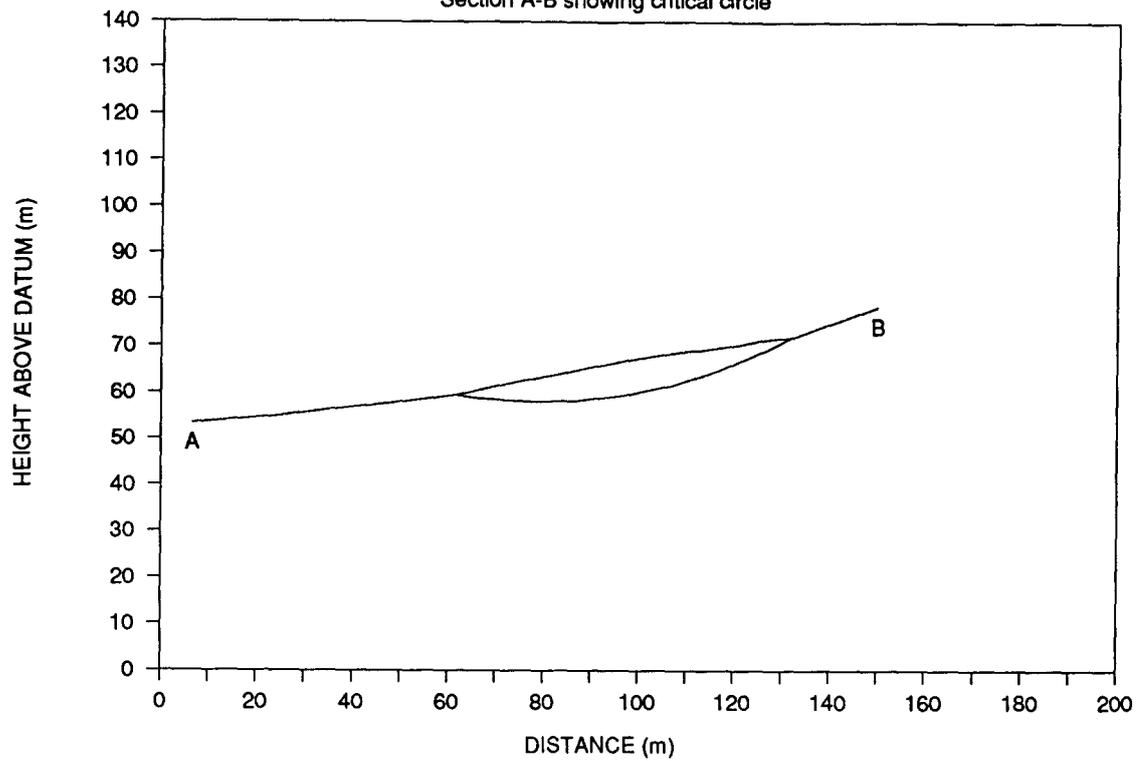
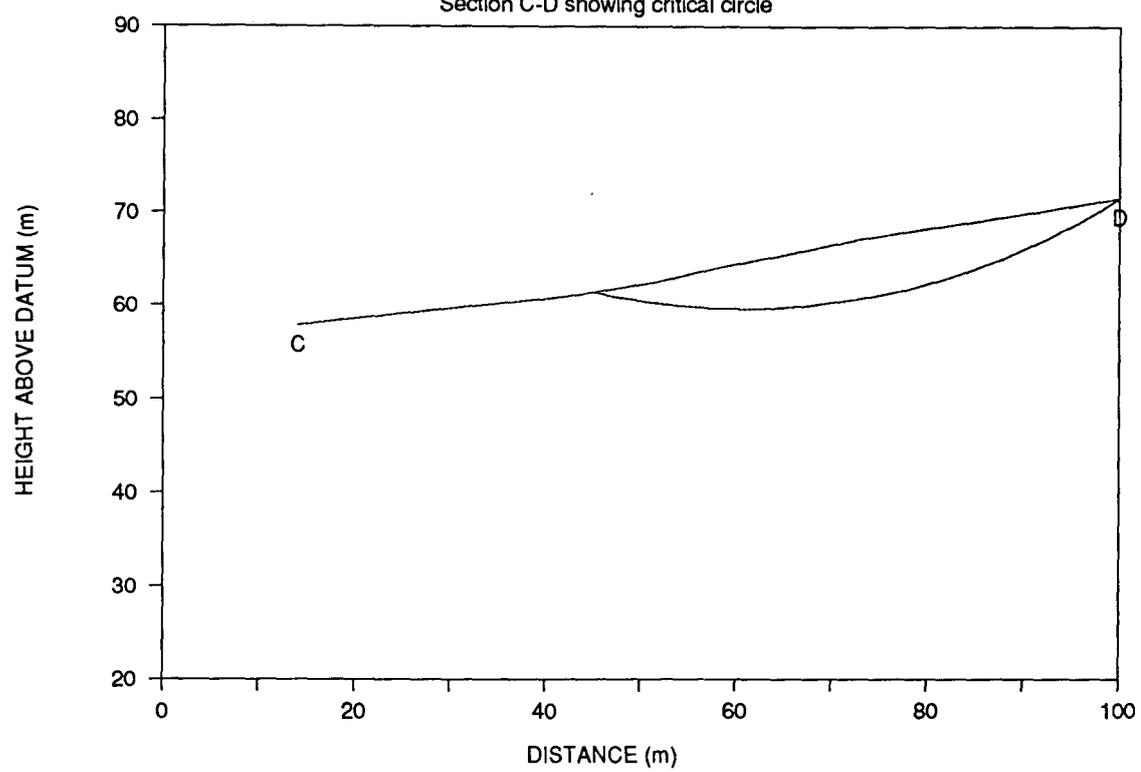
Figure 2. Cross sections used for circular stability analysis, showing the critical failure arc between selected end points.

The most conservative stability analysis is for an effective residual cohesion of zero. This type of analysis is used to determine the long term stability of a slope. The assumption is that small movements of parts of the potential landslide mass over long periods of time tend to reduce the internal effective residual cohesion to zero. Under these circumstances, for the critical failure arcs shown in Figure 2, FS is always less than 1.5 at any pore

pressure ratio for the laboratory determined strength parameters. FS is equal to 1.3 when the pore pressure ratio is about 0.05 (section A-B) and 0.01 (section C-D). This is equivalent to a slope which is drained to a depth of 6.9 m (section A-B) and 6.3 m (section C-D) at the point where the assumed sliding mass is thickest. In summary, drainage of the slope must be assured to a depth of 6.9 m below natural ground level if an FS of 1.3 or better is to be obtained for long term stability.

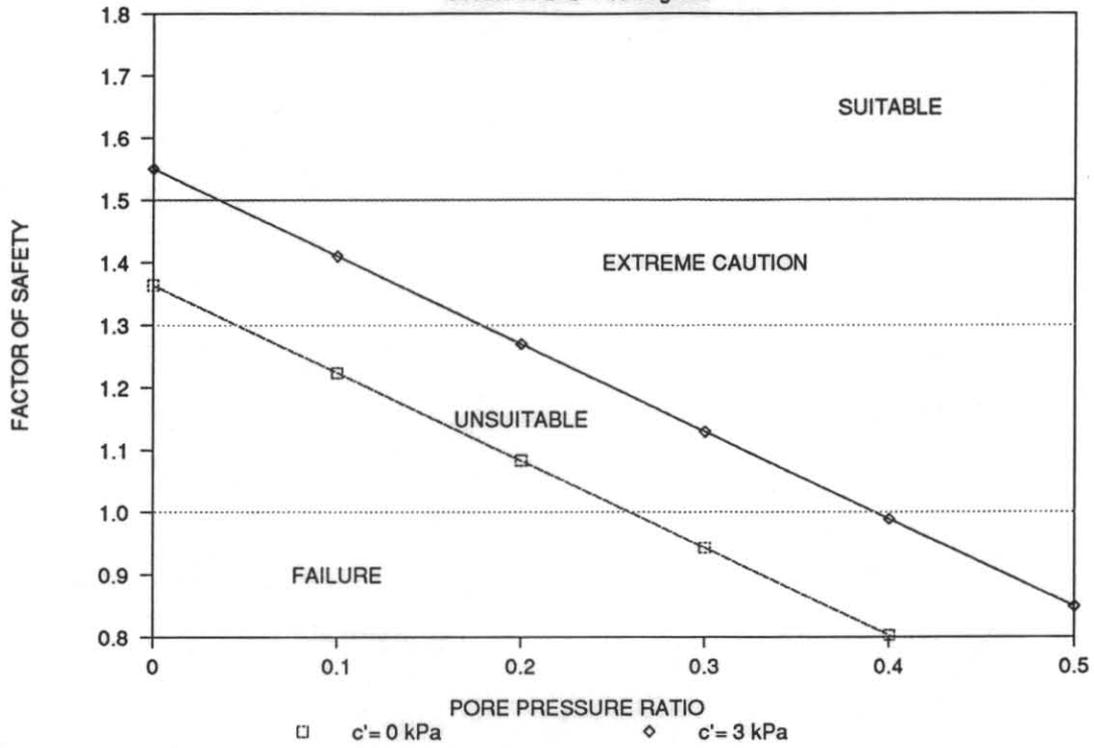
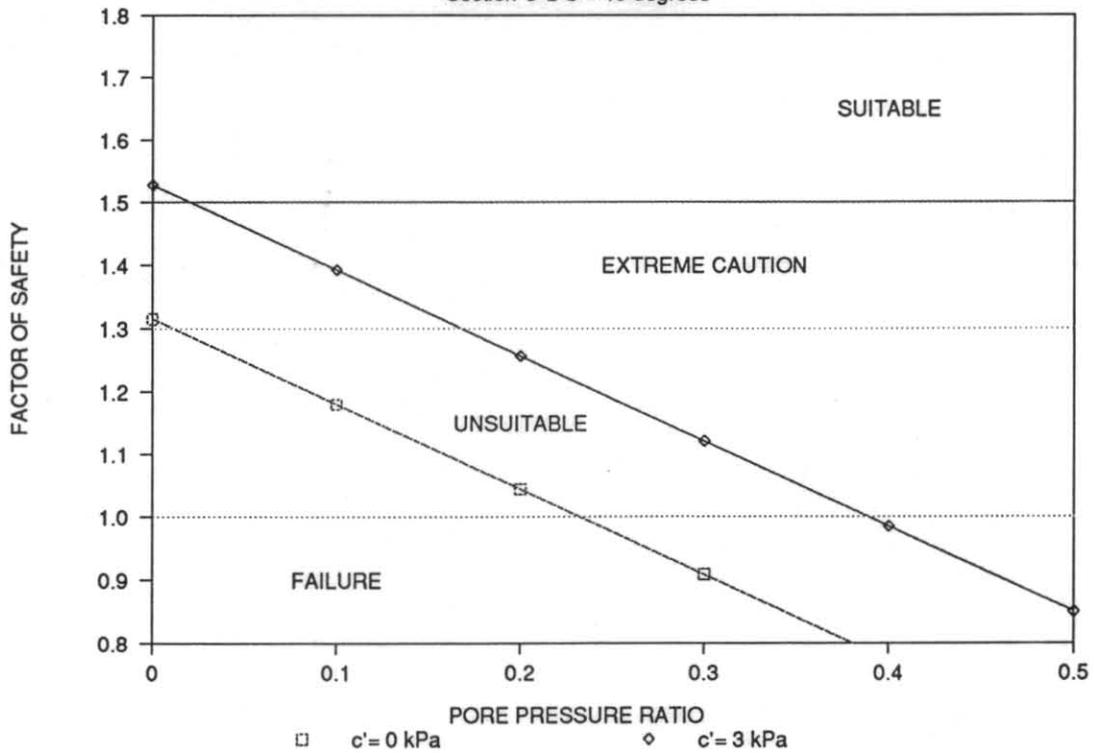
Figure 3. Results of circular stability analysis for cross-sections A-B and C-D plotted as Factor of Safety in relation to Pore Pressure Ratio for effective residual angle of friction of 13°.

Figure 3 shows the results of the stability analysis using the strength parameters as determined for this site by the shear box test for the sample at 3 m depth in test pit 1. It has been assumed that the soil strength parameters obtained from the shear box testing are applicable to the materials at greater depths. The results are shown on Figure 3 as Factor of Safety in relation to pore pressure ratio. A pore pressure ratio of 0.5 occurs when the assumed slide is totally saturated, a ratio of 0.25 occurs when the assumed slide is half saturated, and a ratio of 0.0 occurs when the assumed slide is fully drained.

The laboratory tests indicate that some effective residual cohesion is available in the short term to resist slope movement. In mobilising this effective residual cohesion, a FS equal to 1.5 occurs at a pore pressure ratio of about 0.04 (section A-B) and 0.02 (section C-D). These pore pressure ratios are equivalent to a slope which is drained to a depth of 7.1 m (section A-B) and 6.1 m (section C-D). If a less conservative approach is adopted where a FS as low as 1.3 is considered acceptable, the pore pressure ratio must not exceed 0.18 (section A-B) and 0.17 (section C-D). This is equivalent to a slope which is drained to a depth of 4.9 m below natural ground level (section A-B) and to 4.3 m (section C-D).

Stability analysis using these strength parameters, which are assumed to apply to the materials at greater depth, and a carefully selected circular failure arc indicates that drainage of the slope to depths in excess of 6 m must be installed and effectively maintained to obtain acceptable factors of safety.

Drainage to the required depth is considered difficult to achieve, and the construction of drains may have a deleterious effect on stability because of the removal of lateral support.

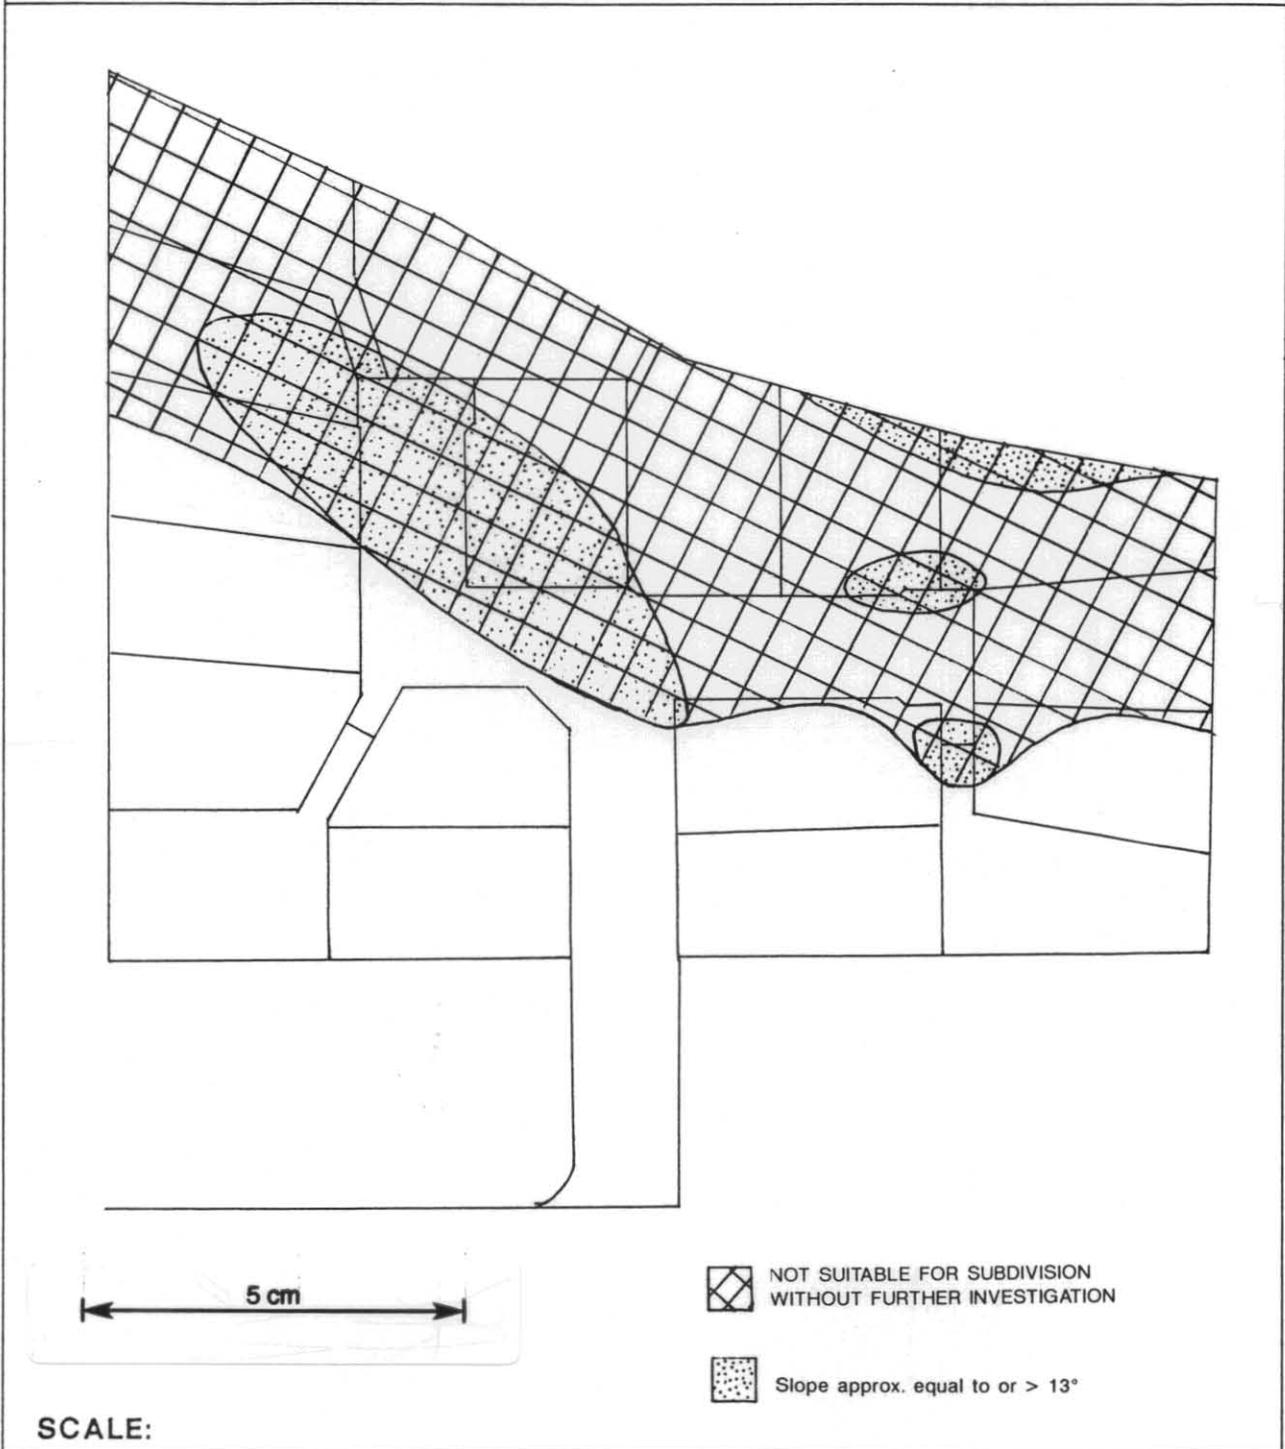
**Figure 4.** Proposed subdivision at Newstead showing areas where the slope is approximately equal to or greater than 13°. The area not suitable for subdivision without further subsurface investigation is hatched.

Slopes in excess of 13° which are underlain by clay have a high risk of landslide movement. Such areas are delineated on Figure 4. Building should not be permitted in these areas. It is also advised that council service trenches should not traverse these areas.

Further investigation of the subsurface conditions beneath the steeper parts of the slope is warranted. The basic assumption that the soil strength parameters obtained from the shear box testing can be applied to the materials at greater depth may not be valid. In the absence of these investigations, development of the property should be restricted to the area delineated on Figure 4. Additional investigations may determine that parts of the area, considered here to be unsuitable for development (refer Figure 4), are not at risk from landslide movement and therefore could be developed.

A revision of the subdivision layout will be necessary.
