Division of Mines and Mineral Resources — Report 1990/29

Interim report on a landslide at Hone Road, Rosetta

by B. D. Weldon

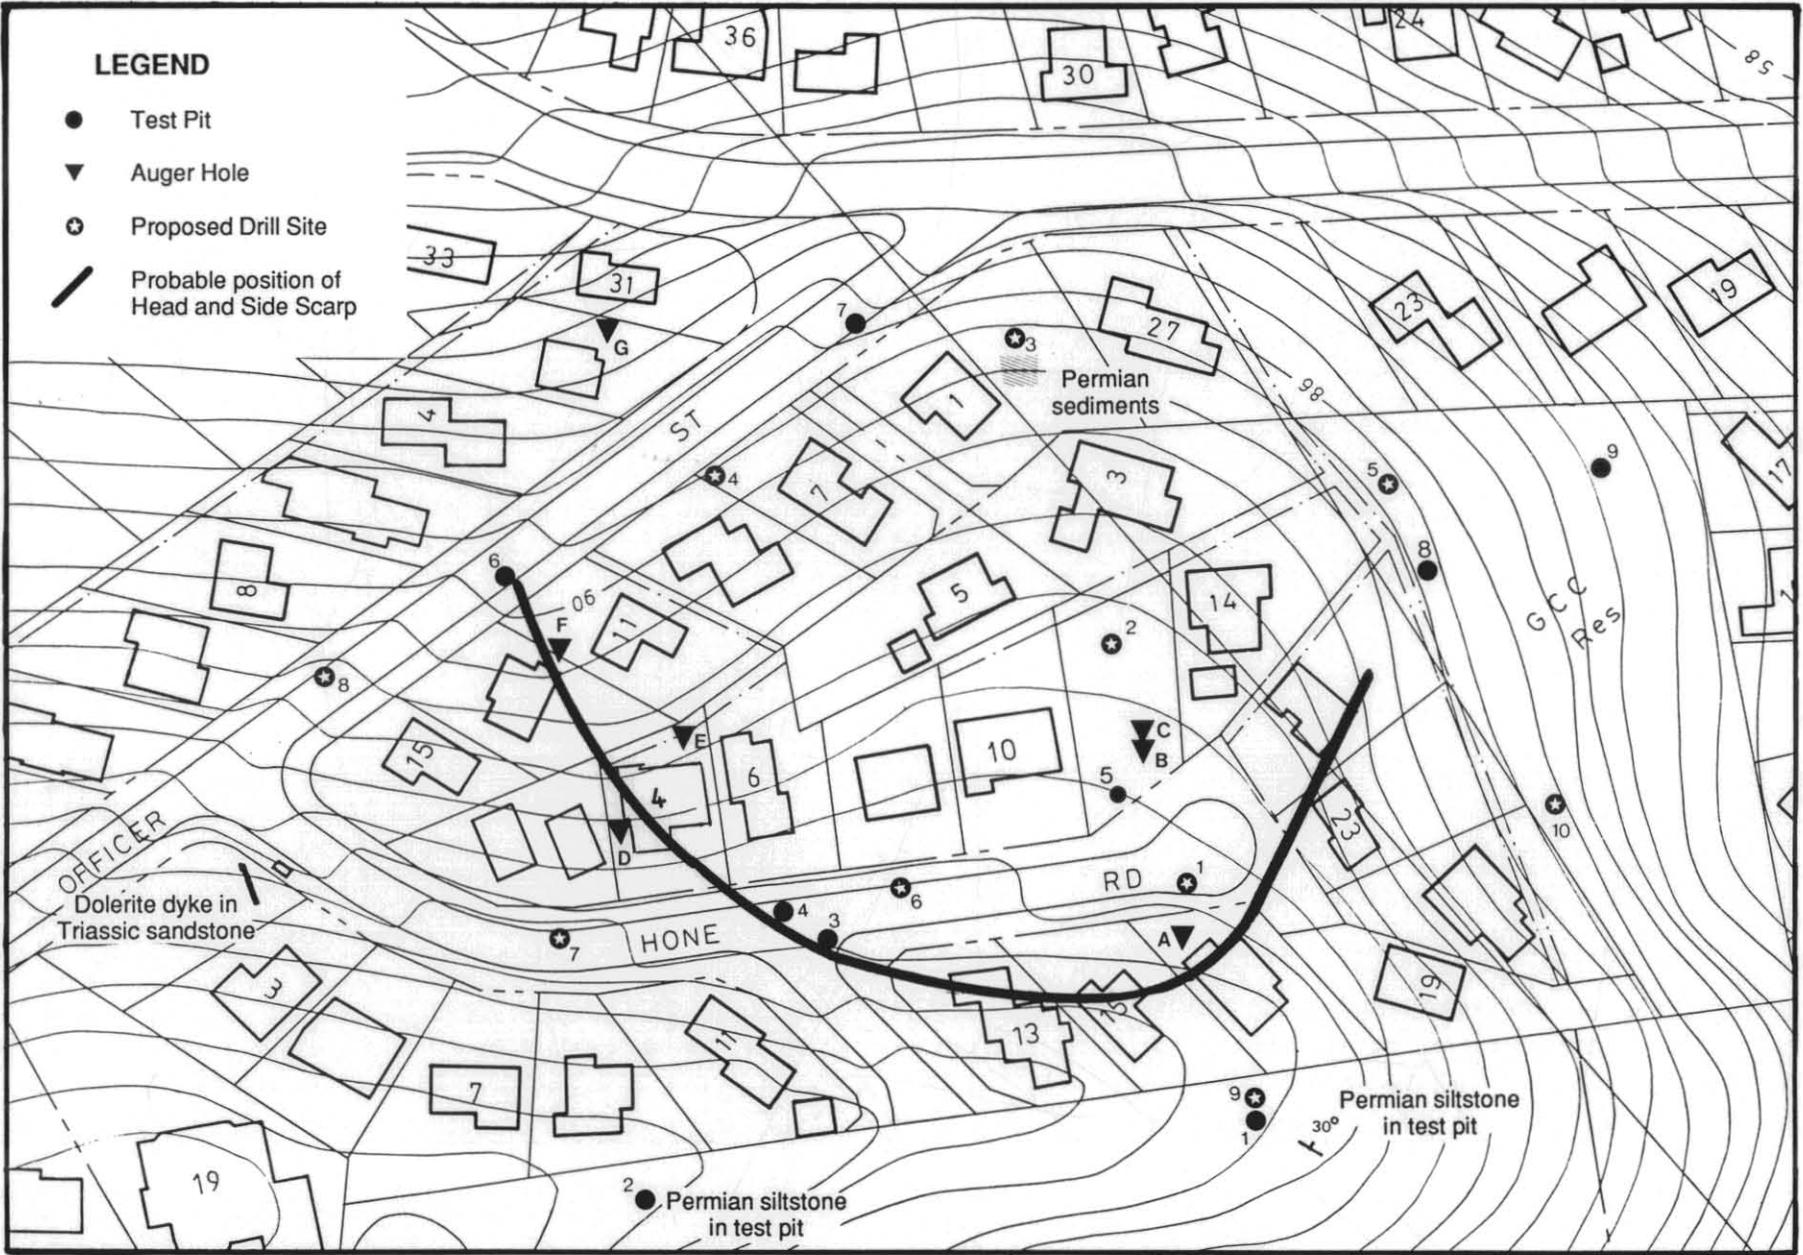
Figure 1. Location diagram — land movements, Hone Road, Rosetta

Figure 1 is presented as a fact map showing the locations of rock exposures and the positions of test pits and auger holes. Table 1 summarises the materials encountered in the test pits and auger holes.

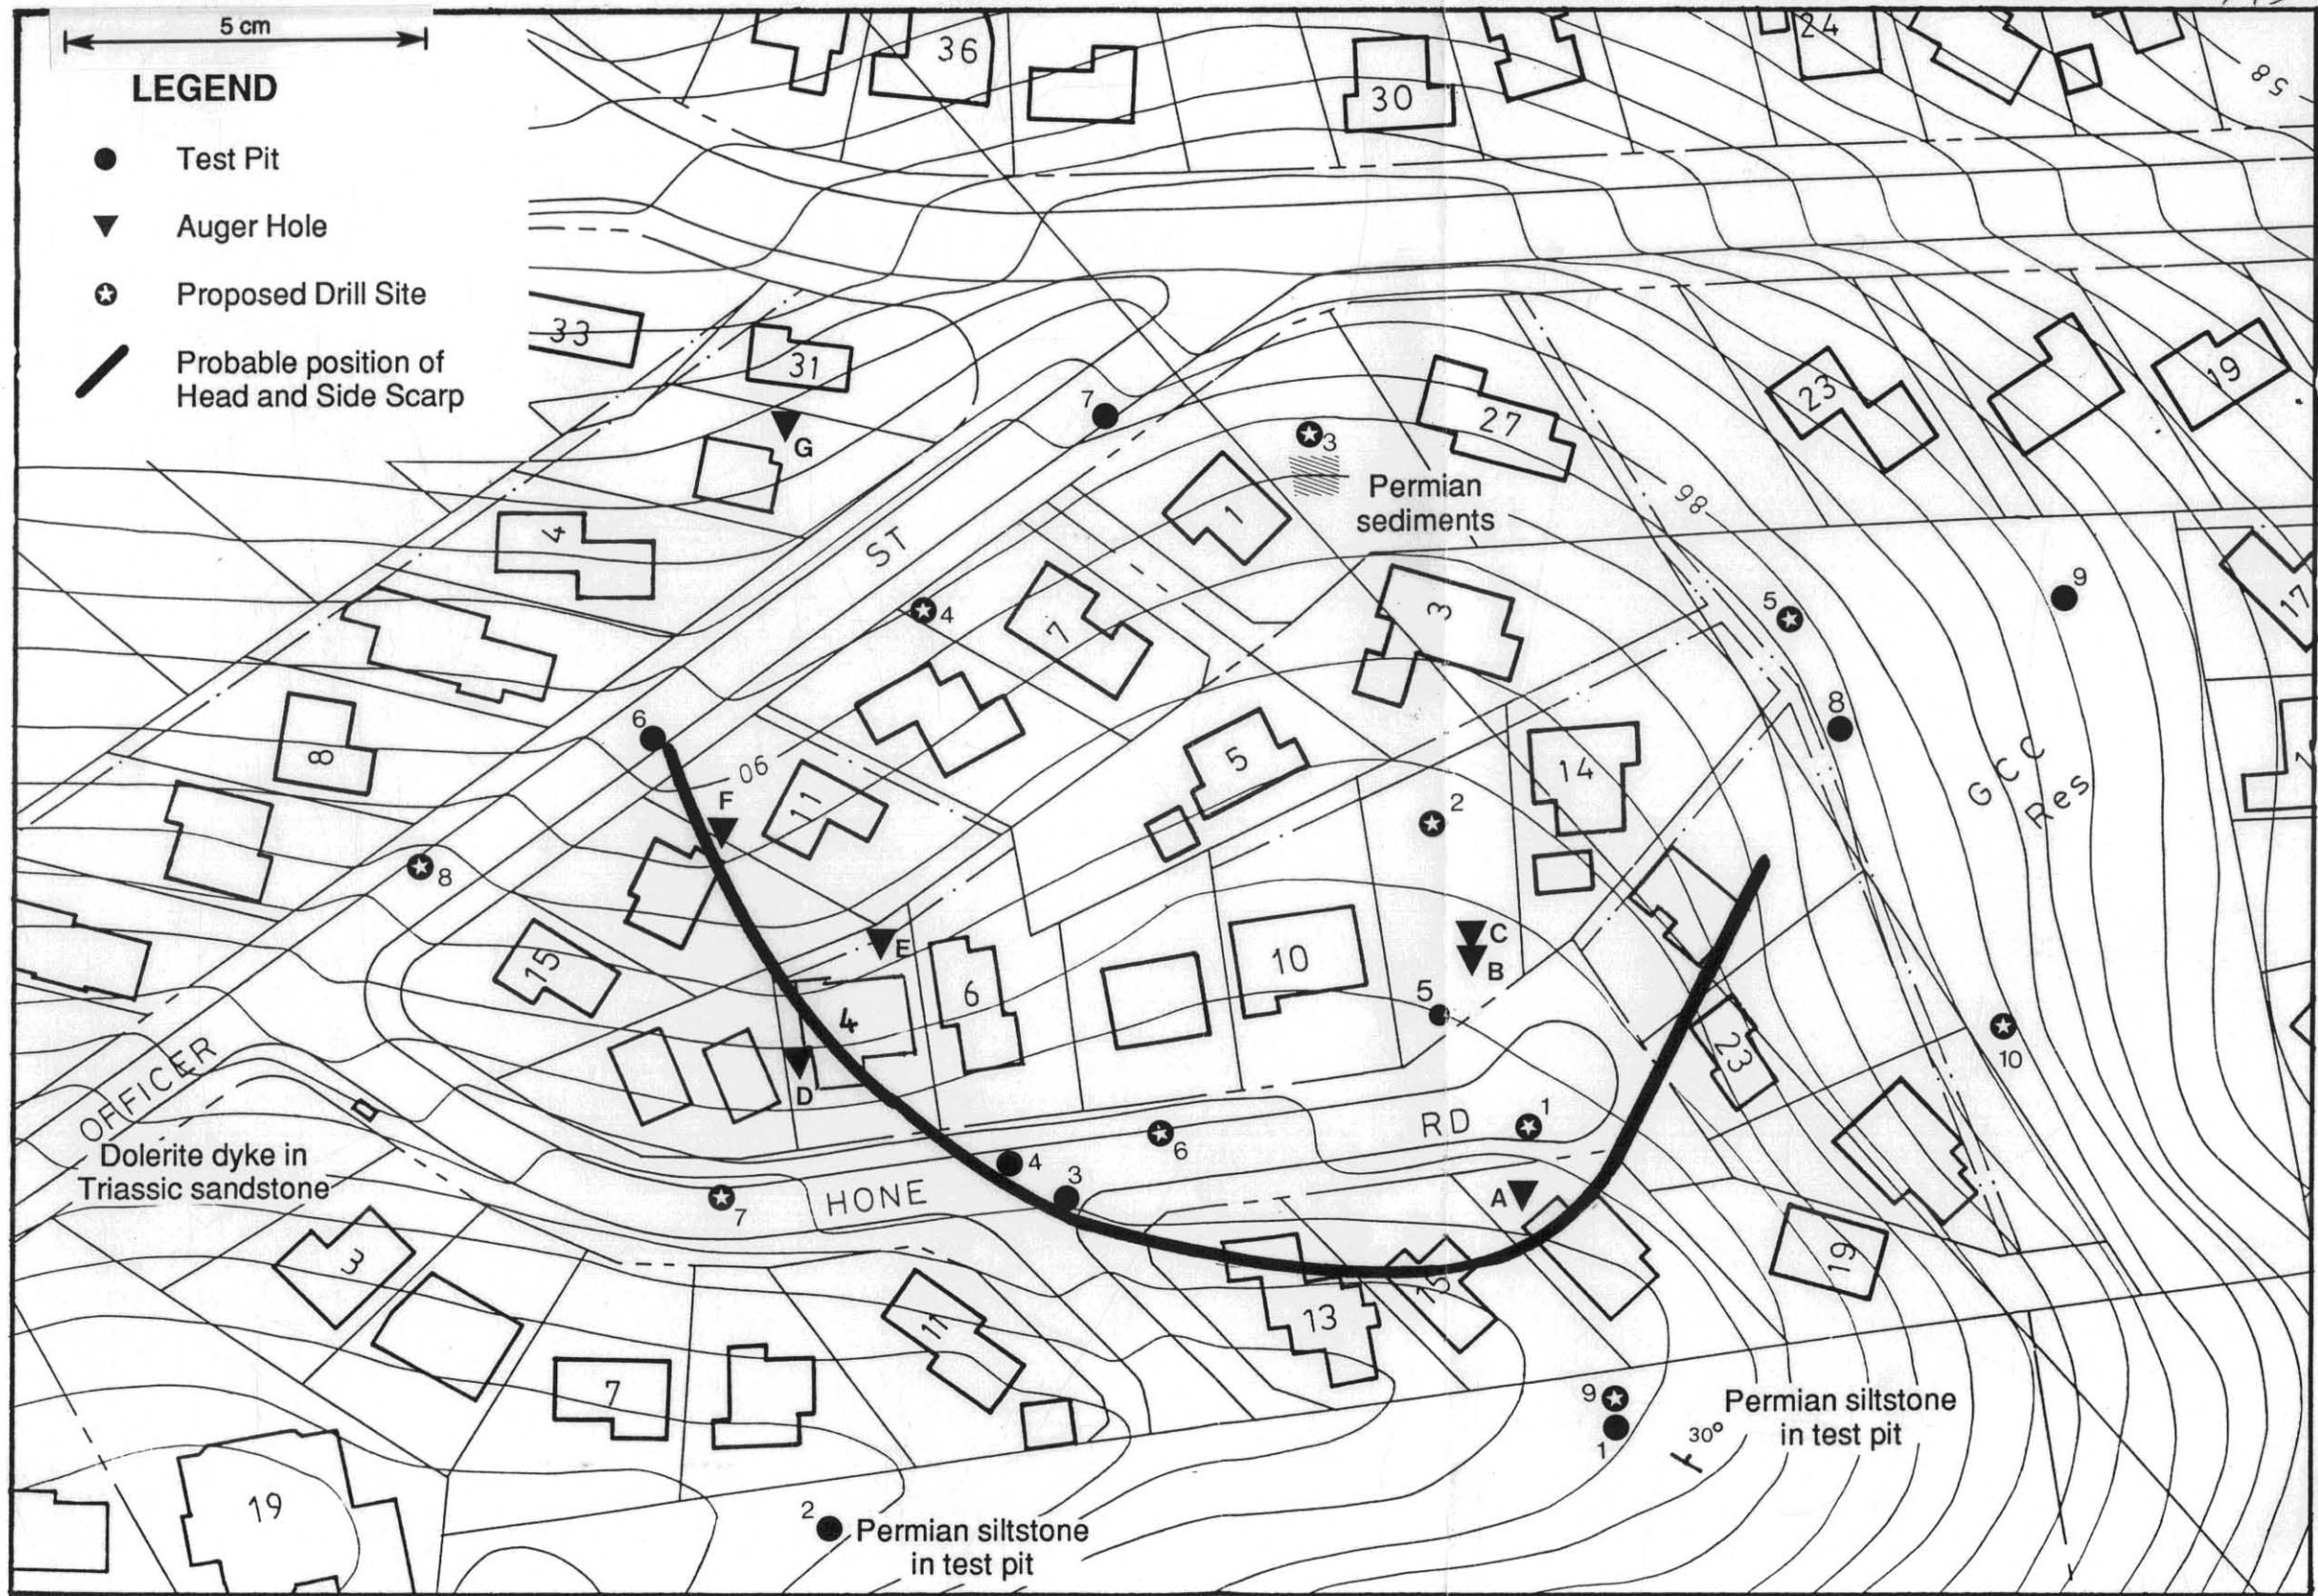
- Test Pit
- ▼ Auger Hole
- ⊛ Proposed Drill Site
- ▬ Probable position of Head and Side Scarp

The locations where it is considered desirable to drill are shown on the attached plan. The holes need to be monitored and logged by an engineering geologist to obtain maximum information. Approximate costing of this work, if undertaken by the Division of Mines and Resources, is presented in Appendix 3.
