Division of Mines and Mineral Resources — Report 1991/33

Investigations at a proposed subdivision at Legana

by *W. L. Matthews*

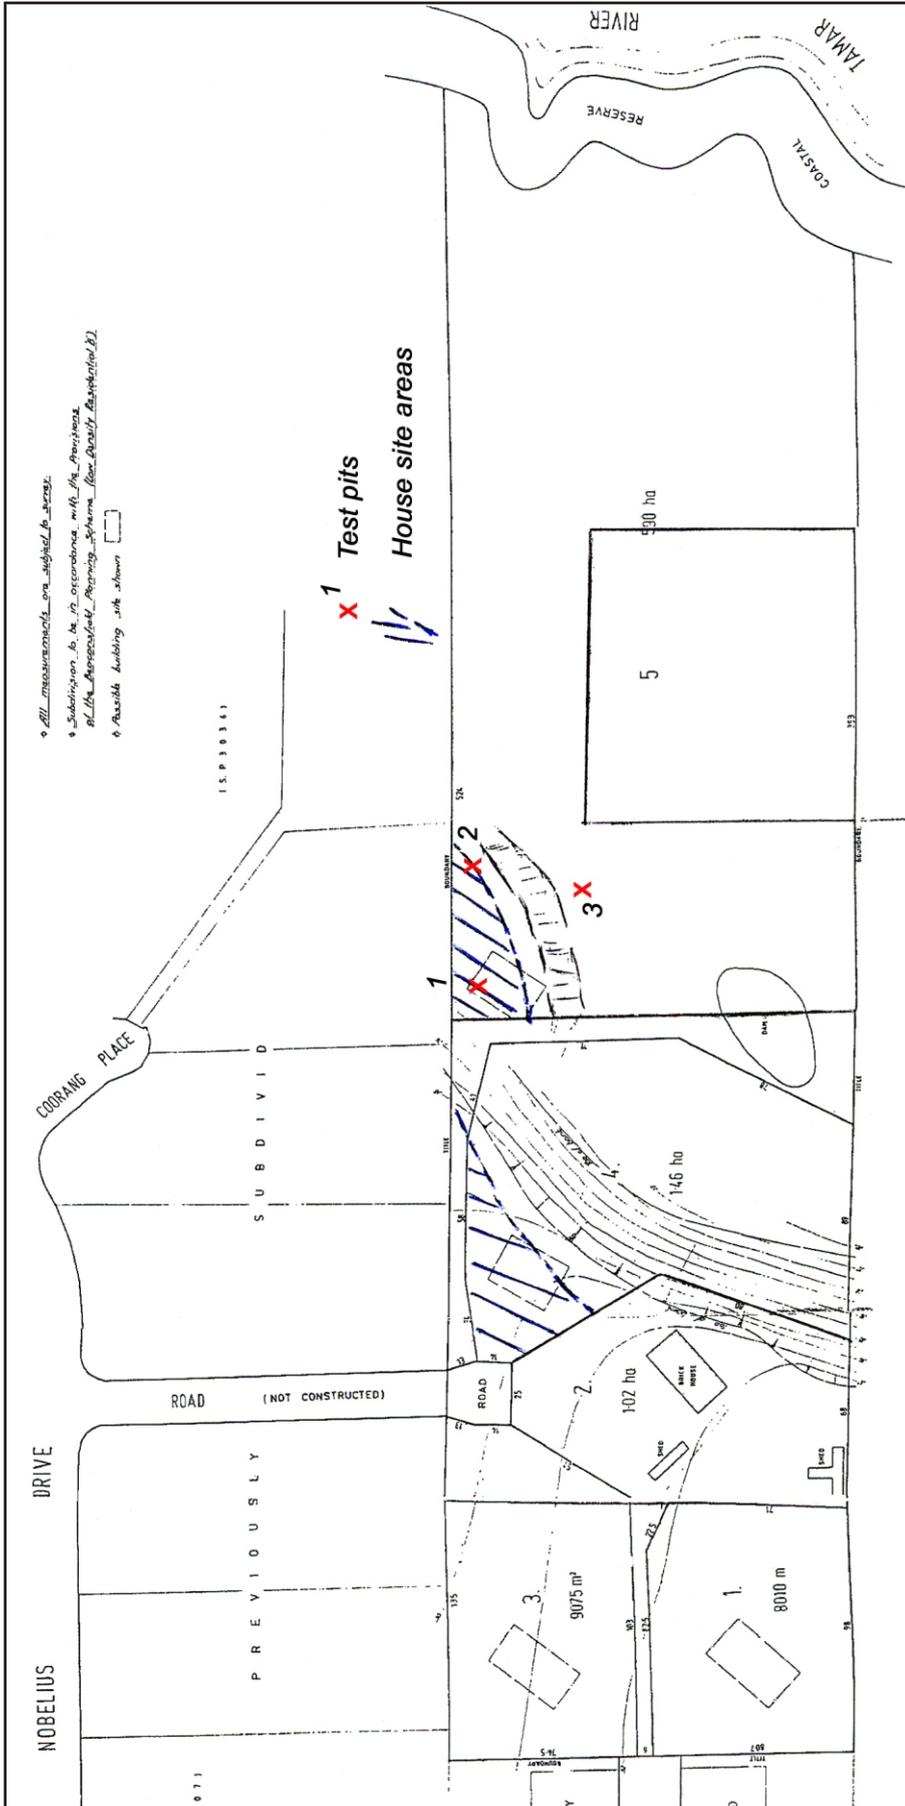
Figure 2
Location of test pits and house site areas.

A flattish area on the northwest corner of lot 5 is the favoured house site. This flat area may have been formed as a result of an old landslide movement or it may be an erosional feature. More definite old landslides are present on other parts of the lot. There is one recently active landslide about 100 m east of the favoured house site.

Test pits at the house site area suggest that the material underlying the general area is stiff and no seepages entered the pit to the depth excavated (see brief descriptions of the test pits). Pit 1 encountered mainly gravelly sand and clay. Material in pit 2 near a large tree was particularly dry and hard, the lower part of this pit being in clayey sediments. Pit 3, on a lower bench, penetrated sandy gravel near the surface before passing into dominantly clayey material which became stiffer with depth.

The area nearby is a proclaimed landslide area and if the A and B zones were extended across the adjoining boundary the house site on lot 5 would probably be in a B landslip zone. With particular care in development, it should be possible to build a house on the lot where test pits 1 and 2 were dug. The special building code

that applies to B landslip land should be followed as closely as possible. Any house should be sited as close as possible to the northwest corner of the lot and away from the slope to the lower bench where pit 3 was excavated. Drainage around the site should be excellent and water should not be allowed to accumulate at any point near the house. In particular a drain should be installed at the base of the slope near pit 3 as this area may allow water to pond. This area should be free draining.

Septic tank effluent, household sullage and storm water should be dispersed at least 25–30 m away from the house site but not downslope of it. Seepages some 50 m downslope of the house site should be free draining and it may be necessary to install french drains into the area to ensure this.

In summary, a safe house site exists on lot 4 and with precautions (for drainage and excavations) it should be reasonably safe to build a house on the extreme northwest corner of lot 5.
