Division of Mines and Mineral Resources — Report 1991/34

Slope stability of land near Rosevears Drive

by W. L. Matthews

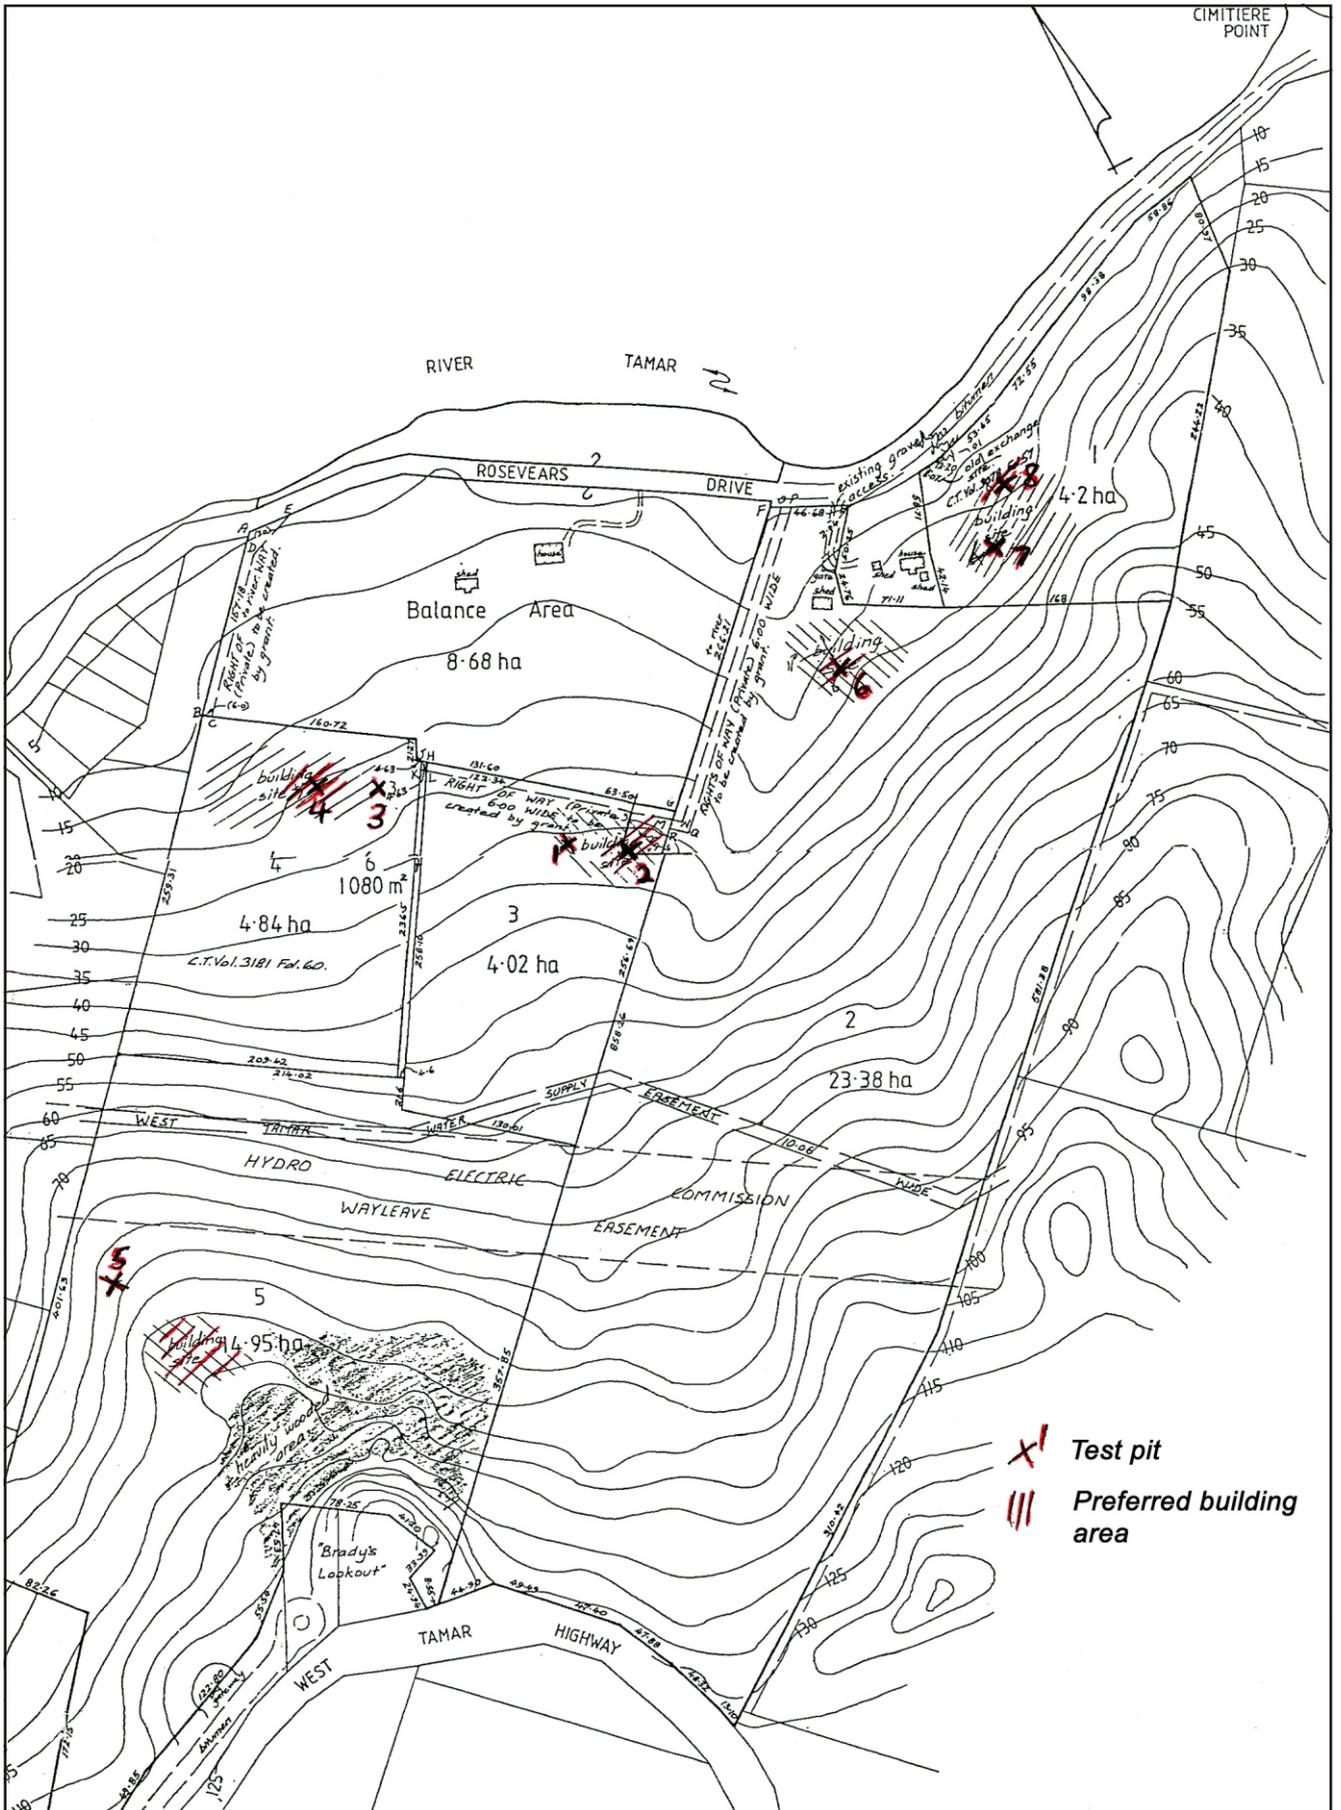
Figure 1
 Location of possible building sites and test pits.

Eight test pits were excavated on the property in January 1991 to examine subsurface conditions. The approximate positions of the pits are shown on Figure 1, with brief descriptions given in Appendix 1.

Two test pits (7 and 8) were dug on lot 1. Pit 7 was sited on a broad flat area adjacent to an existing house while pit 8 was dug on lower land, again on a flattish area a few metres above road level. These flat areas may represent old landslide features or they may be erosion terraces in part. Each pit encountered hard clayey sediments below about one metre from the surface. Soil and plastic clay overlies the harder clay.

One pit (6) was dug on lot 2. Again hard clay was struck at about one metre below the surface. The site is again on a gently sloping bench and house placement and development recommendations as outlined for lot 1 are recommended.

Two pits (1 and 2) were dug on lot 3. The land in the vicinity of pit 1 is a little hummocky and although fairly hard clay was exposed, the area around pit 2 may be more favourable for a house site (just east of the fence and in the old orchard). The house should be sited on the flatter land away from the slopes to the shallow valley. Drainage and excavations should be dealt with as outlined above.

Lot 4 had two pits excavated (3 and 4) and each encountered fairly soft clay at depths of up to 1.2-2 metres. Below these depths the clay became harder. A minor seepage entered pit 4 at shallow depth. A house site near pit 4 is favoured as it is a little more distant from steeper slopes.

Only one pit was excavated on lot 5 and this was sited below the suggested building site. Soil and fairly soft plastic clay overlies harder clay at about 1.5 metres. The proposed house site is on the middle of a ridge and comprises relatively flat land. Deep excavations around the side of the ridge near the house site should be avoided and good drainage should be maintained.

Either area appears reasonably safe for house development. Any house should not be sited any closer than about 10 m from the steep slopes to lower

levels, any excavations should be supported by strong drained retaining structures and disturbance of the slopes (particularly downslope) should be avoided. Excellent drainage should be maintained around the house site and water should not be allowed to accumulate on the surface. Sullage, septic tank and stormwater should not be discharged directly downslope of the house but conveyed around the contour and discharged.
