Division of Mines and Mineral Resources — Report 1991/39

Investigation of a proposed house site near Bradys Lookout

by W. L. Matthews

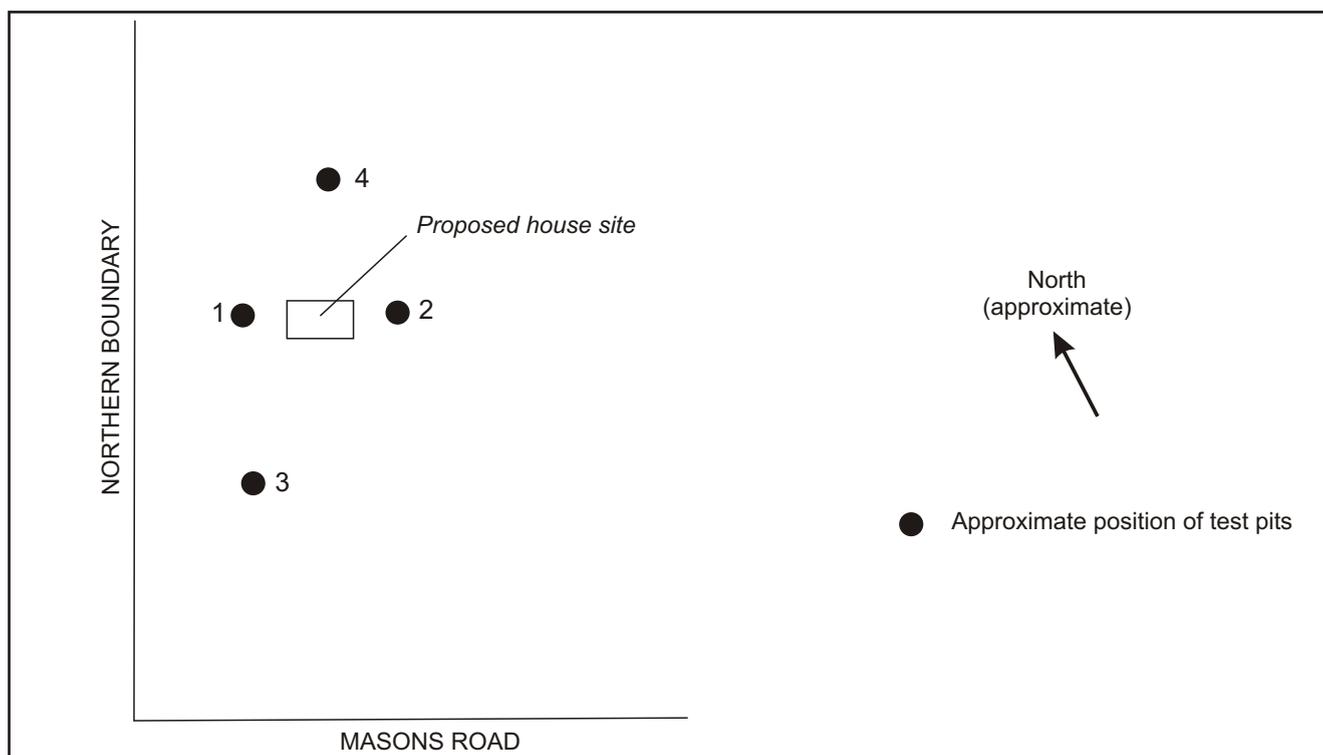
Figure 2. Approximate locations of test pits.

Four test pits were dug on the lot. Brief descriptions of the material are given in Appendix 1 with the approximate locations of the pits shown on Figure 2.

- 0 - 0.2 m Dark brown silty clay soil, roots, moist.
- 0.2 - 0.9 m Mid brown plastic to fragmented clay, moist and fairly soft.
- 0.9 - 3.1 m Light brown grey clay, fairly stiff large massive zones of brownish clay, a little calcite (weathered rock?), some large slip surfaces.

- 0 - 0.2 m Dark brown silty clay soil, moist.
- 0.2 - 1.1 m Mid brown plastic to fragmented clay, soft, some fracturing visible, basalt boulders up to 150 mm across, some slip surfaces, layer slopes to north.
- 1.1 - 2.9 m Light brown and grey clay, fairly hard (difficult to indent with thumb). Some centres with calcite nodules.

- 0 - 0.2 m Dark brown silty clay soil, roots, moist, some basalt boulders.
- 0.2 - 1.2 m Mid brown loose clay, fissured but plastic when worked.
- 1.2 - 3.05 m Light brown and grey plastic clay, hard and fractured, calcite rich nodules, 30 mm iron oxide seam on south end of trench.

Small seepage at 0.6 m

- 0 - 0.2 m Dark brown clay soil, some basalt boulders, wet, roots.
- 0.2 - 0.8 m Light brown clay, fissured and soft, plastic when worked.
- 0.8 - 2.3 m Light brown mid grey mottled clay, hard, some fracturing. Basalt boulders in this zone to within 0.3 m of base.

Seepage water coming in through soil layer at a few points.

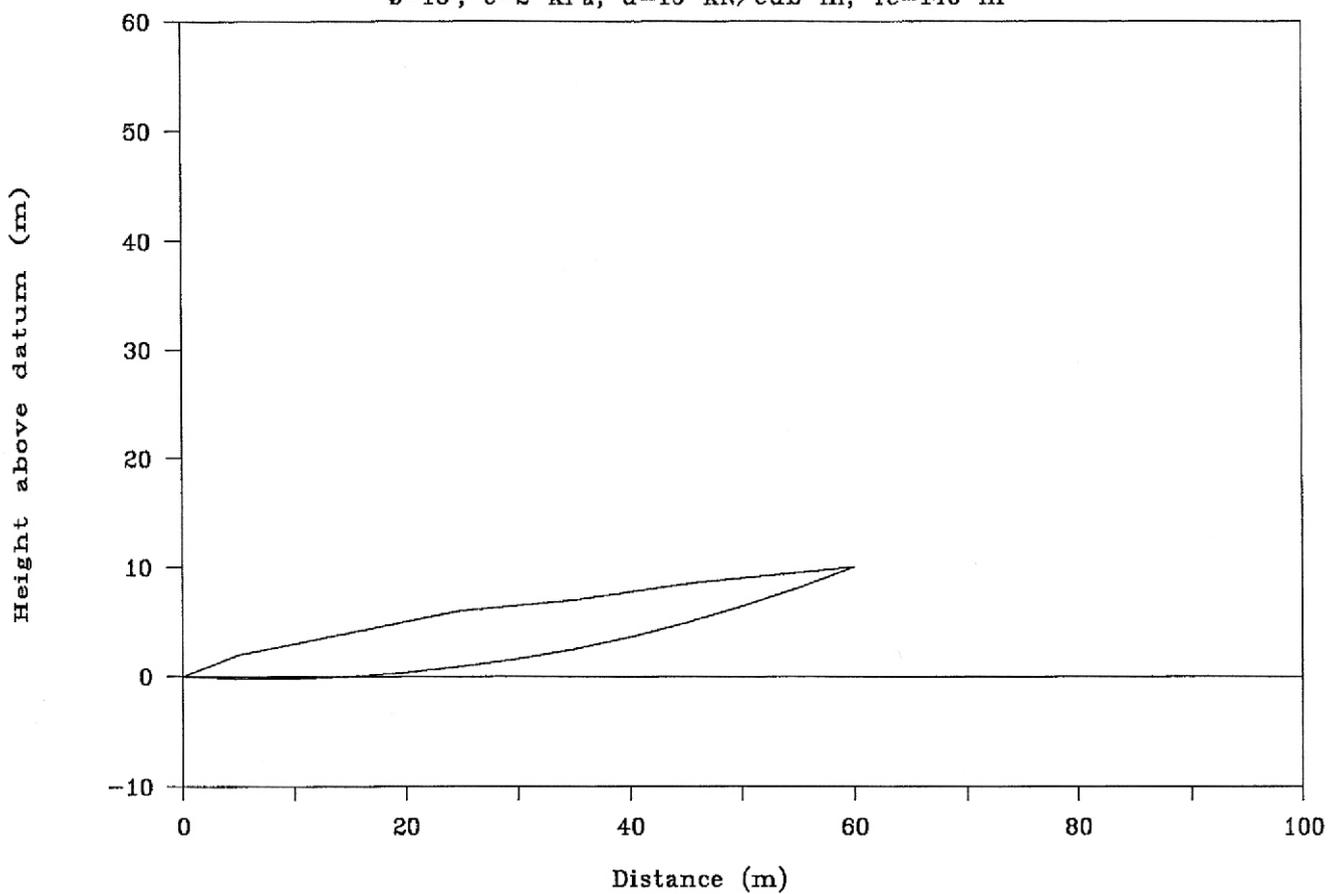
STABILITY ANALYSIS:

Stability calculations were undertaken by B. Weldon using these strength tests (Appendix 2). A safety factor of 1.3 is usually regarded as the lowest value indicating long term stability. It can be seen that when saturation of the theoretical slide is complete (i.e. approaching 0.5 for R_u) the factor of safety drops below 1.3. Drainage measures need to be undertaken to ensure that saturation of the soil to the surface does not occur.

$\phi=15^\circ$, $c=2$ kPa, $d=19$ kN/cub m, $Yc=140$ m

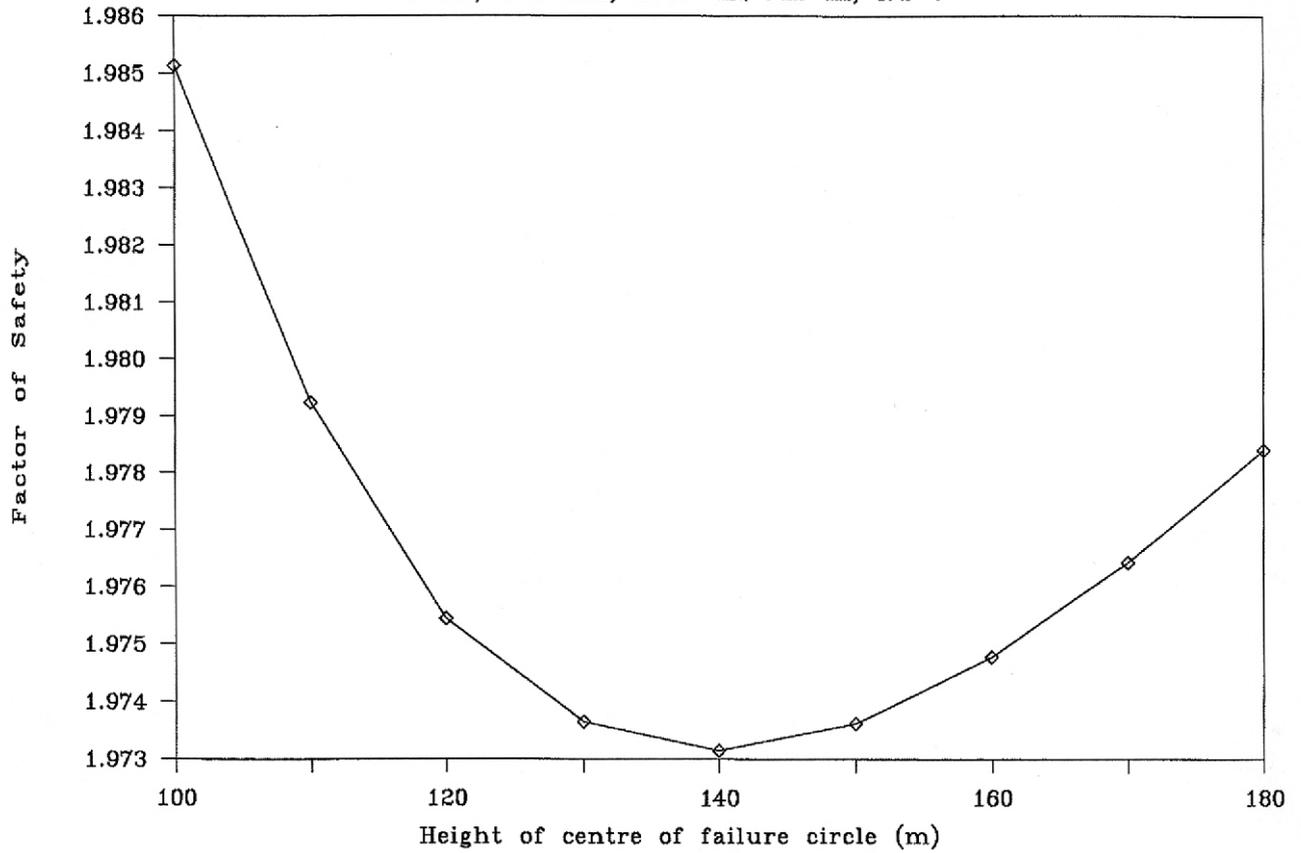
STABILITY ANALYSIS:

$\phi=15^\circ$, $c=2$ kPa, $d=19$ kN/cub m, $R_u=0$

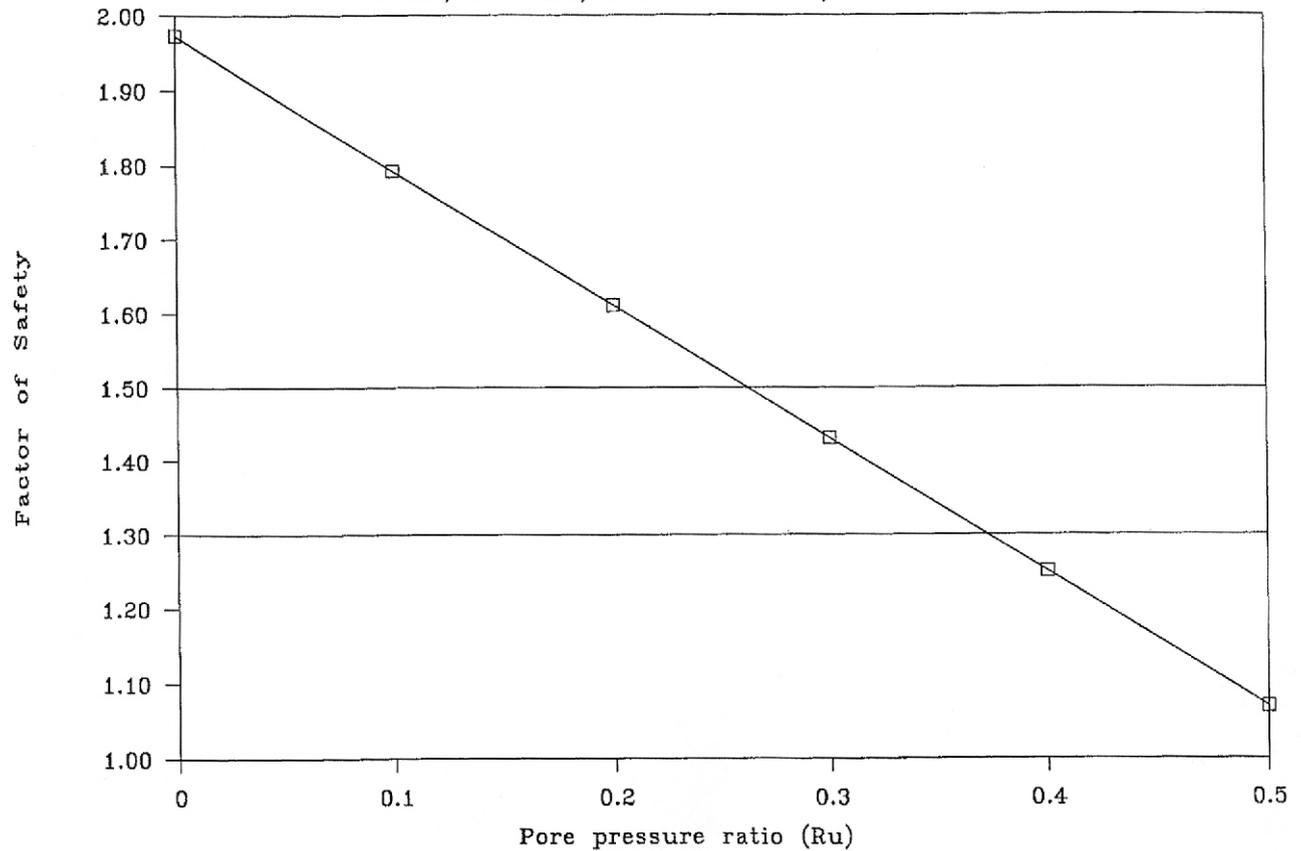
STABILITY ANALYSIS:

$\phi=15^\circ$, $c=2$ kPa, $d=19$ kN/cub m, $Y_c=140$ m
