Examination of a landslide in a private forest near Weegen a

by B. D. Weldon

A landslide of significant dimensions has occurred in the private forest [DQ556119] and an inspection was requested by APPM.

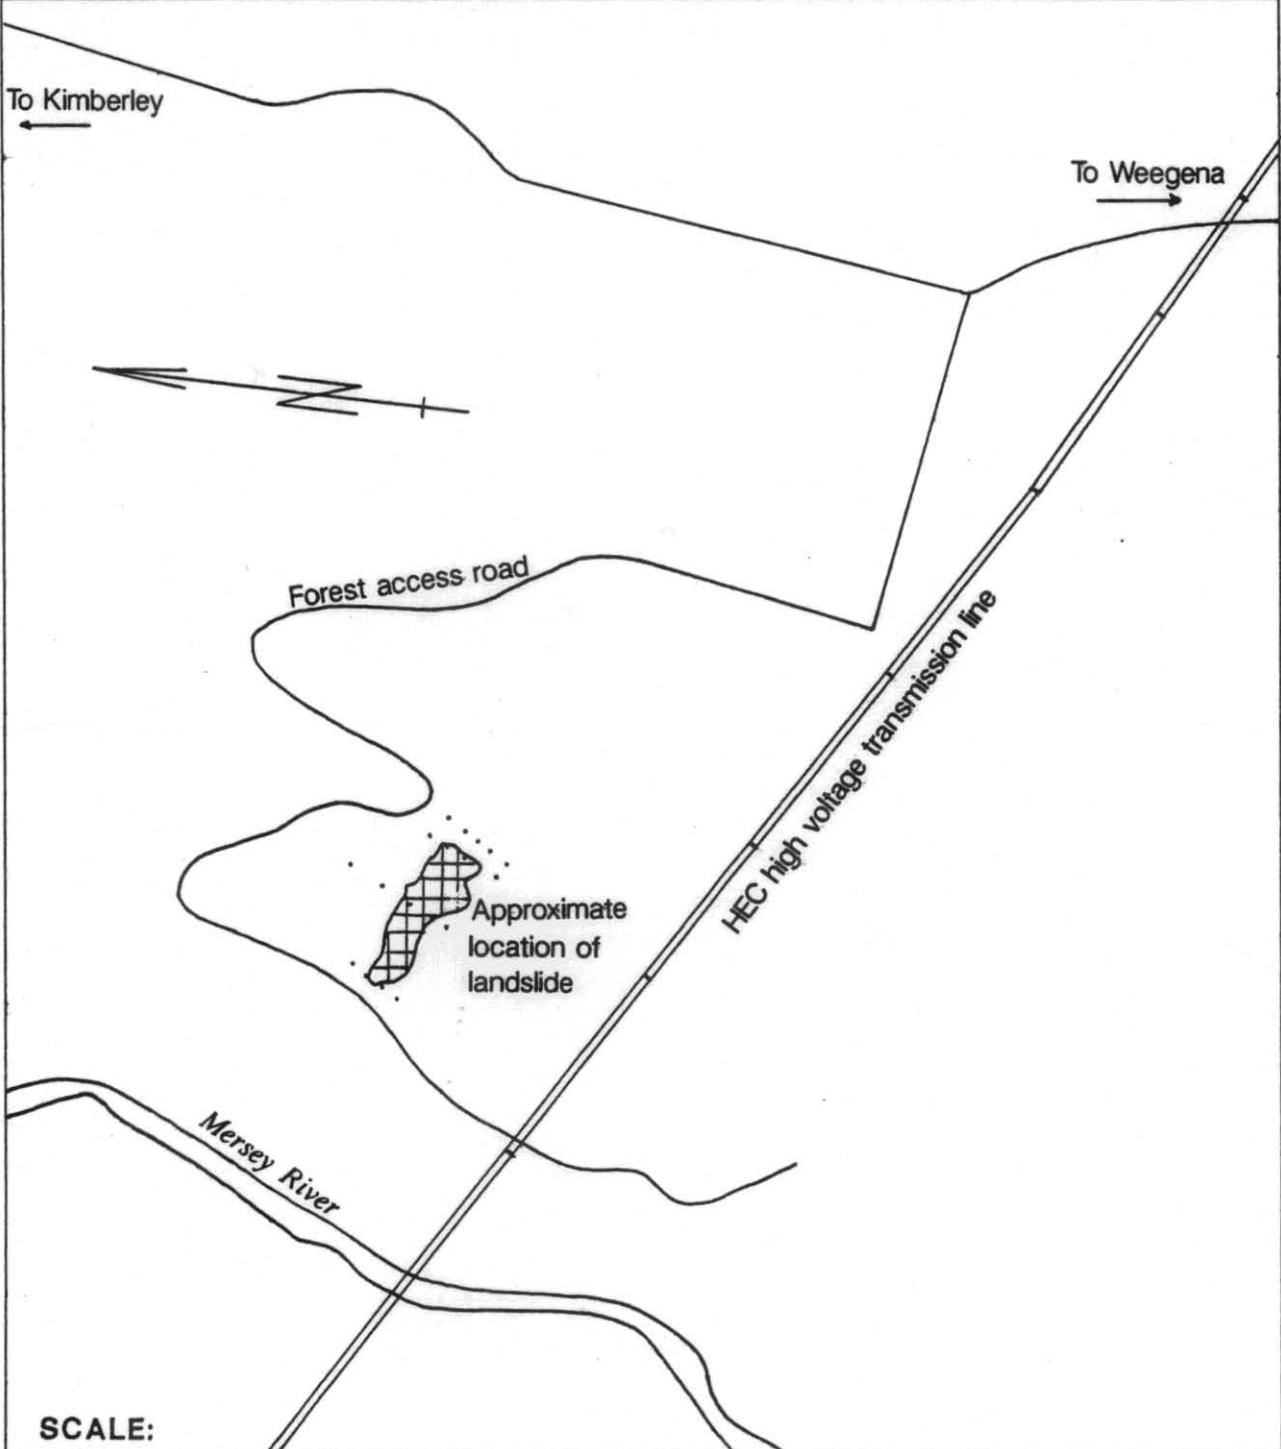
Figure 1.

The landslide (fig. 1) is some 200 m long, commencing as a broad arcuate-shaped head scarp about 80 m wide at its widest point and narrowing downslope into a lobe. This lobe is constricted to a width of about 30 m at a point roughly one half the length of the landslide. Downslope from the constriction, the lobe widens to between 40 and 50 metres. The body of the landslide is considerably disrupted with tension cracks. Some sections of the landslide have a back slope and ponded water. Noticeable features of this landslide are the lateral ridges on either flank. Displaced material occurring in the toe or foot of the landslide has obscured the location of the toe of the surface of rupture.

The overall impression is that the landslide is probably less than 10 m in depth. The lag in time between harvesting the original forest and the occurrence of the landslide was about 4 years. This is a relatively short period of time with respect to time scales usually associated with root decay. This suggests that the surface of rupture is probably below the depth of significant root penetration. In the head region the landslide appears to be of rotational type but further downslope becomes translational. The landslide is thus complex. The landslide has probably occurred because of significant changes in the hydrological conditions accentuated by the delay between harvesting the original forest and establishing regrowth.
