Land stability assessment of three sites at Penguin Road, Lonah

R. C. Donaldson

Following a request from The Municipality of Ulverstone, three sites on and adjacent to Penguin Road at Lonah, west of Ulverstone, were inspected on 8 October.

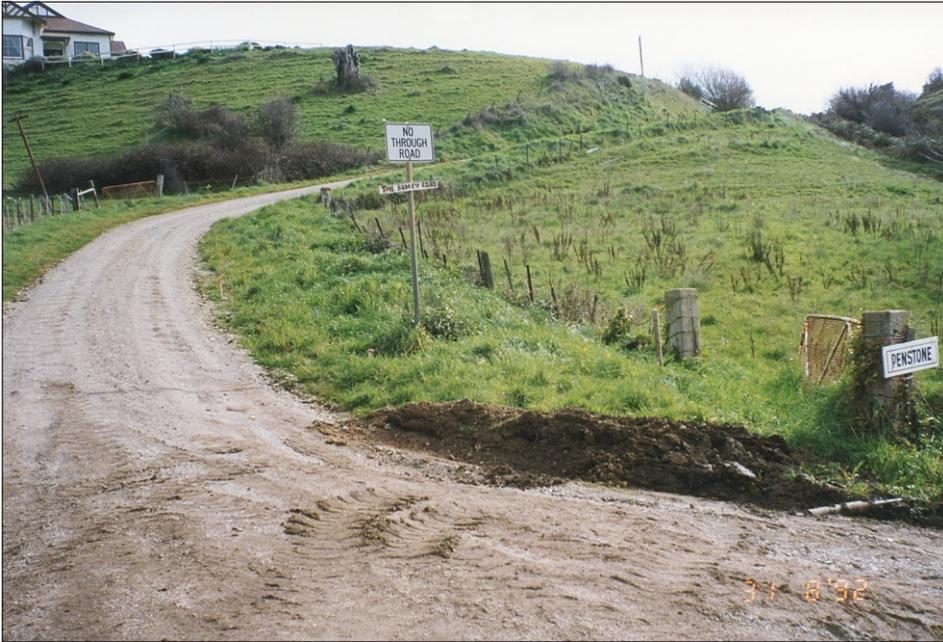
The reconstruction of Robertsons Road (426400 mE, 5445950 mN) will entail the widening and slight re-alignment of the existing gravel road. Of particular concern to Council is the stability of the slope in the area where additional cut is required, between about chainage 50–100 metres (Photo 1).

The existing road cutting along this section is estimated to be between three and four metres in height. The proposal is to cut back into the slope several metres more, to between three to five metres; this will result in an increase in the height of the cutting by only about one metre.

Examination of the existing cutting revealed brown high plasticity clay with associated basalt boulders; bedrock was not observed outcropping in the cutting, but a slightly weathered basalt was noted outcropping in the creek bed on the lower side of Robertsons Road. From the evidence available, it is probable that 'bedrock' is unlikely to be encountered in the proposed extension to the cutting; the profile is likely to be residual weathered materials in the form of basalt soils and associated boulders.

The existing cutting shows no signs of instability and has stood the test of time. As a result, there is little reason to suggest that the proposed new additional cut will behave differently.

Photo 1: Robertsons Road looking towards cutting

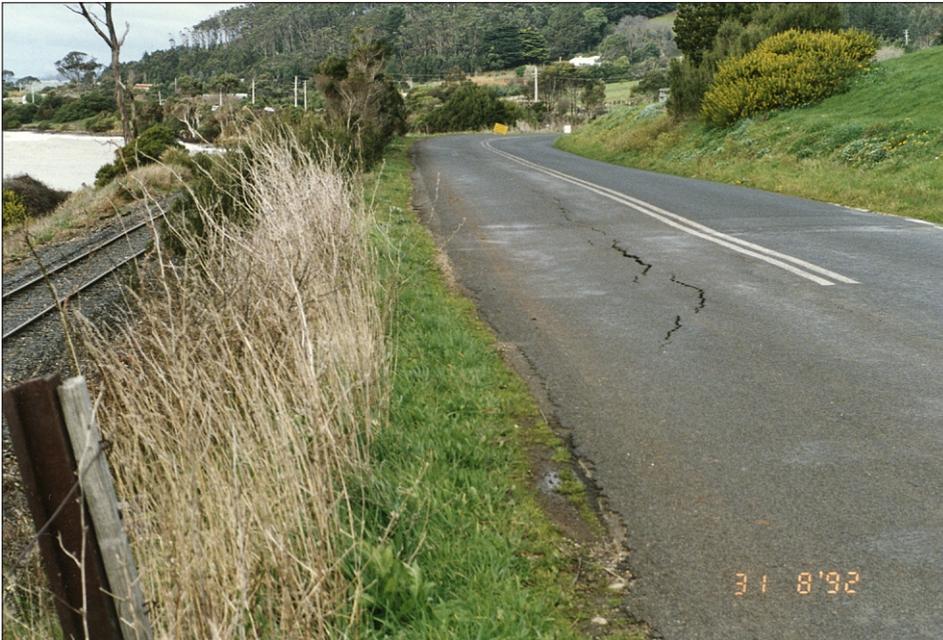
The failure of a section of Penguin Road (426630 mE, 5445780 mN) has caused severe cracking and settlement of the pavement which is evident over a distance of about sixty metres (Photo 2). An inspection of the road pavement revealed a series of longitudinal or *en echelon* cracks developed along the northern traffic lane. There appeared to be two main areas of road failure; a 10 m long segment followed by a 50 m long segment adjacent to the first. The tension cracks were observed to be up to 30 mm across, although the total lateral movement associated with this failure is considered to be significantly greater. Substantial vertical movement appears to have also occurred as shown by the disrupted stormwater drain beneath the road, which has been displaced by an estimated 100–150 mm. Council has reportedly repaired the road surface on several occasions as the vertical movement in the pavement was making conditions potentially hazardous for driving.

The factors or mechanism that led to the road failure could not be determined from the initial on-site visit. What is of greater concern is to establish whether movement is confined only to the roadway or whether it is a larger deep-seated failure involving the railway. There are signs of bulging in the embankment between the road and railway but no obvious signs of movement were observed either in the alignment of the rail tracks or in the ground down to the shoreline. Whilst it is unclear as to the extent of the movement, it may be necessary to consider the road failure as part of a larger landslide feature.

At the time of the visit, it was raining heavily and it became readily apparent that movement is being accelerated by the ingress of surface water through the unsealed cracks in the road, and from the seepage of runoff water into the ground via the disrupted subsurface stormwater drains beneath the road. The volume of water issuing from this stormwater drain

was estimated to be between 0.7 and 1.0 litres per second. This water was being discharged onto the ground beside the railway track and then being picked up again and piped under the railway and again discharged directly on to the steep slope segment below the track. This is an ineffective road drainage system and as it exists, can only aggravate the problem.

Photo 2: Pavement failure, Penguin Road

It is recommended that further work be carried out, especially with respect to defining the limits of movement. It is proposed that the Department of Mines map the area where deformation is evident and establish two or three survey lines across the area to effectively monitor the extent and rates of lateral and vertical movement. It is envisaged that the lines would be resurveyed at regular intervals of about three months.

An effective road drainage system is required to reduce the direct ingress of surface waters into the slip. Existing drains should be repaired where damaged and the water piped down to the foreshore before being discharged.

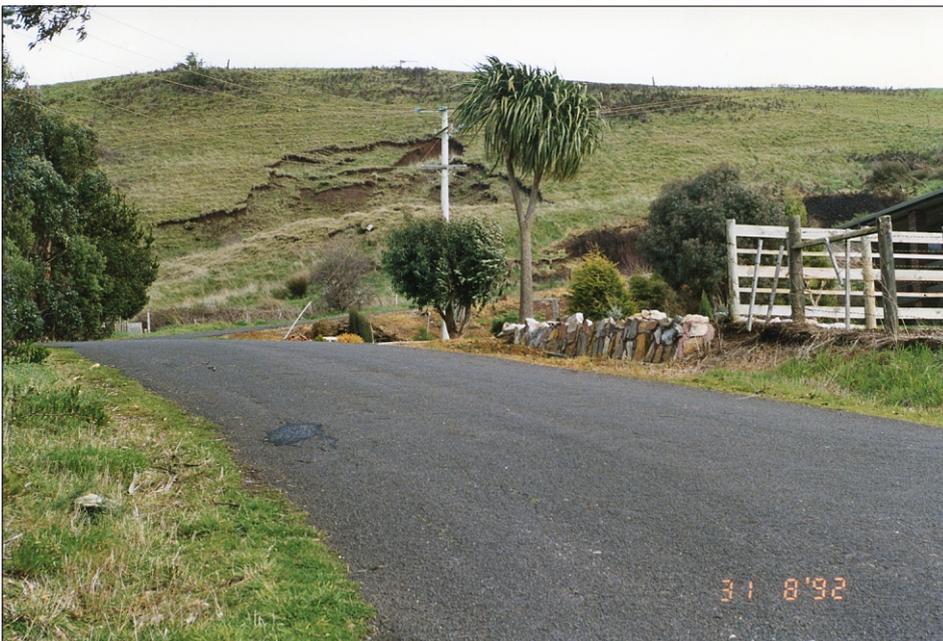
Only a cursory inspection was made at this site (426600 mE, 5445700 mN) due to inclement weather. A small slip has developed which has resulted in subsidence of part of the road by up to 150 mm over several metres (Photo 3). This feature needs to be re-appraised with respect to determining the following:

- is it a problem associated with road fill only;
- is it associated with movement of the larger landslide which developed upslope several years ago;
- is it likely to affect the house downslope.

Photo 3: Rockliffs Road — landslide and road failure
