# Geological and land stability assessment: Lake Fenton pipeline

*R. C. Donaldson*

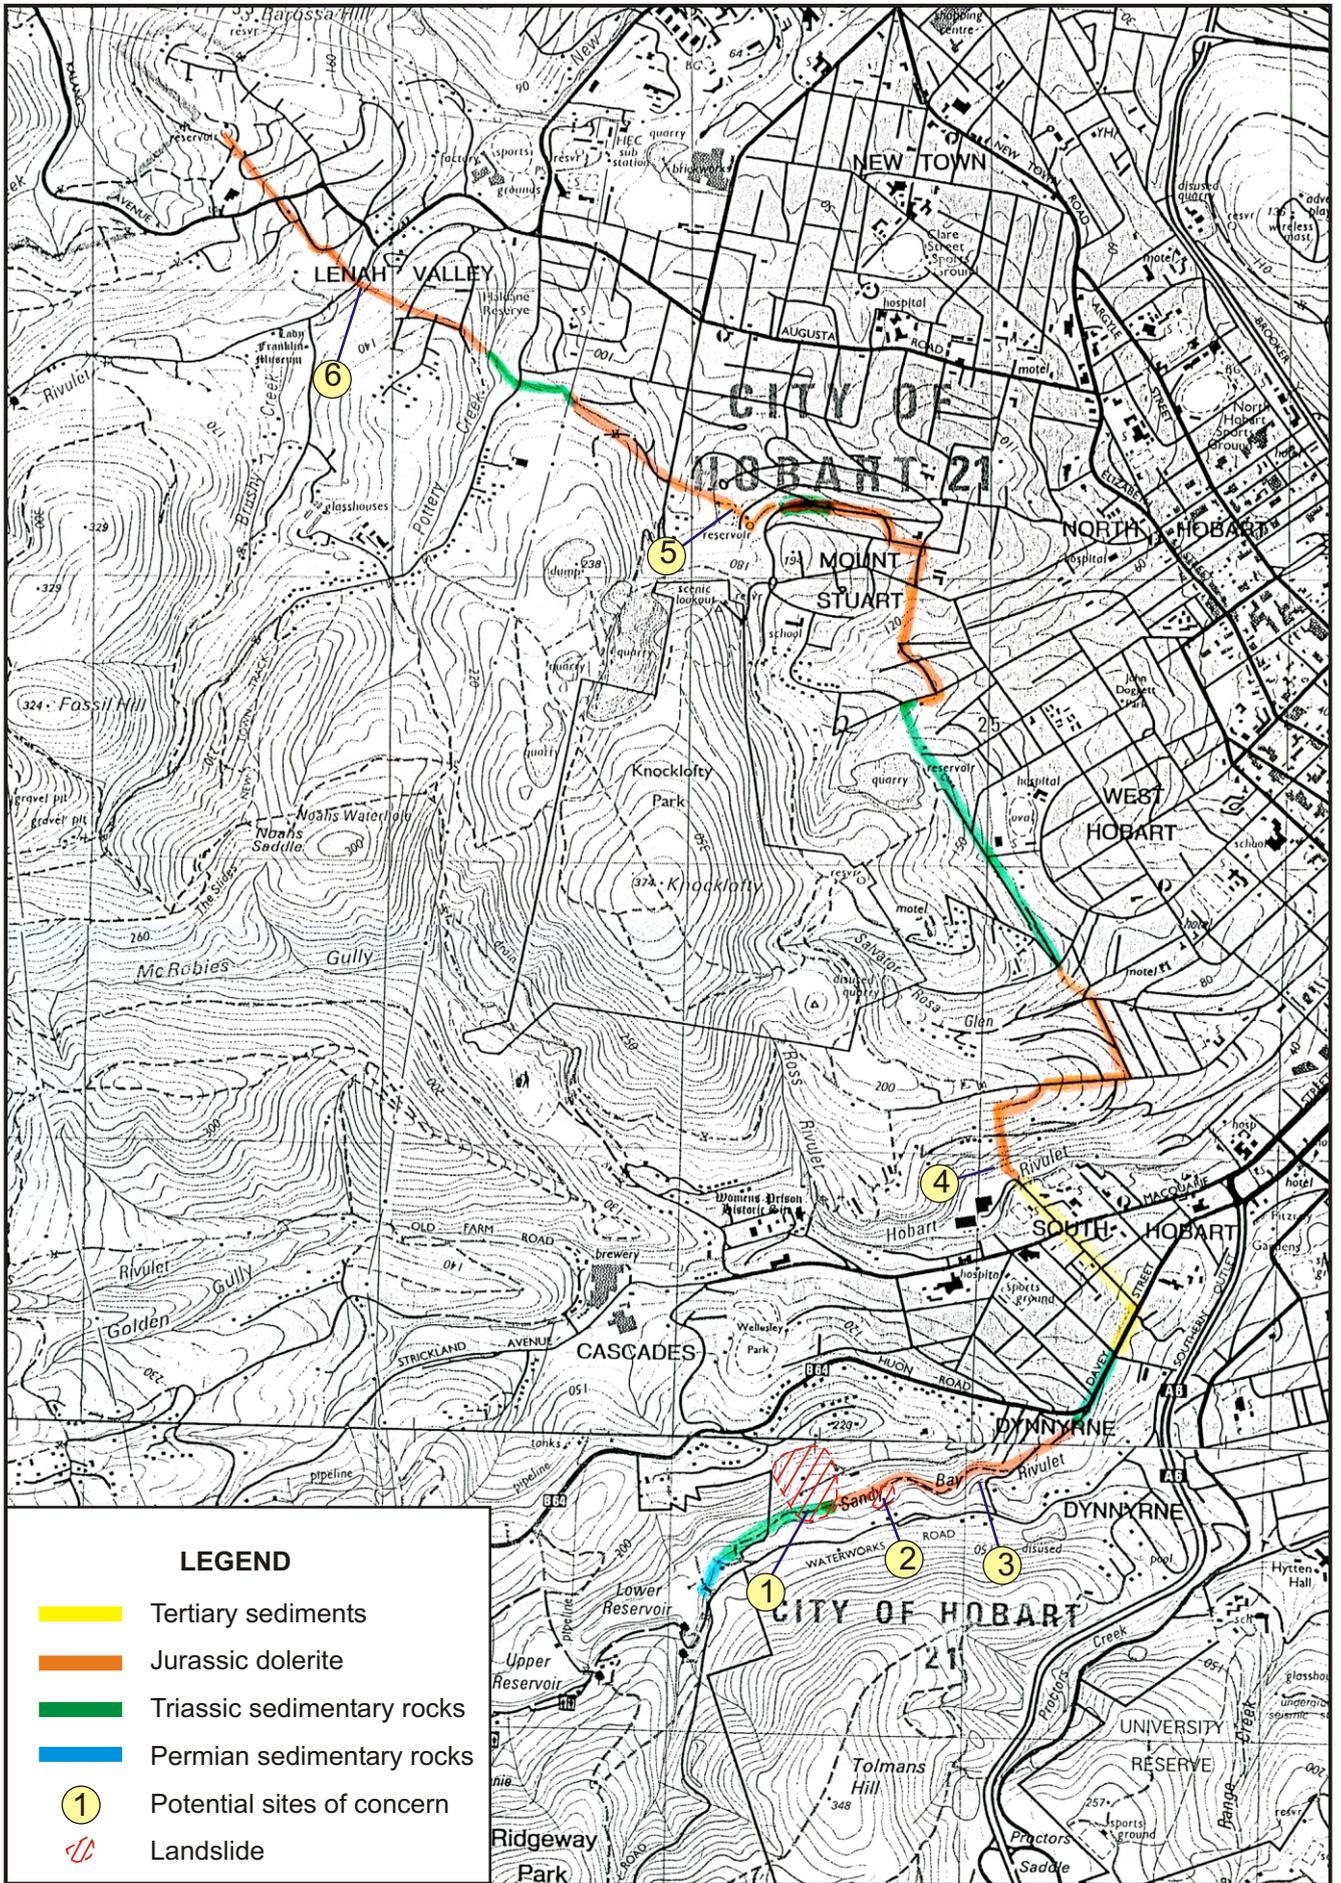
Figure 1

The provisional 1:25 000 scale engineering geology map of the greater Hobart area (Hofto, 1990) shows that the pipeline passes through a variety of rock types; their distribution is indicated in Figure 1. Jurassic dolerite underlies some 65% of the route, Triassic sedimentary rocks 25%, with Tertiary and Permian sedimentary rocks making up the balance.

Existing slope instability and areas of potential instability are evident along sections of the pipeline between Lower Waterworks Reservoir and Romilly Street. These areas are indicated as sites 1 to 3 on Figure 1. A probable fossil landslide, some 200 m in length and 150 m across, was recognised from aerial photographs; the pipeline crosses this currently dormant feature approximately between chainages 350 and 500 m commencing from the Waterworks Reservoir (Site 1). There are no obvious signs of active movement associated with this feature, but factors such as cut and fill, trenching, or removal of material from the toe region of a landslide is generally detrimental to the long term stability of the slope.

Evidence of a second landslide feature is readily apparent on the slope segment between the pipeline and the rivulet approximately between chainages 600 and 700 m (Site 2). It would appear from field examination that a series of shallow, recently active landslides (earth flows) has developed parasitically in the toe region of an older failure. These recently active features occur in close proximity to the existing pipeline and have the potential to develop further upslope and threaten the pipeline. The dimensions of the older failure are not known; the headscarp region was not determined during the field inspection.

A further potentially hazardous area is the steep slope segment prior to where the pipeline enters Romilly Street (Site 3). This area is underlain by relatively unconsolidated dolerite talus and under saturated soil conditions, there exists the potential for small-scale shallow earth flow type movement.

The steep slope segment between the Hobart Rivulet and Forest Road warrants comment (Site 4). The existing steel pipe is currently exposed in several places. The slope is underlain by dolerite talus which was observed to have a thickness in excess of 2.0 m in several places. There was no sign of bedrock cropping out, and although there were no signs of landsliding, the potential exists if the soil profile becomes saturated.

Two other locations along the pipeline were briefly inspected at the request of Mr Barnard. The first of these was in the vicinity of Newlands Avenue Reservoir (Site 5) where the pipeline passes close to the cut on the northern side of the Benjafield Terrace recreation oval. The cut exposed a typical weathered dolerite profile and it is unlikely that failures will occur in the cut and affect the pipeline.

The final site inspection occurred where the pipeline crosses New Town Creek along Lenah Valley Road (Site 6) . Again the area is underlain by dolerite, and although the slope is relatively steep, it is not

anticipated that stability problems are of any real concern over this section.
