Ground movements and house monitoring — Channel Highway, Tarooma

B. D. Weldon

Abstract

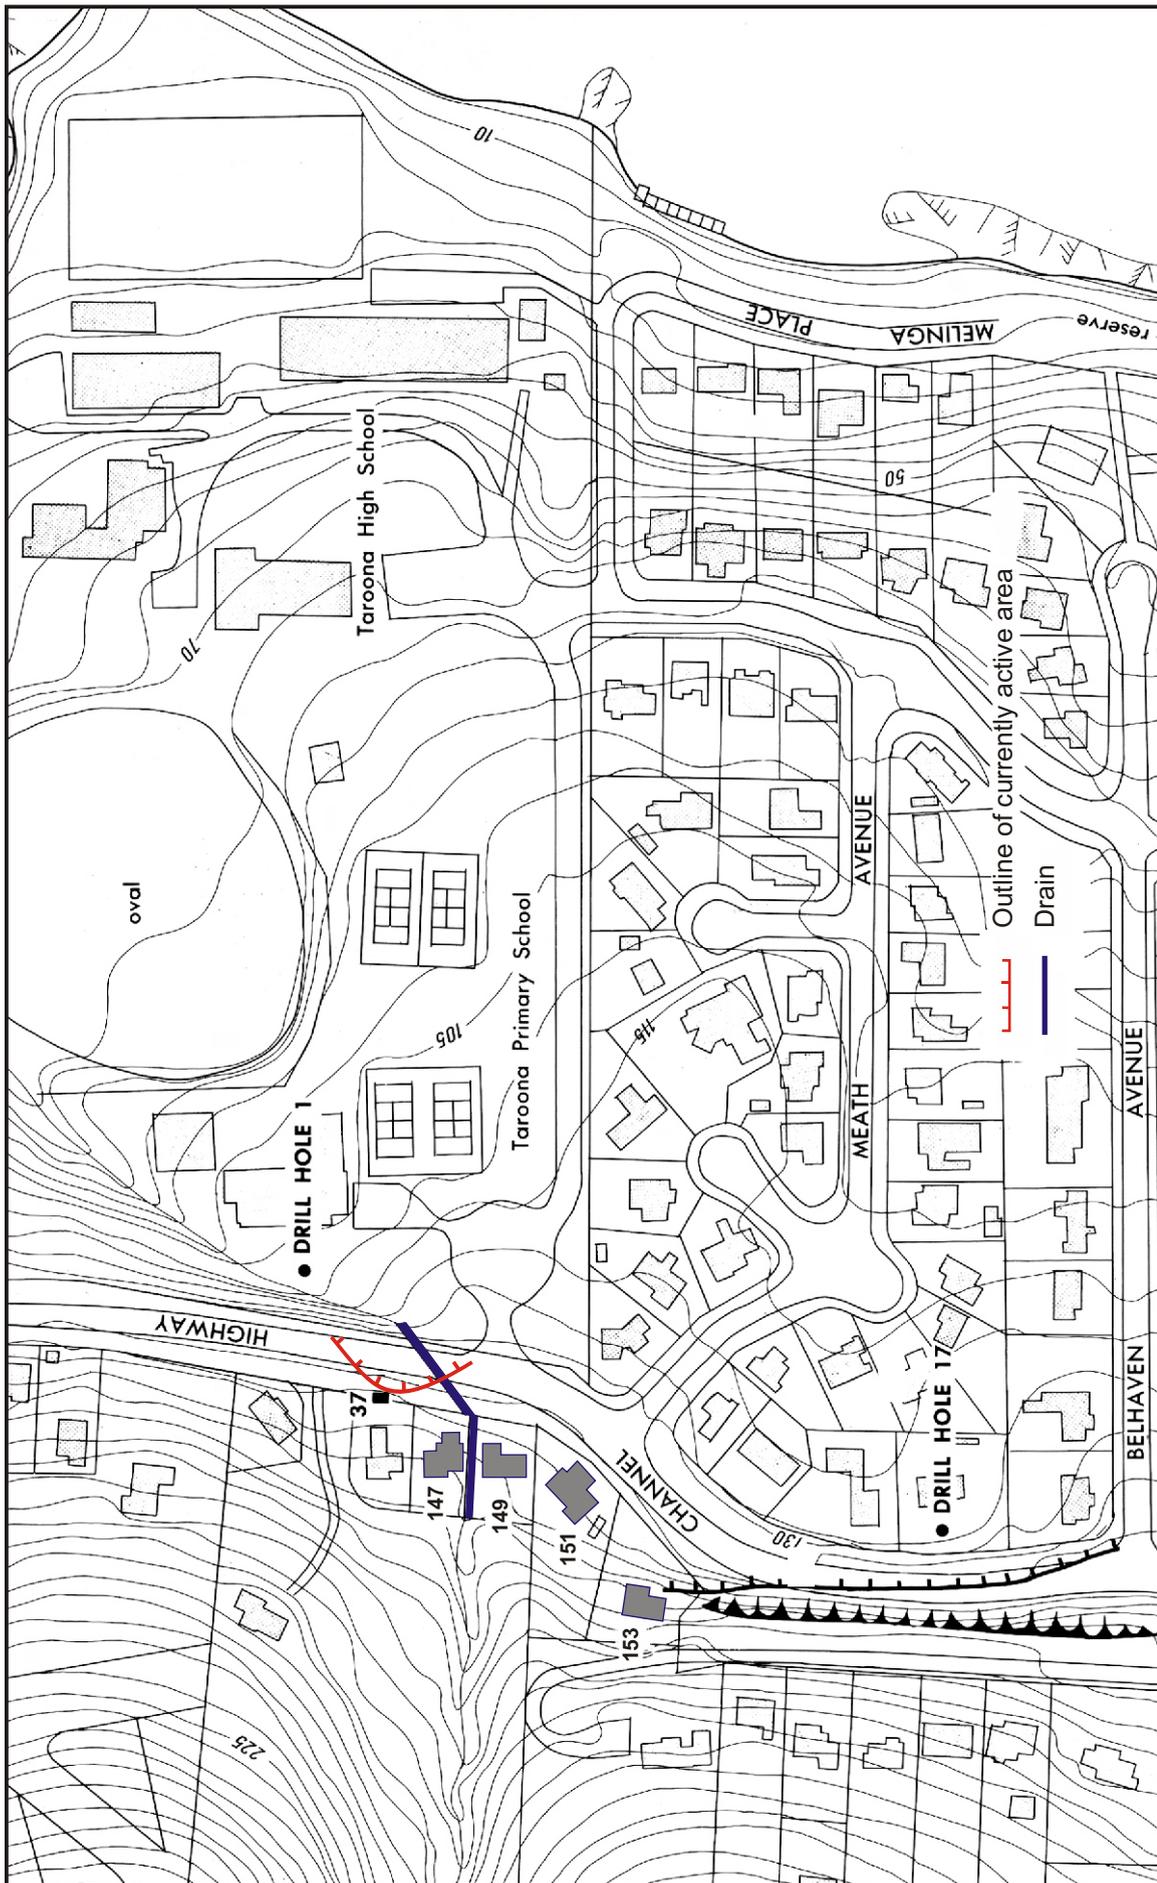
Figure 1
 Location of active areas and monitored houses

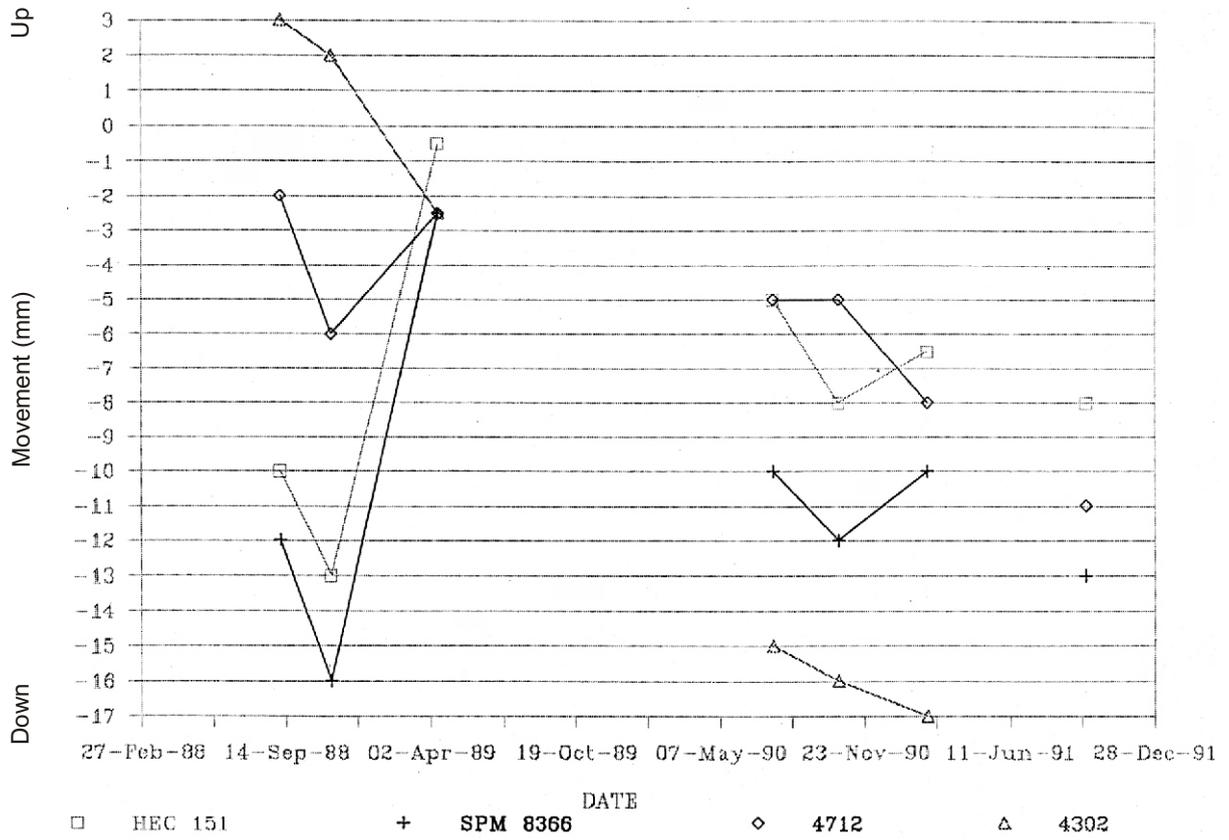
The results of surveys are reproduced in Figures 2 to 7. Interpretation of the results is not simple. All figures indicate that the surveyed objects are subject to vertical movement. This movement is considered to primarily reflect changes in the moisture condition of the reactive clays which are known to exist in the area. These clays swell upon the uptake of moisture and shrink with loss of moisture.

Figure 2
Survey monitoring, SPMs, Channel Highway, Taroom

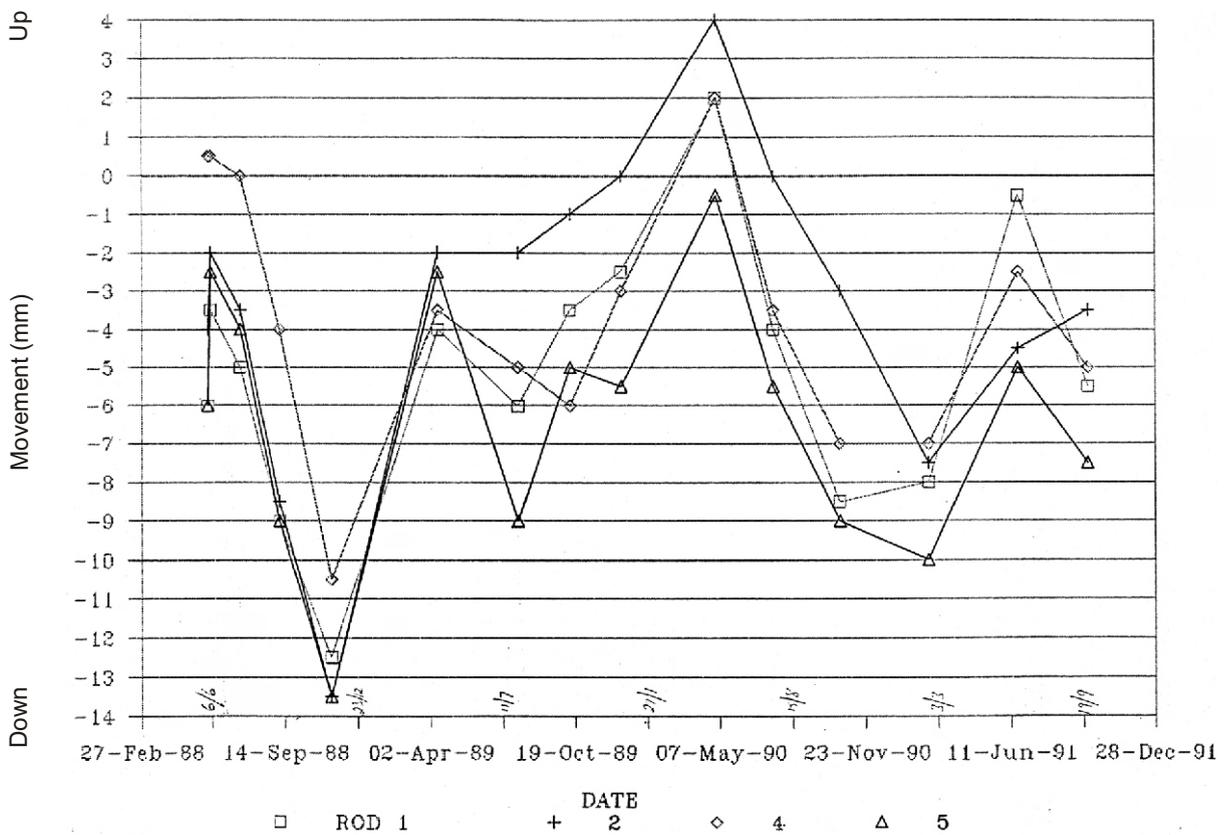
Figure 3
Survey monitoring, rods, Channel Highway, Taroom

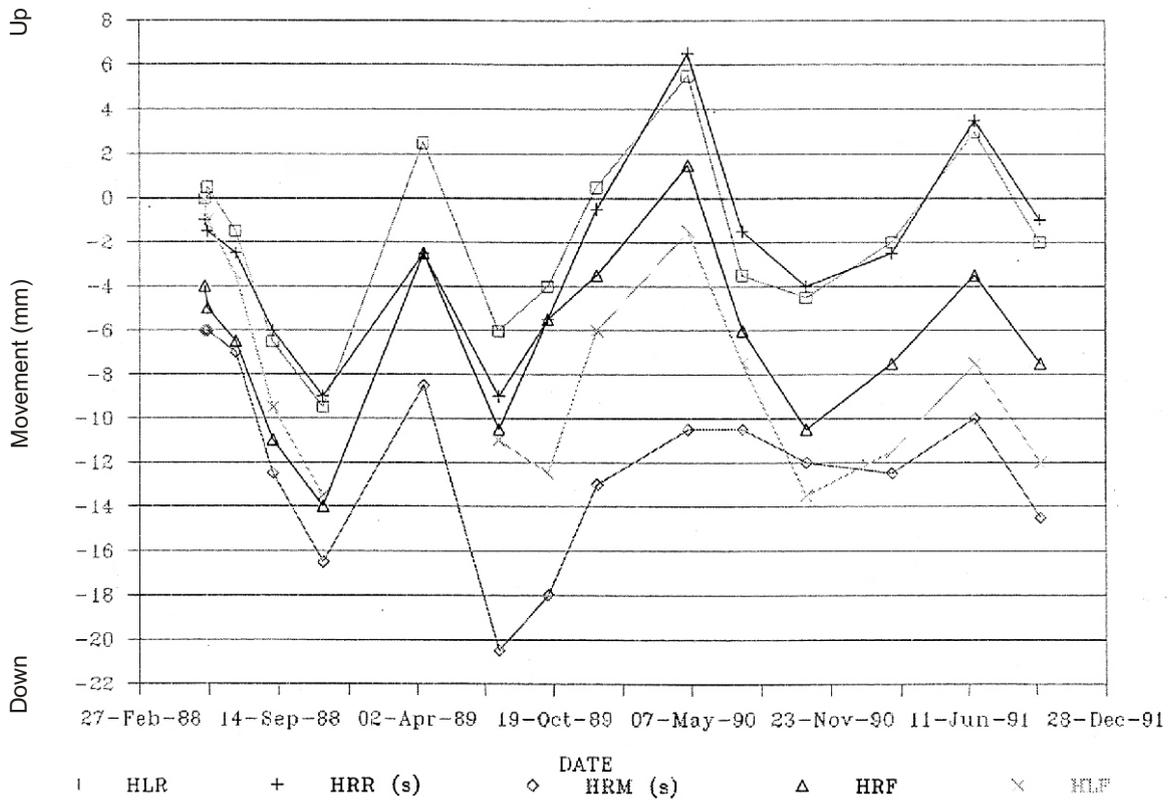
Initial readings at 147, 149 and 153 Channel Highway were also within a relatively narrow envelope, but as time has progressed, this envelope has broadened. This is interpreted to indicate that some other and unknown factor has come into effect. Some possibilities for the unknown factor are:

Figure 4
Survey monitoring, 147 Channel Highway, Tarooona

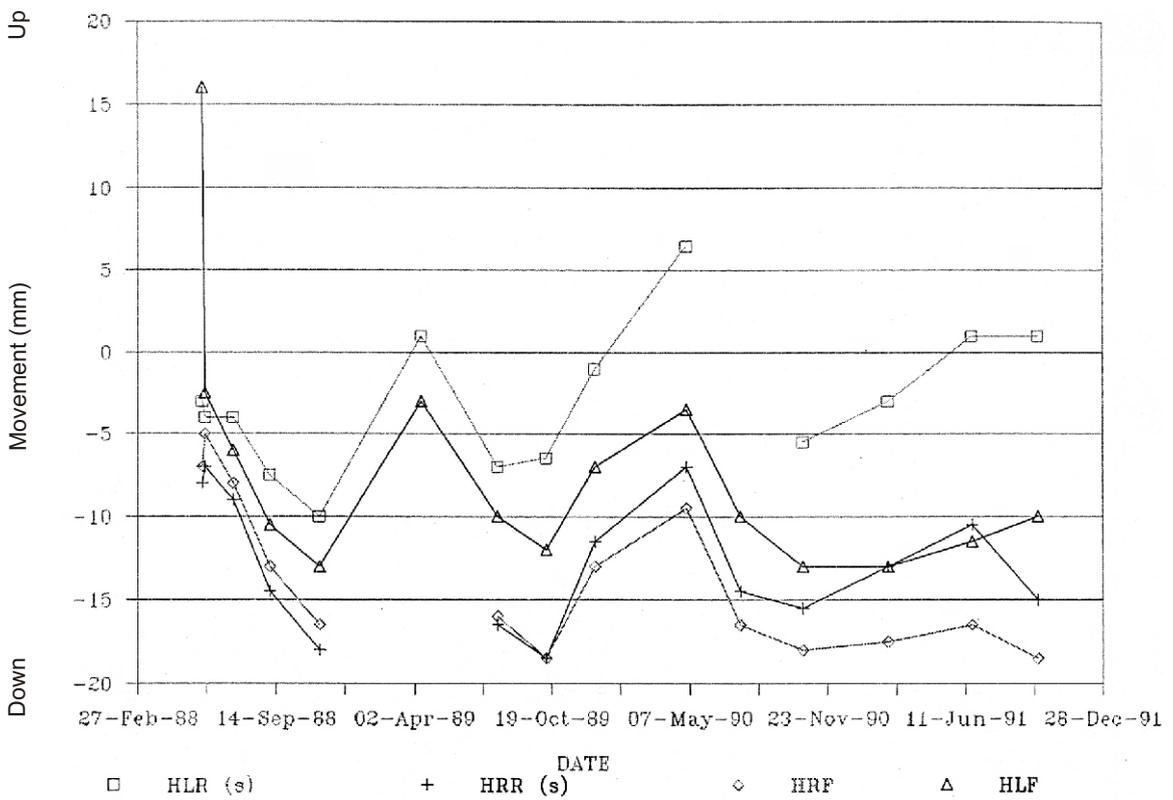
Figure 5
Survey monitoring, 149 Channel Highway, Tarooona

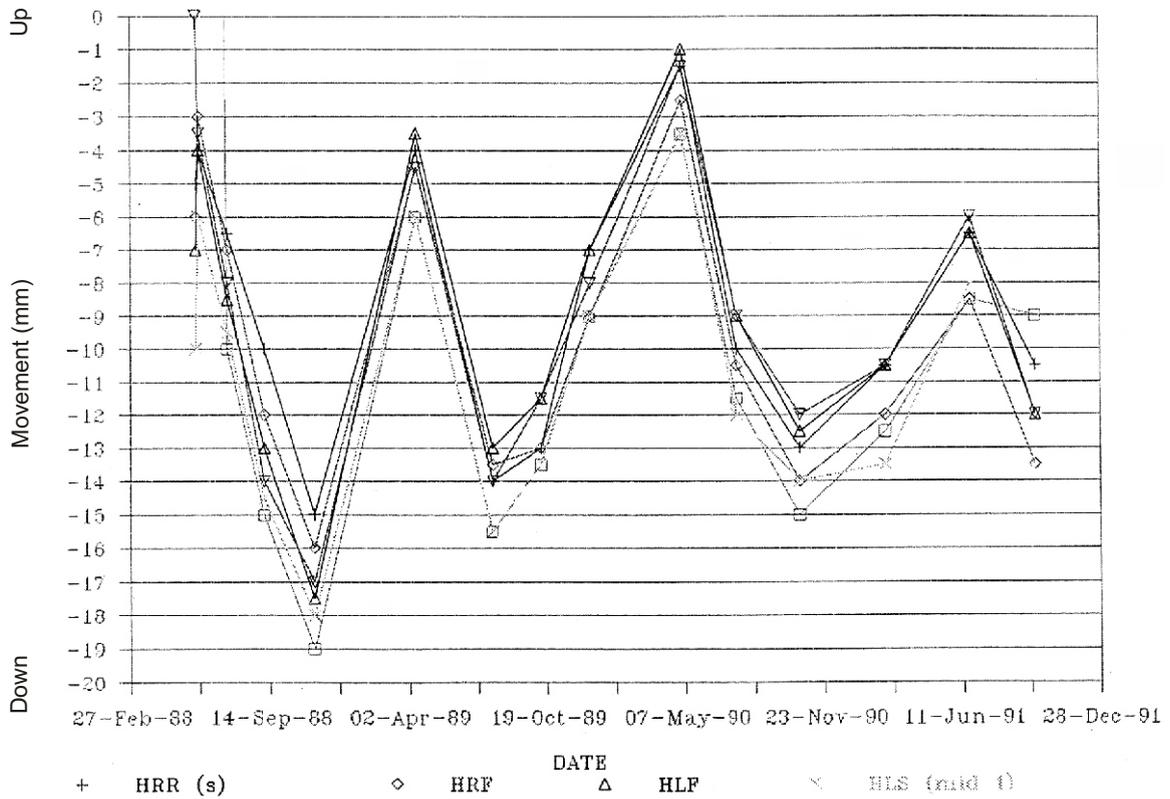
Peaks in the movement are generally associated with the wetter months and troughs are associated with the drier months. This pattern is best indicated at 151 Channel Highway (refer fig. 6) where the scatter of values at a particular point in time is restricted to a relatively narrow envelope. This suggests that the house is riding relatively uniformly up and down in response to changes in the volume of the underlying clay.

Figure 6
Survey monitoring, 151 Channel Highway, Tarooona

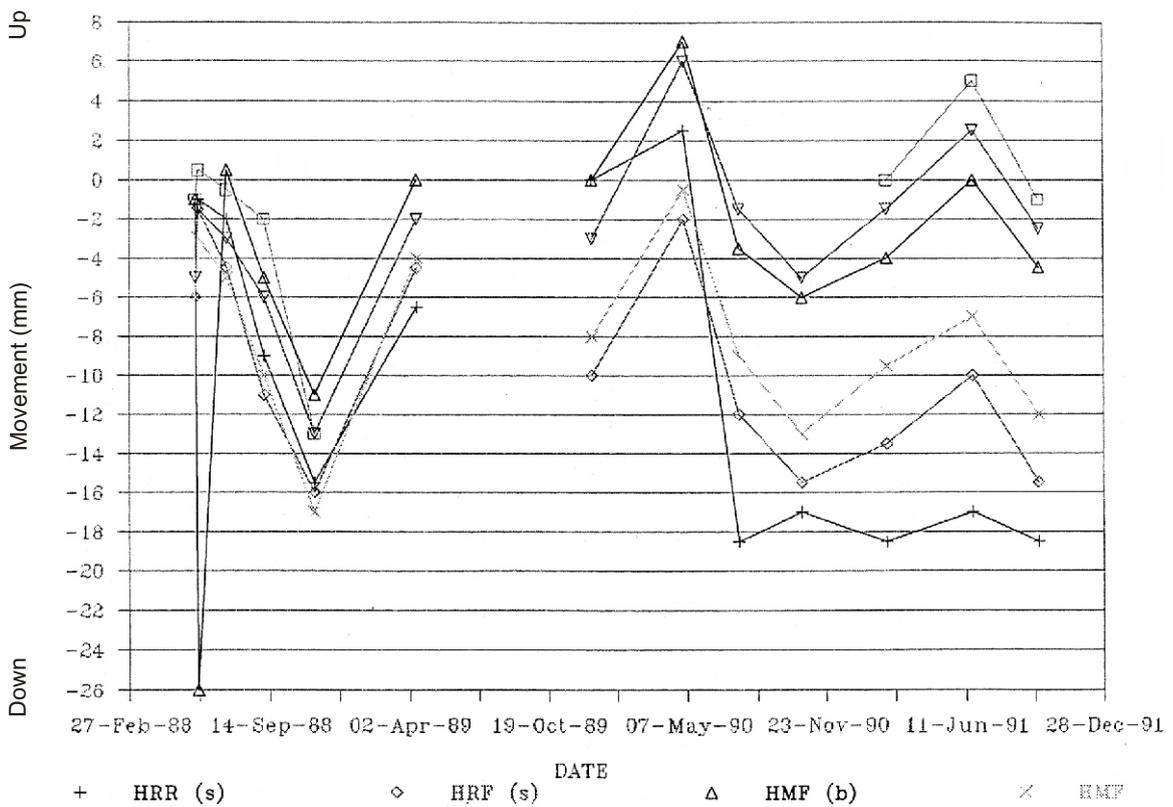
Figure 7
Survey monitoring, 153 Channel Highway, Tarooona

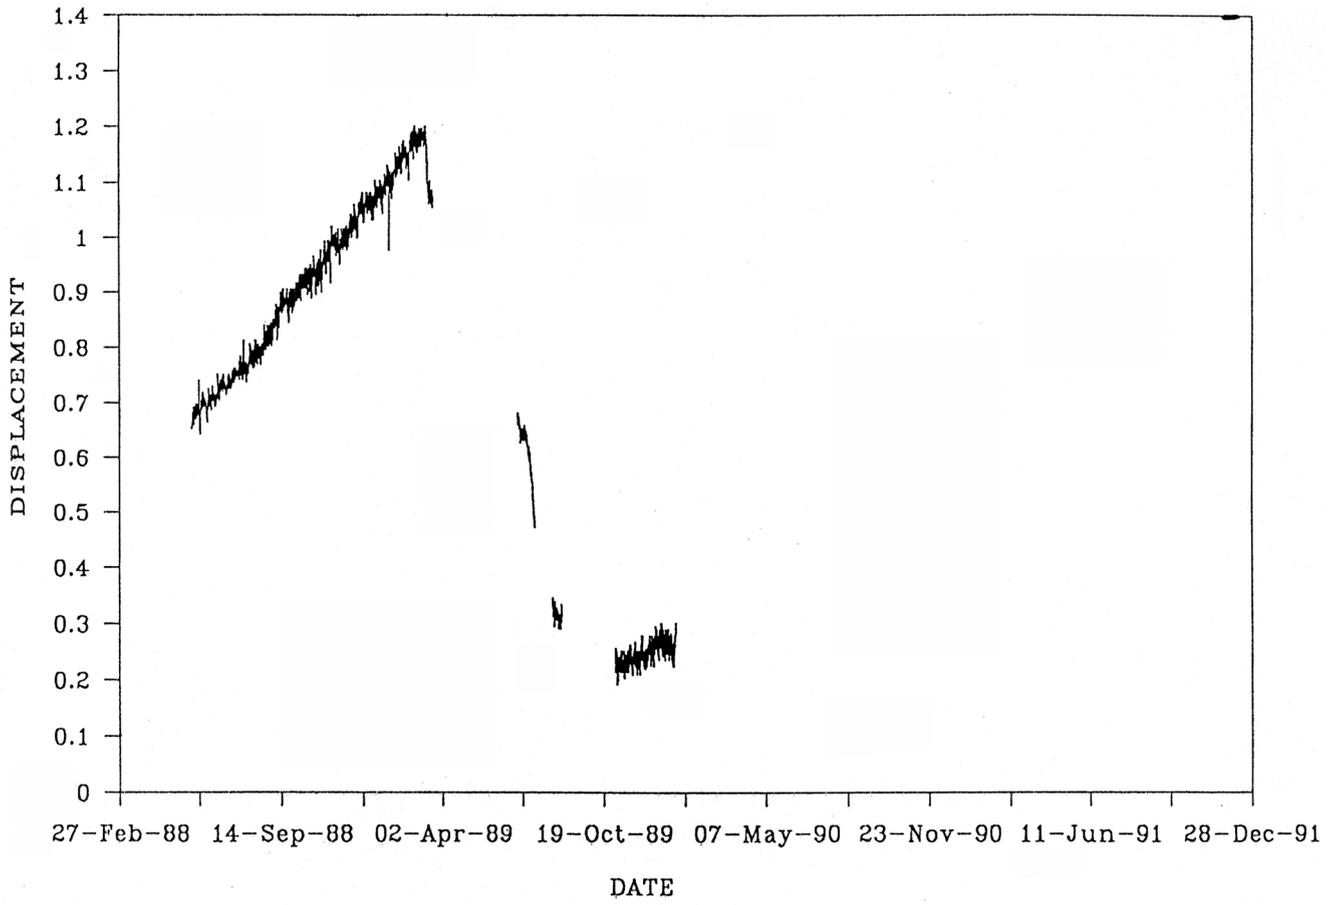
The most reliable data (fig. 8) was recorded in 1988/1989. The results show a constant extension of the gap between May 1988 and March 1989 with total displacement of about 0.65 mm. From March 1989 to January 1990, the data is broken but a general closing of the gap with total displacement of about 1.1 mm is indicated. Recordings from January 1990 onwards have shown either no displacement or have exceeded maximum displacement of the instrument and cannot be interpreted. At the request of the owner of 149 Channel Highway, the installation was removed in August 1992.

Where the data is considered reliable, the magnitude of the movement is small but insufficient to draw conclusive results. Movement can equally be explained by landslide movement or changes in the volume of the soil underlying the foundations of the concrete retaining wall.

Figure 8
Taroona monitoring station
27 May 1988 to 6 December 1991
