### Test pits at 52 William Street, Ulverstone

W. L. Matthews

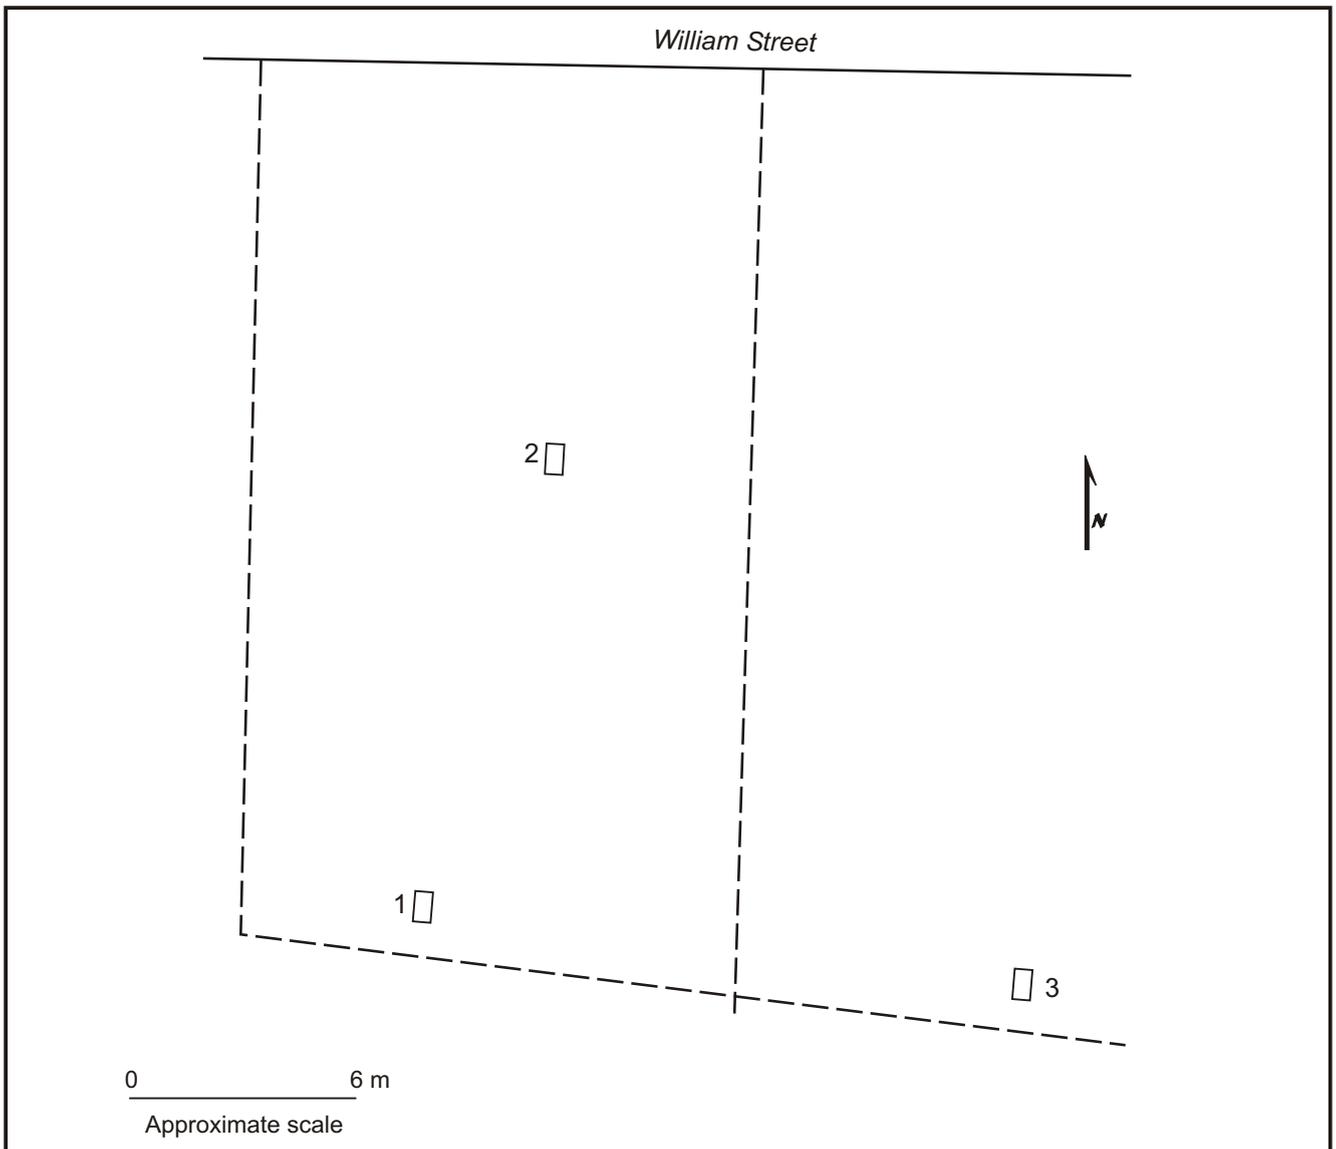
The locations of the test pits are shown on Figure 1 and brief descriptions of the material encountered are attached.

**Figure 1.** Sketch plan, 52 William Street, Ulverstone, showing location of test pits.
