A landslide at Pelverata

by W. L. Matthews

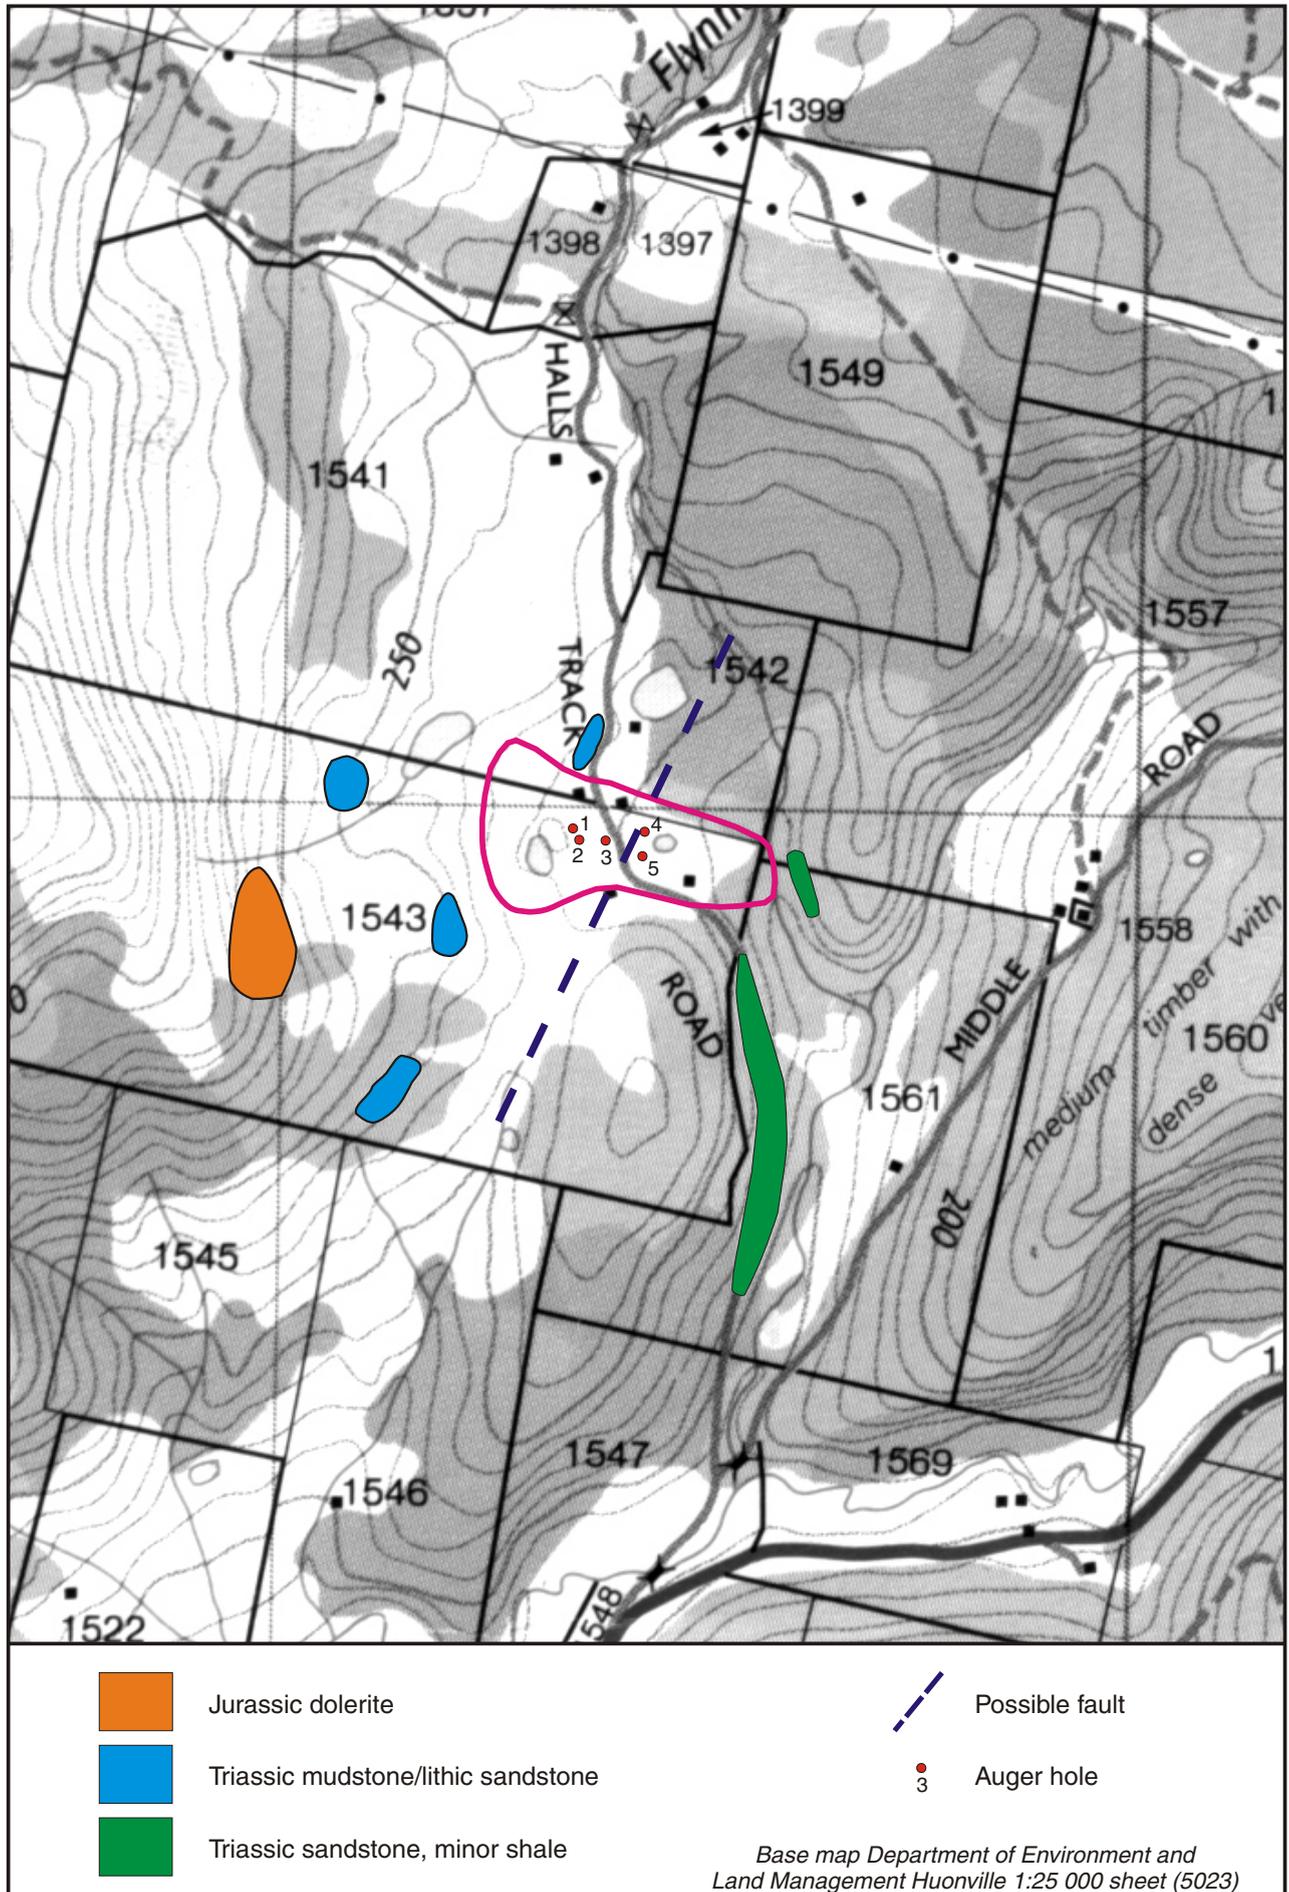
Figure 1

A landslide, affecting an area of about 4.5 hectares, has taken place just north of Pelverata in the Huon area of southern Tasmania. The slip is located about one kilometre along the southern part of Halls Track Road from its junction with the Sandfly–Pelverata Road (at approximately AMG 509 400 mE, 5235 000 mN). The movement occurred during early 1996 and appears to be related to above average rainfall starting from December 1995. One timber house is located within the moving mass and about fifteen metres from the margin, while several sheds are also within the landslide. Another (brick) house is located about half a metre from the edge of the slip on unaffected land. The movement also affects a section of Halls Track Road. The approximate location and extent of the landslide are shown on Figure 1.

The landslide has taken place on an unusually low slope angle of about 7° and extends for about 350 m down the slope. The slip is about 180 m wide at the head but narrows in the toe zone to about 90 metres. The total translational movement is about one metre or a little more since the movement began early in 1996.

Halls Track Road extends across the middle of the landslide. The head zone of the slide shows typical tension cracks and minor graben features, with vertical scarps in the soil of about 750 mm in height. The flanks of the movement are relatively straight for long distances while the toe is being eroded by the creek, with exposed bare soil about five metres in height. The erosion has maintained a steep slope and, as a result, slumping in the toe area has occurred. Cracks can be seen at various points within the slide mass. The timber house within the slide mass has been damaged by the movement but the brick house marginal to the slide is undamaged at this stage, apart from the septic tank outlet which extends into the landslide. The depth of the movement is unknown but it is probable that movement is taking place at the contact of the talus and weathered Triassic mudstone. The slide appears to extend under the creek bed.

Auger drilling was used in an attempt to locate the depth of the slip surface and the standing water level of the groundwater within the landslide. The drilling did not extend to the depth planned because of the presence of boulders under the surface. Five holes were attempted above and below the road (fig. 1), the deepest reaching about 6.6 m before drilling was stopped (Table 2). Each hole passed through brown clay and clay with dolerite boulders to the final depth.
