**Stability conditions at
Shark Point Road, Penna**

by W. L. Matthews

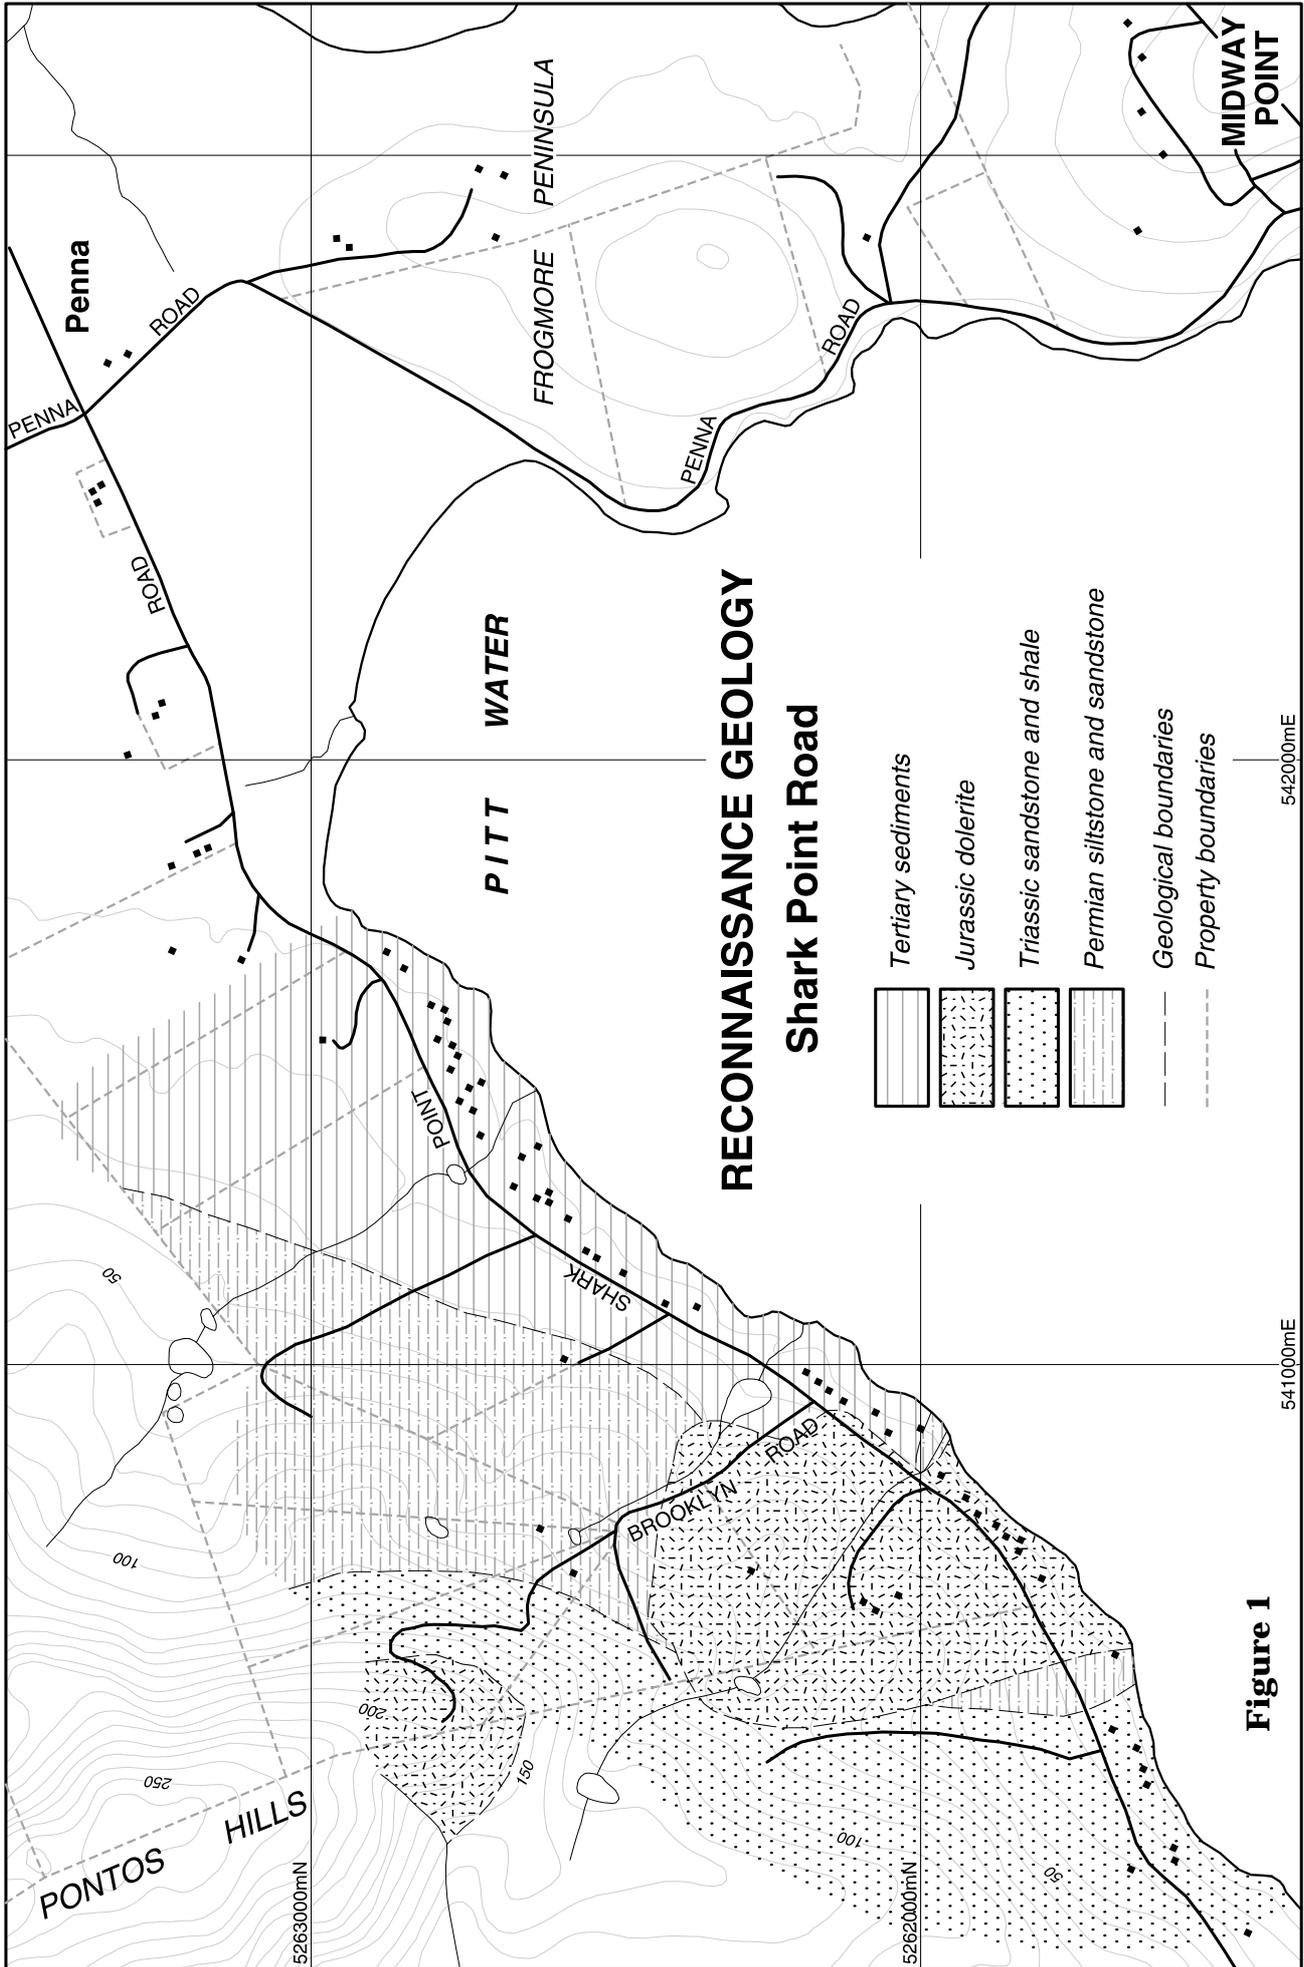
The rock types occurring in the area comprise Permian-age siltstone and fine sandstone containing a few pebbles, Triassic sandstone (probably with minor shale beds), Jurassic dolerite, Tertiary clay and silty clay, and localised Quaternary deposits including wind-blown sand. The distribution of these materials is shown on Figure 1. Tertiary basalt occurs to the east of the area.

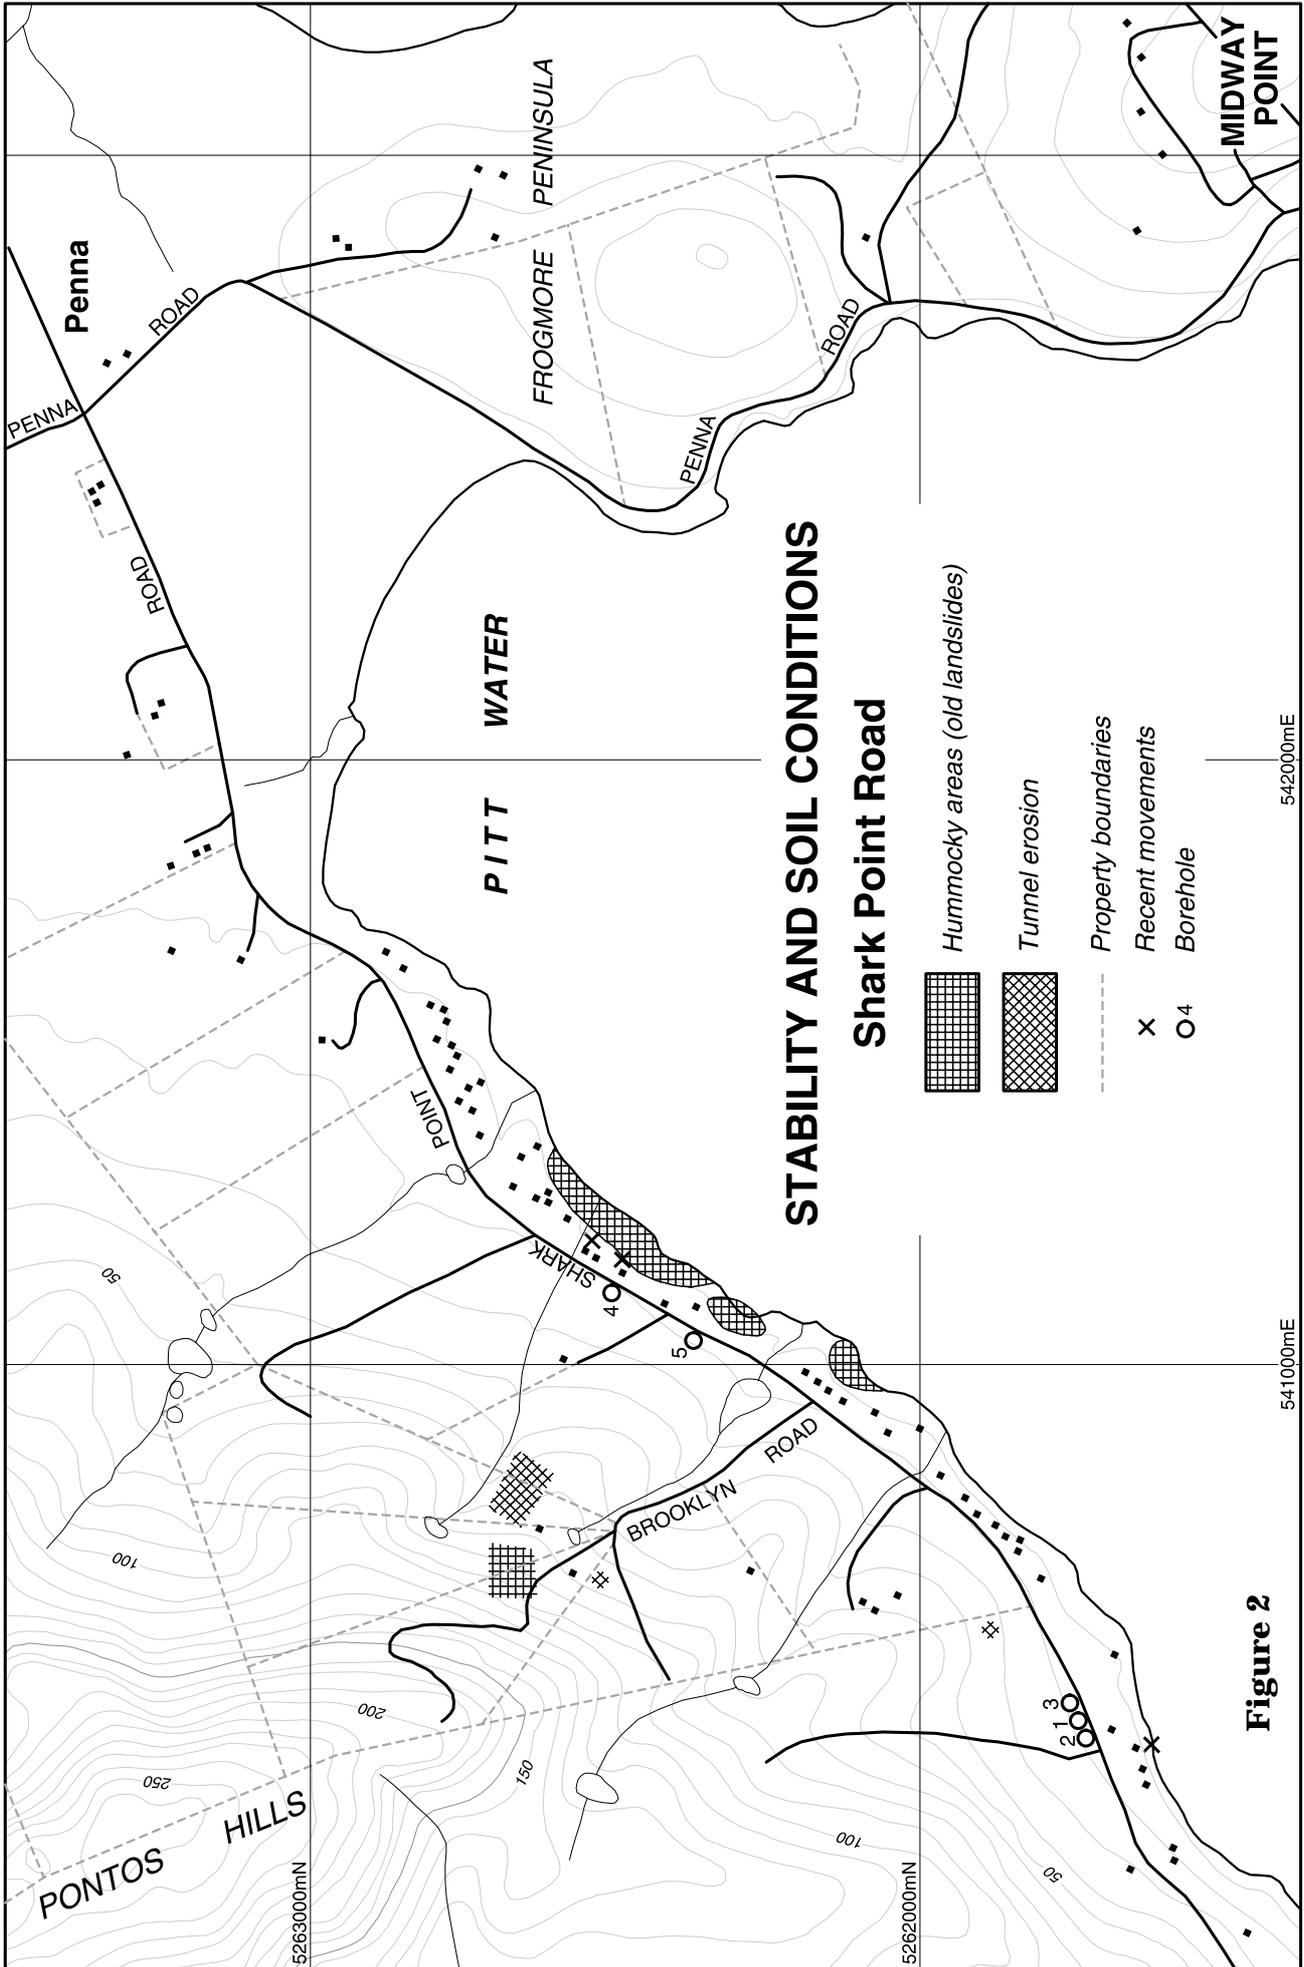
Recent landslide movements are evident within the built-up area, all occurring on the steep slope to the shoreline (fig. 2). The three known active areas do not appear to have affected the nearest structures significantly but in each case there are cracks in the soil very close to these structures. There are also signs of old landslides at some points between the road and the shoreline and probable old landslides in one area of steeper land above the road.

Tunnel and gully erosion are evident in some parts of the area (fig. 2). These features are often associated with soils on Permian, Triassic and Tertiary sediments, and in the Shark Point area the most obvious examples are in the Permian soils above the road.

Five holes were drilled at selected sites (fig. 2) to examine the rock sequence in areas where problems have occurred. These holes were left open for a time to enable measurement of groundwater levels.
