## Investigation of house cracking at Beach Road, Legana

by W. L. Matthews

### Introduction

A house was built at 82 Beach Road, Legana, in about 1970. In 1993 attempts were made to repair structural damage to the house, which was apparently caused by earth movements. Examinations by the building inspector for the West Tamar Council and by a geologist from Mineral Resources Tasmania (MRT) resulted in conclusions that the property was being affected by landslip. At a later stage, the West Tamar Council requested that an investigation of the property be undertaken.

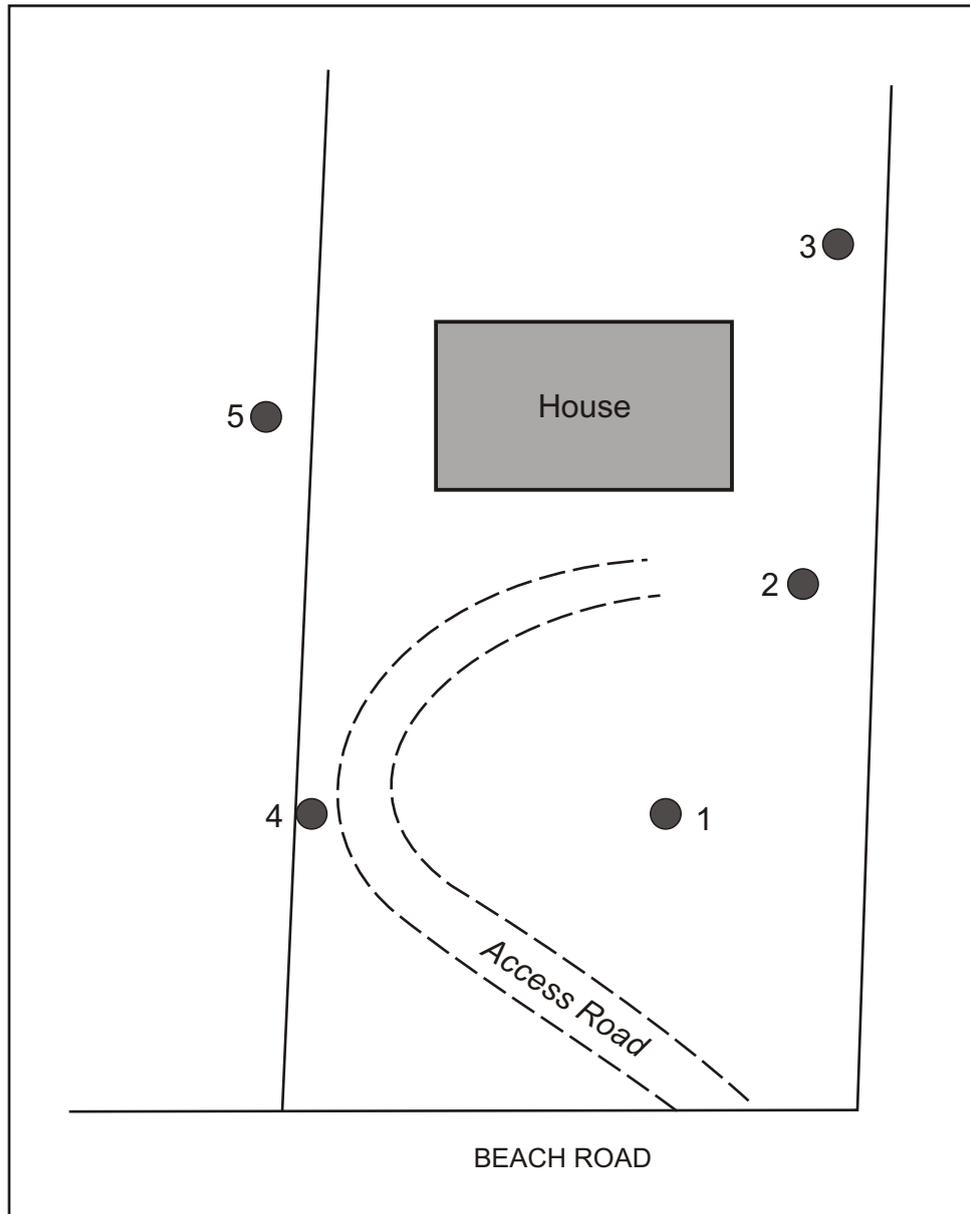
**Figure 1**

The investigations resulted in the auger drilling of five holes on the property to a maximum depth of nine metres and the installation of 50 mm PVC pipe into the holes to measure standing water levels and to place devices to measure approximately where the PVC pipe is distorted, if affected by a landslip movement. Brief descriptions of the material encountered in the auger holes are given in Appendix 1 with the approximate positions shown on Figure 1.

Water levels and signs of distortion in the PVC pipe have been monitored from time to time over a period of about three years. It was apparent at the time of monitoring the holes on 8 March 1996 that some distortion of the PVC pipe in three of the holes had taken place, suggesting movement. The depth of these distortions was about 5.8 m from surface in hole 1, 6.5 m from surface in hole 3, and about 6.6 m from surface in hole 5.

*Sketch plan of borehole locations, 82 Beach Road*
