Tasmanian Geological Survey
Record 2007/04

Lawrence Vale Landslide Investigations: implications for landslide hazard assessment in Launceston

by A. R. Ezzy and C. Mazengarb

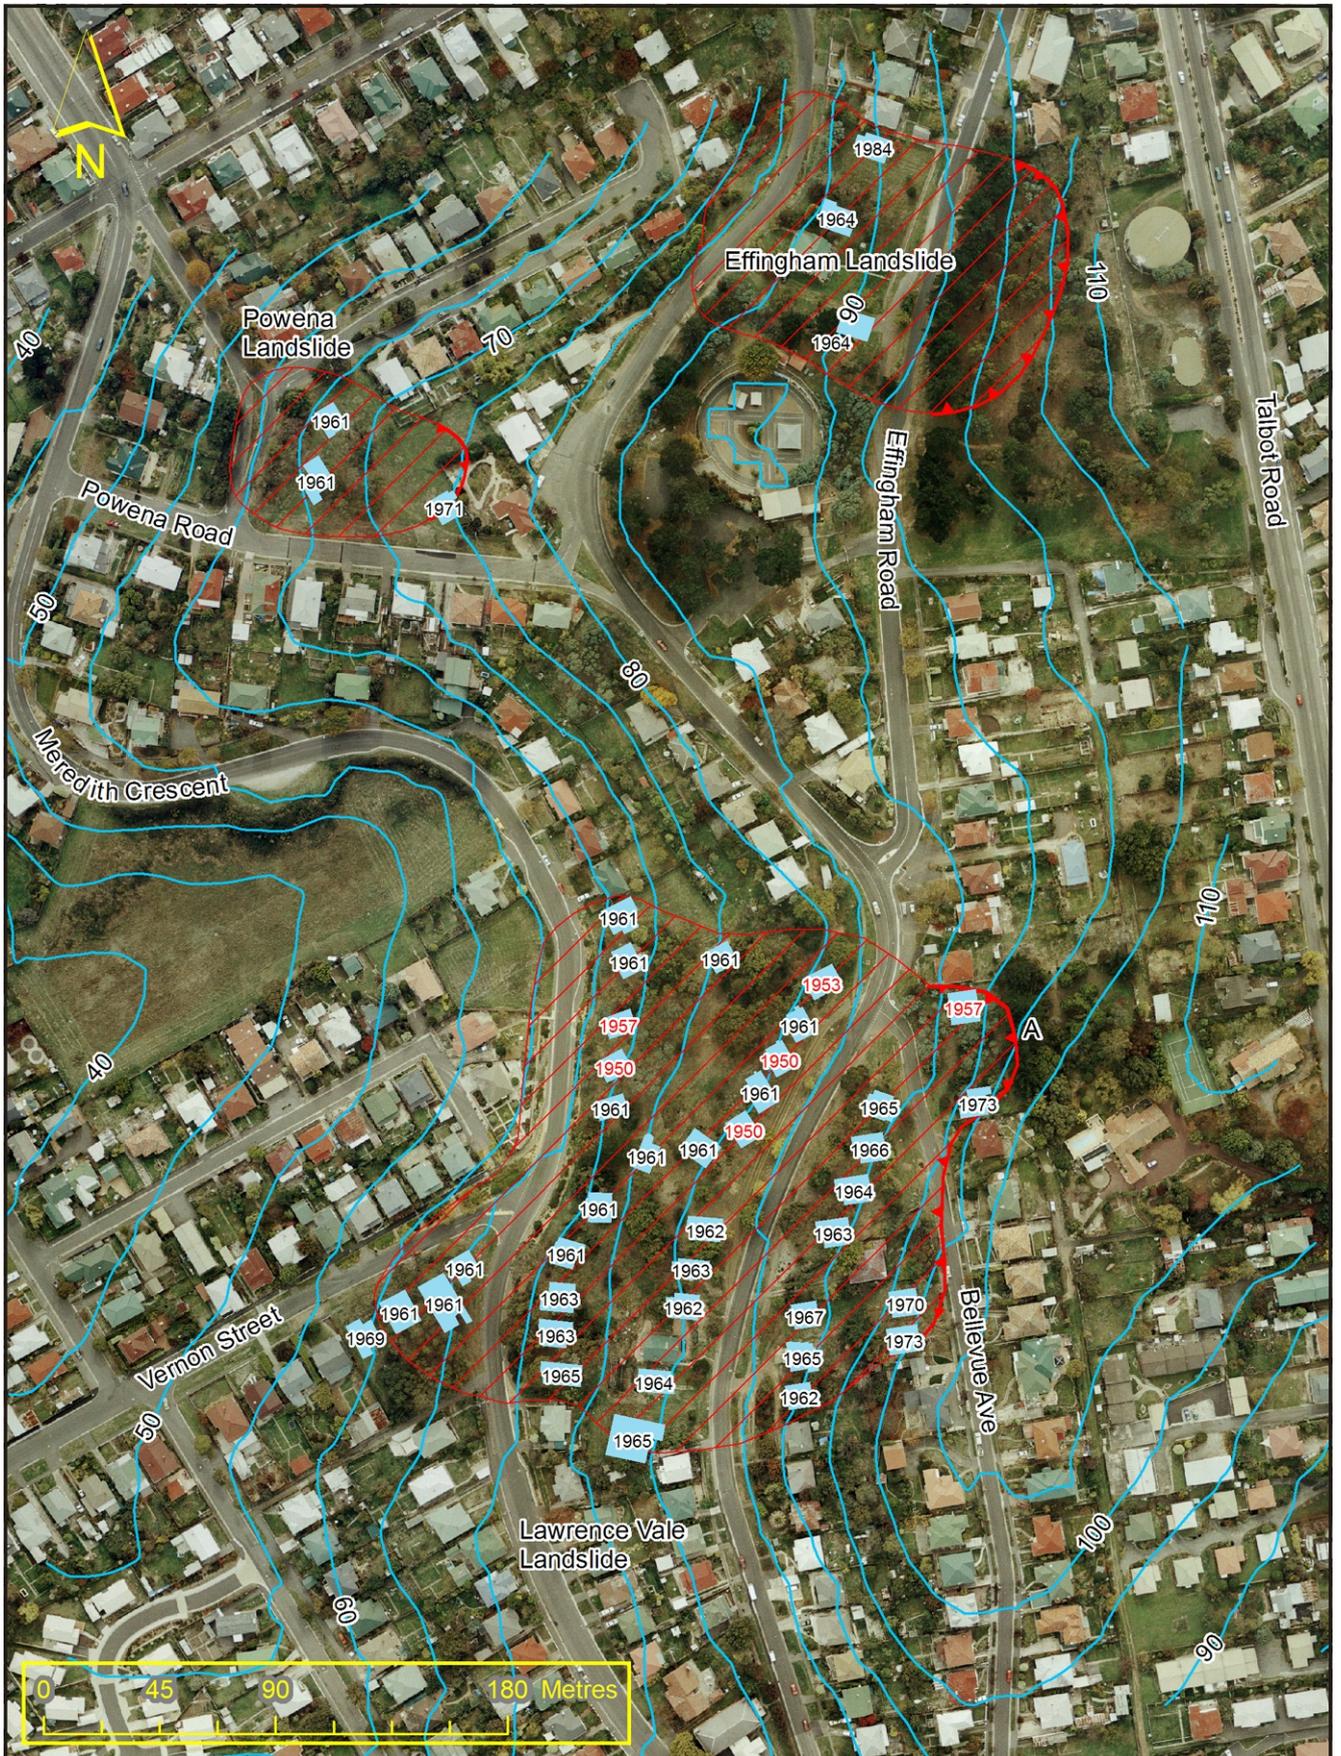
Figure 3

Map showing the Lawrence Vale area (informal name) including the three landslides under discussion (red hatching) with headscarps indicated by red ticks. Blue polygons indicate position of demolished houses; red labels indicates year of earliest known damage (from MRT records); black labels indicate year of proclamation under the Lawrence Vale Landslip Act when first damage date is unknown. Topographic contours are from Department of Primary Industries and Water. Orthophoto base (flown in 2003) is the property of MRT.

Total distance of movement for the three landslides cannot be precisely determined. In the case of the Lawrence Vale Landslide, the size of the head scarp and the toe mound suggests displacement in the order of 20 m or more. Total displacement on the other two landslides is probably much less based on surface morphology. On consideration of house damage details and previous monitoring results (fig. 3), the rate of movement is classified as Extremely Slow (<15 mm/year) using the Cruden and Varnes (1996) scale. While it is possible to build houses on Extremely Slow moving landslides (Cruden and Varnes 1996), the distribution of damage suggests that the landslide was not moving as a single rigid block. Rather, surface deformation such as warping and faulting has probably occurred over much of the area.

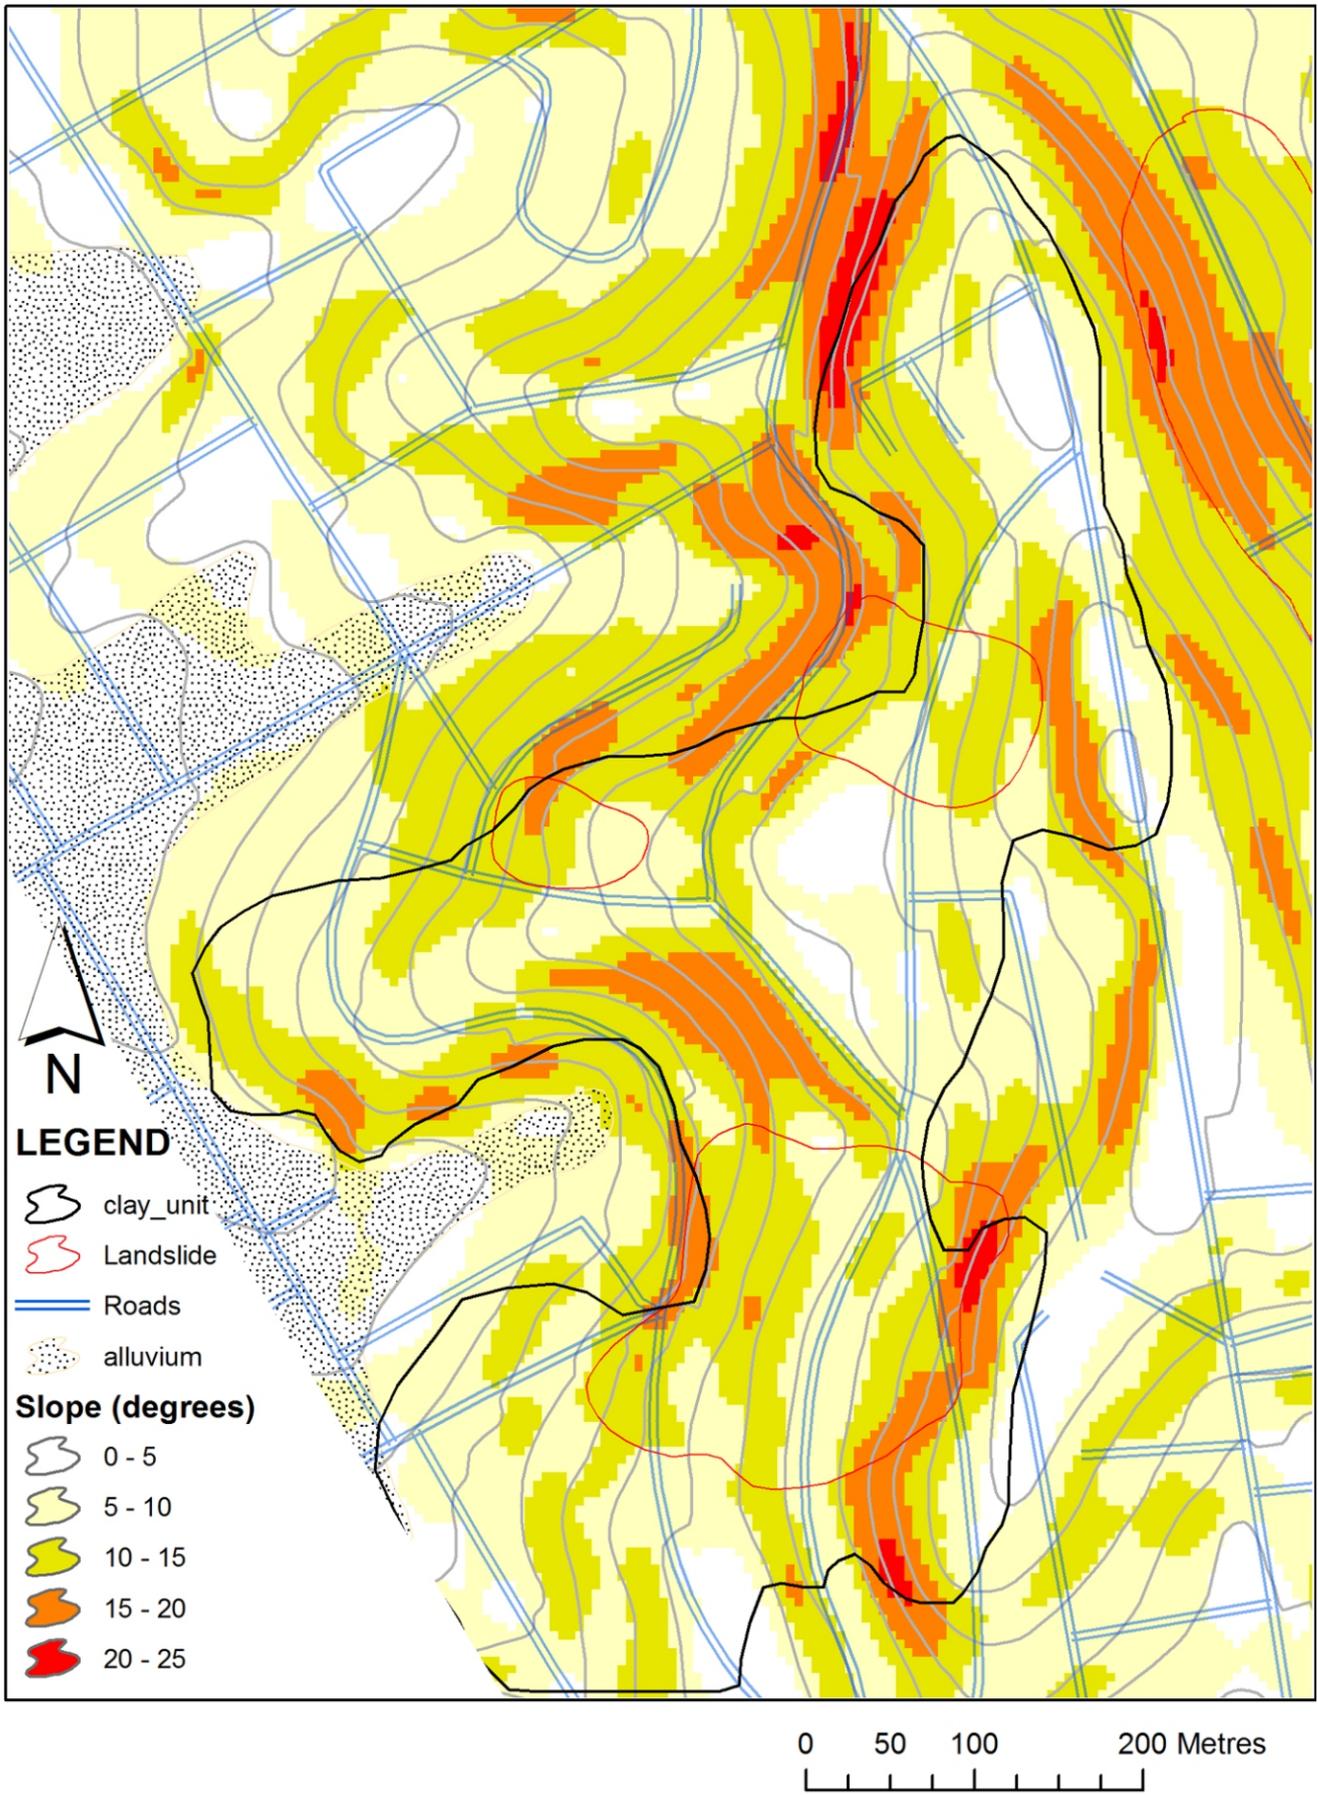
Figure 4
 Map showing slope categories at Lawrence Vale, important geological units and landslides.

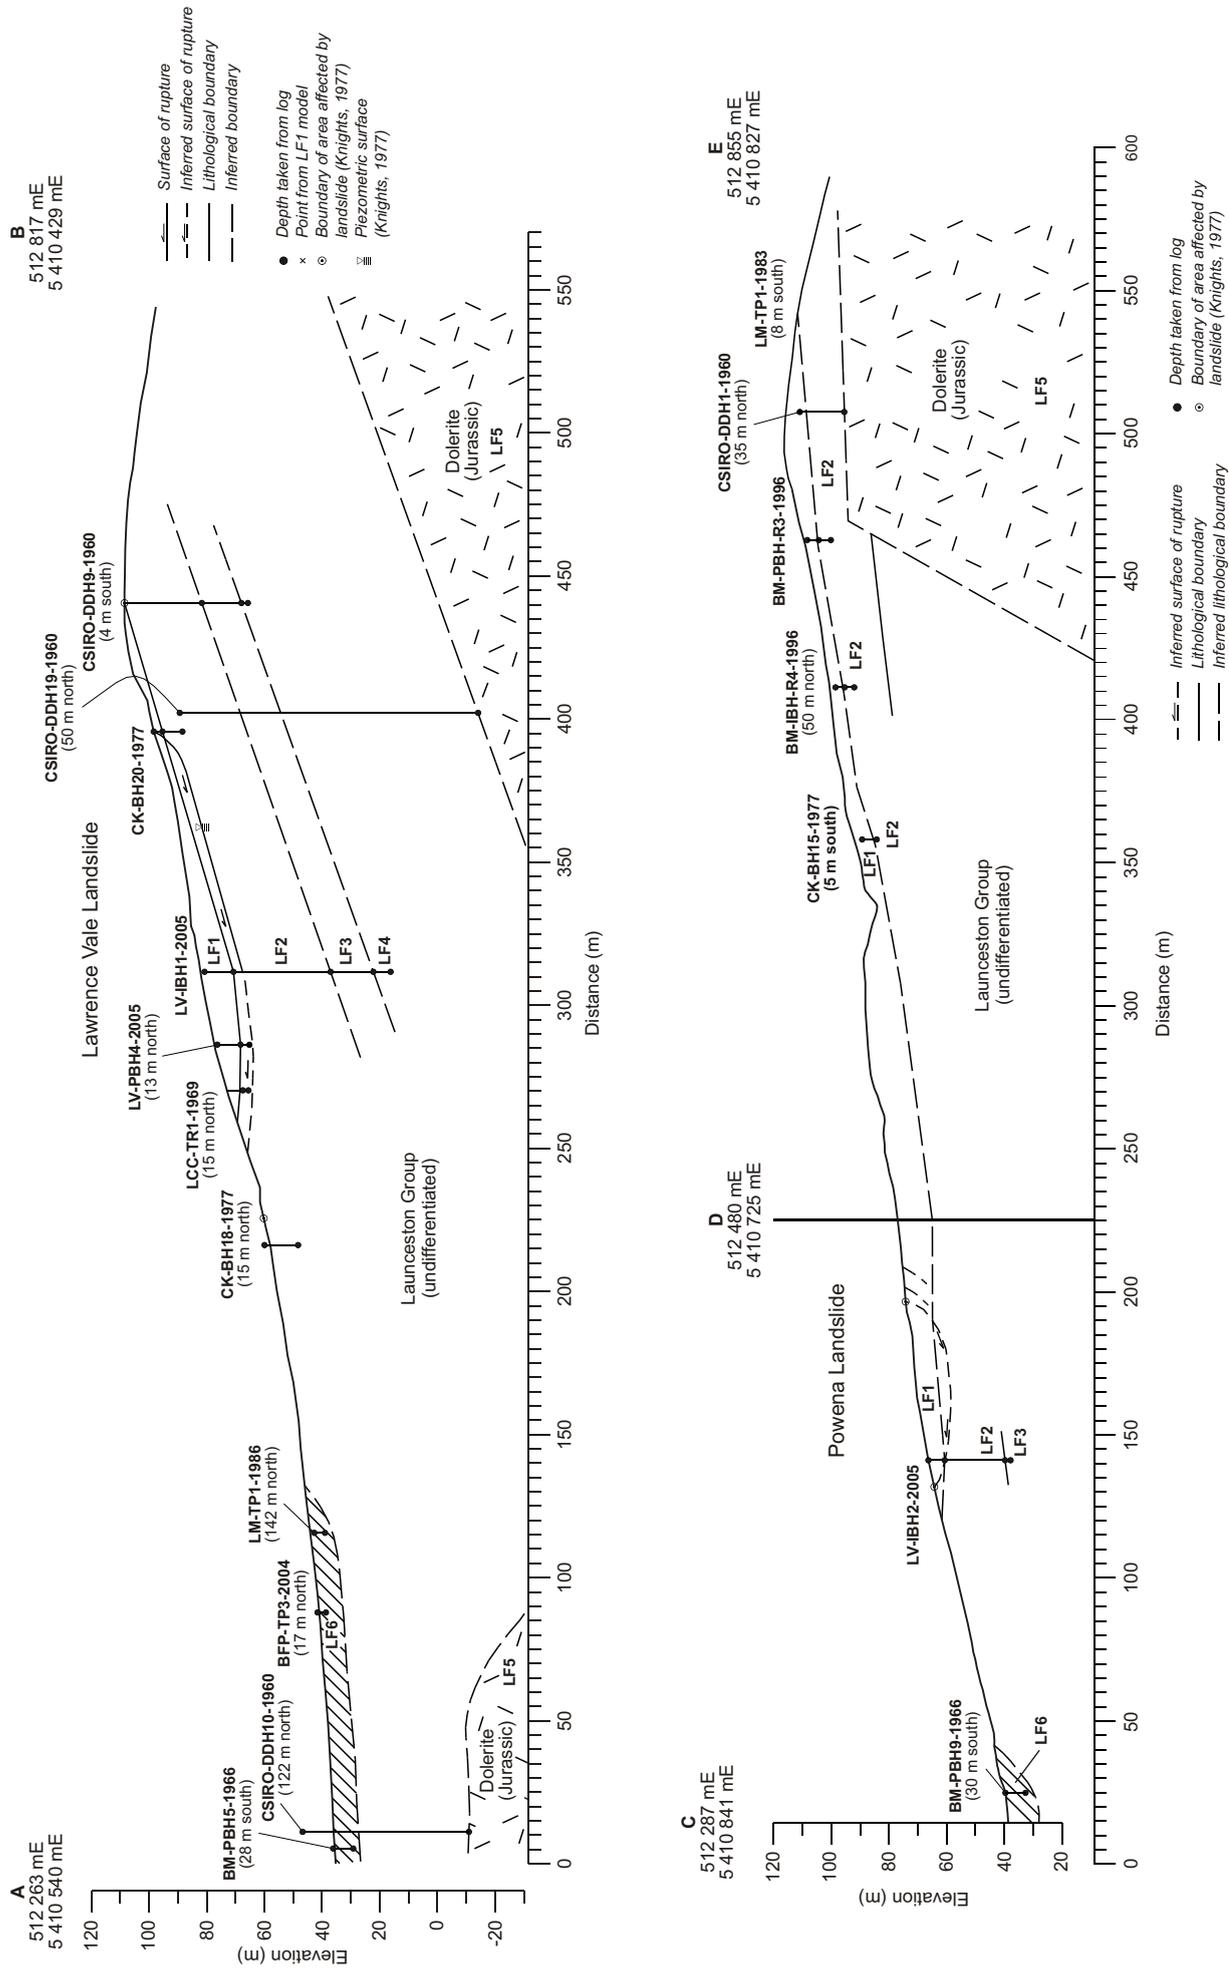
Figure 7

Interpretative cross sections based on drill hole data in the Lawrence Vale area.

the hillside slope, and the contrast in hydrological properties between LF1 and LF2, we have interpreted the failure surface to be situated approximately along this boundary over much of its length. With this geometry the three landslides would appear to be a combination of rotational and translational failure styles. Modelling of slope stability (Appendix 5) indicates that pressure changes in the LF1 fissured clay aquifer in the toe of the landslide are as important to landslide movement as LF2 pressure changes.

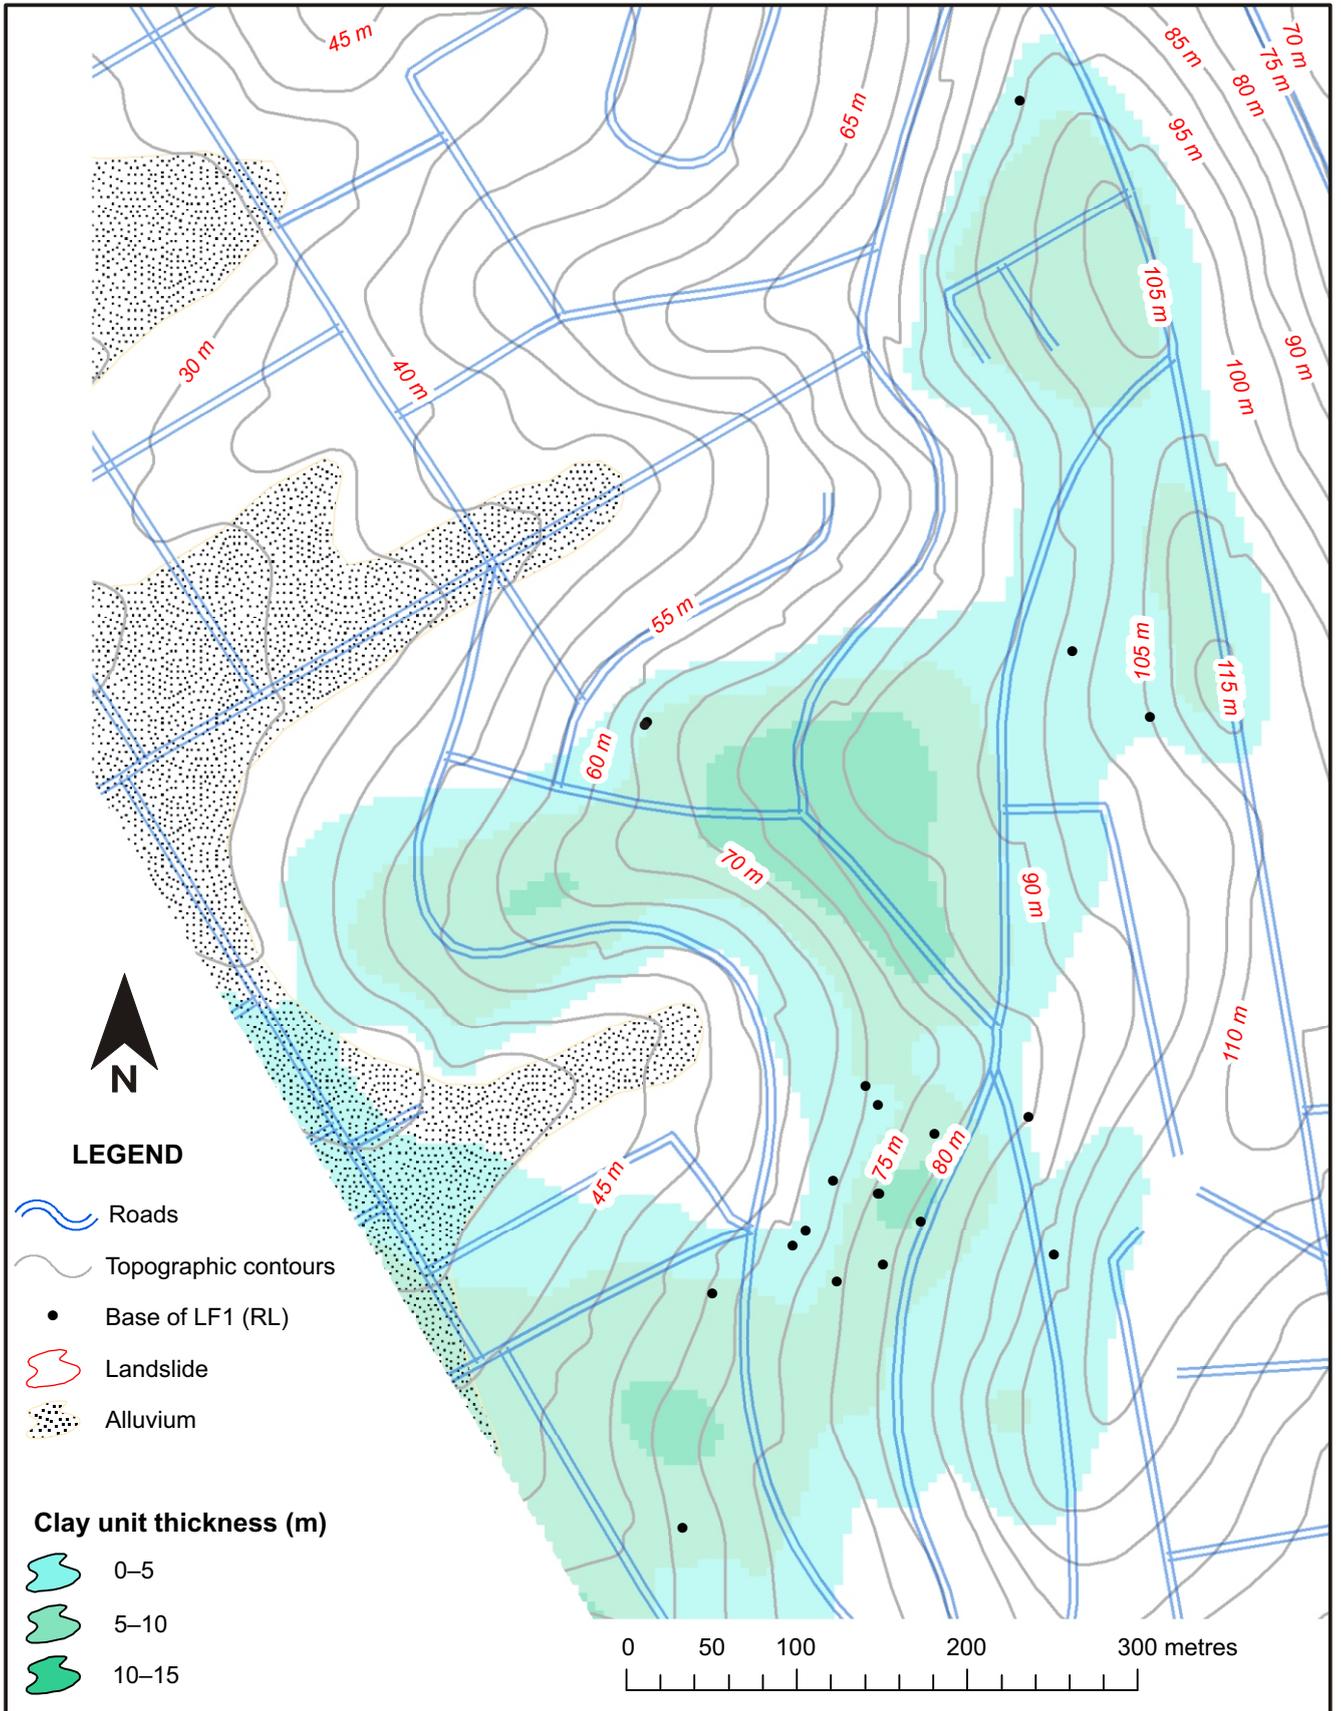
Figure 8
 Modelled extent and depth of the upper clay layer, lithofacies LF1.

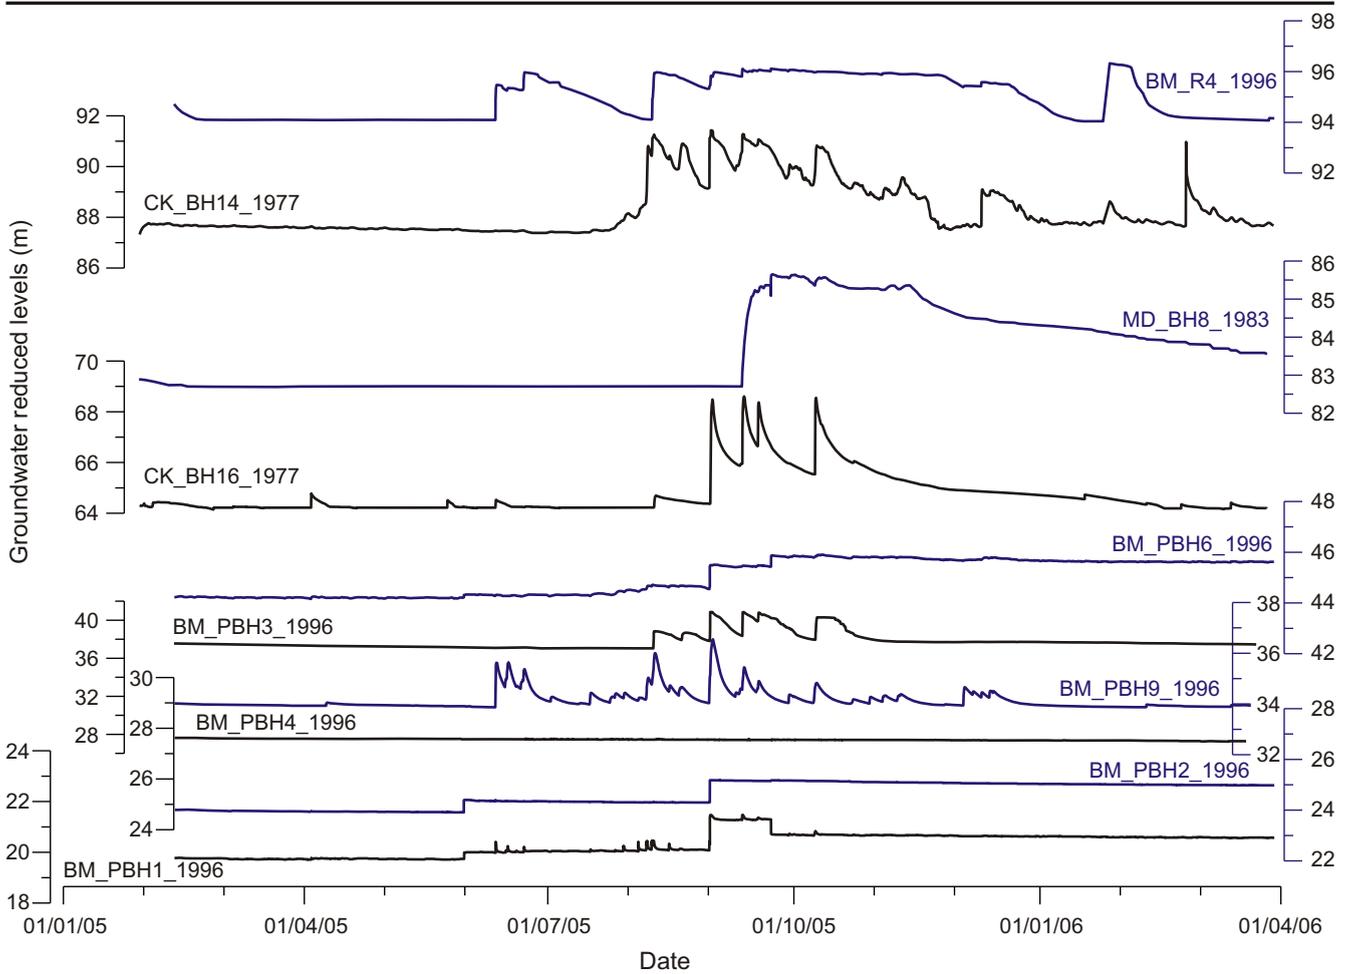
Figure 9
Hydrographs of standing groundwater levels in the study area.

monitoring interval, has been obtained from the Bureau of Meteorology to analyse the response of the piezometers to climatic events. Hydrographs of the piezometers are depicted in Figure 9 and many of them show convincing relationships to rainfall events (fig. 10). In particular, borehole CK_BH14_1977, above the Lawrence Vale Landslide and situated in the sand dominated unit (LF2), shows rapid response to rainfall events. A slug test in this hole indicated a hydraulic conductivity of 10^{-2} m/d using the Bouwer and Rice

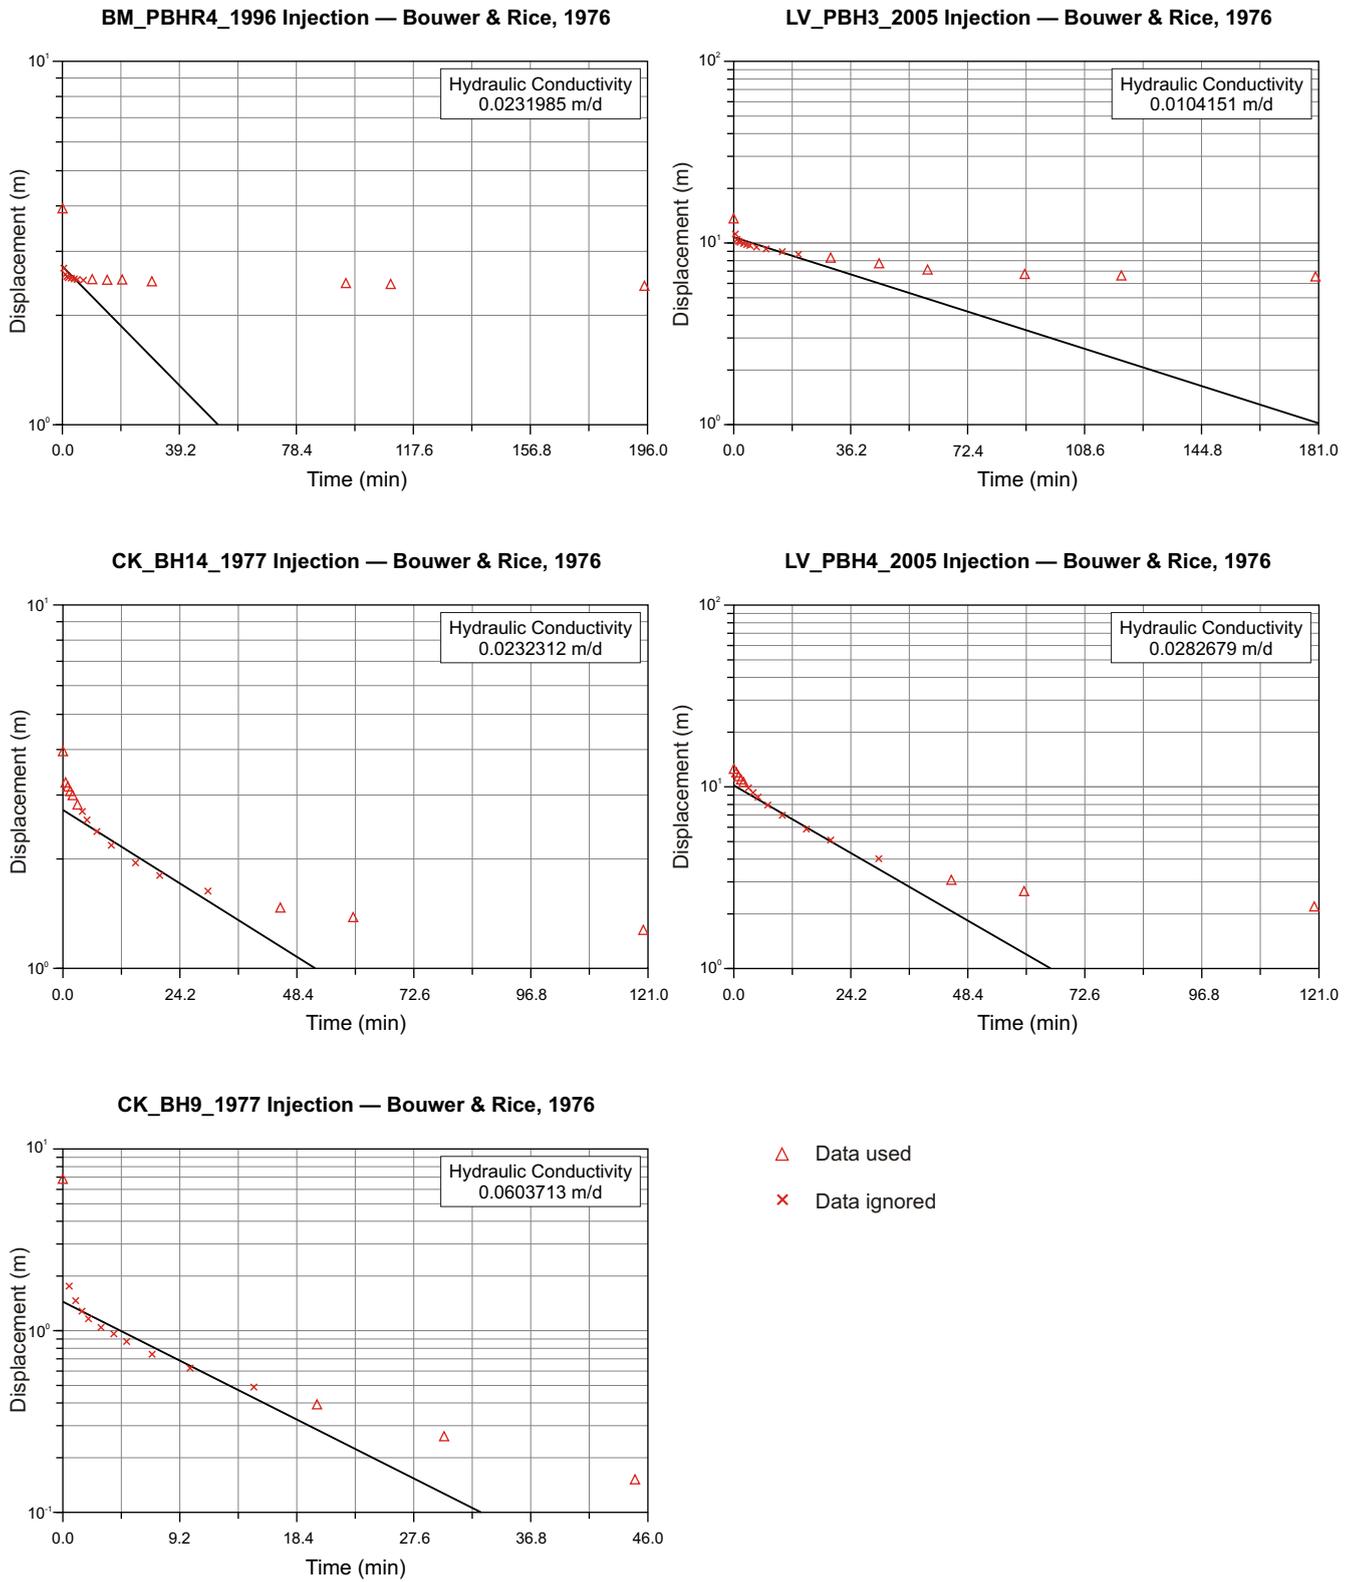
Figure 11
Solutions of in situ permeability tests and hydraulic conductivity values.

(1976) method (fig. 11) and is consistent with theoretical values of this lithology. Figure 12 also indicates that all other slug tests undertaken produced the same order of hydraulic conductivity. Hydraulic conductivity was calculated on borehole CK_BH16_1977 for the falling head component of the base flow recession curve, i.e. the section following significant rainfall events (fig. 12). The result is two orders of magnitude less (10^{-4} m/d) than a slug test on the same bore (10^{-2} m/d). In short the aquifer at this location is quick to recharge but slow to drain.

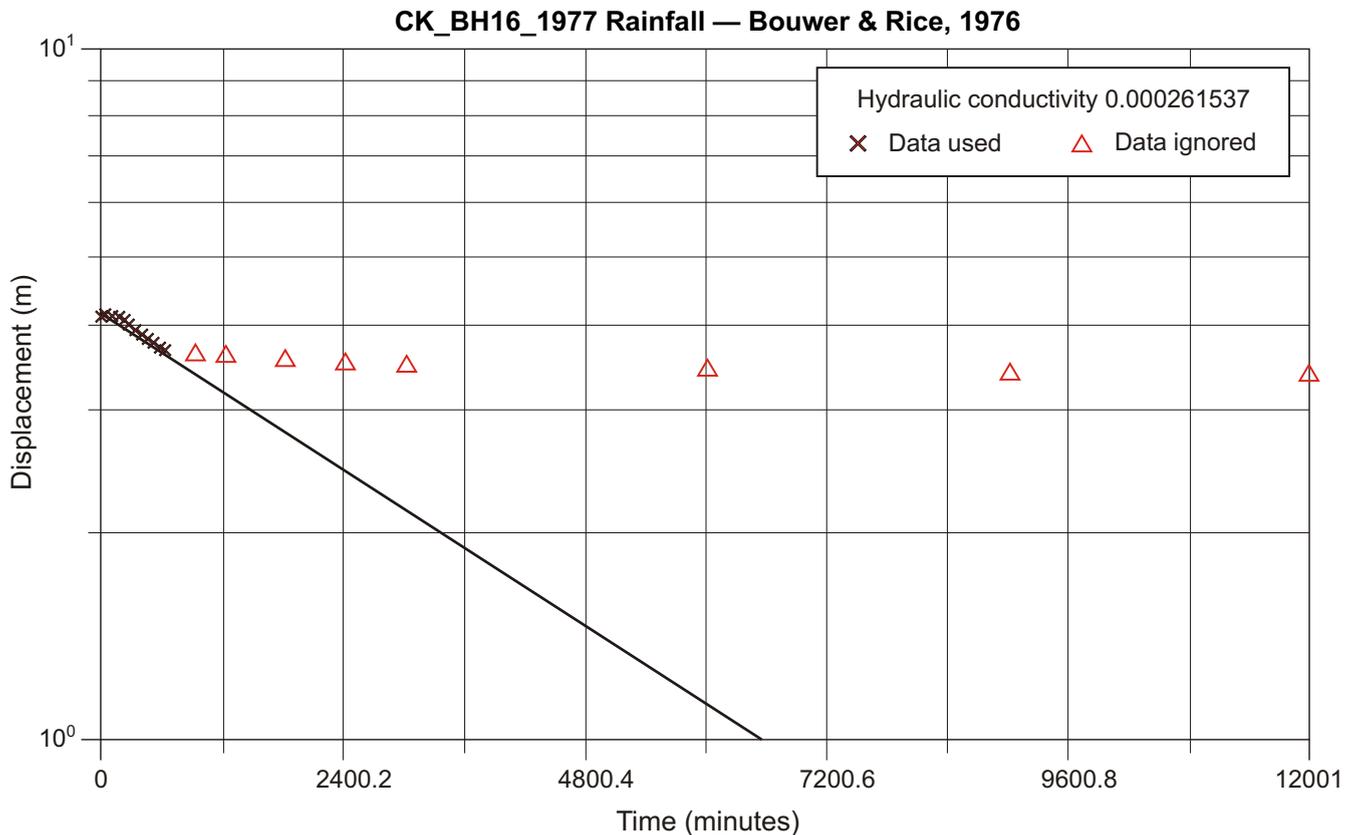
Figure 12
Solution of base flow recession curve for borehole CK_BH16_1977.

The high apparent conductivity for borehole CK_BH16_1977 (fig. 12), situated in clay, is possibly because the porosity is dominated by fissures in the clay medium. Fissuring has been observed in the clay and these features would allow water to flow readily, although it is not known how deep the fissures penetrate the subsurface and they may not necessarily extend to the base of LF1. In the case of the borehole CK_BH14_1977, uphill of the landslide and situated in the second sandy lithofacies with the same order of K (10^{-2} m/d), we suggest that while the local conductivity is normal for sand, there are impediments to flow over a larger area. A likely explanation is the effect of complex internal stratification that has been observed directly and is theoretically likely for fluvial deposits such as sand channels intercalated with overbank mud deposits. The sand aquifer in LF2 is complex in that it contains confining lenses of interbedded ironstone and high plasticity clay (as indicated by the borehole logs for

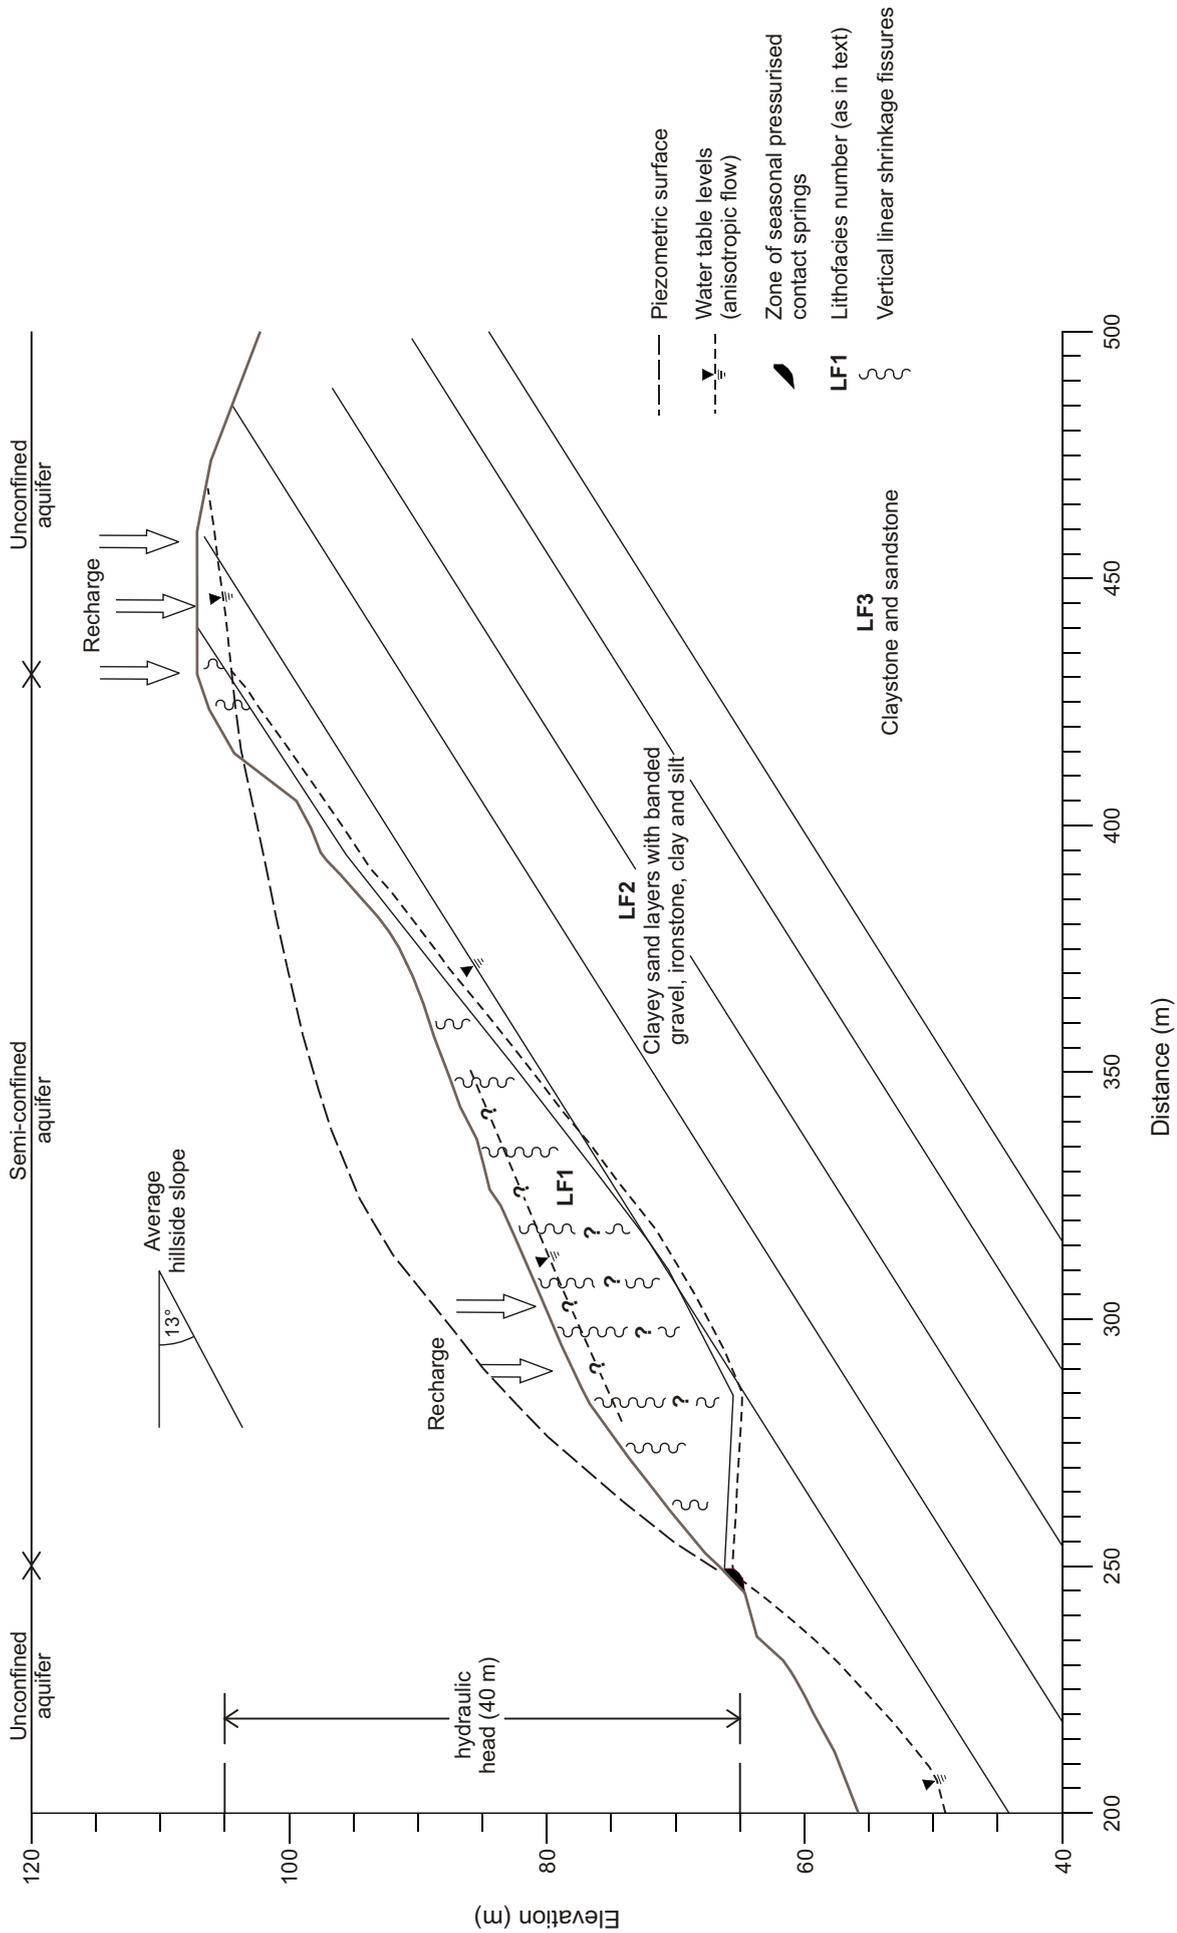
Figure 13

Time series data indicate that recharge on the ridge appears to occur where LF2 is exposed at the surface (as seen in the hydrograph of borehole CK_BH14_1977) and potentially via clay fissures in LF1 (as seen in the hydrograph of borehole CK_BH16_1977). As the hillside semi-confined aquifer is recharged, anisotropic flow rapidly increases the pore pressures within the aquifer (with a theoretical hydrostatic head of up to 40 m), perching water on the upper slopes of Talbot Ridge. During the winter months of 2005 the upper slopes of the Talbot Ridge aquifer remained perched, as seen in the hydrograph of borehole BM_R4_1996 (fig. 9). Recharge migrates downslope beneath LF1 to discharge from hillside springs topographically below LF1 or into the valley floor aquifer (LF6). This conceptual model is depicted in Figure 13.

Hydrogeological conceptual model for the western side of Talbot Ridge.

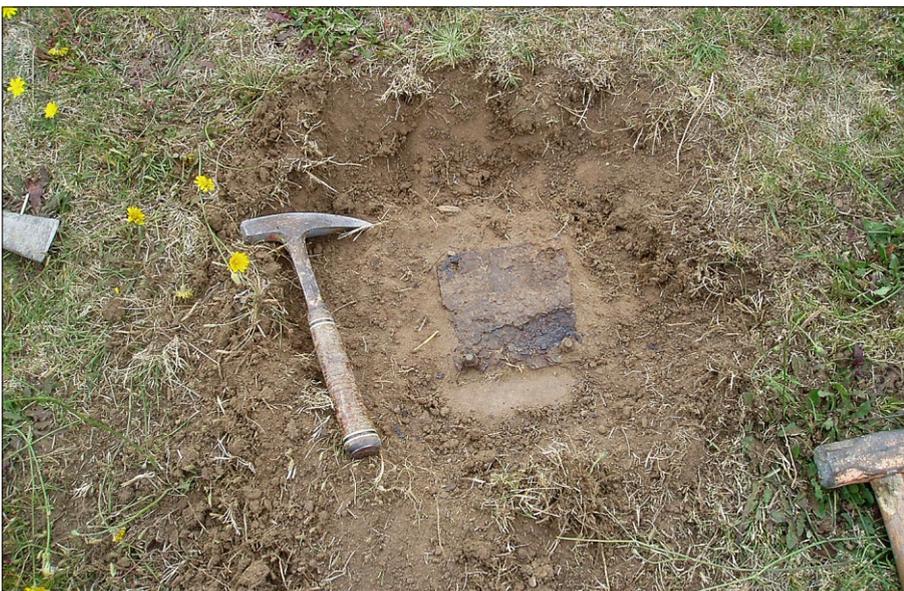
Plate 2

Initial collar condition of bore hole 14 (Knights, 1977) January 2005.

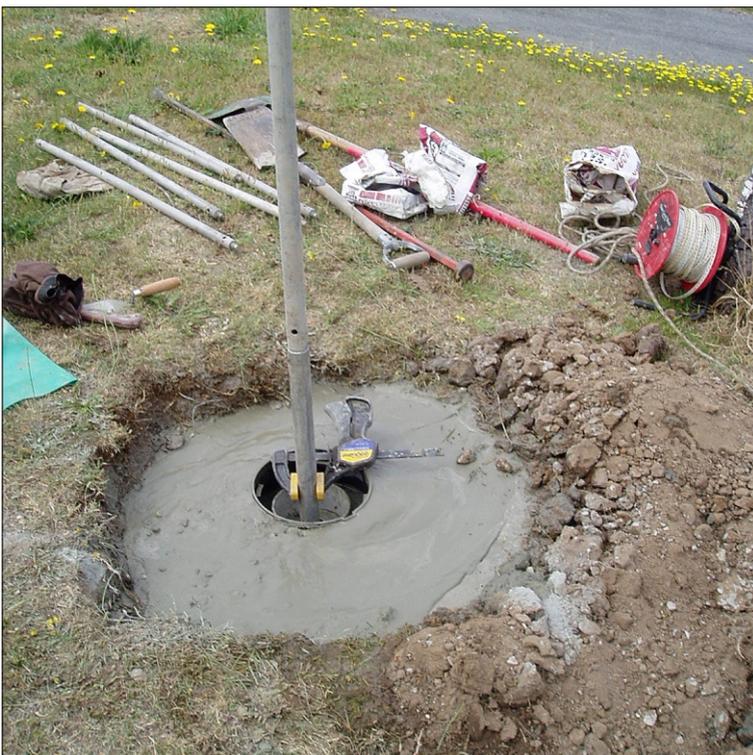
Plate 3

Maintenance works being undertaken on bore hole 14 (Knights, 1977) during January 2005.

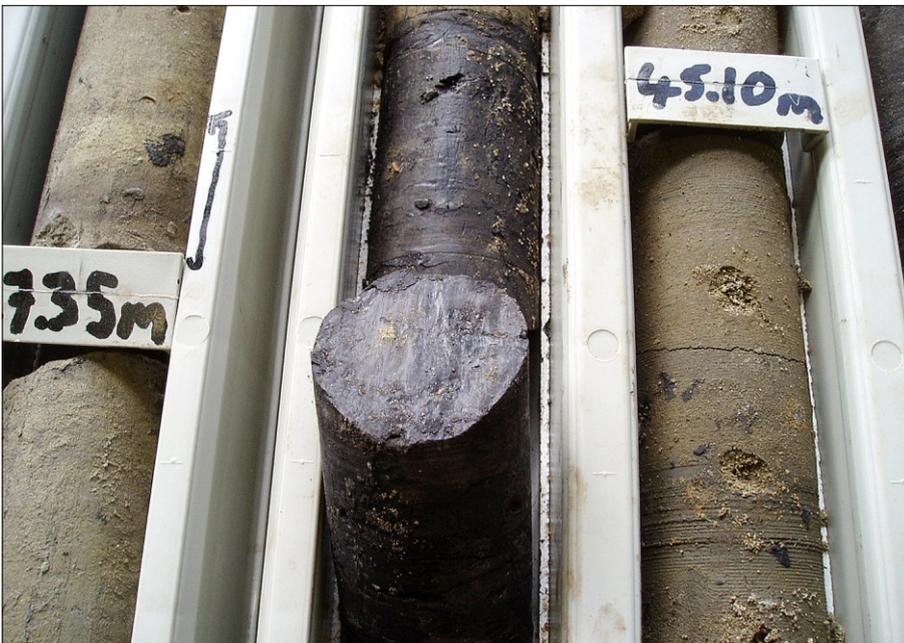
Plate 8
*Polished slickenside defect in coal
at 46.50 metres in drill hole
LV_IBH1_2005.*

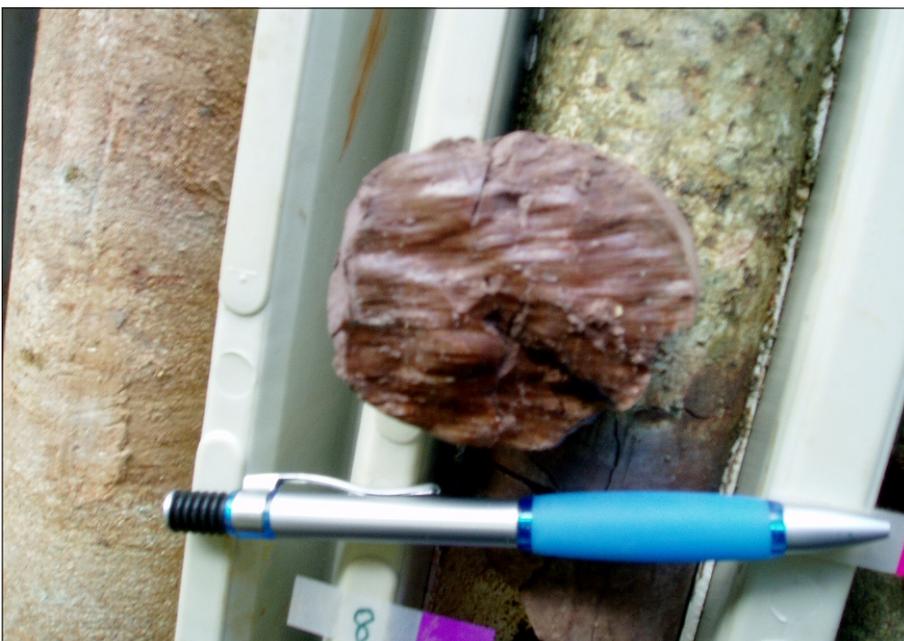
Plate 9
*Polished slickenside defect in
claystone at 62.80 metres in
drill hole LV_IBH1_2005.*
