**DATA ACQUISITION
SUPERVISION REPORT**
For the
2007 SILVEREYE 3D SURVEY
Conducted by

**ORIGIN ENERGY
RESOURCES LIMITED**

Block T/44P
Offshore Tasmania

Volume 1 Seismic Data Acquisition

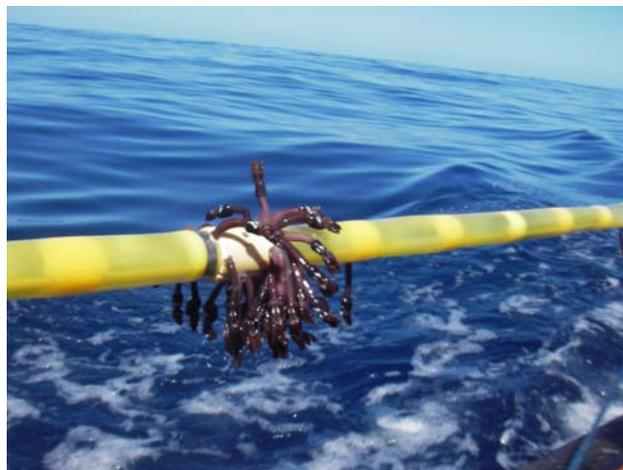
Hydroscience's gel-filled streamers were used on this project. The streamers proved to be a great improvement from the old fluid filled streamers with regard to noise levels in marginal sea conditions. This, coupled with better processing techniques meant that the deciding factor for shutting down in poor weather conditions was no longer streamer noise but was due to noisy compass data. The streamers do have their own noise signature which translates as coherent noise. The moveout of the said noise is vastly different than that of data and can be safely removed by an F-K type filter. It is also effectively removed by the P.G.S. SINK filter.

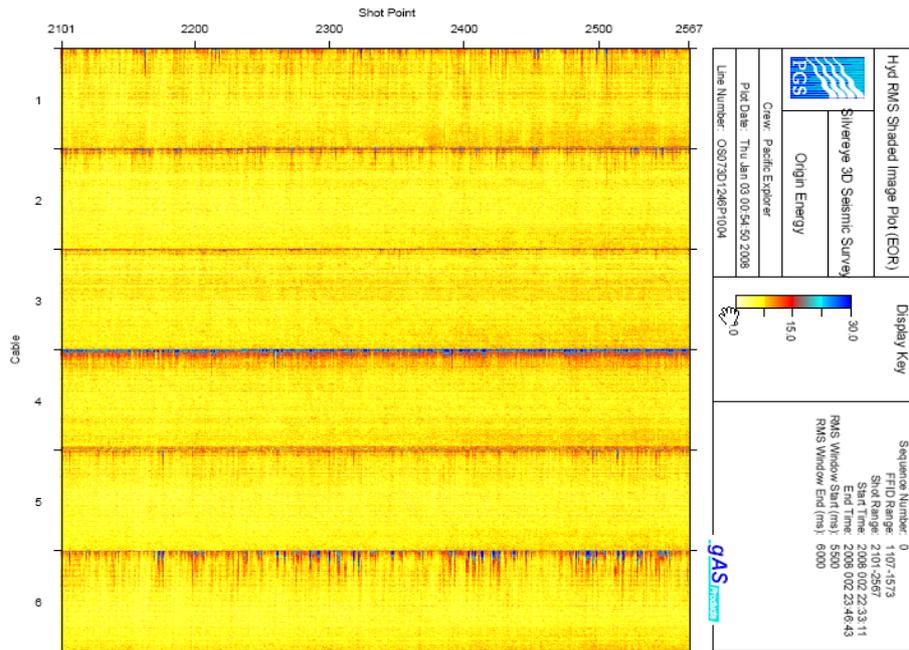
A noticeable amount of front-end noise on streamers 1, 2, 4 and 6 was experienced from the beginning of the survey. An example is displayed in the gAS RMS display below. The level of noise increased whenever the sea state deteriorated.

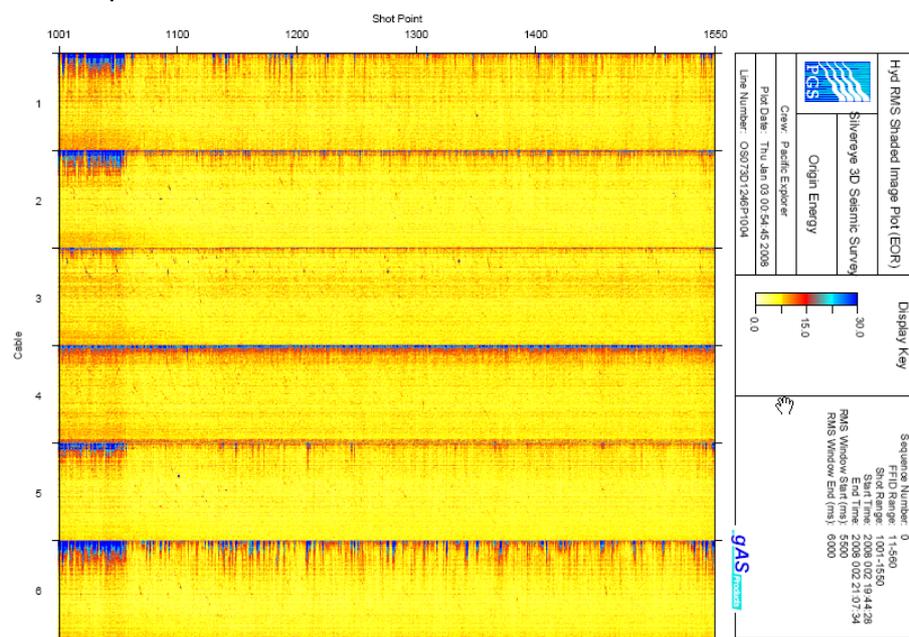
The display below illustrates the effect of the front-end noise reduction across all streamers whenever the vessel speed was reduced online.

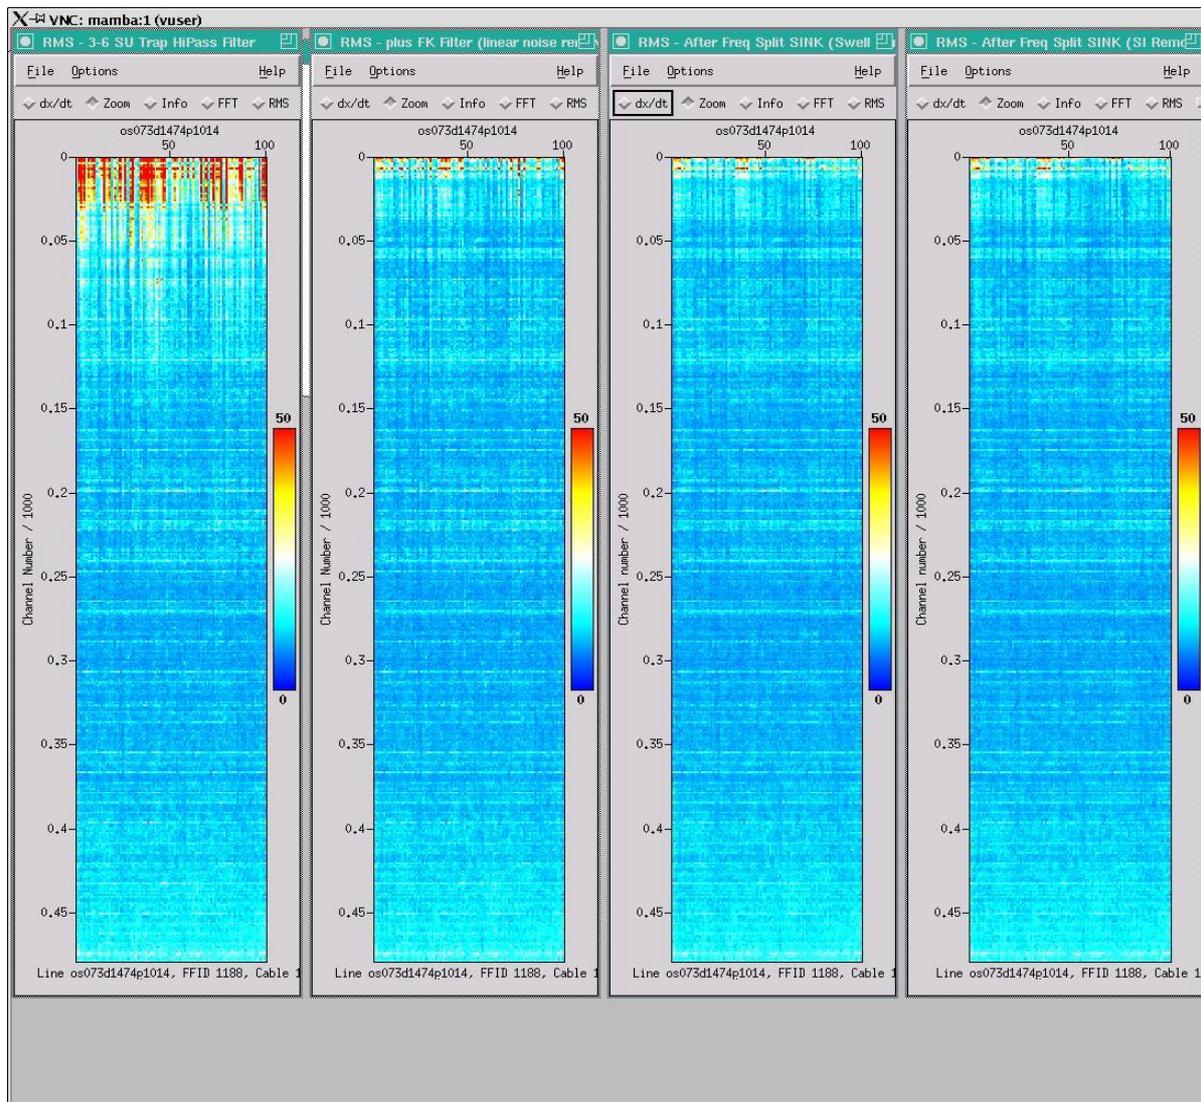
The following QC displays shows the effect of applying FK filters and SINK to raw data affected by front-end streamer noise.

After the crew change in Burnie, the equipment was redeployed. From this point the separation between streamers 3, 4 was high. The front ends were retrieved after sequence 70 as the separation rope appeared tangled. On redeployment, the separation was till high though improved on that of sequence 70. This was observed closely during production and no loss of coverage was noted.

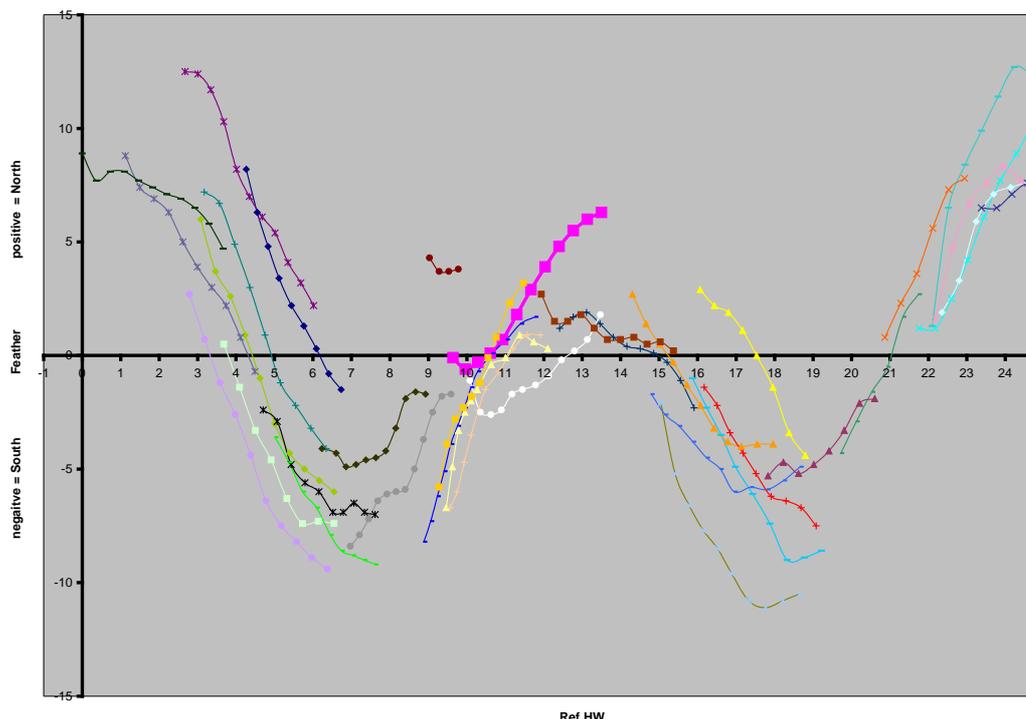
Inspection of the feather acquired showed that while a diurnal cycle was obvious, the variations in magnitude of feather for the same point in the cycle would make it impossible to reliably predict feather for a line.

This chart shows the first week of feather data, all relative to the highest high tide. It can be seen that the magnitude of feather varies a lot for the same time relative to high water, meaning that even if line change was extended, a match was not guaranteed.

It also demonstrates the large and rapid feather swings experienced throughout the job, presumably due to consistently marginal weather.

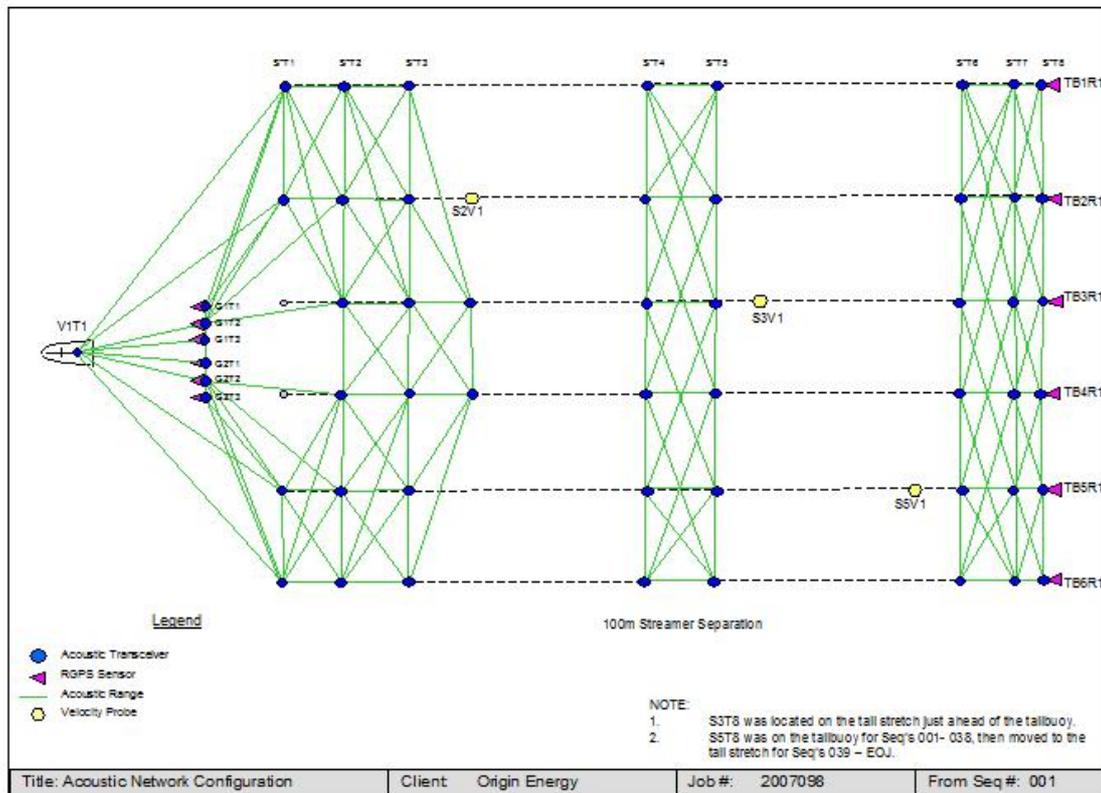
The survey was acquired with three acoustic networks as displayed below.

Discussion was entered into about moving to a full acoustic network to alleviate problems with noisy compasses, however this does have other implications:
