**TENEMENT ENVIRONMENTAL EXIT REPORT**  
**RETENTION LICENCE RL 8810 -- MOINA**  
**CRADLE MOUNTAIN REGION, NORTHERN TASMANIA**

**DATE:** FEBRUARY 2001

**AUTHOR:** BRYAN FREW

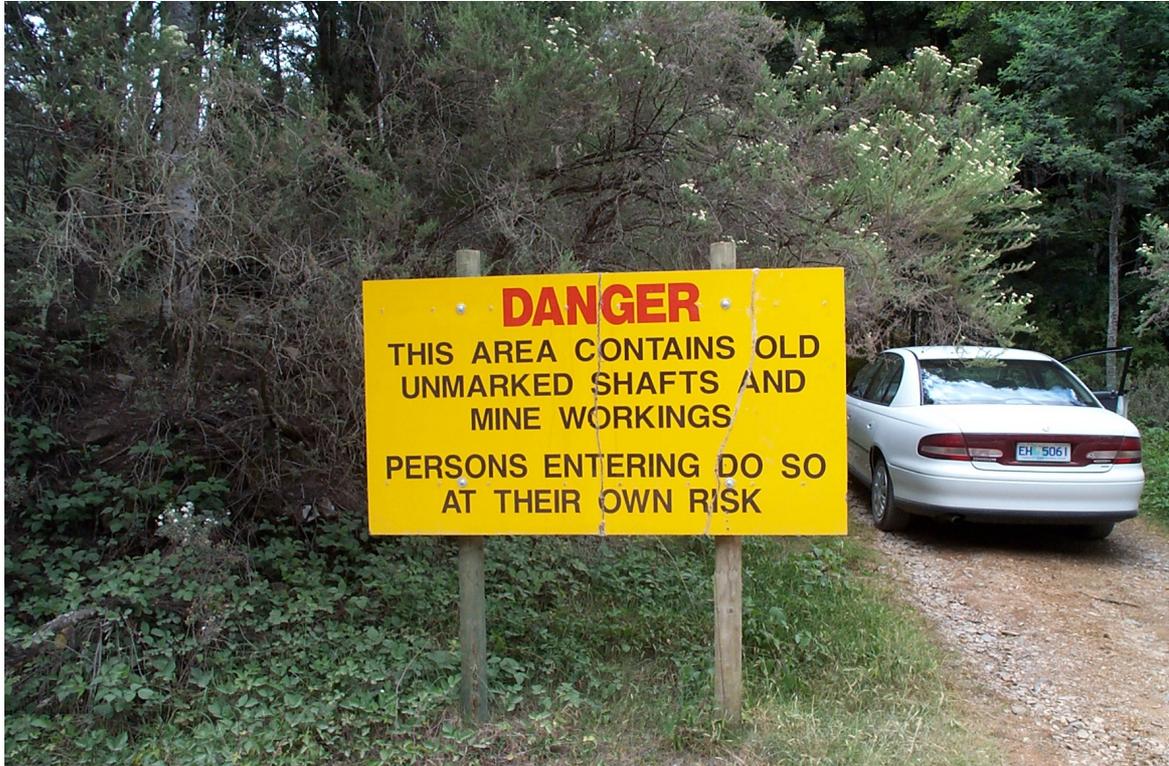
Discussions with the Department (David Gatehouse, Environmental Field Officer) during the Environmental Exit Audit revealed that they have no concerns regarding the rehabilitation of drill holes and any other exploration work undertaken on the tenement. During a recent site visit by David Gatehouse, repairs were carried out to a number of the (vandalised?) original security signs at their expense. (See Appendix IIIA, Photos 1, 2 & 6)

Photo 1 – Warning sign at Bismuth Ck. track, old Shepherd & Murphy Mine areas

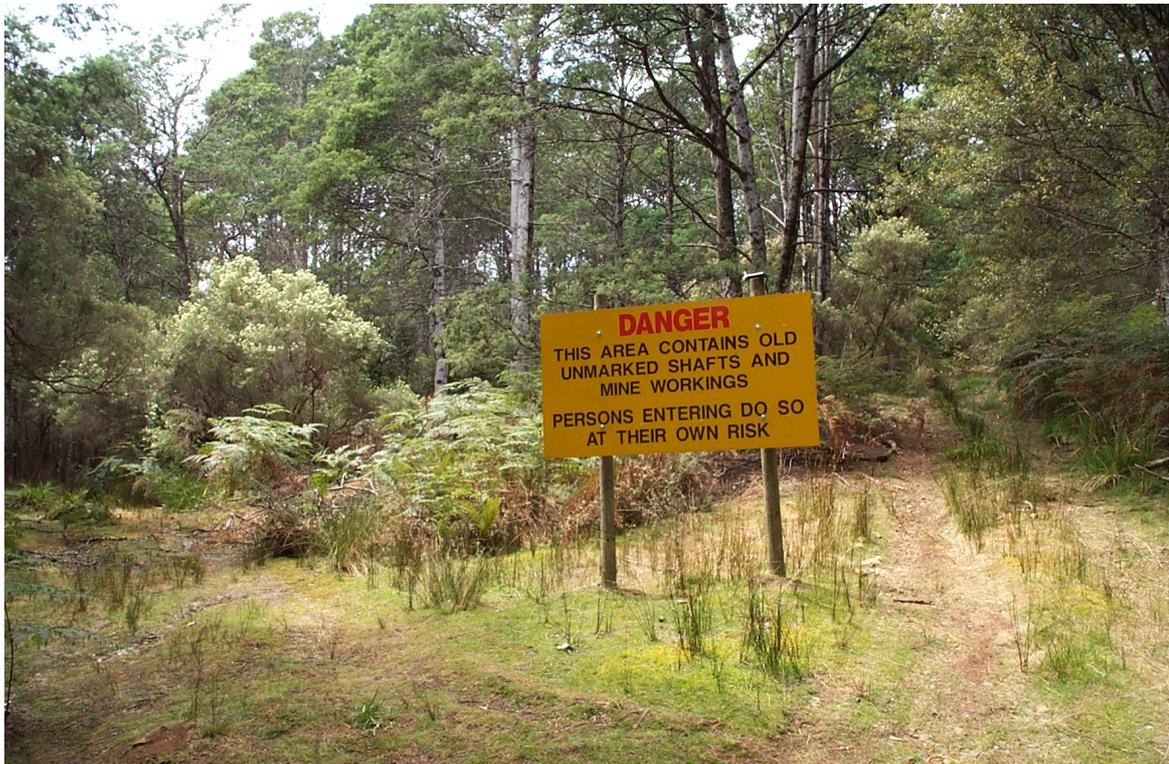
Photo 2 – Second warning sign near Shepherd & Murphy Main Shaft

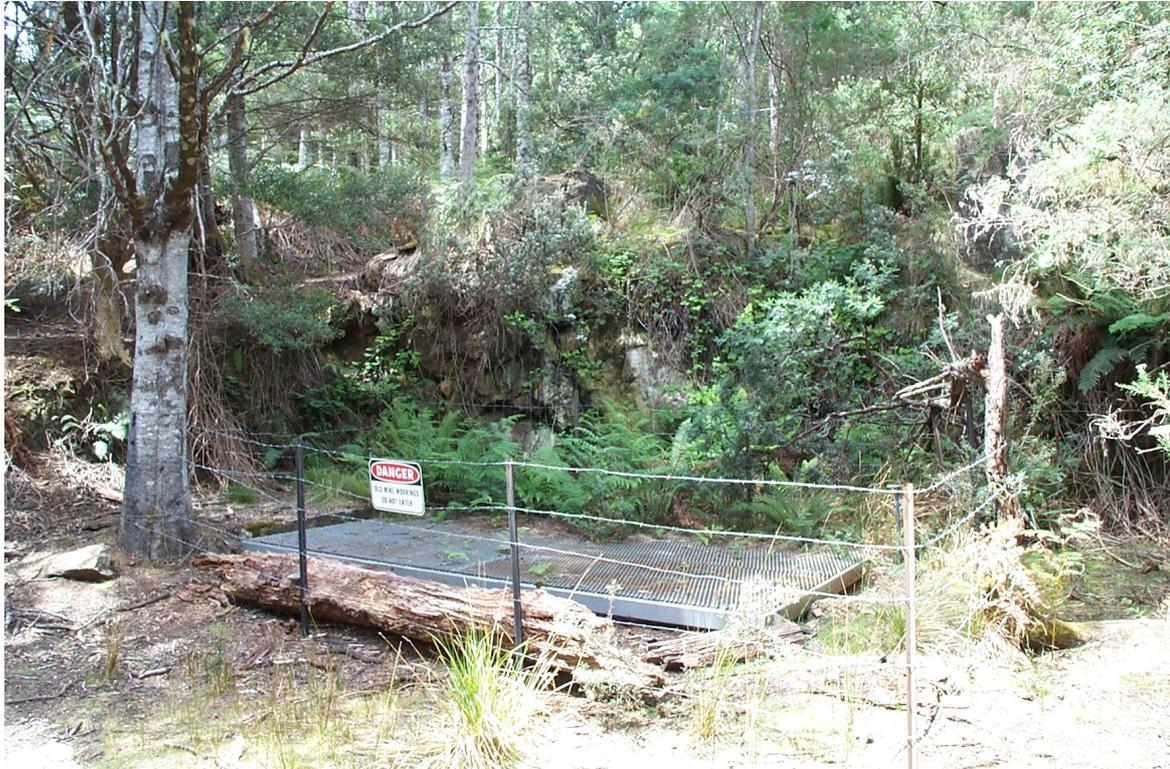
Photo 3 –Shepherd & Murphy Main Shaft cover and security fence

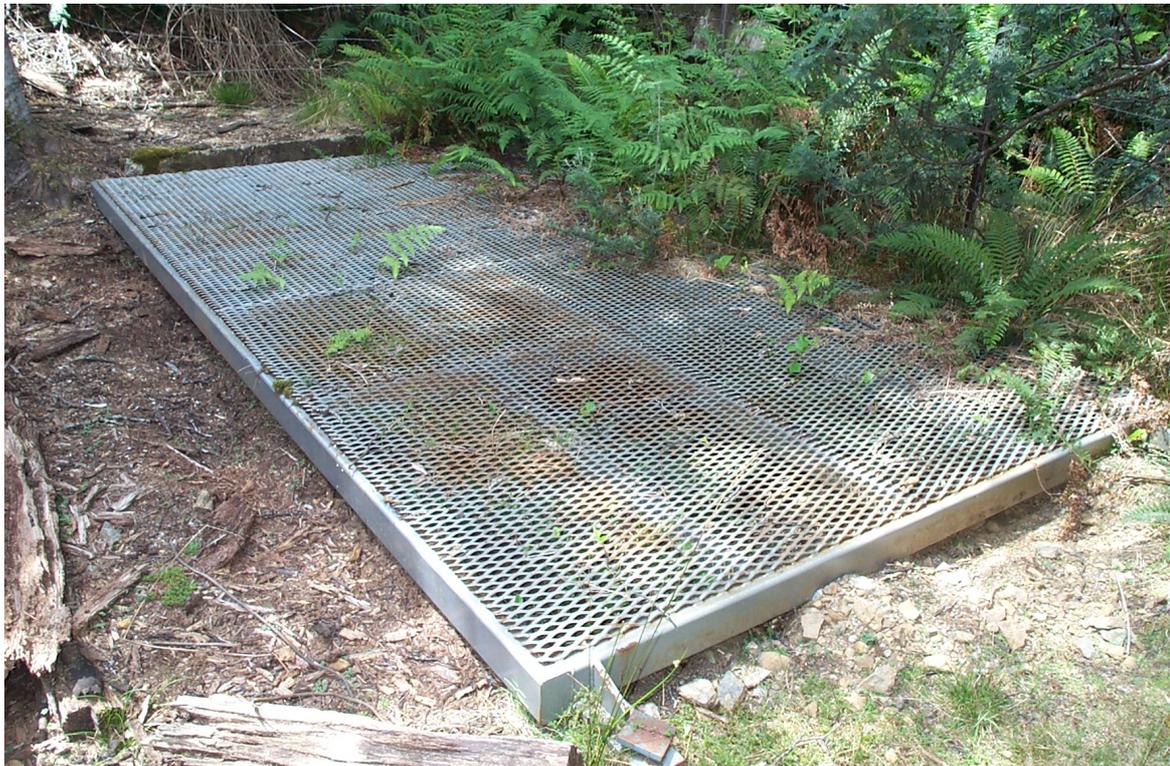
Photo 4 – Shepherd & Murphy Main Shaft cover close up

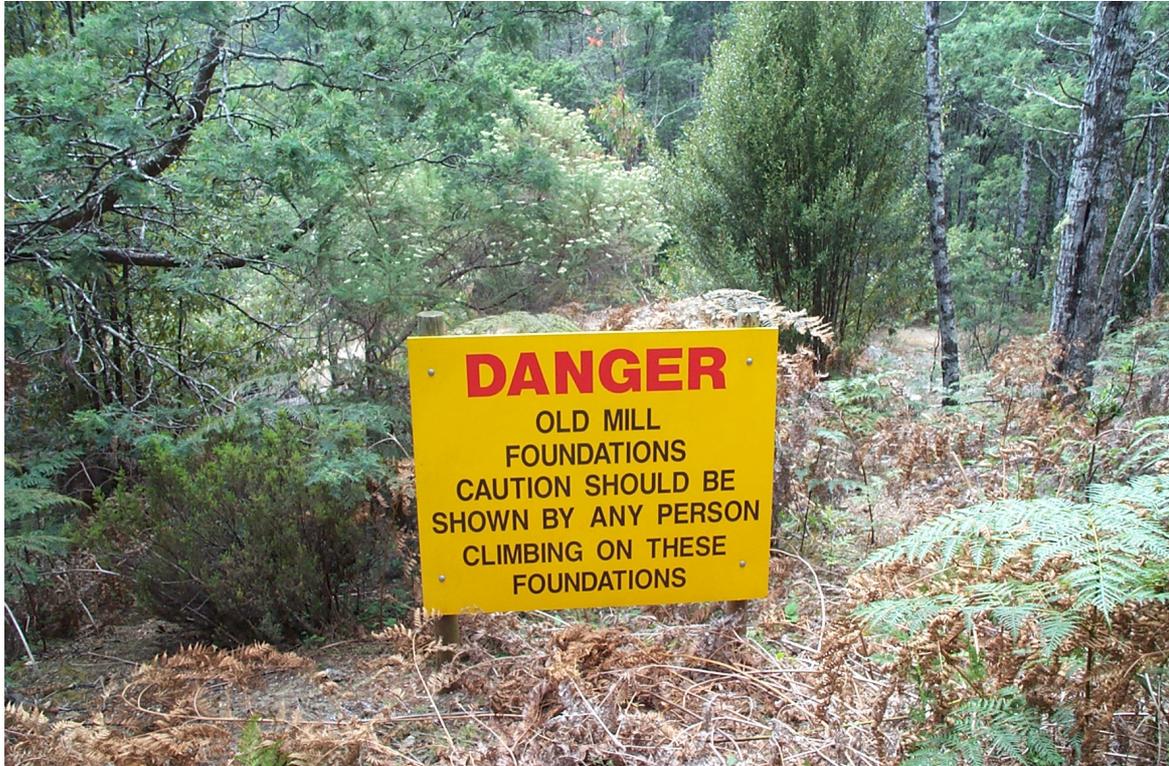
Photo 5 – Warning sign at old Shepherd & Murphy Mill Site

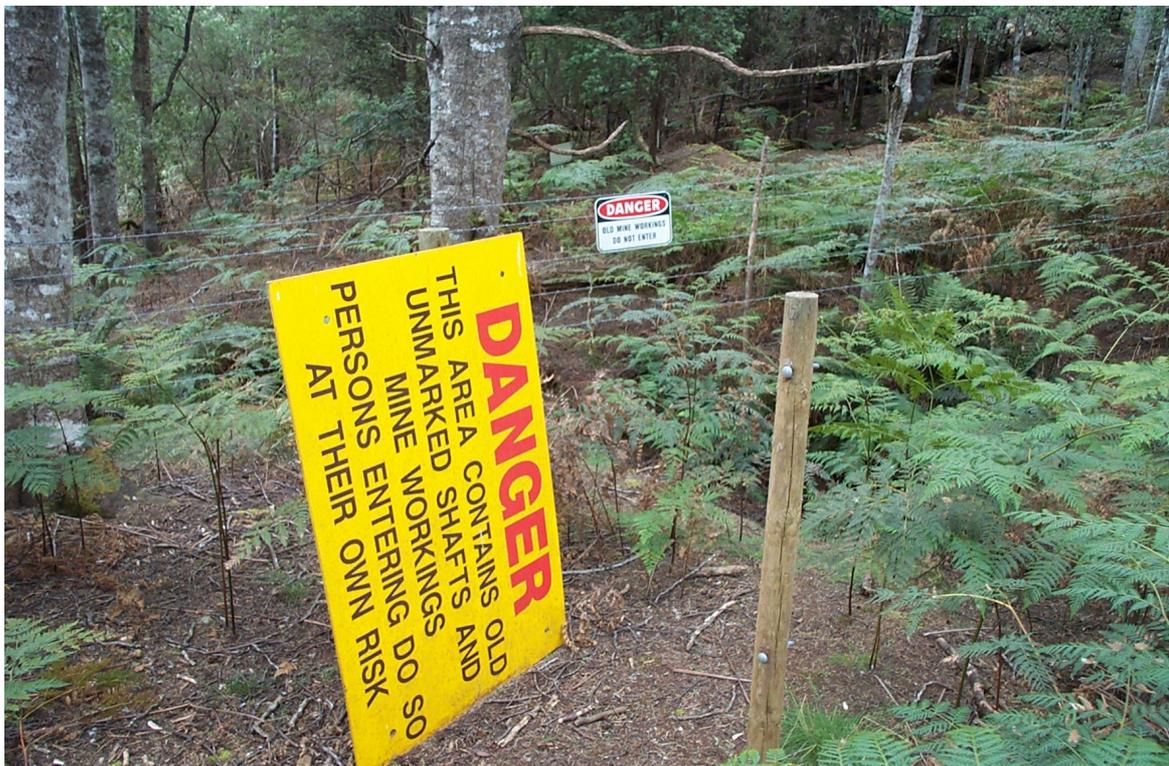
The security arrangements provided by the Moina JV at the Shepherd & Murphy workings are in excellent condition, even though there appears to have been some signs vandalised. These signs were recently repaired by the Departments' Environmental Field Officer during an inspection of the area. These security provisions remain as protection to the general public and the numerous tourists who reputedly visit the area.

Photo 6 – Vandalised? sign at No. 6 Lode open stope, showing security fence.

It is recommended that any ongoing maintenance of the security systems at the Shepherd & Murphy workings be left to the Department.

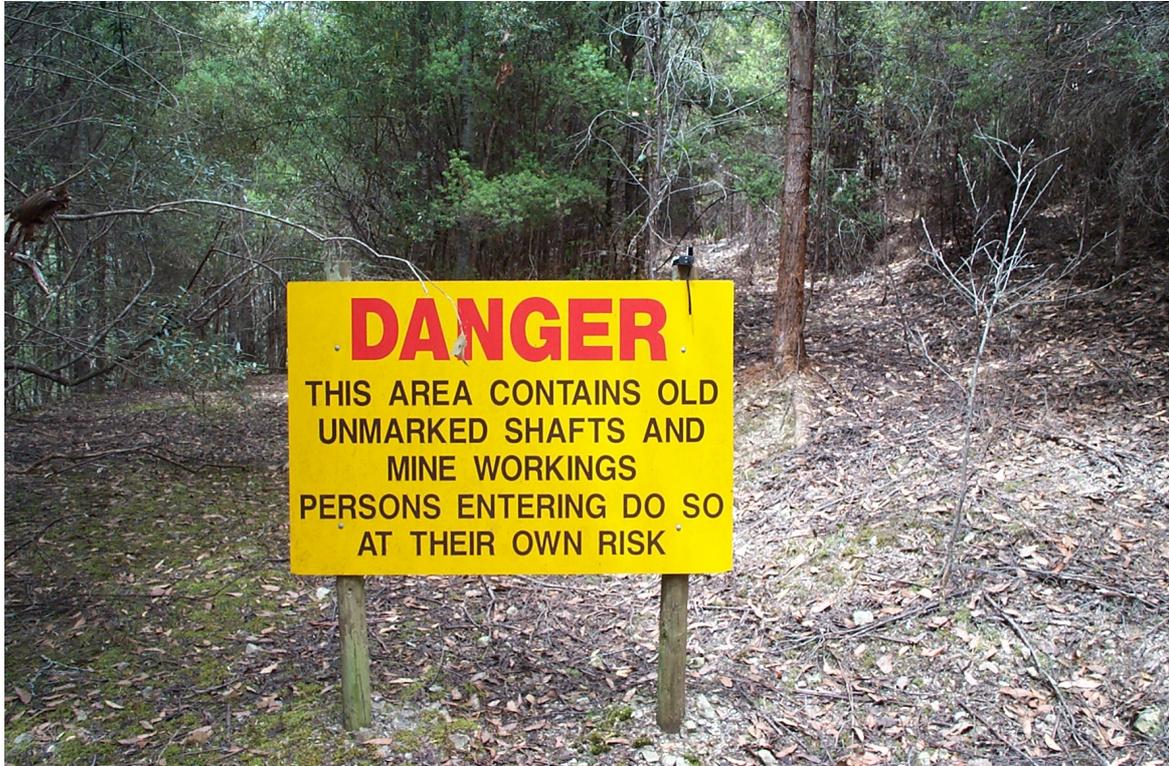
Photo 7 - Warning sign near Shepherd & Murphy No 1 Adit

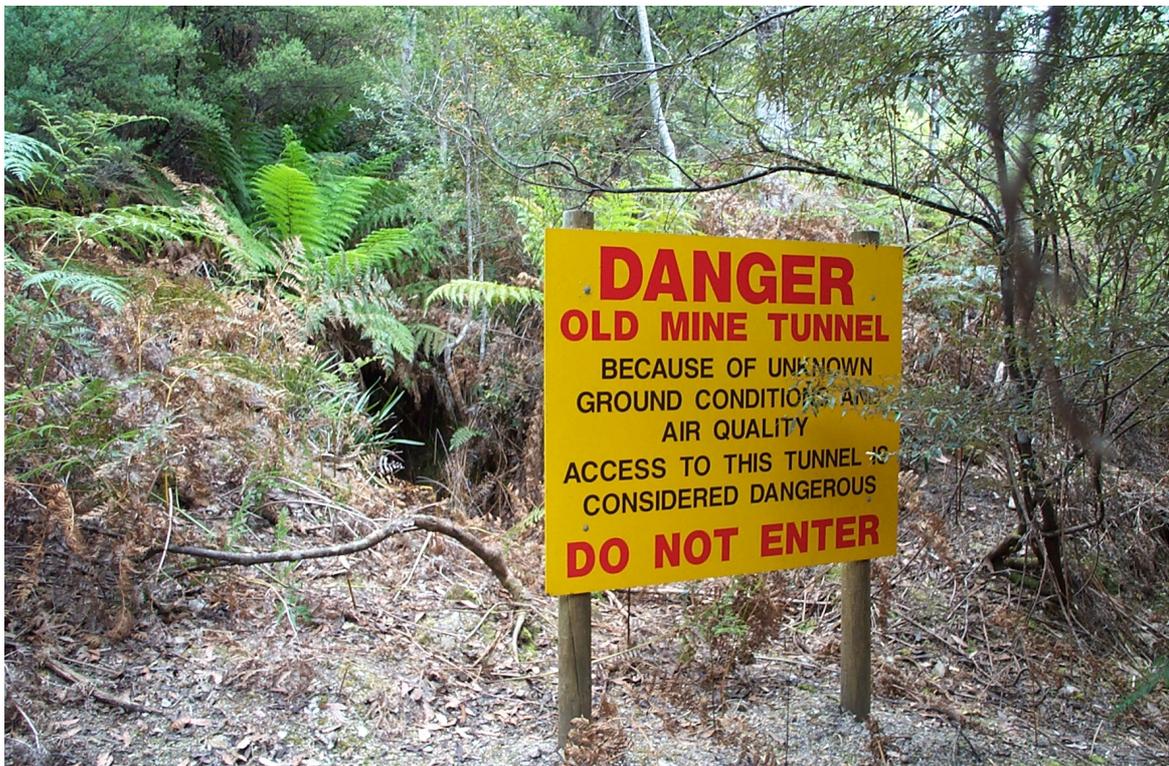
Photo 8 – Warning sign at entrance to Shepherd & Murphy No 1 Adit

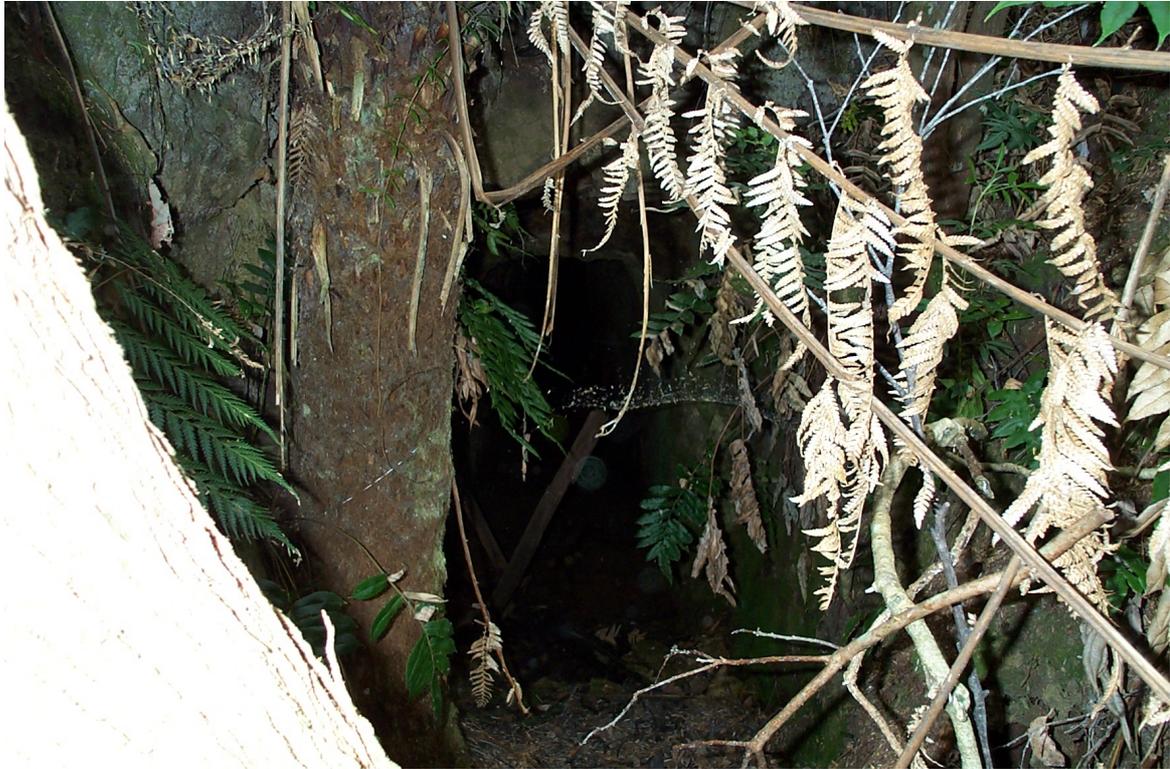
**Photo 9 - Shepherd & Murphy No 1 Adit, showing well hidden behind regrowth**

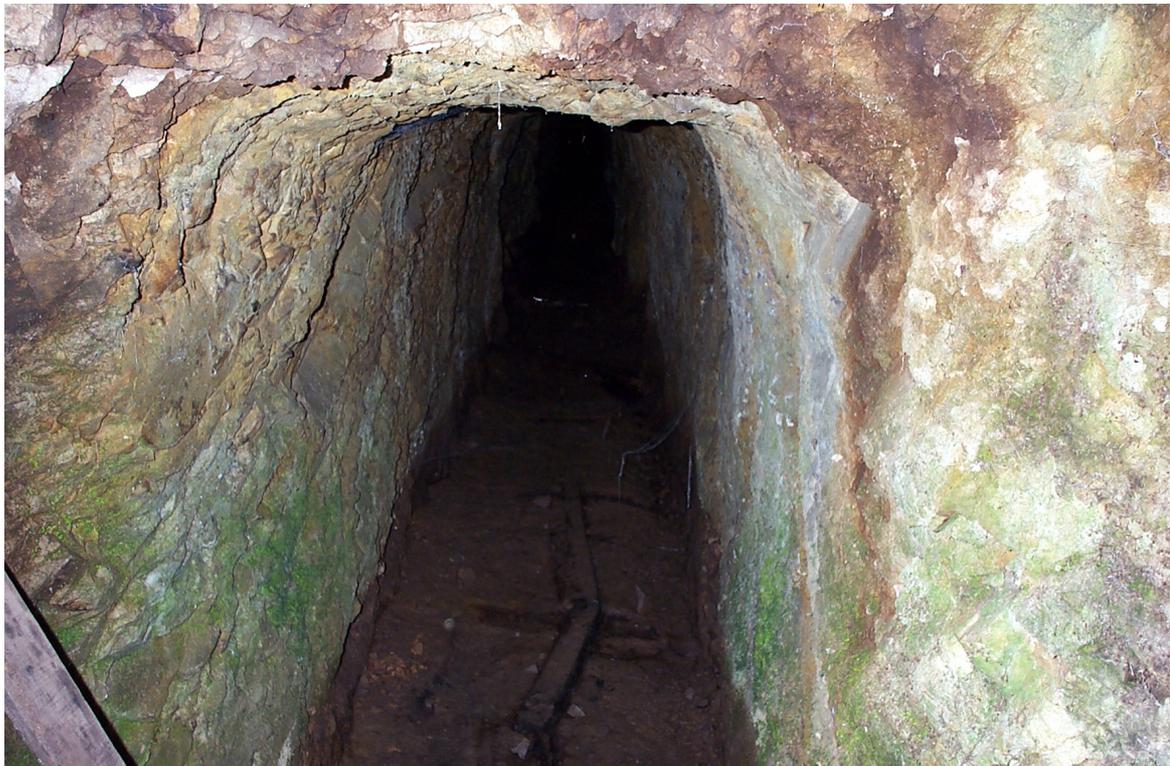
**Photo 10 – Shepherd & Murphy No 1 Adit, showing unsupported workings**

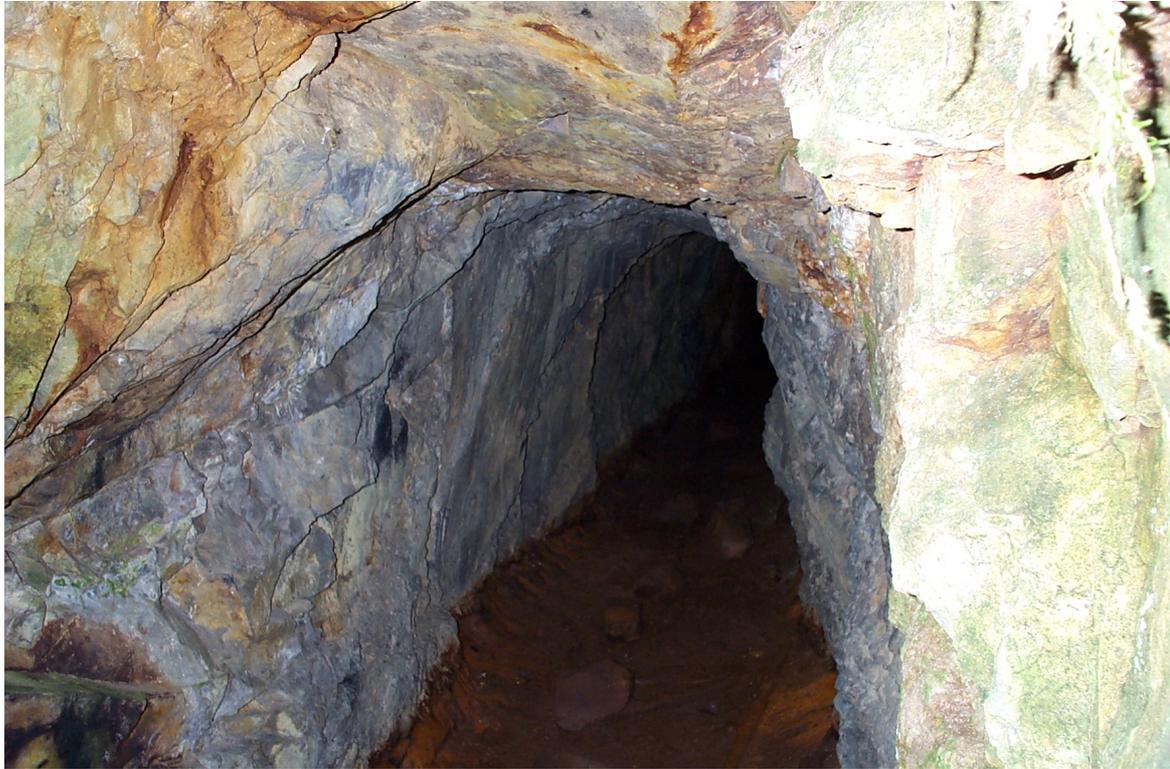
**Photo 11 - Shepherd & Murphy No 4 Adit, showing unsupported workings**

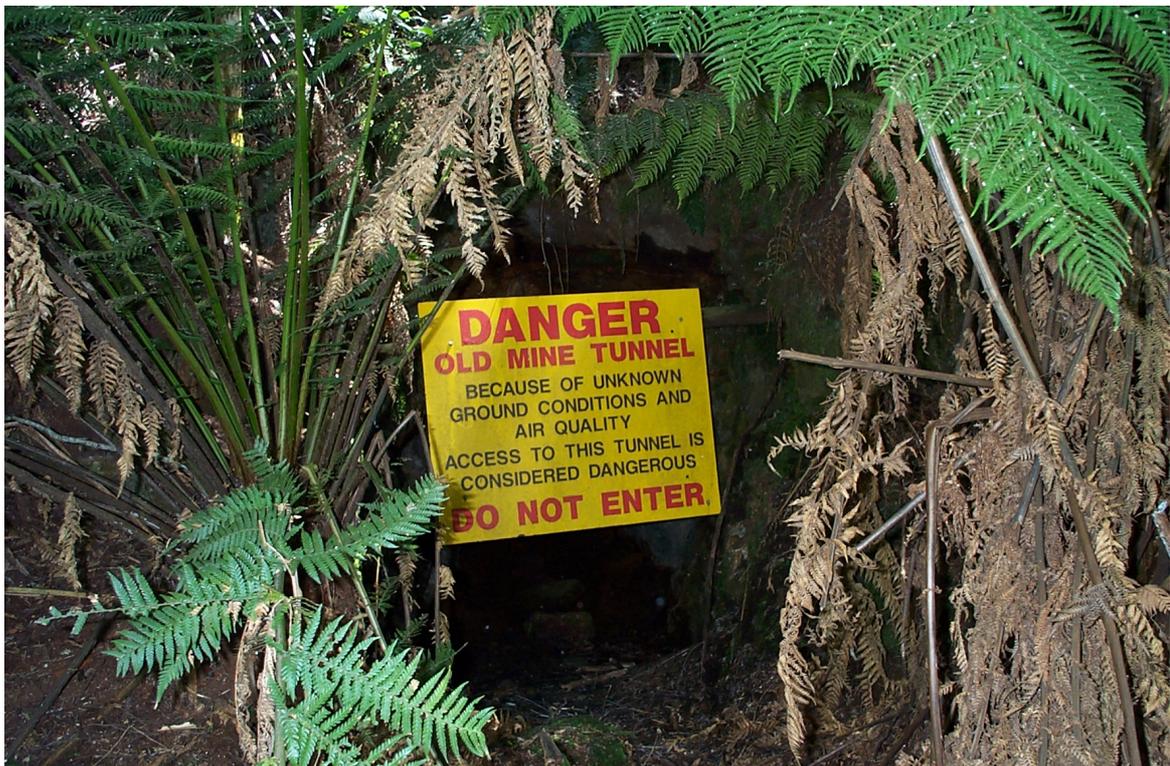
**Photo 12 – Warning sign at entrance to Shepherd & Murphy No 4 Adit, well hidden.**

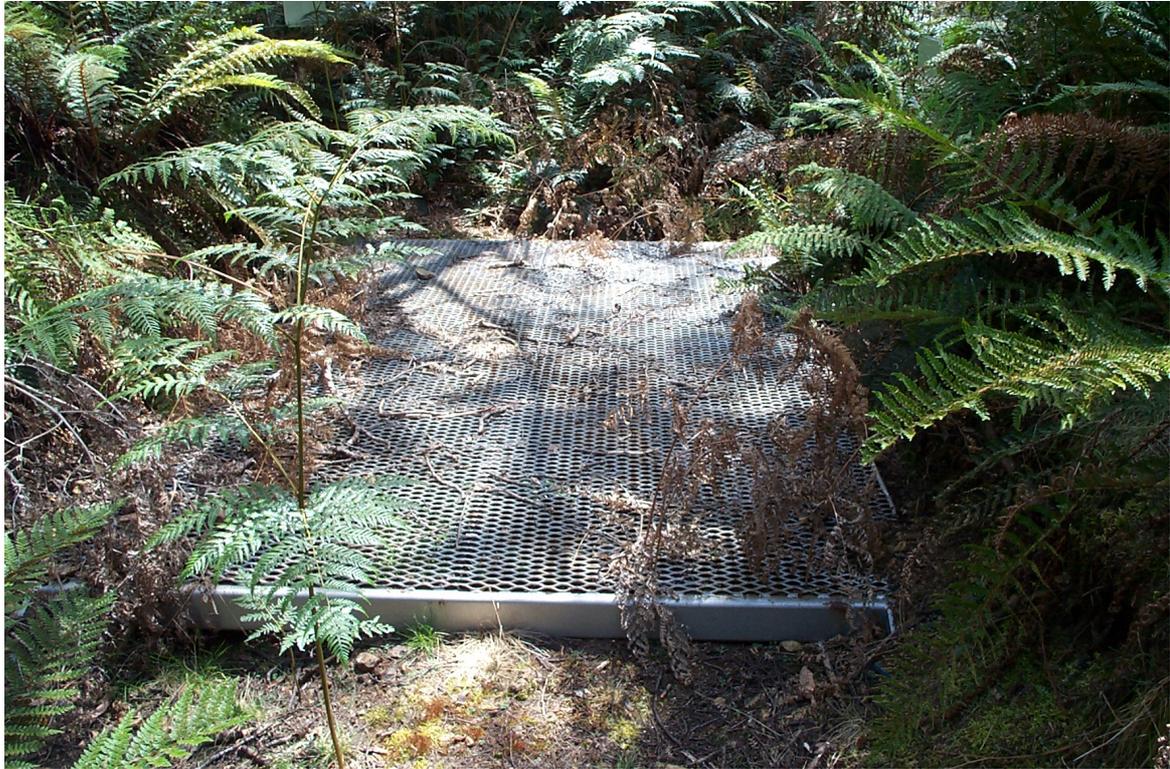
Photo 13 - No 5 Vent Shaft cover looking from east

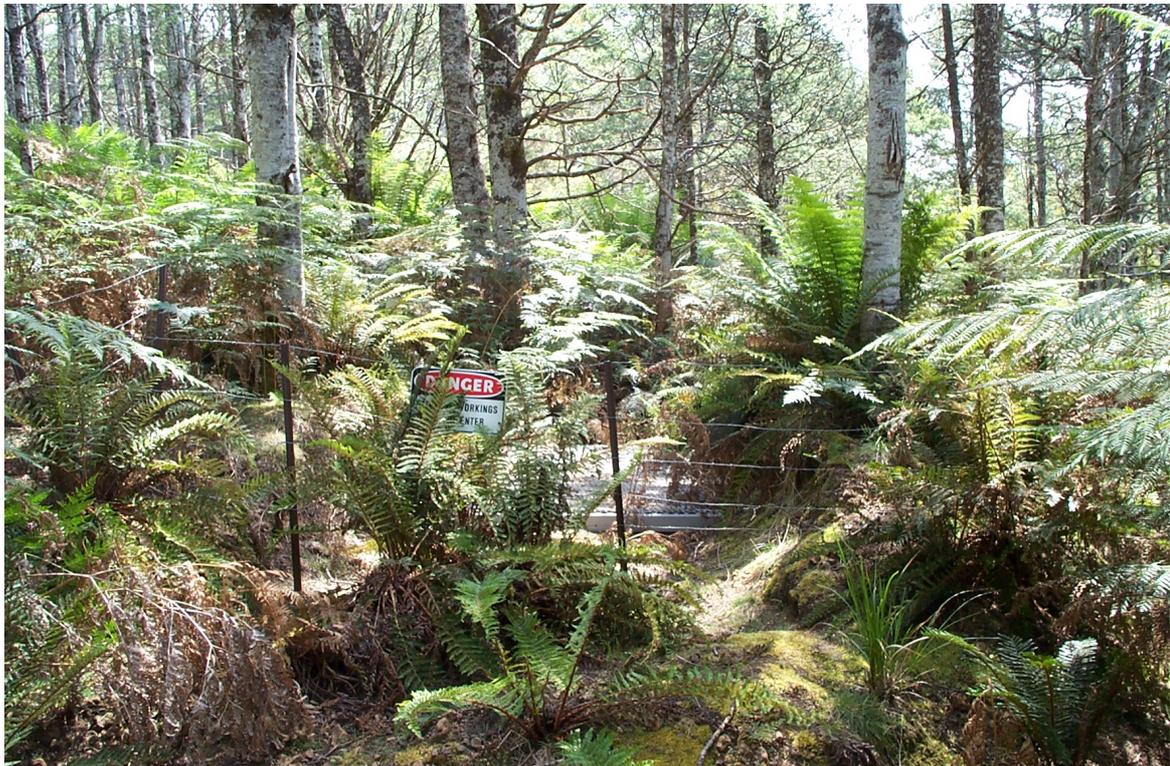
Photo 14 – Security fence and signage at No 5 Vent Shaft, looking from east

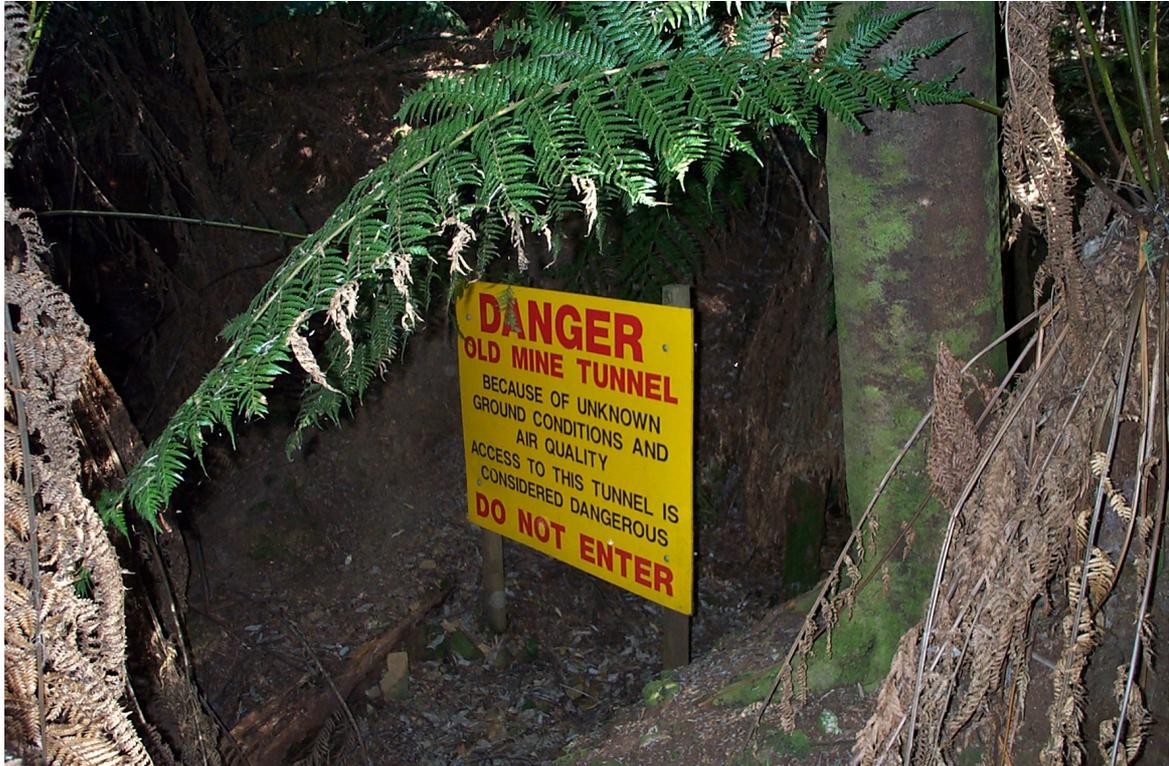
Photo 15 - Warning sign at entrance to Shepherd & Murphy No 2 Adit, well hidden.

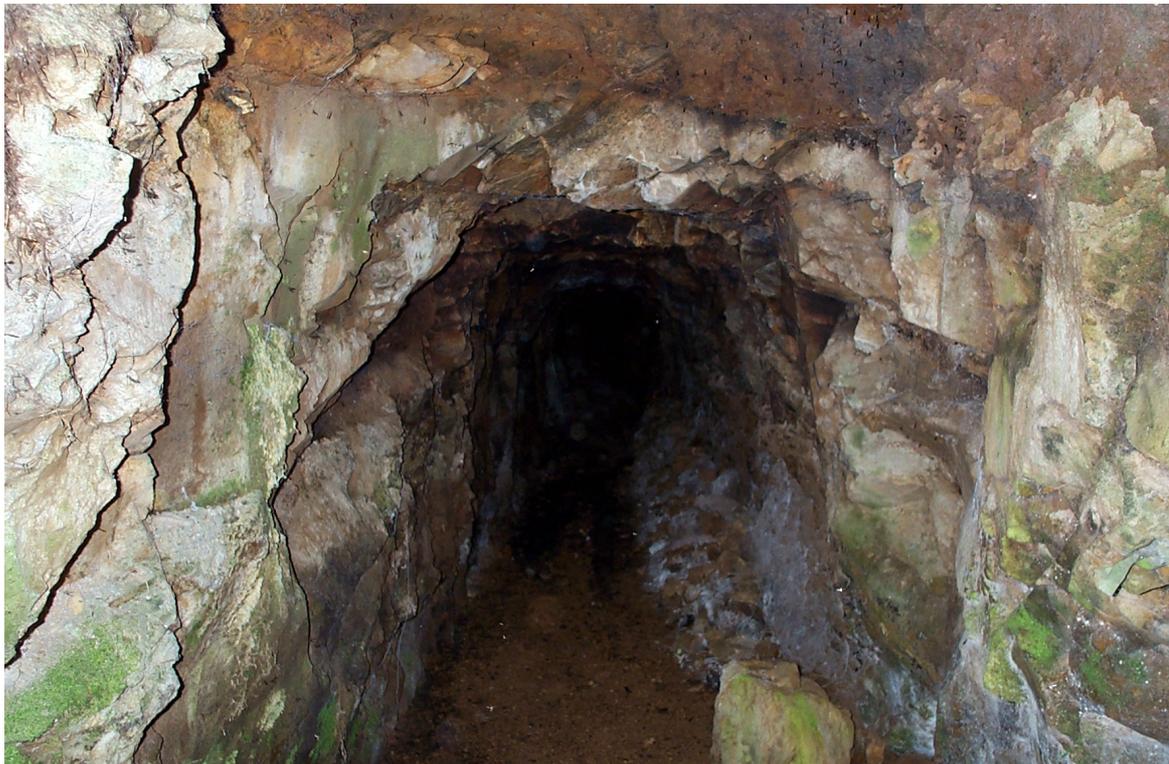
Photo 16 – Shepherd & Murphy No 2 Adit, showing unsupported workings

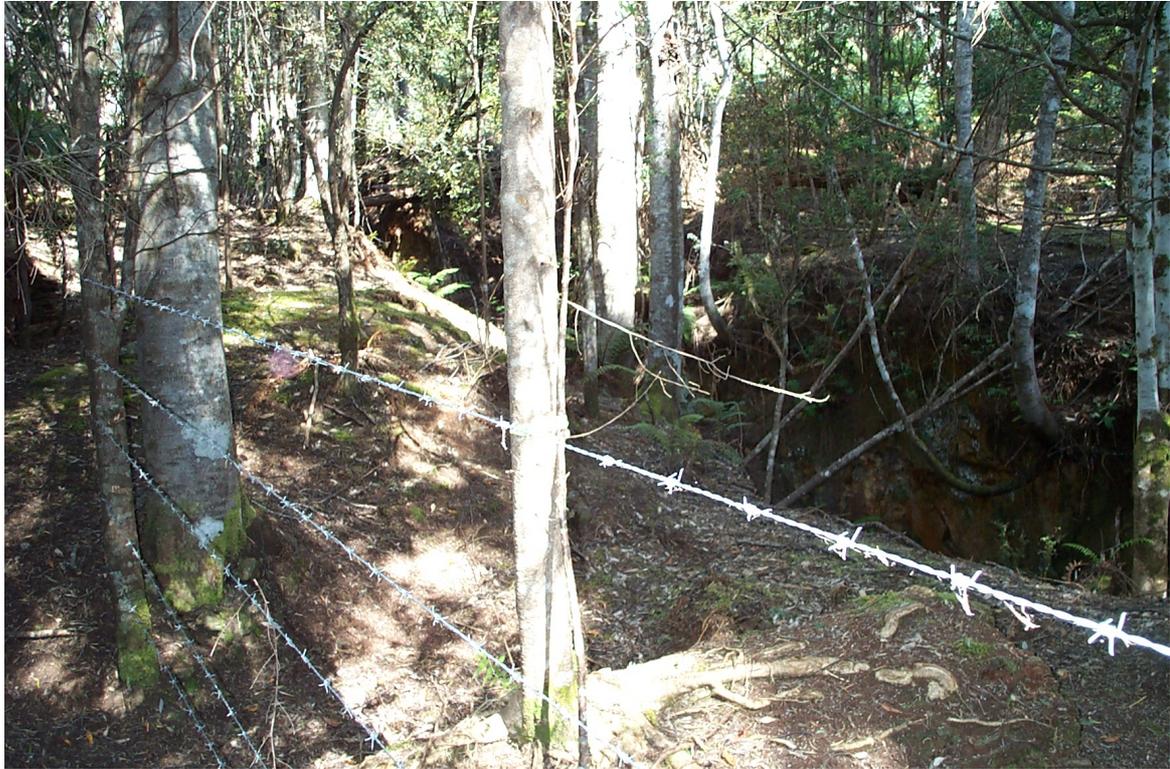
**Photo 17 – No 6 Lode open stopes, showing security fence and regrowth**

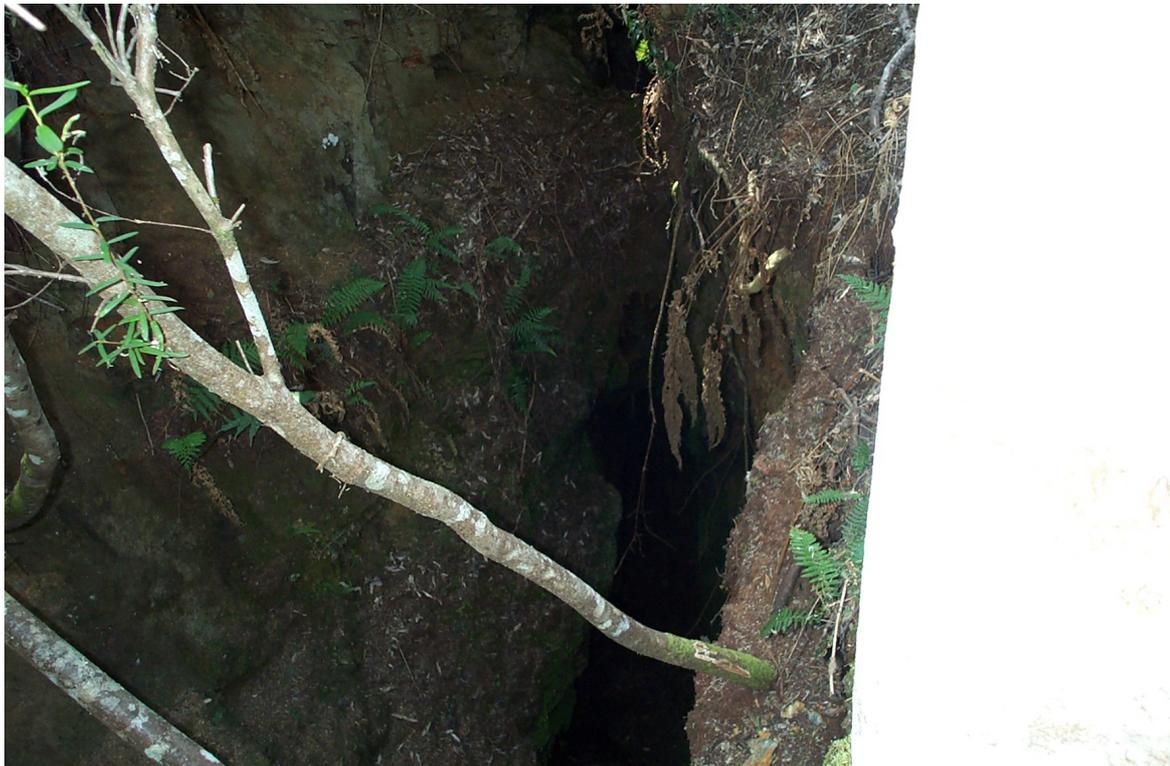
**Photo 18 – No 6 Lode open stopes, showing depth of stopes excavation.**

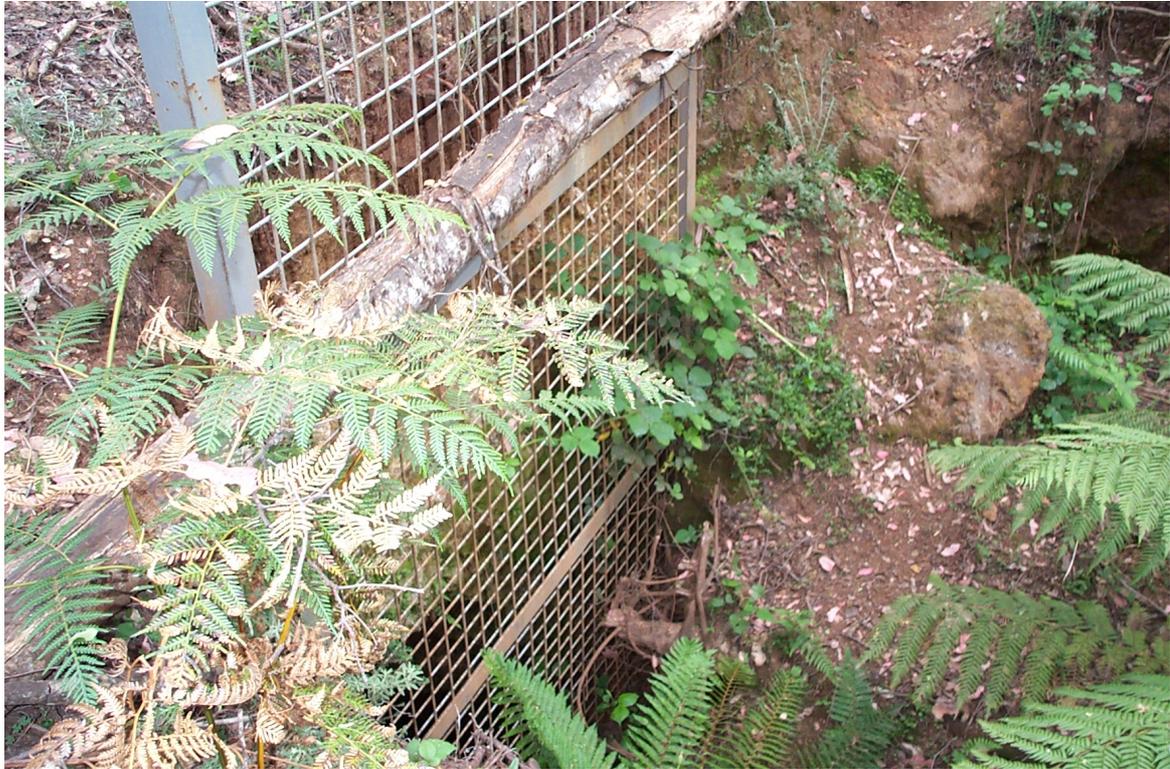
Photo 19 - Shepherd & Murphy No 3 Adit, showing portal grating

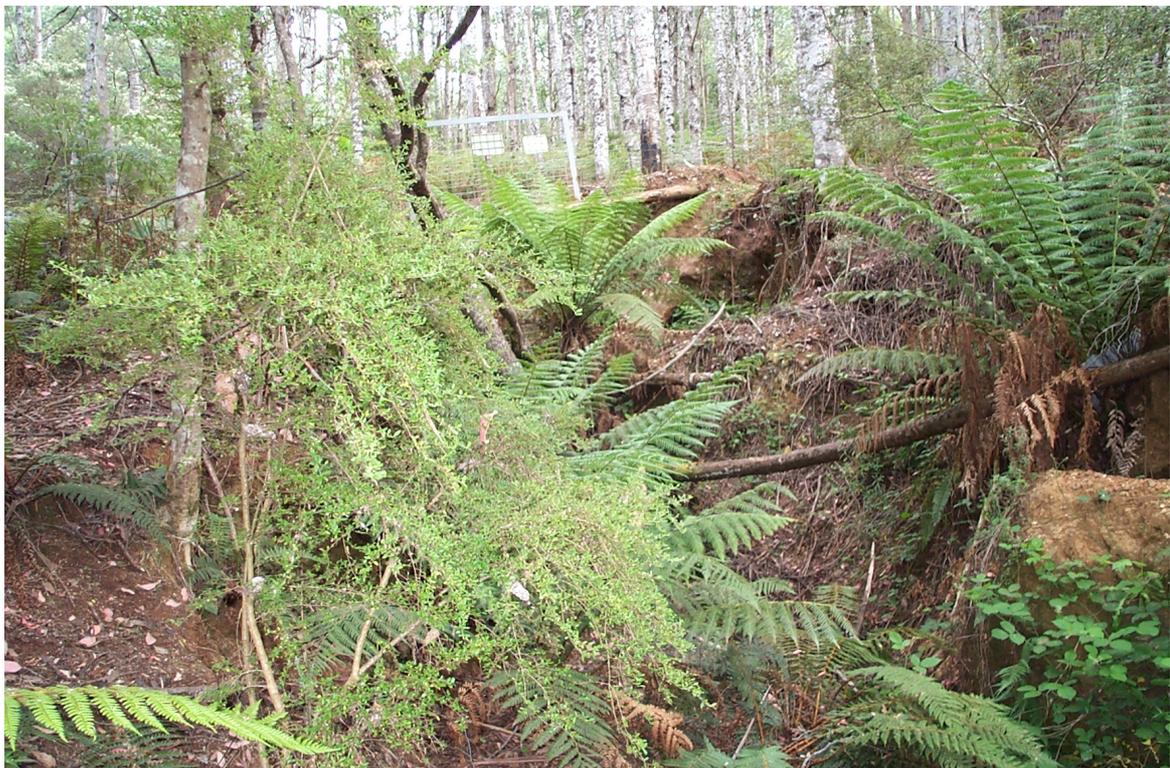
Photo 20 – Shepherd & Murphy No 3 Adit, showing regrowth in excavation.

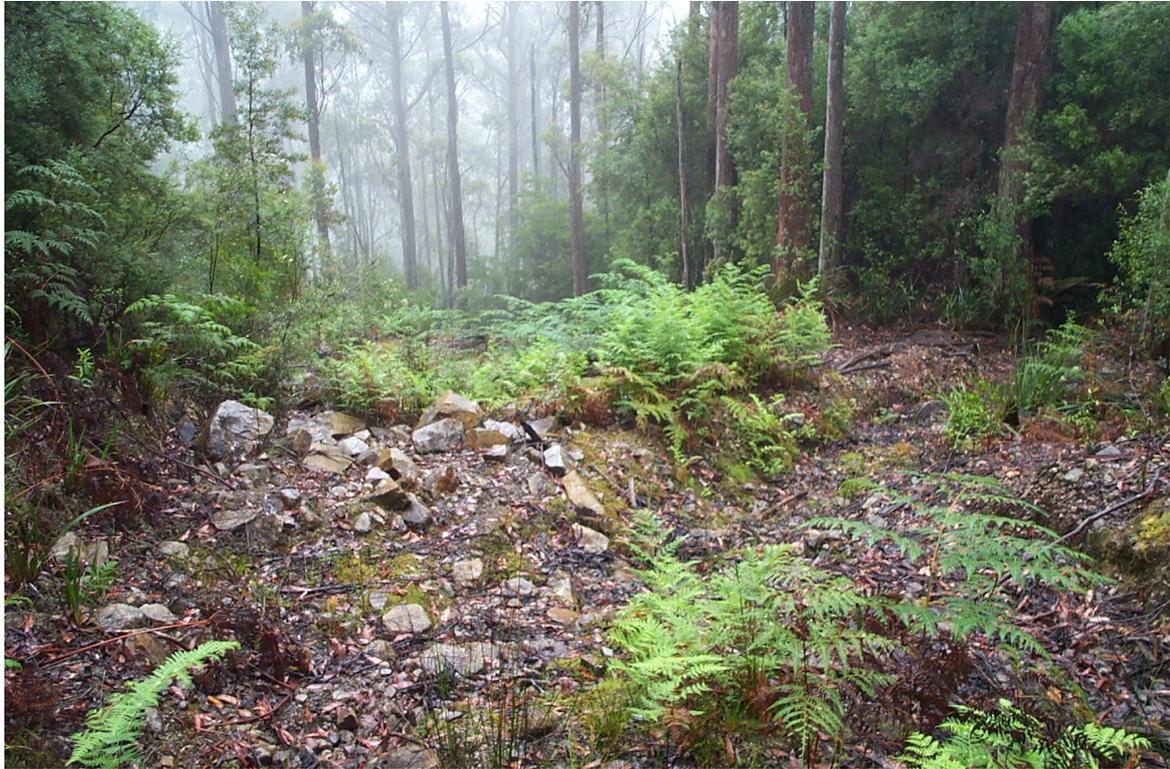
**Photo 1 – Access track at MD2 site, showing contour drain and regrowth.**

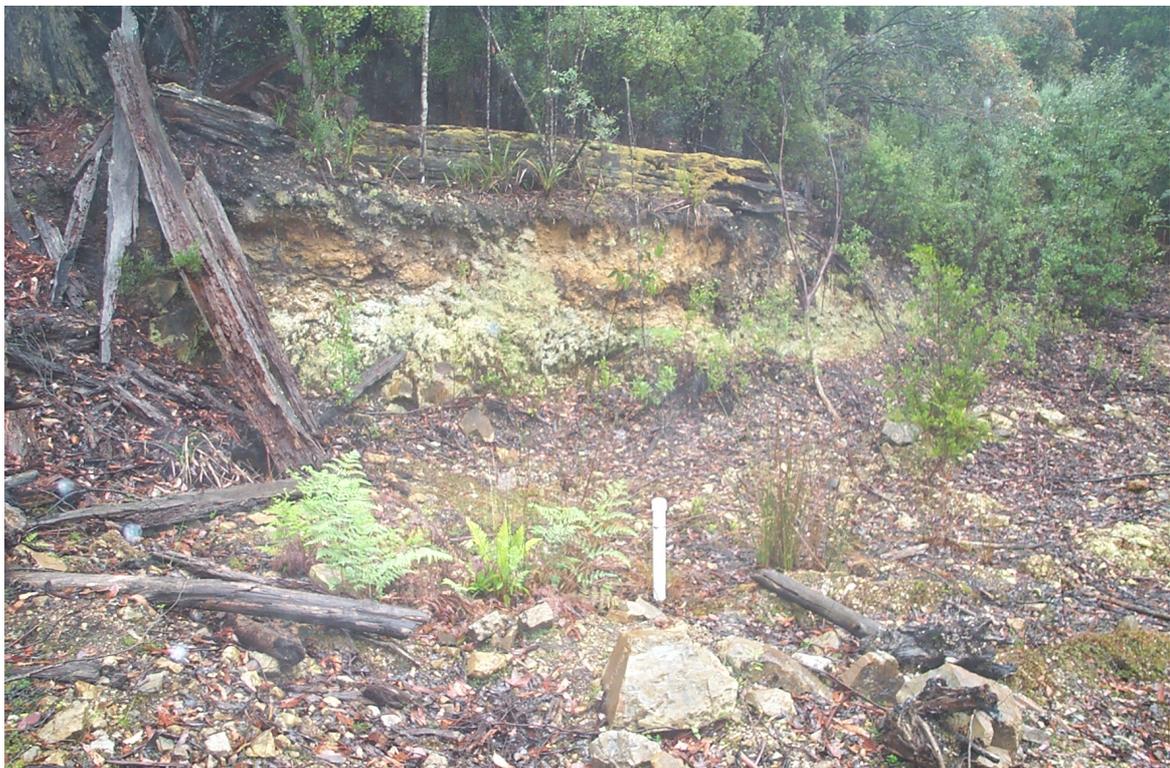
**Photo 2 – MD2 Drill Site looking east, with remnant EM PVC casing visible.**

Generally all rehabilitation requirements have been completed satisfactorily with excellent results. Although there remains EM PVC casing at two sites and steel NW casing and an anchor at one other, It is recommended that these remain as is. Following the discussion held with the Departments' Environmental Field Officer (David Gatehouse), the view is that the rehabilitation has been conducted to an acceptable standard, and no further work is required. The Officer has confirmed this by a site visit himself following the completion of rehabilitation by Goldstream.

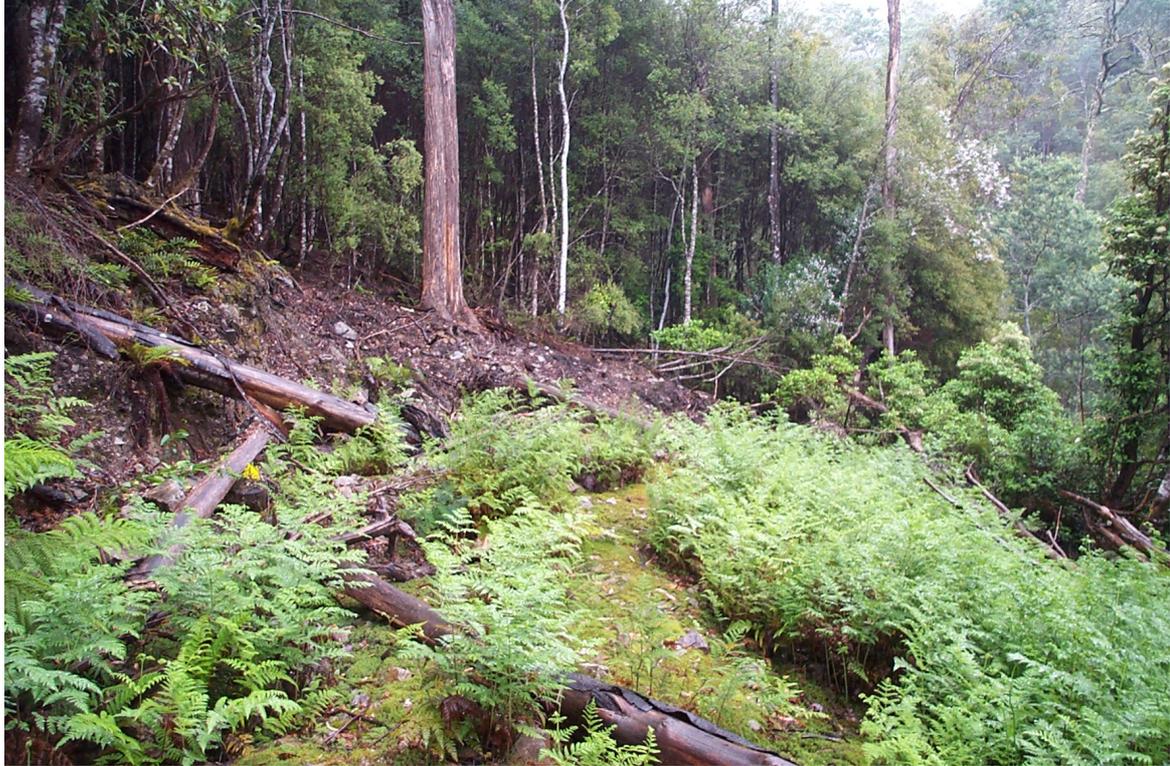
**Photo 3 – HS5 Drill Site looking south east, backfilled and recontoured**

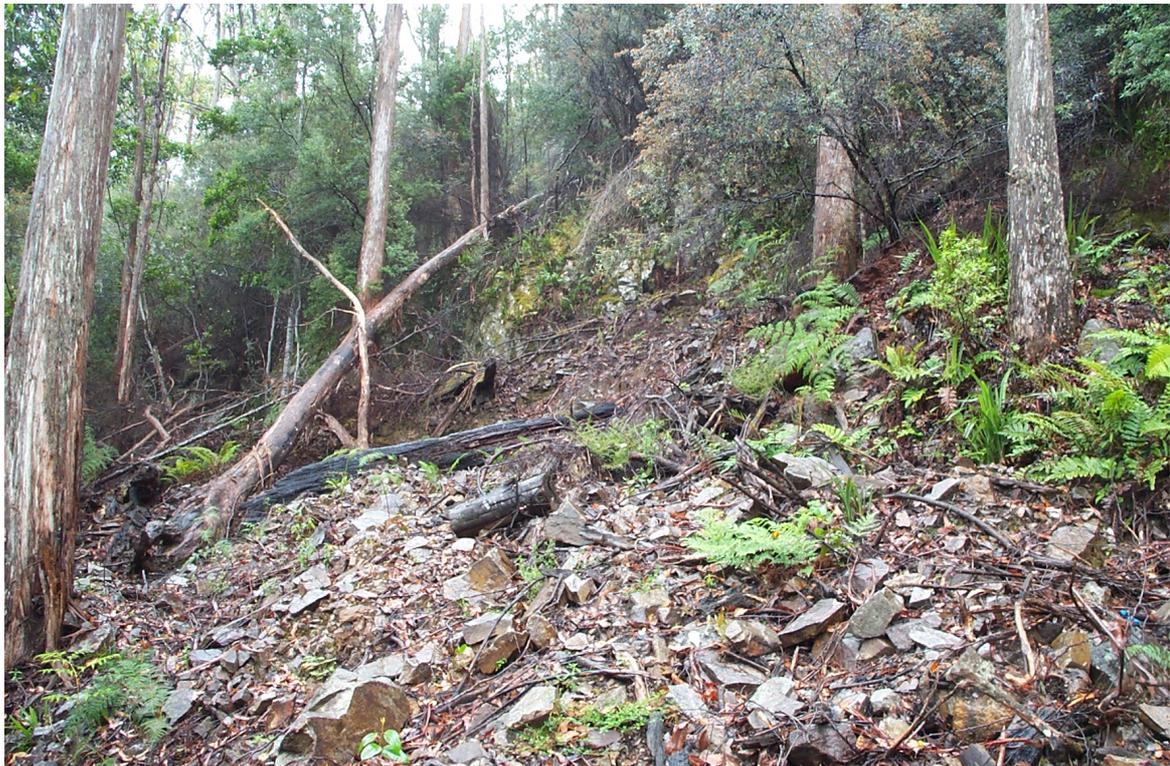
**Photo 4 – HS11 Drill Site looking north, backfilled and recontoured**
