**TENEMENT ENVIRONMENTAL EXIT REPORT**  
**RETENTION LICENCE RL 8810 -- MOINA**  
**CRADLE MOUNTAIN REGION, NORTHERN TASMANIA**

**DATE:** FEBRUARY 2001

**AUTHOR:** BRYAN FREW

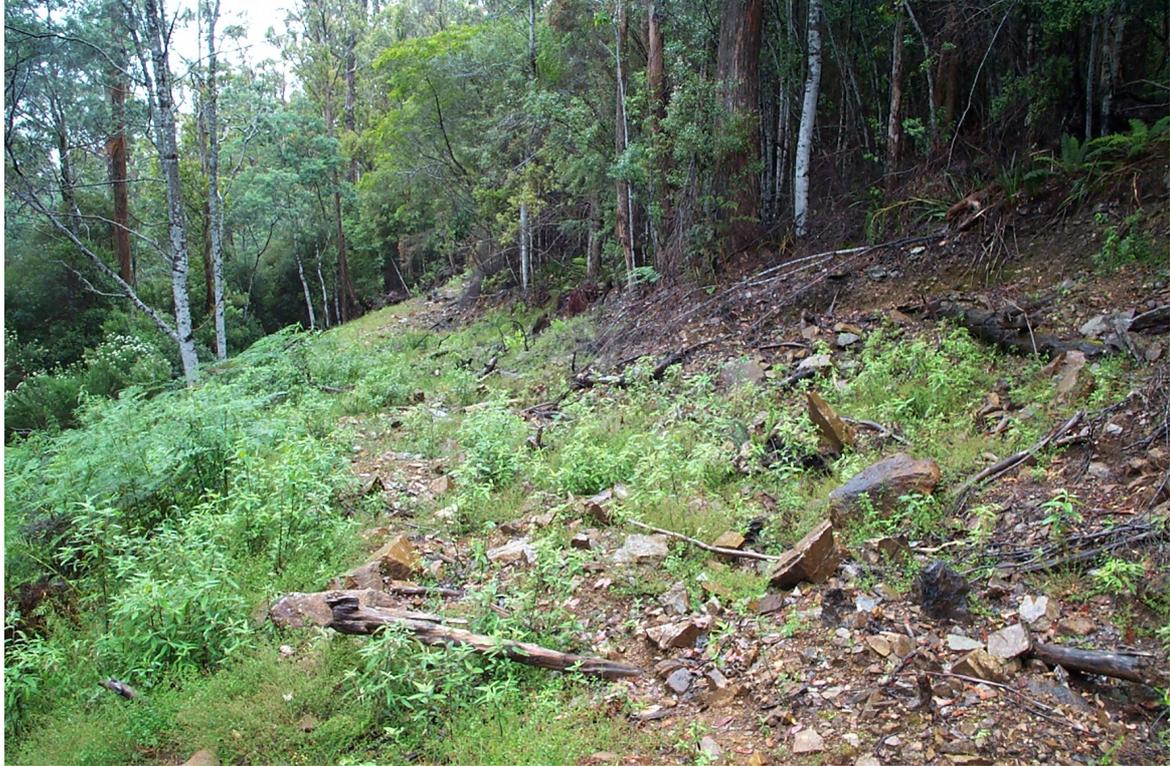
**Photo 5 – HS2 Drill Site looking north, backfilled and recontoured**

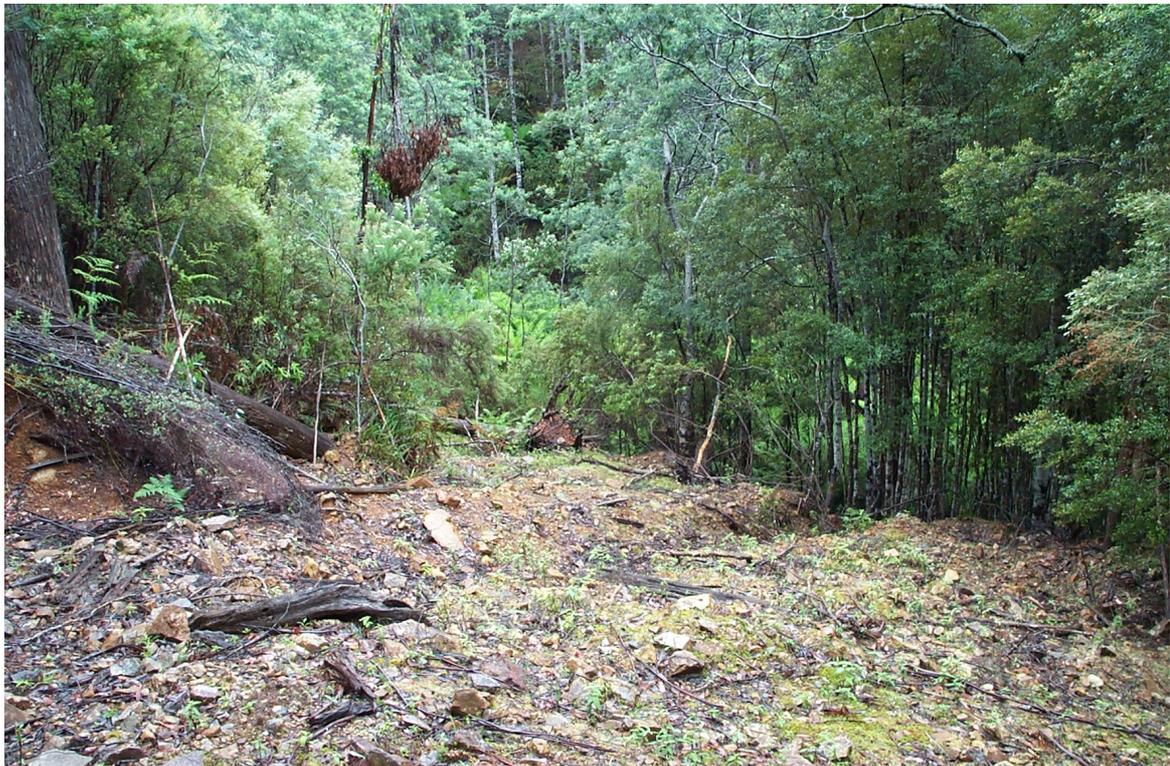
**Photo 6 – MD32 Drill Site looking south into Bismuth Creek, showing regrowth**

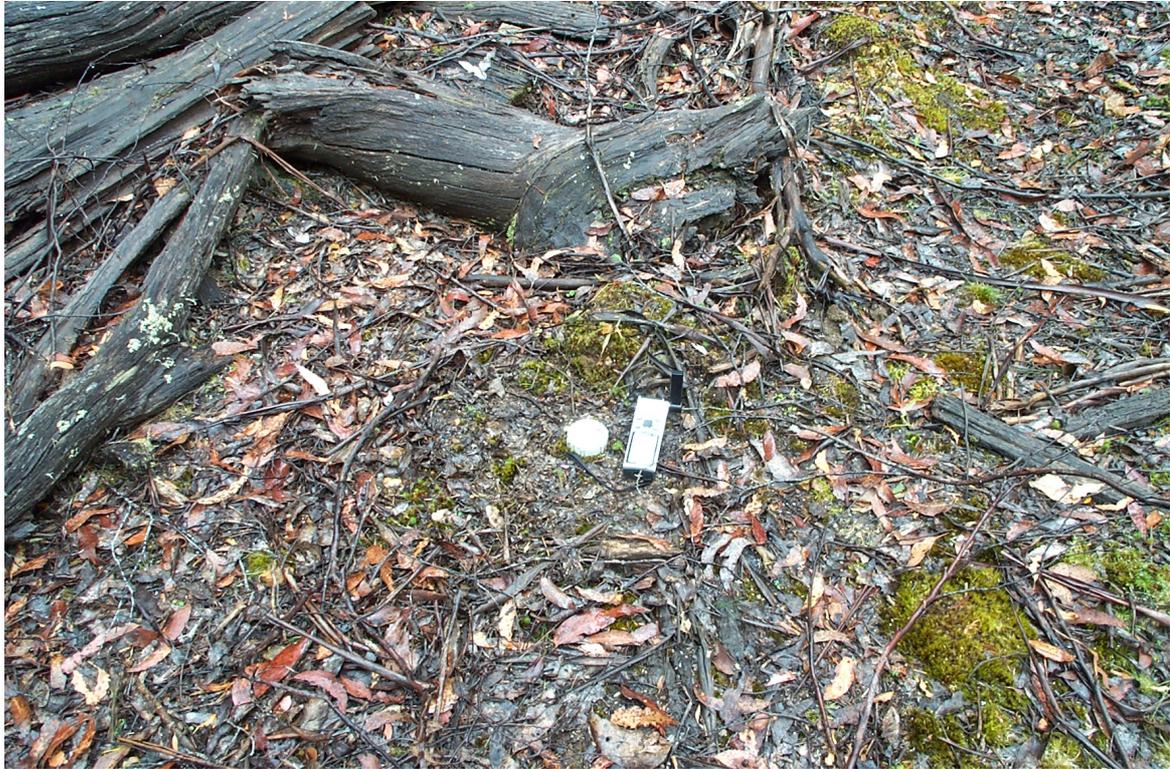
**Photo 7 - MD43 Drill Site looking south, with remnant EM casing visible**

Generally all rehabilitation requirements have been completed satisfactorily with excellent results. Although there remains EM PVC casing at two sites and steel NW casing and an anchor at one other, It is recommended that these remain as is. Following the discussion held with the Departments' Environmental Field Officer (David Gatehouse), the view is that the rehabilitation has been conducted to an acceptable standard, and no further work is required. The Officer has confirmed this by a site visit himself following the completion of rehabilitation by Goldstream.

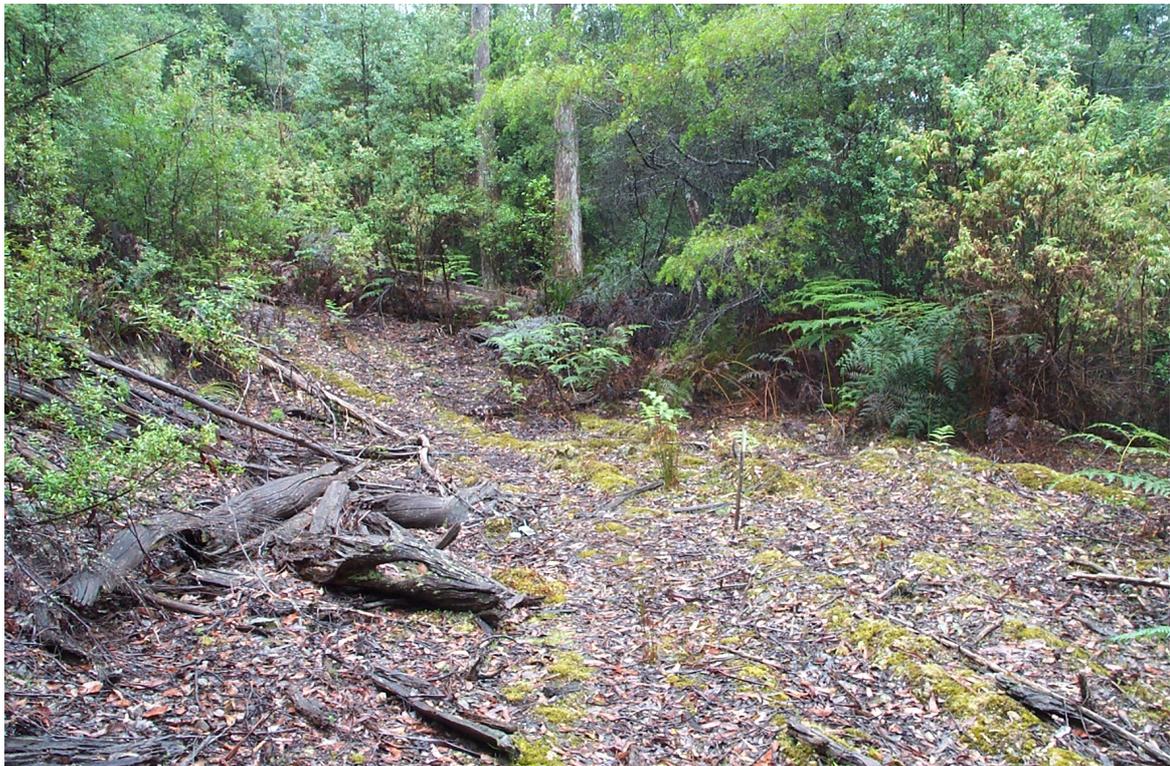
**Photo 8 - MD43 Drill Site looking south west, backfilled and recontoured**

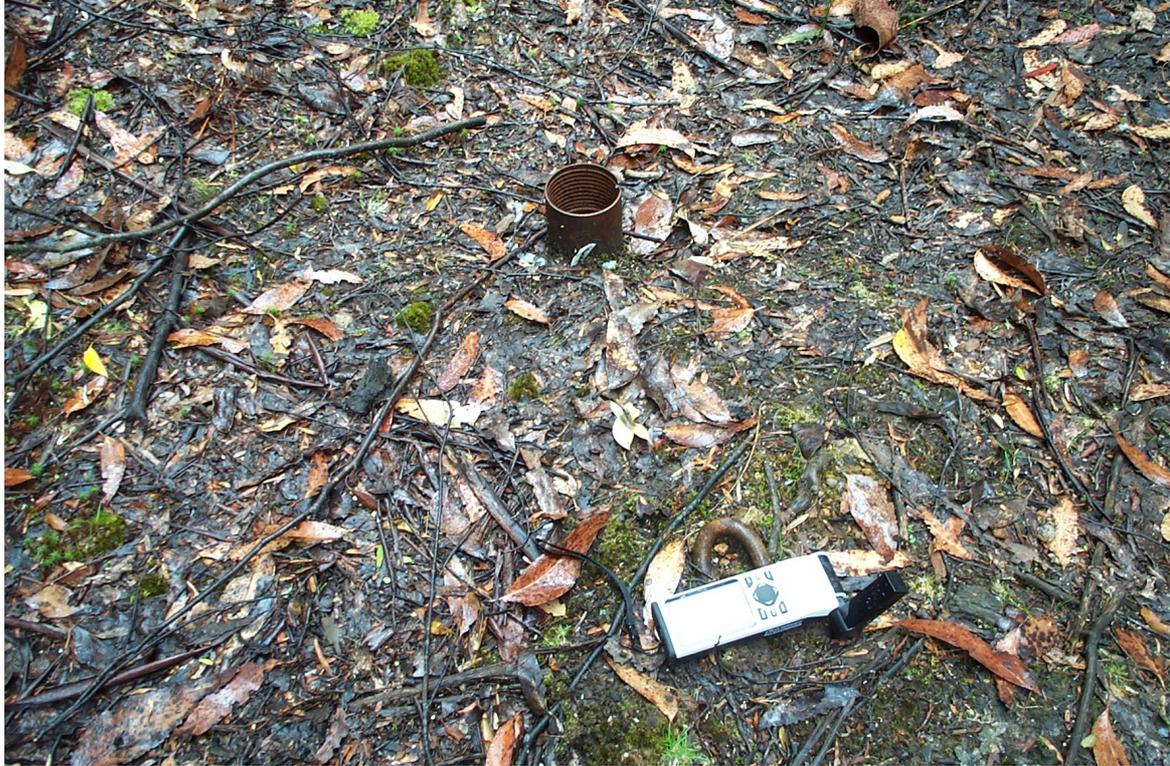
**Photo 9 - SMD13 Drill Site looking south, showing NW steel casing and anchor.**

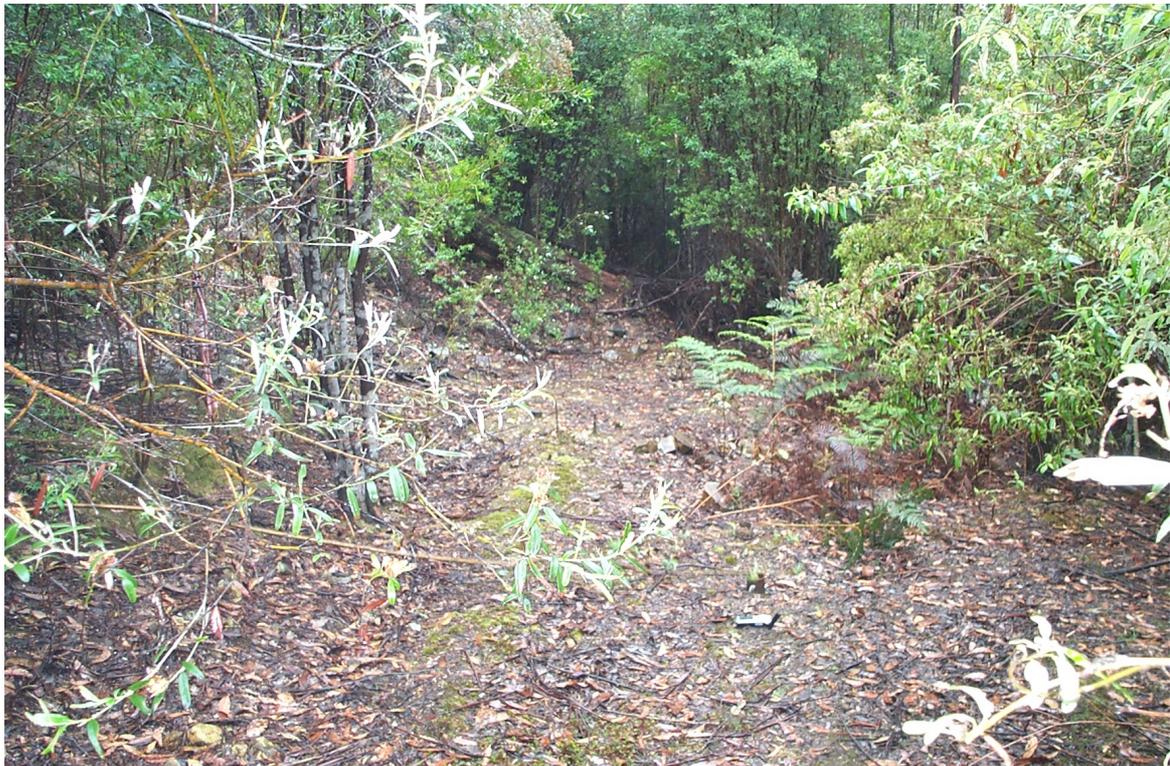
**Photo 10 – SMD13 Drill Site looking south, showing undisturbed regrowth**

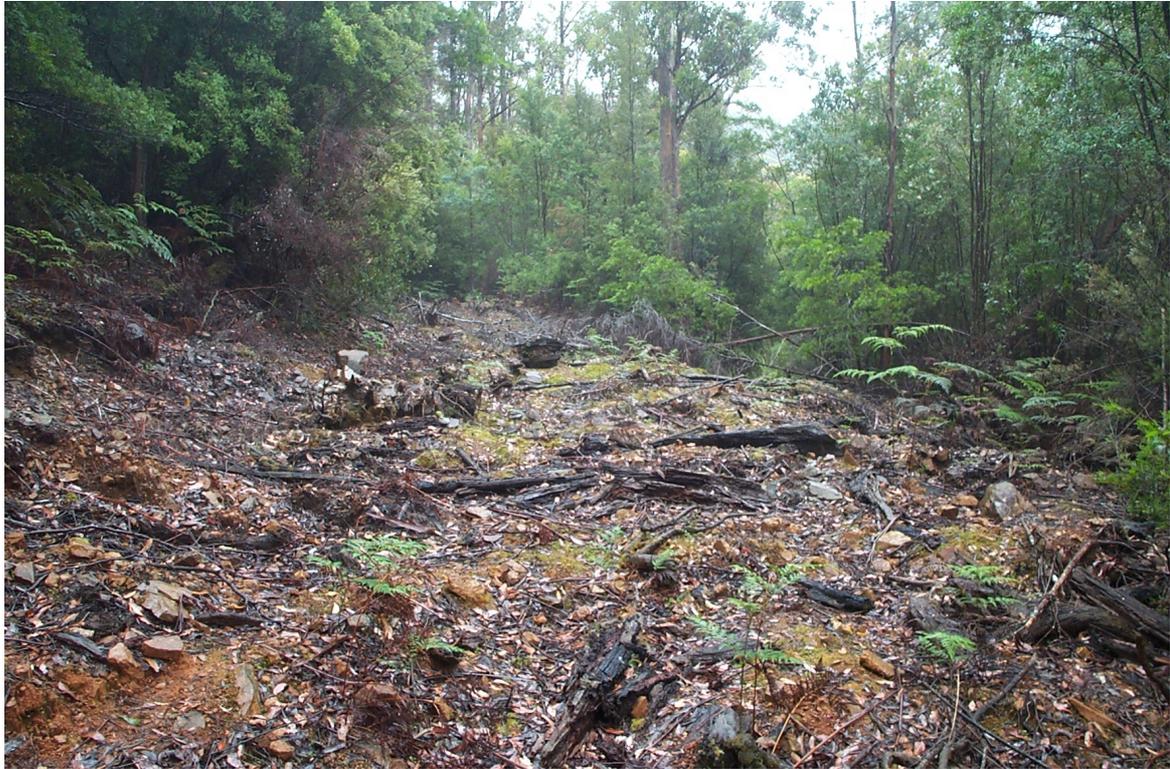
**Photo 11 - HS9 Drill Site looking south west, backfilled and recontoured**
