Merrywood Open Cut, Report on Landslide Activity
and Fine Reject Pond Safety
Merrywood Coal Company Proprietary Limited*; Thom
Anon 31M/1992

MERRYWOOD COAL CO. PTY. LTD.
MERRYWOOD OPEN CUT
REPORT ON LANDSLIDE ACTIVITY AND
FINE REJECT POND SAFETY

Thompson & Brett Pty Ltd
7 Bayfield Street, Rosny Park, 7018.

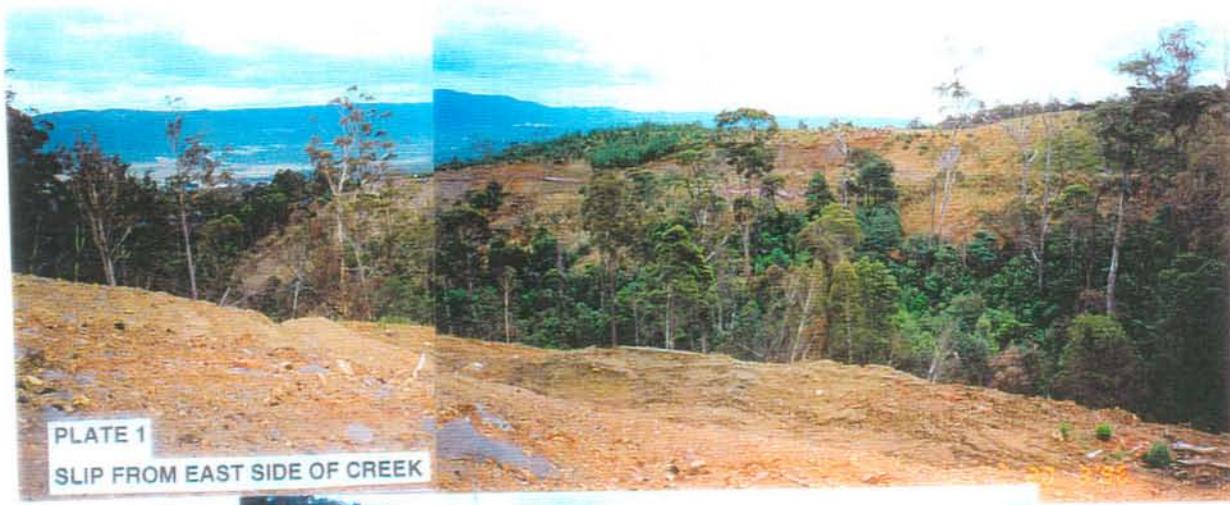
PLATE 1
SLIP FROM EAST SIDE OF CREEK

The landslip is located on the western bank of the Merrywood Creek as shown in Figure 1 and Plates 1 and 2. The slide appears to be a reactivation and extension of an historical slide which predates the current mining activity and shows up as a scar on the mapping for Figure 1.

The slide appears to have developed in dolerite talus material on the banks of the creek, which sloped at approximately 25° at the site.

The slide had been recognised some years ago and, with recent haul road construction and overburden dumping, efforts made to ensure the stability of the area by installation of a deep subsoil drain across the mid section of the slip. However, following very heavy rain in February, the slip reactivated over an extended area with displacement in excess of 3m being measured.

This has caused exposure of a significant head scarp and heaving of the toe. Significant tension cracks are evident across the mid-section of the slide.

Anecdotal evidence suggests that the slip has redeveloped due to exceptionally heavy rain, perhaps generating inflow of water along a fault zone through the foundations mid-way along the slip zone. Possibly the

existence of a waste dump above the slide may have contributed but this is unclear at this stage. Contribution to groundwater from reject ponds above the slide is a possible contributory factor but this is considered unlikely.

I considered that the slip will continue moving. The subsoil drain has been destroyed and tension cracks could lead to further water infiltration. Stabilisation by conventional means of drainage and head load removal would involve major earthworks and are considered essentially impractical. The only practical method of stabilisation believed feasible and compatible with mine development is to buttress the slip by specific extension of the overburden dump to fill the Merrywood Creek over the slip zone.

This would involve construction of a "flow through" dump base in the creek utilising selected durable sandstone from overburden removal operations. This material would be dumped over a high face of at least 10 metres, commencing to the north of the slip and proceeding down creek to the southern extremity of the slip. With the inherent coarse nature of this rock, aided by segregation from the high face tipping, a permeable drain would develop in the creek bed, sufficient to allow drainage of the normal creek flow.

In the meantime the "flow through" dump base should be constructed as a matter of urgency.

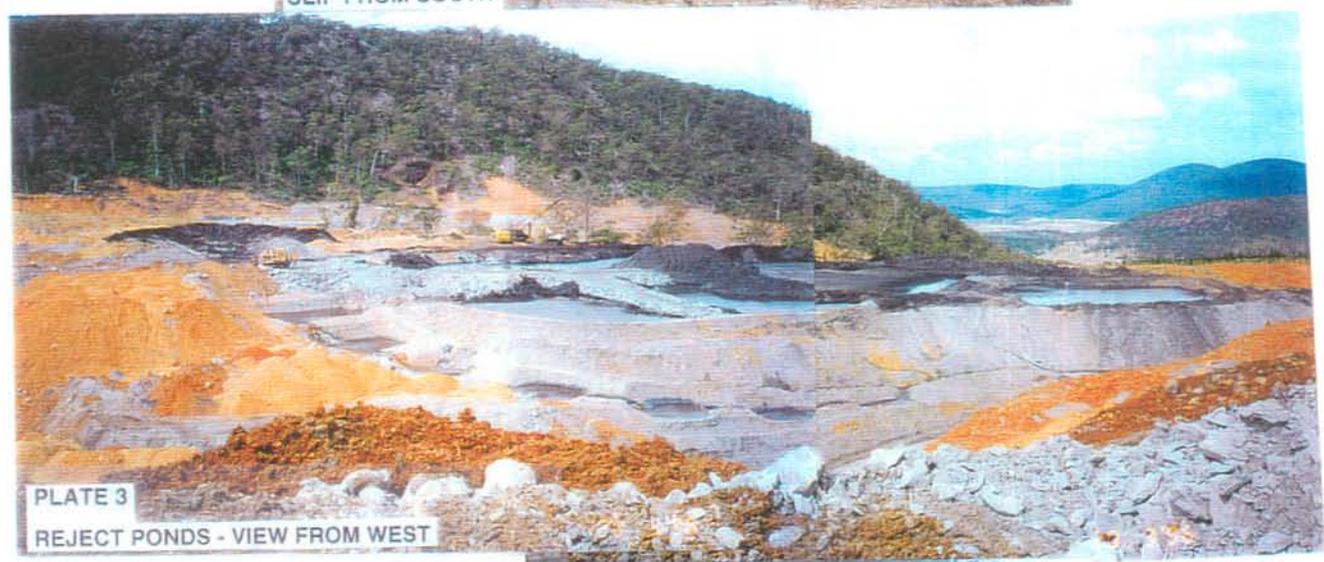
PLATE 3
REJECT PONDS - VIEW FROM WEST

A series of fine reject ponds has been developed on the top of an old overburden dump to the west of the Merrywood Creek slip area, as shown in Plate 3. This comprises an arrangement of four main ponds which can be used independently and which overflow to a series of smaller settling ponds.

The arrangement allows settling of fine reject from the washery and clarification of the return water.

The main ponds are clay lined and the smaller ponds are lined with geomembrane.

Water is critical to the plant operation and the ponds appear to have been carefully constructed to prevent water loss. It is thus considered unlikely that water is saturating the underlying foundation and contributing to instability. However this has not been proven and could be possible.

It is recommended that the fine reject dams concept should be reconsidered in line with the proposed overburden dump planning to allow the dams to be relocated away from steep dump batters and designed such that dredging of settled reject is not required.

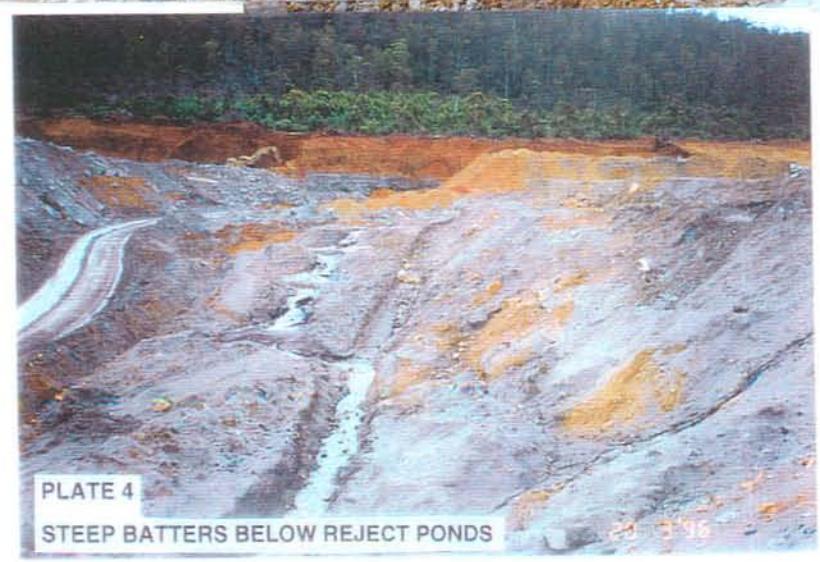
PLATE 4
STEEP BATTERS BELOW REJECT PONDS

The main pond construction is not ideal with steep batters as shown in Plate 4. Freeboard is limited. However in view of the small quantity of water stored, any failure of the ponds would not cause significant impact below the mining lease.

Time for this redevelopment should be allowed as it is not considered that the ponds are dangerous in the short term.
