EL 28 /1988 Annual Report 2010:

Appendix 5, Environmental Rehabilitation

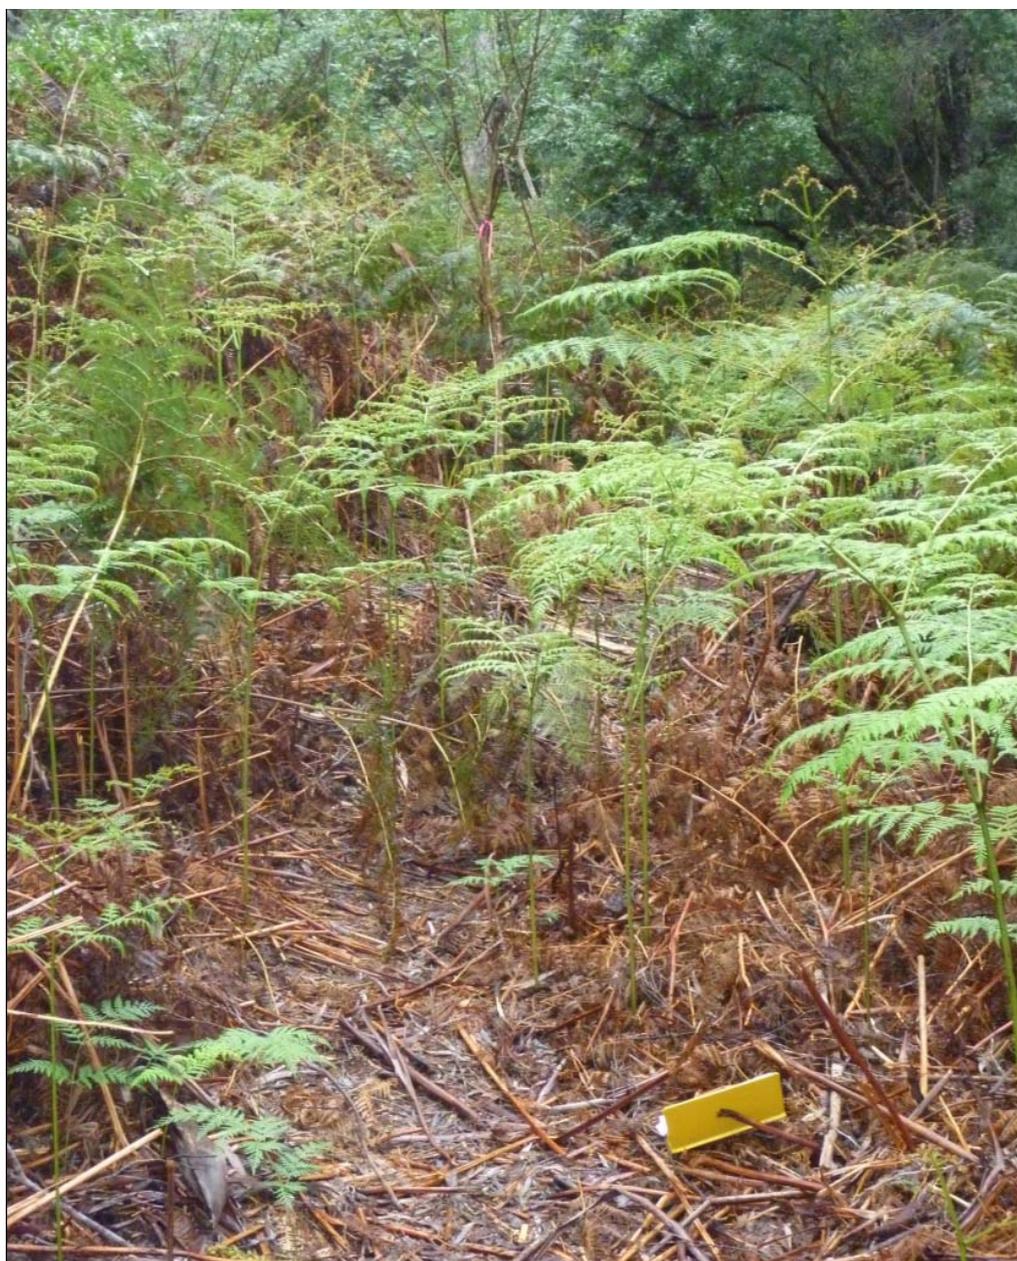
Access track to drill site. View is to the NE heading up the hill away from the drill site. Understory vegetation in this area is dominated by bracken fern. Although the track is still open, the bracken fern in many places is beginning to enclose the path.

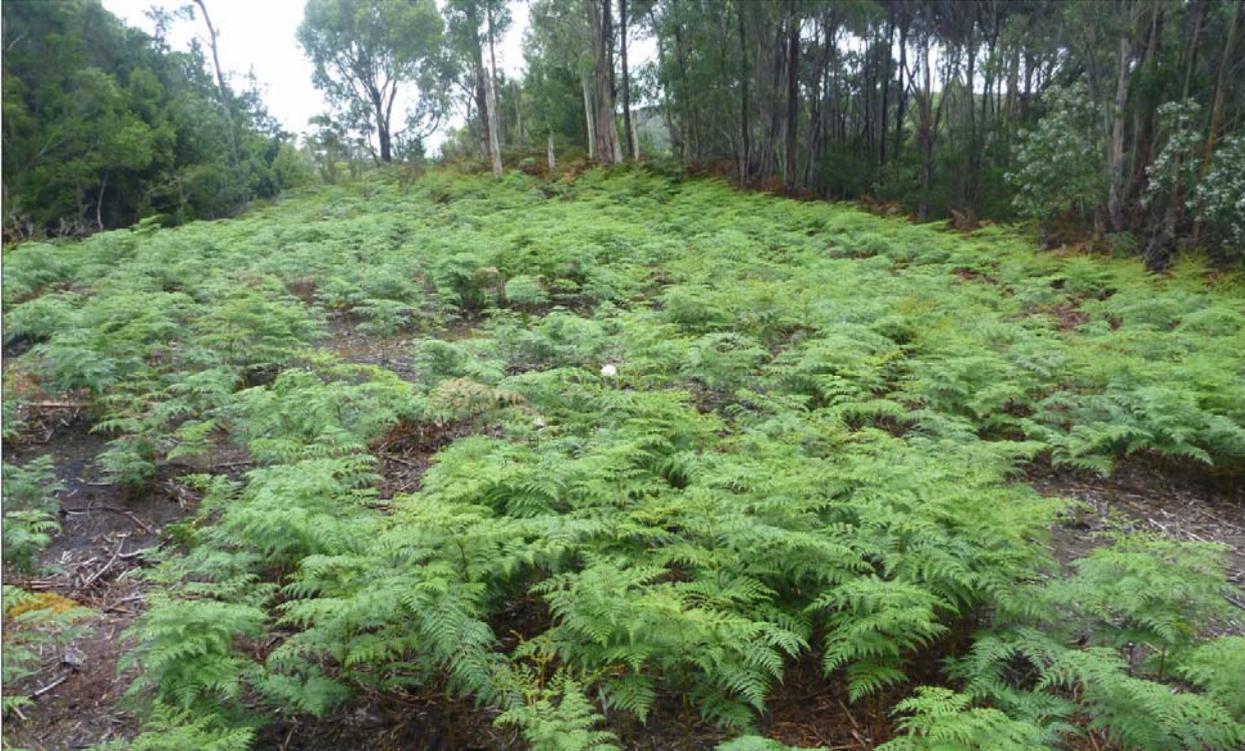
The drill site of B012 has also been re-established with bracken fern. As pictured (white circle in centre) the collar has been lined and capped with pvc. The drill site was inspected and found to be clear of rubbish and all drilling related fluids and materials.

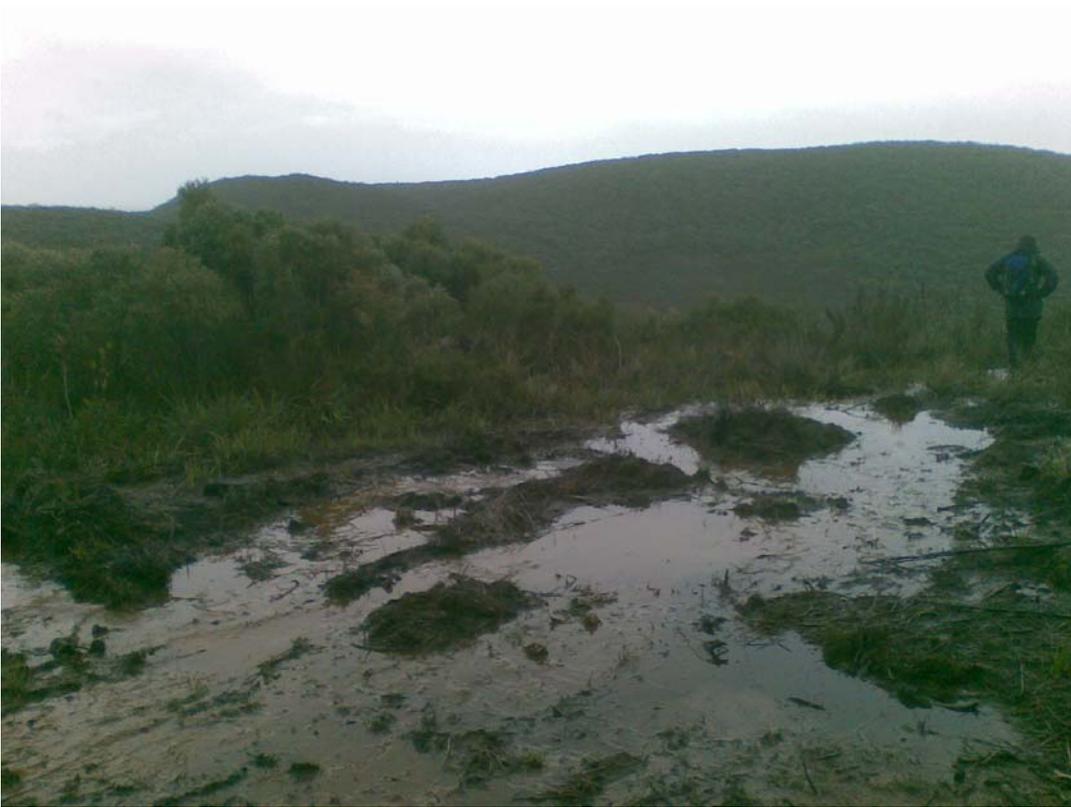
It is the authors' opinion that most of the water pooling around A223 is surface water and is not directly related to the drill hole. The area is flattened out and slightly recessed allowing ponding of surface waters. The water then adjoins a much larger catchment of surface water runoff before discharging to the valley below. No additional mitigation work is considered warranted.

Area near where drill hole collar A223 pictured in August 2009. Note the large amount of surface water and Fe oxide flocculent. The large amount of water is surface runoff from up gradient catchment area after persistent winter rains. Picture is viewing towards the south east.

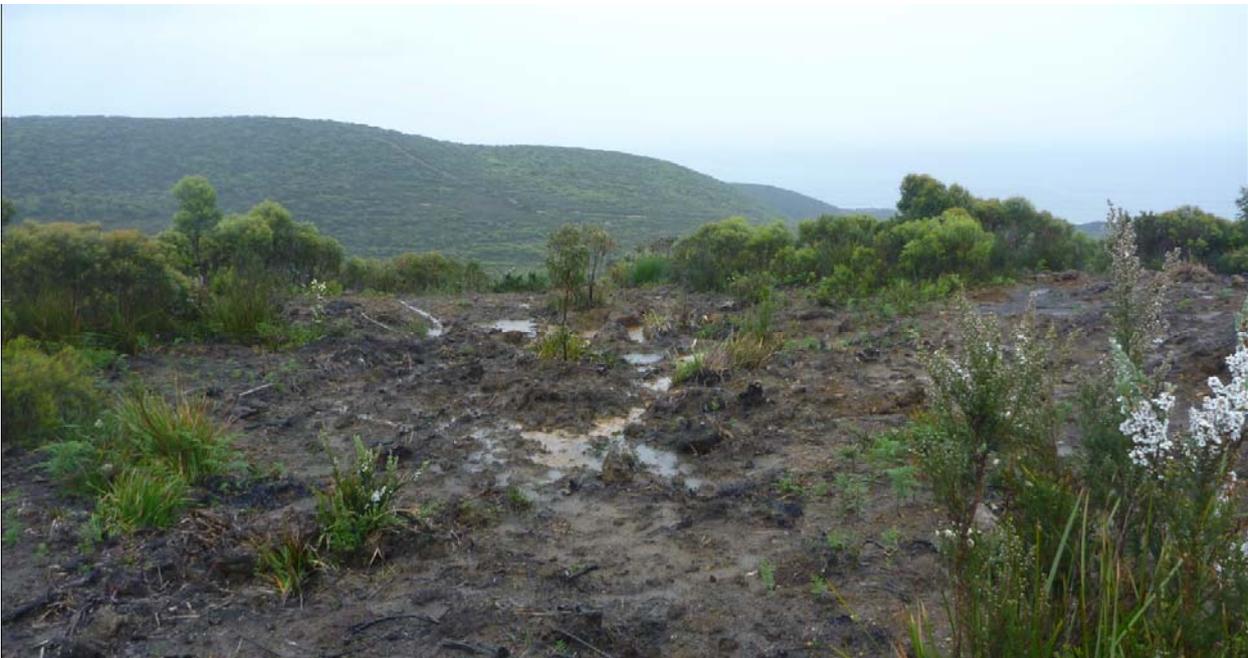
Drill site A223 showing surface water accumulating in the flat recessed area of the drill collar. Minor Fe oxide flocculent has accumulated around the collar but is dissipated by other surface water runoff. Photo taken in November 2010. View is to the west. The drill hole collar was buried during top soil replacement as part of the environmental rehabilitation. Compare this image with the picture taken in August (winter) 2009. It is evident that most of the water is derived from surface runoff and is not a direct result of the drill hole.

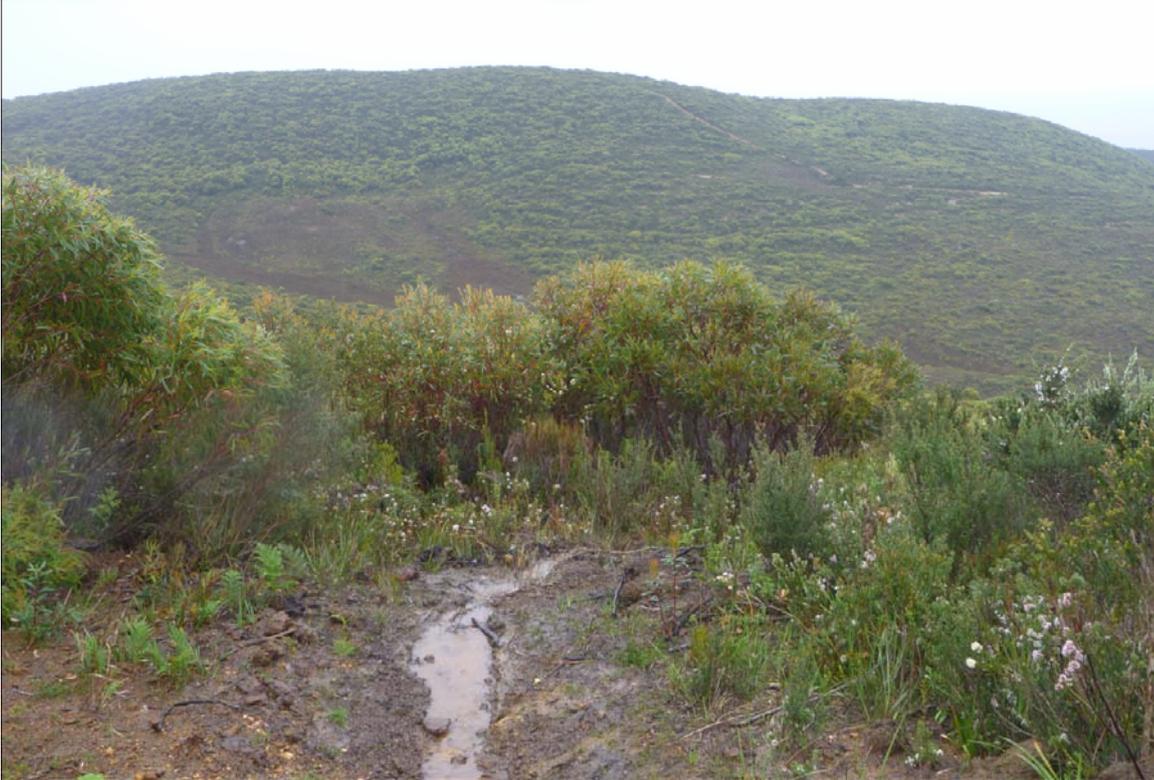
View looking west from the drill site of A223. There is minimal water leaving the site. The water adjoins and is diluted into a much larger catchment area before entering into the valley below and eventually running into the ocean.

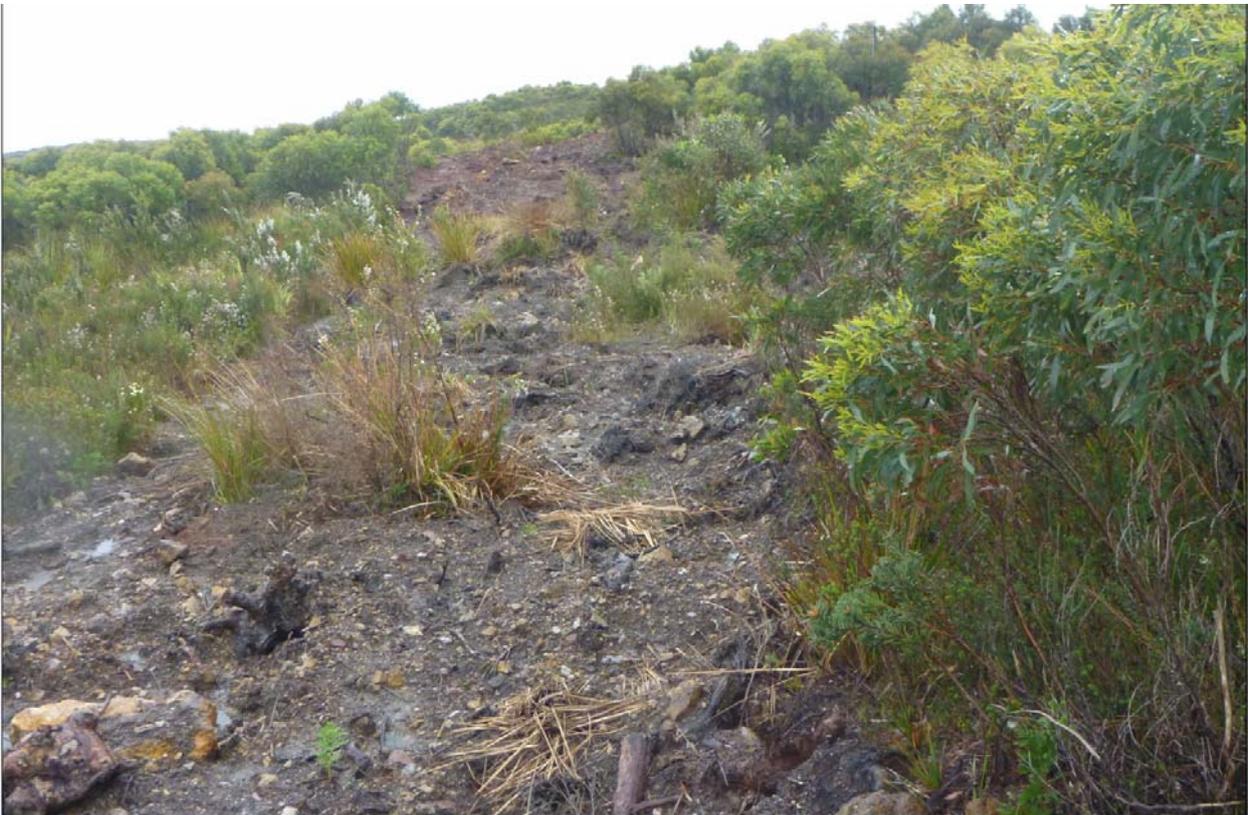
View to North along 2009 drilling vehicle access track. Islands of vegetation have been established and are seen to be spreading out into the other parts of the track. Germination by smaller native plants within the disturbed soil are encouraging signs that the rehabilitation process is well advanced.
