Unity Mining Limited
Henty Gold Mine
EL 34-2010 Tullah
Diamond Drill Hole Status
Report

April 2014

Drill Hole Status Reports

EL34_2010 - Tullah/Lakeside

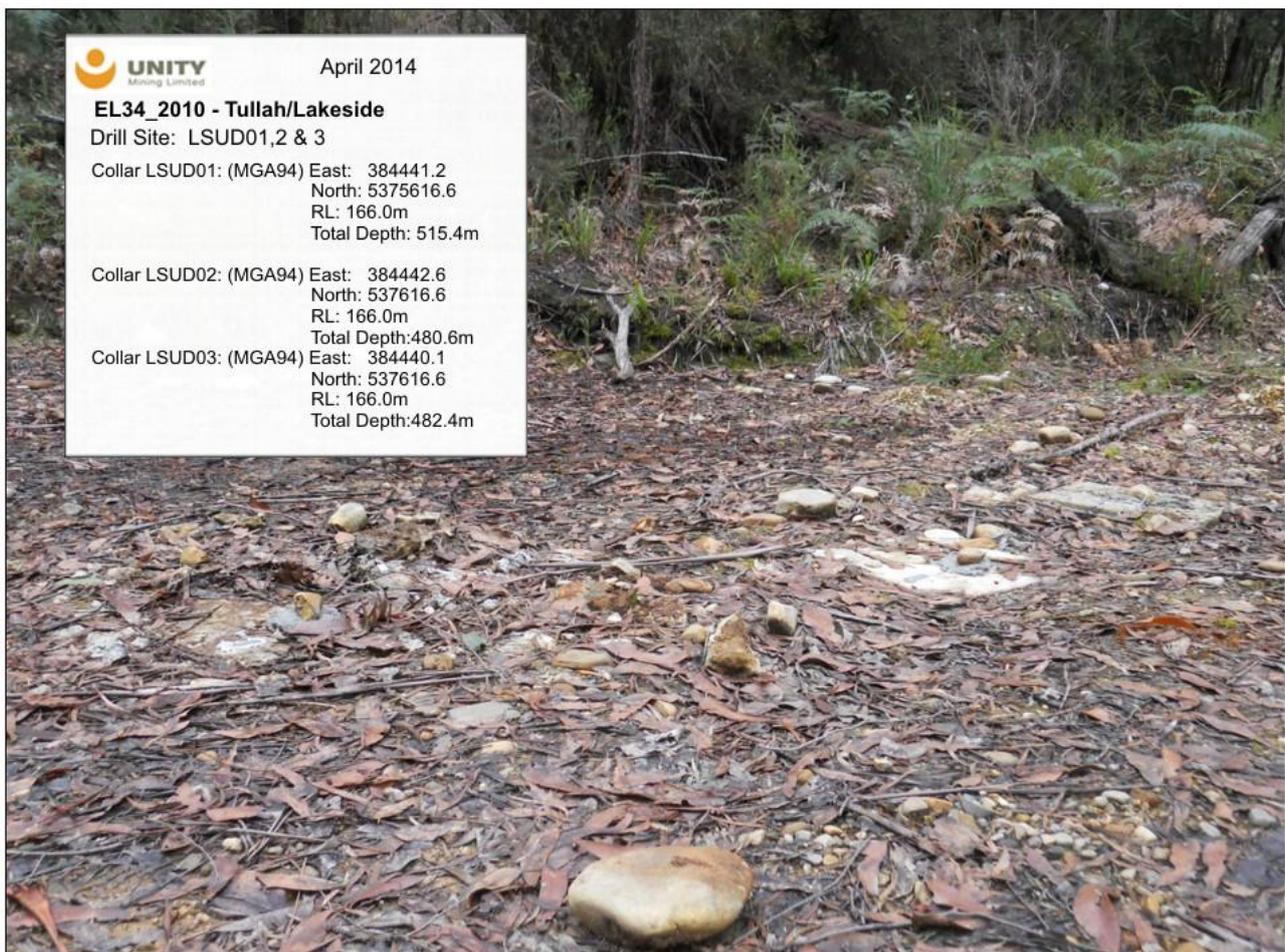
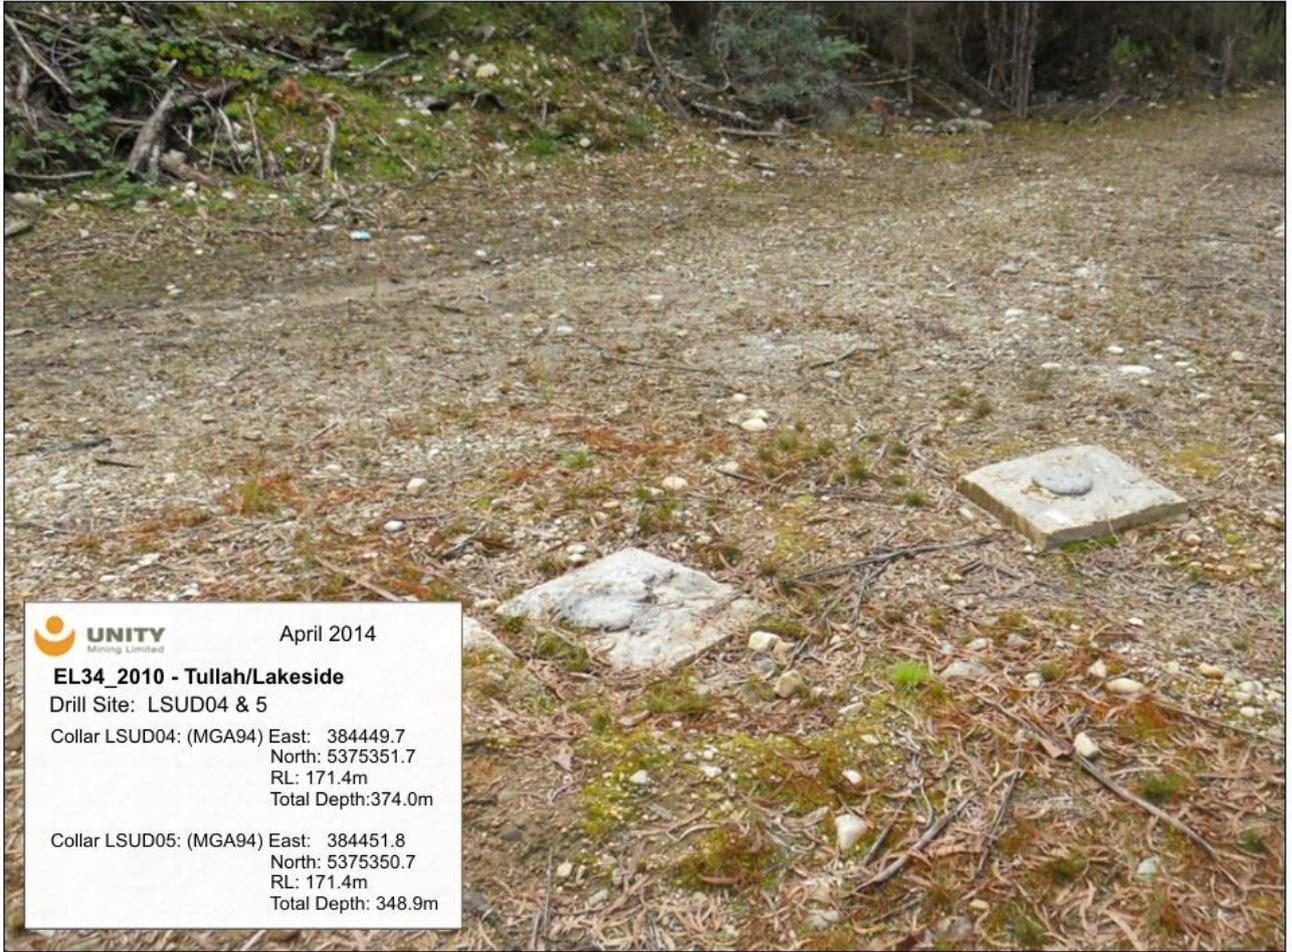
Drill Site: LSUD04 & 5

Collar LSUD04: (MGA94) East: 384449.7
North: 5375351.7
RL: 171.4m
Total Depth: 374.0m

Collar LSUD05: (MGA94) East: 384451.8
North: 5375350.7
RL: 171.4m
Total Depth: 348.9m

All drill sites have been and left in a condition Drill Holes were cased with PVC to 'end of hole depth' and all waste material (hydrocarbon waste, drill-cuttings, flagging tape, etc.) has been removed from sites. All drill collars have been cemented shut at ground level and numbered, 'collar grouted' and are not making water. All collars have also been stabilized/secured with cement.

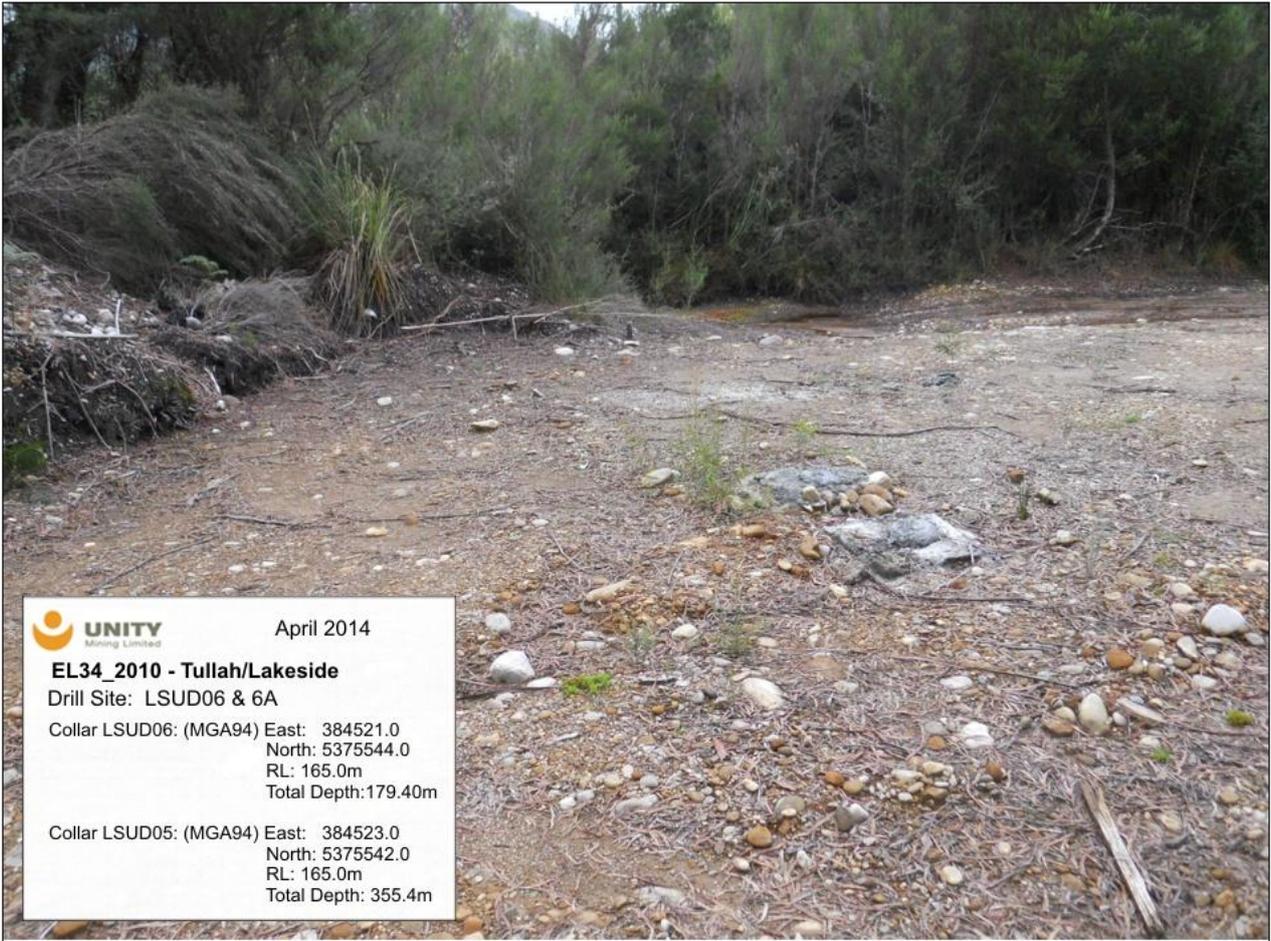
Drill Site: LSUD06 & 6A

Collar LSUD06: (MGA94) East: 384521.0
North: 5375544.0
RL: 165.0m
Total Depth: 179.40m

Collar LSUD05: (MGA94) East: 384523.0
North: 5375542.0
RL: 165.0m
Total Depth: 355.4m
