## **Memo – Gauge board setup details, St Dizier Creek above Tunnel and Webber Creek 100 Upstream of Old Rail Line.**

### ***St Dizier Creek above Tunnel***

## **Webber Creek 100 m upstream of old railway track**

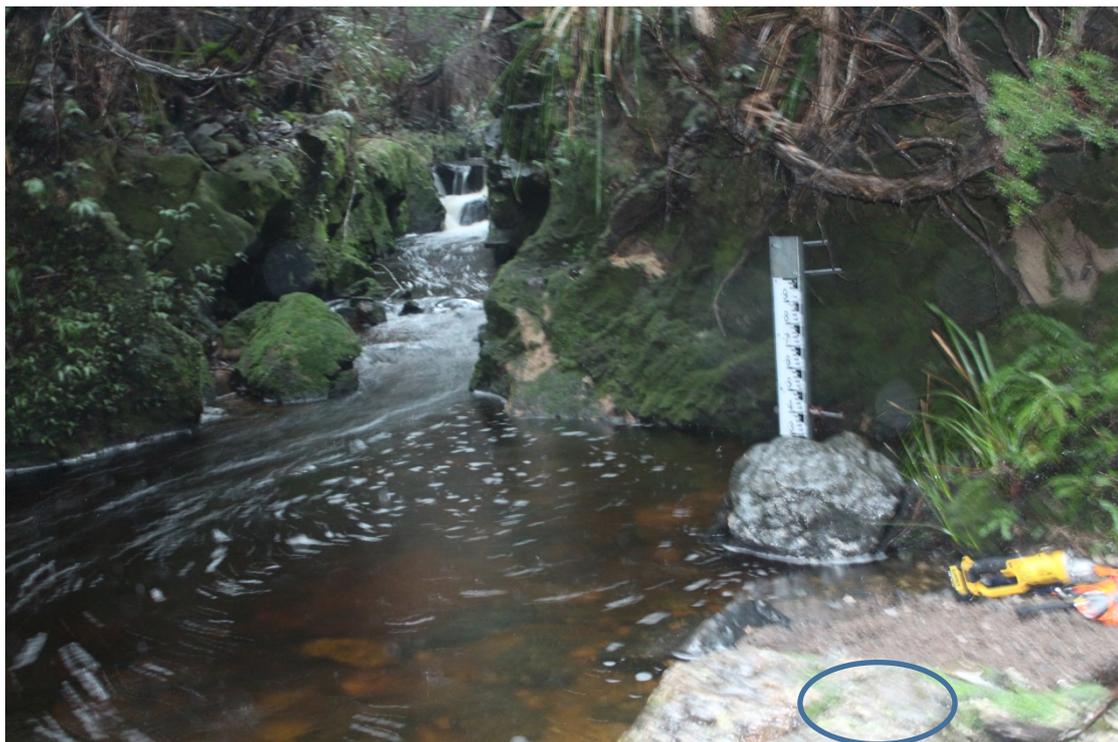
<b>Item</b>	<b>Rating</b>	<b>Rational</b>
Flow Control	Fair	Flow is restrained by competent rock outcrop in pool where gauge board is placed. There is some loose rock on the base of the control point that may alter the level flow relationship with time. Also makes the measurement of the cease to flow level imprecise. Bend in river after control, not ideal.

Gauge Board stability	Fair	The gauge board is secured to weathered granite with similar consistency to clay. Due to moss the material does appear to be competent rock. There is potential for movement and the height of the gauge board relative to the benchmark should be checked periodically. There is a possibility gauge board will be removed in flood, but is protected by embankment. 5 anchor points have been used to overcome the above issues.
Benchmark	Excellent	The benchmark is installed in solid rock (bottom right of Figure with blue oval around approximate location).
Safety	Reasonable	Due to the presence of the tunnel downstream s gauging during higher flows via wading could be hazardous. Assessment will have to be made prior to each gauging. Entura may need to be contracted for higher flow rating curve development if required.

Figure 1 – St Dizier gauge board with benchmark bottom right on rock outcrop.

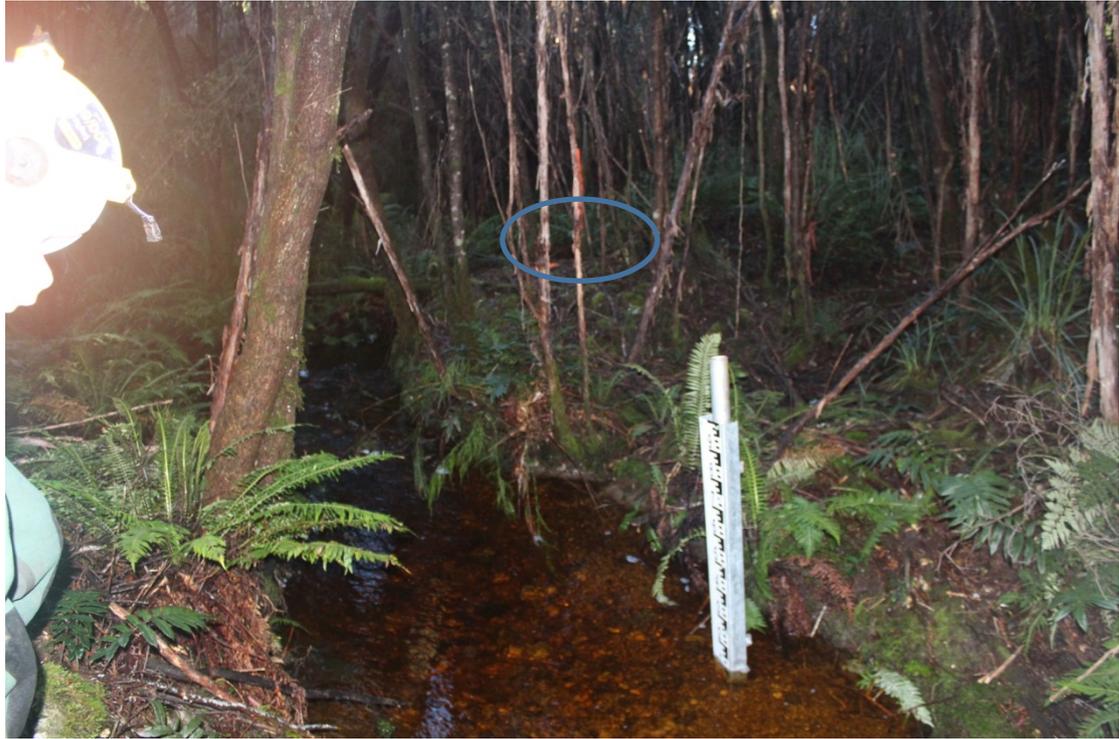
<b>Item</b>	<b>Rating</b>	<b>Rational</b>
Flow Control	Poor	Flow is restrained earthen control and is likely to move with time. Gaugings are recommended while this flow station is used.
Gauge Board stability	Fair	The gauge board is driven into rocky ground with pole driver. The pole may move if hit by log during flood. The gauge board has a slight lean, but this is not likely to lead to substantive error in measurement.
Benchmark	Poor	The benchmark is installed in earth as no suitable Rock could be found. The benchmark is a long bolt hammered into the ground in an endeavor to provide stability.
Safety	Requires attention	The nearby rotten tree needs to be cleared to ensure that they do not fall on samplers. Once this work is carried out the site will be relatively safe with normal precautions associated with remote sites.

Figure 2 – Webber Creek gauge board with benchmark top middle on earthen mound.
