Argent Minerals Tasmania Fieldtrip February 15-18th 2018

Ian O'Sullivan and Matthew Robertson

Objectives were to assess each access road within the Queensberry and Ringville tenements for road conditions, track restoration required, gate accessibility, availability of preexisting infrastructure and communication with landholder and other relevant stakeholders.

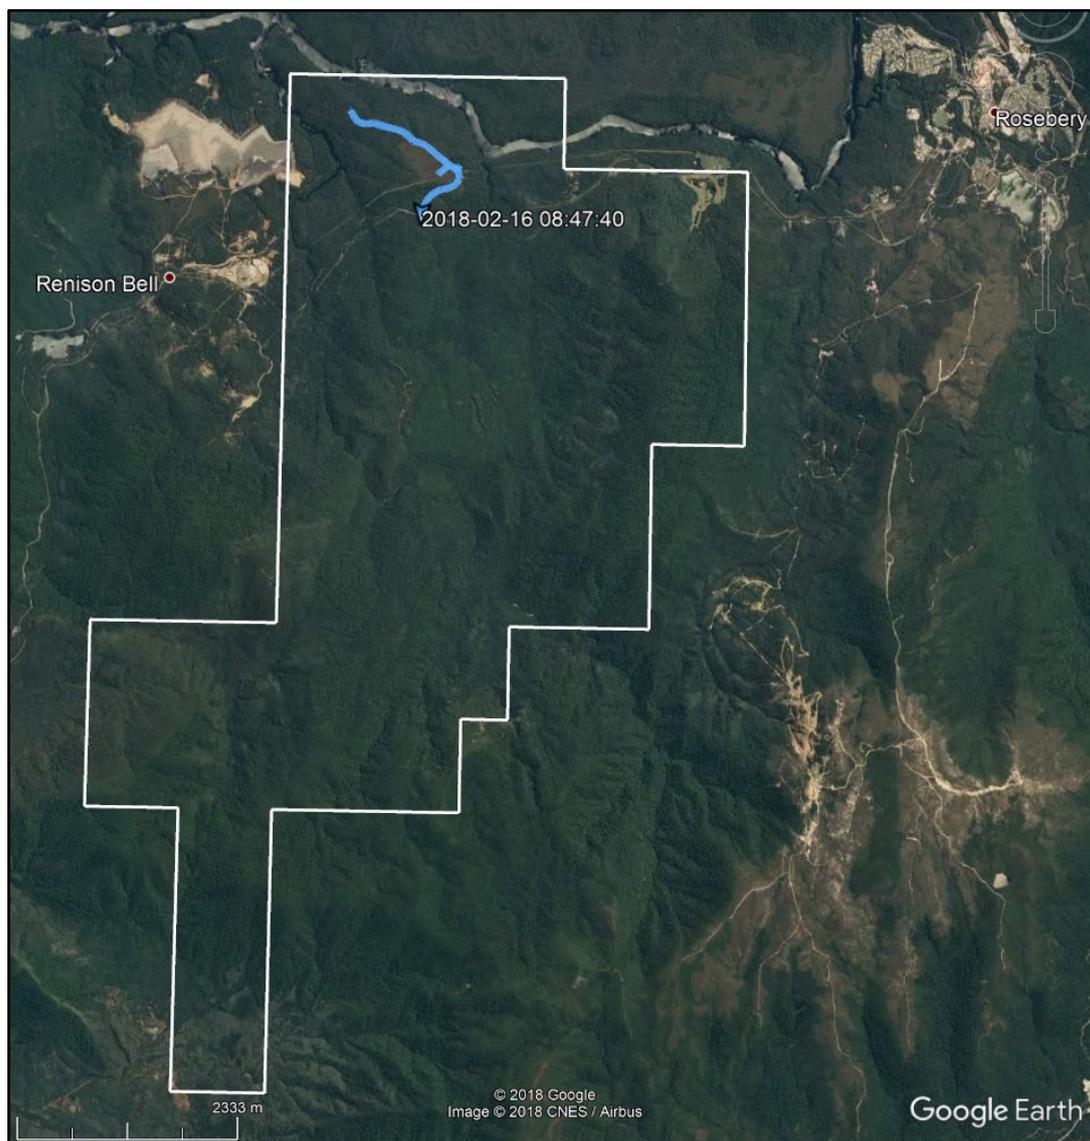
Figure 1 - Salmons/Pieman track on the Ringville tenement

The ungated Salmons/Pieman Track (figure 1) is in excellent condition (figure 2) and will require no upgrades. The track is ~300m from the Murchison Hwy and railway line and 100m from existing telegraph lines. It should be noted there is a private bee yard 50m east that may be impacted on during drilling. The track further northeast and several side trails all narrow and have become overgrown requiring repair if access is needed. Figure 3 shows rough position of both lodes.

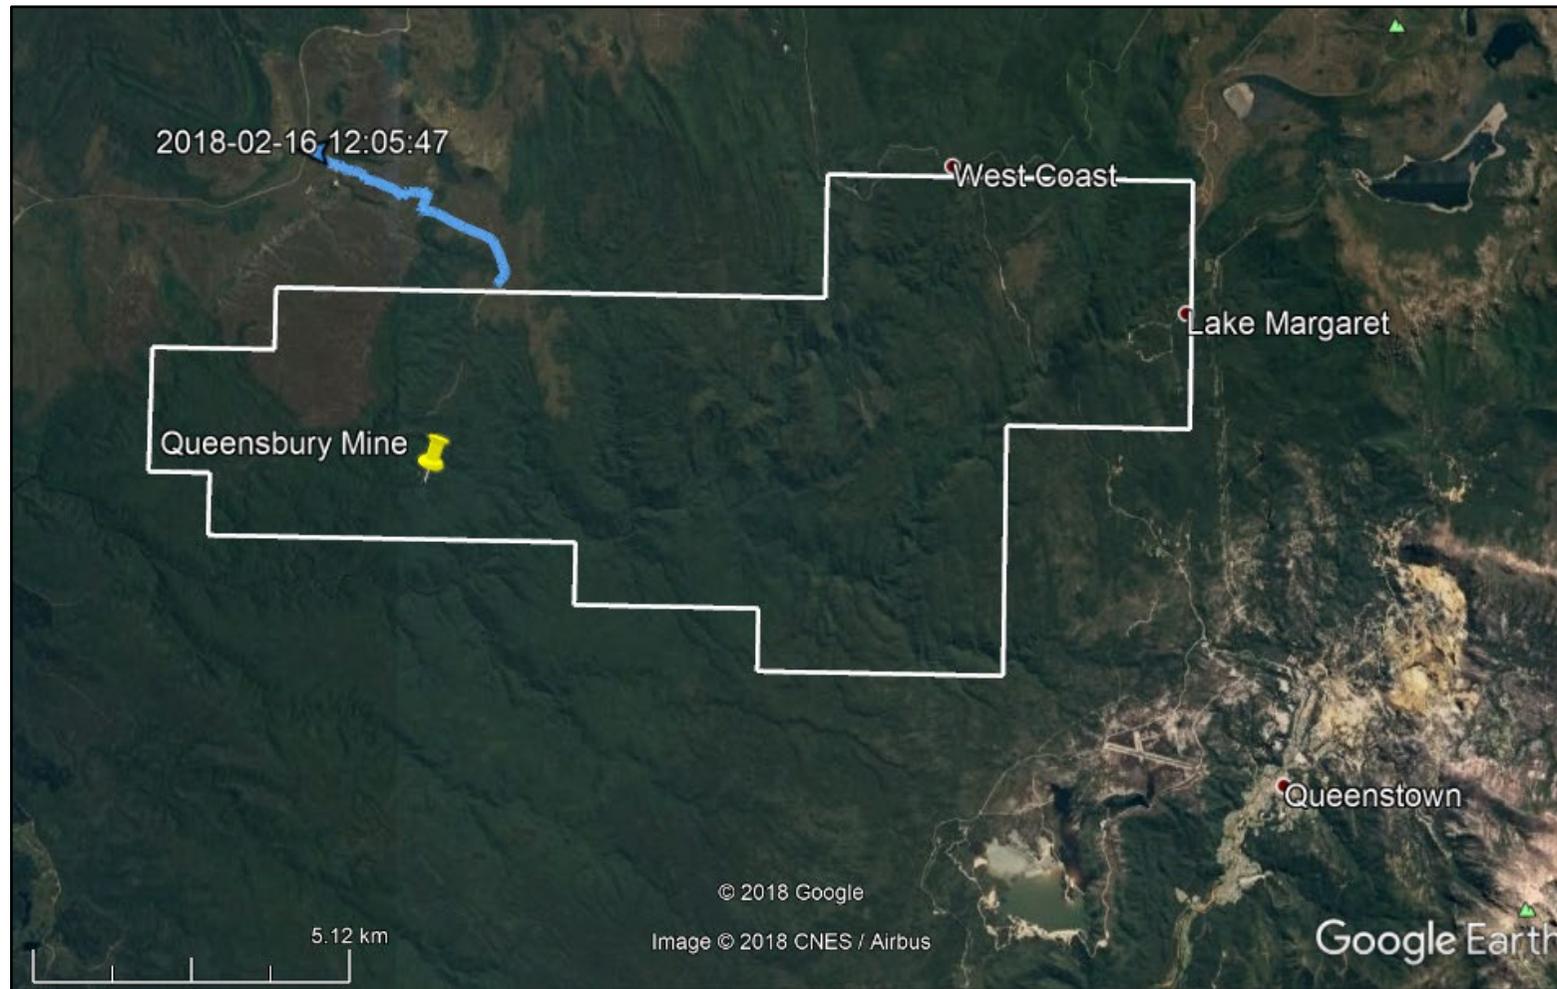
Figure 4 - Queensberry Track

The Queensberry Track (figure 4) was the least accessible of the three tracks with access after 5km inaccessible due to poor weather/track conditions. The access gate lock has been replaced and new keys issued to;

The first 1.5km of the track which includes the hill climb onto the plateau will require a digger to fill in ruts and drains that have been washed away. The digger will have better access and can repair any drainage required throughout the maintenance while working and travelling along the road. The going rate of a digger and operator can be around \$2500 - \$3500 on a 10-hour day rate. This does not include the mobilisation rate which can be up to \$3000 from the machinery's base to work program site. Road repairs could take a matter of 3--4 days.

The plateau itself is okay condition with some drainage. Once off the plateau however the track become narrow, rough and boggy and will be difficult to pass in wet conditions irrelevant of the vehicle. The track off the plateau and into Queensberry Mine will require upgrade to be all weather accessible.

A Toyota Trayback is recommended for vehicle access into the Queensberry Mine, any low-lying vehicles especially fitted with only 2 ply tyres, may end up being a costly exercise and could be a lengthy time to recover a bogged or stuck vehicle.

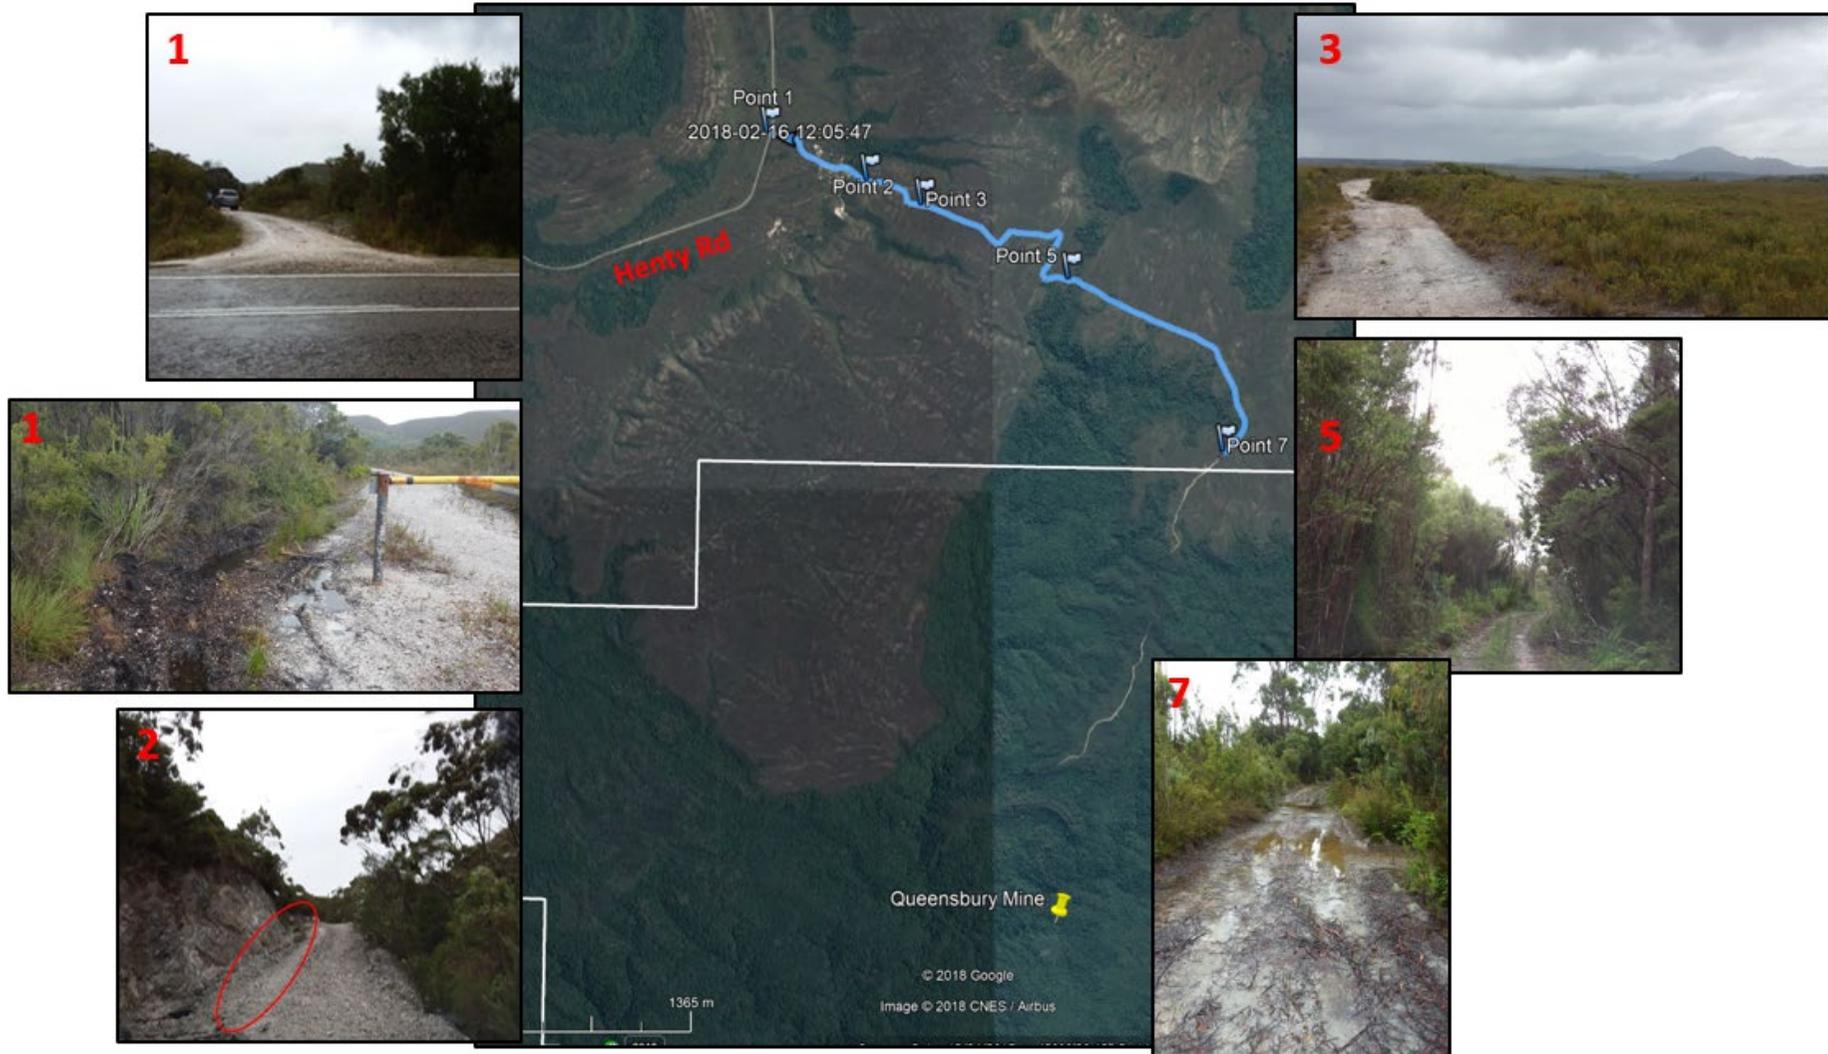
Figure 5 - Queensberry track with points of interest

The Access gate (figure 5) does not stop 4-wheel motorbikes or small 4WDs gaining access to the site and it is recommended that a trench and bund or pylon be constructed besides the gate to prevent future unauthorised access.

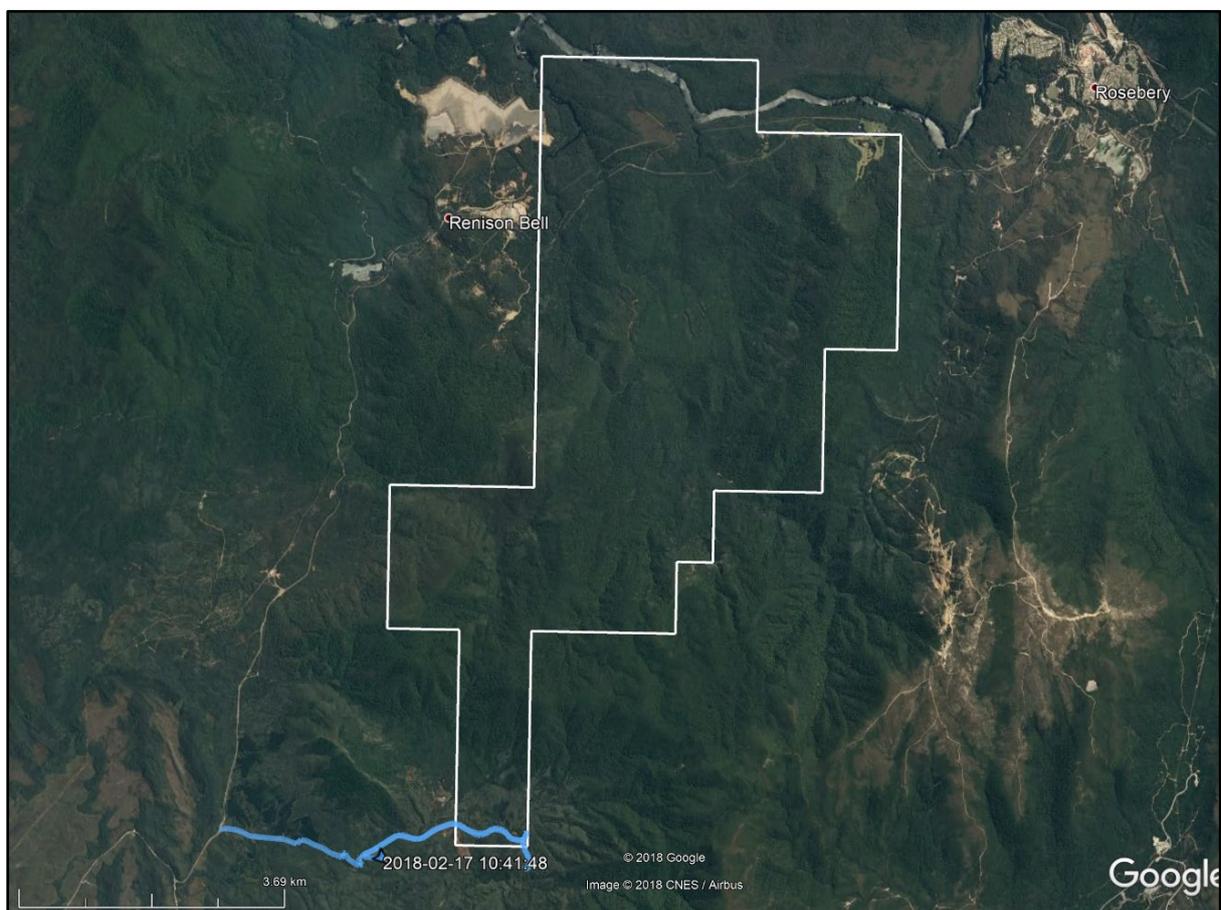
Figure 6 - Dundas track on the Ringville tenement

The ungated Dundas track (figure 6) is well maintained by several stakeholders (M&E Phelan, Bee Keepers, et al) (Figure 7). In a 2-hour meeting with Michael & Eleanor Phelan who own two mines (Stichtite and Crocoite) in the nearby area were both very accommodating and happy for any future exploration to occur.

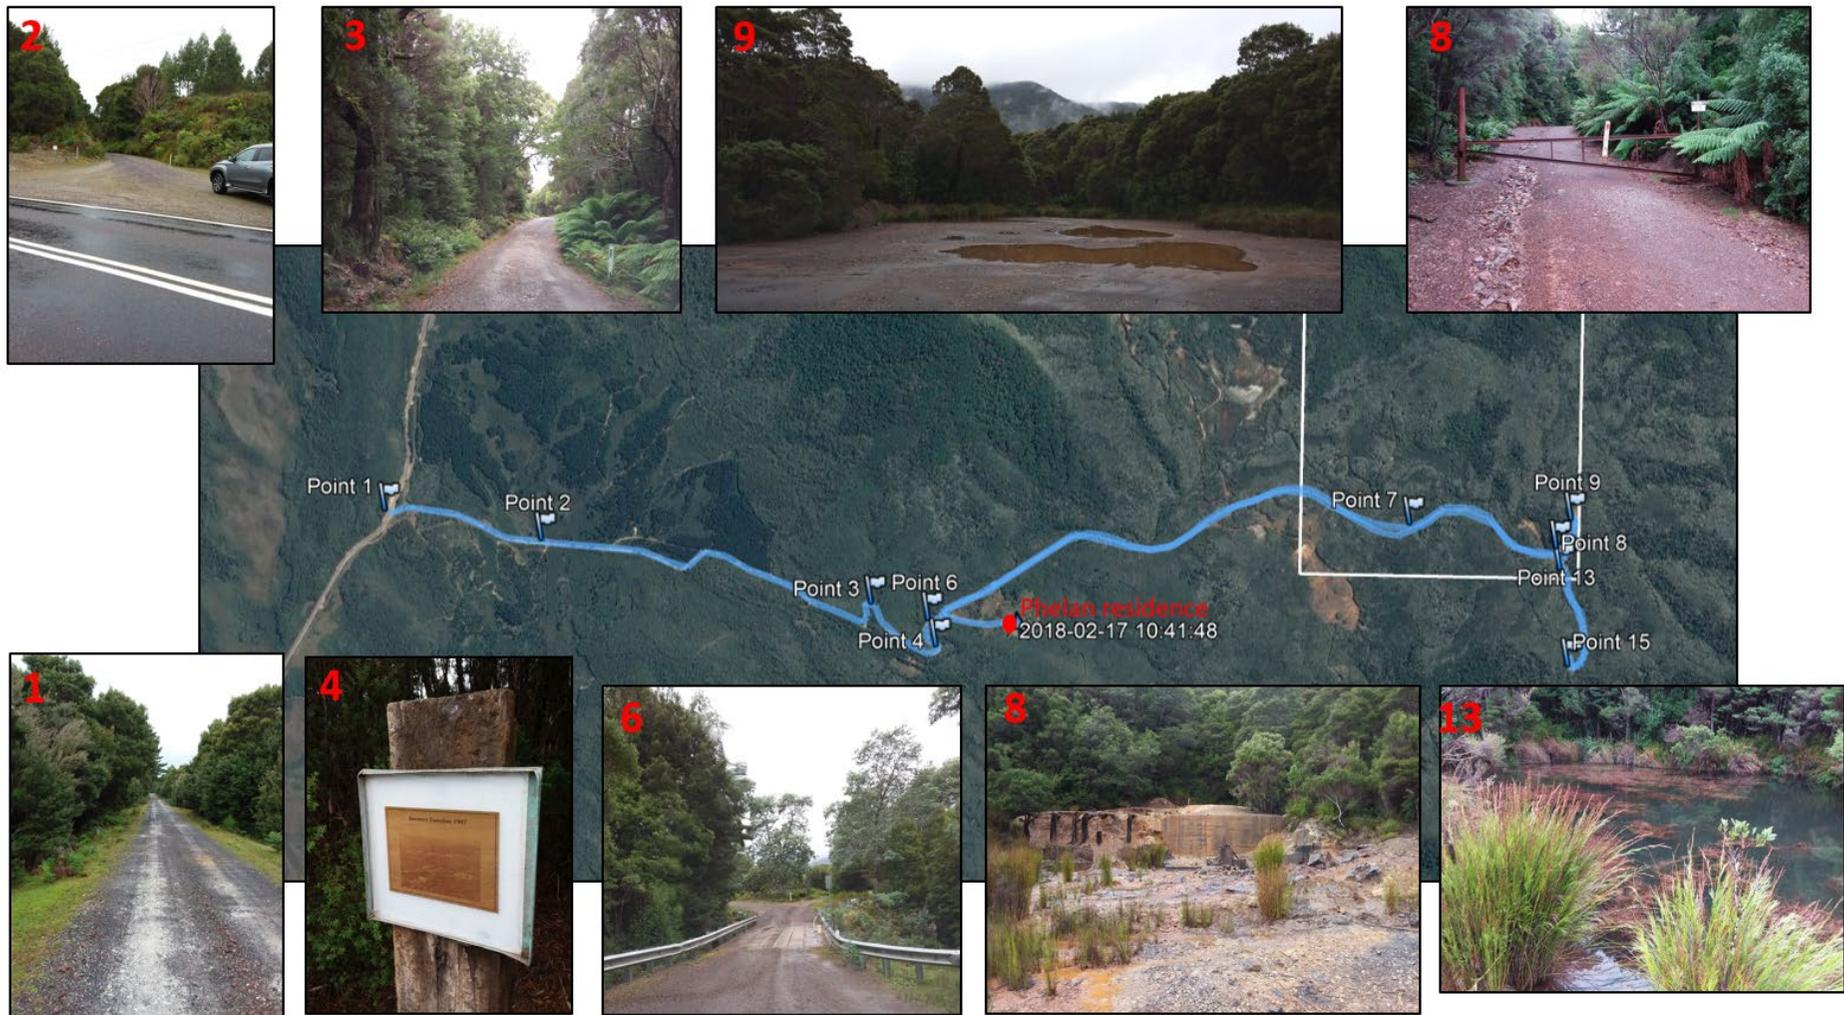
Figure 7 - Dundas Track points of interest

Along the track Mr Phelan has built tourist display plaques (figure 7 pt 4) which are scattered along the track displaying historic mining in the area along with a picnic area. The bridge (figure 7 pt 6) was built by a previous mining company after their drill rig destroyed the original wooden one and is now built to accommodate >30 tonne vehicles. At the end track, old workings of the Maestris mine (ore bins pt 8 & 13, ROM pad pt 9, etc) remain. There is a locked gate which Mr Phelan holds the key and is happy to lend.
