A GUIDE TO RE-ACCESS OF THE DOLPHIN MINE

KING ISLAND

A.D. Fudge - Mining Superintendent
15th January 1991

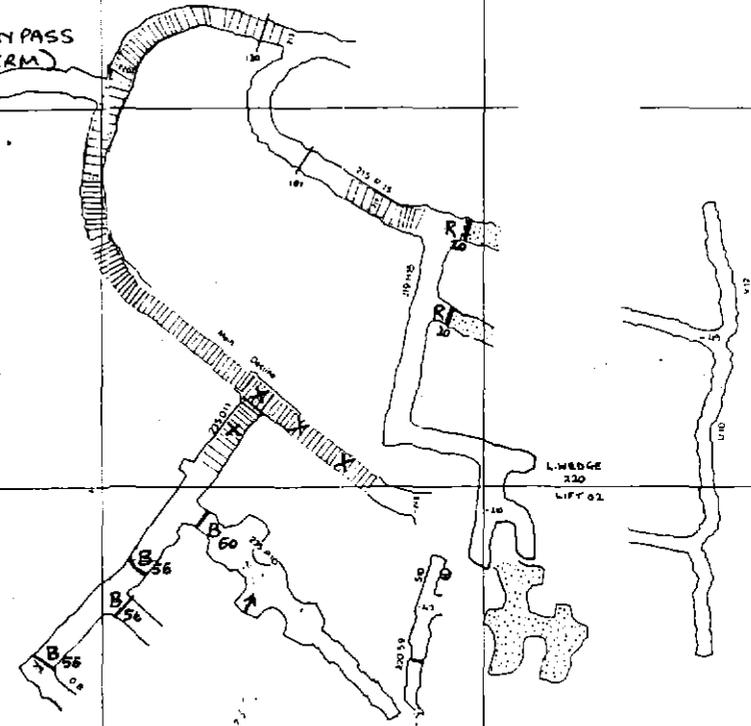
- 225m ZONE

I would anticipate access could be satisfactorily restored as far as the -235m R.L. Q11 but that a by-pass to the Southern Swan area will be required to establish long term access to the lower mine.

DECLINE BYPASS
(LONG TERM)

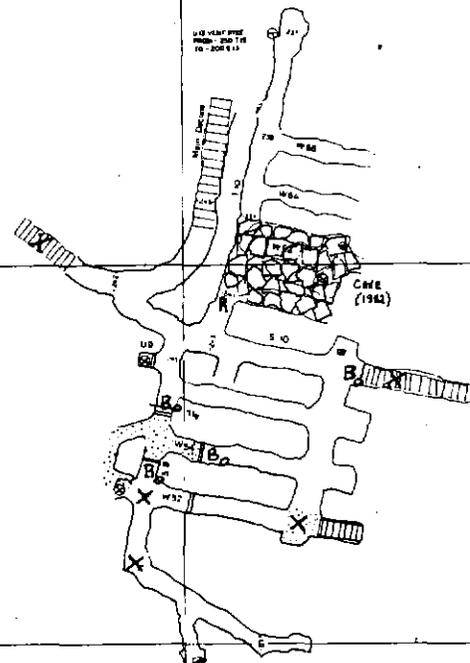
SCALE 1:1000	LOCATION: DOLPHIN MINE
B - BULKHEAD	SURFACE: -240 m ZONE
R - ROCK BARRICADE	
X - POOR GROUND

A short term access in ore was commenced from the L.Wedge -240m R.L. to the L.Wedge -260m R.L. just prior to closure. This could be used as a temporary lower mine access provided the Main Decline can be re-established to the Lower Wedge -240m R.L.

The two other major high grade production stopes are below the Decline collapse but could be accessed quickly through the L.Wedge 240-260 access ramp which could be mined within a month of dewatering the face.
