GEOTECHNICAL ASSESSMENT OF
TIN MINING OPERATIONS AT
PIONEER, TASMANIA.

CLIENT:
Amdex Mining Limited,
119 York Street,
SYDNEY. N.S.W. 2000.

OUR REFERENCE:
Report No. 7878/1
Job No. E-078
28th July, 1978.

GEOTECHNICAL ASSESSMENT.

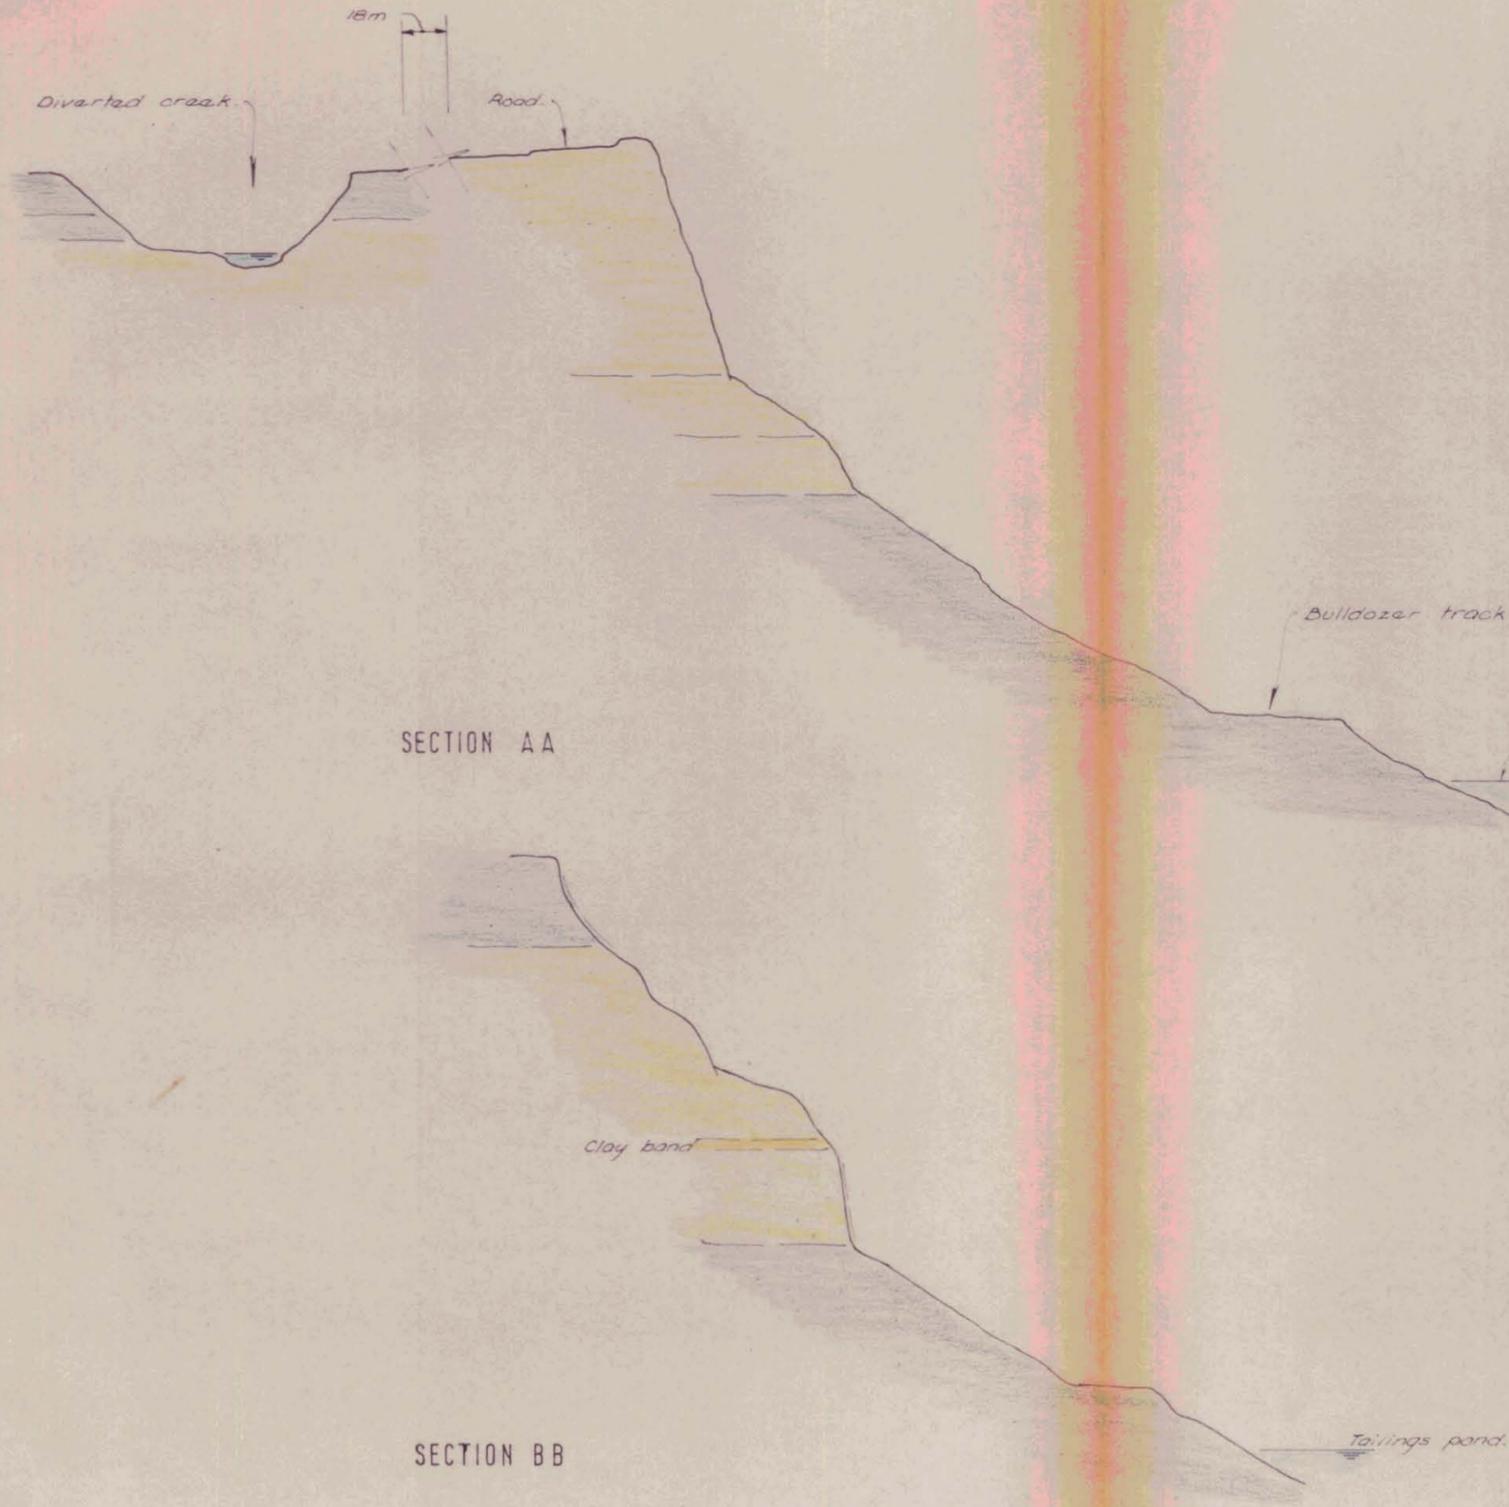
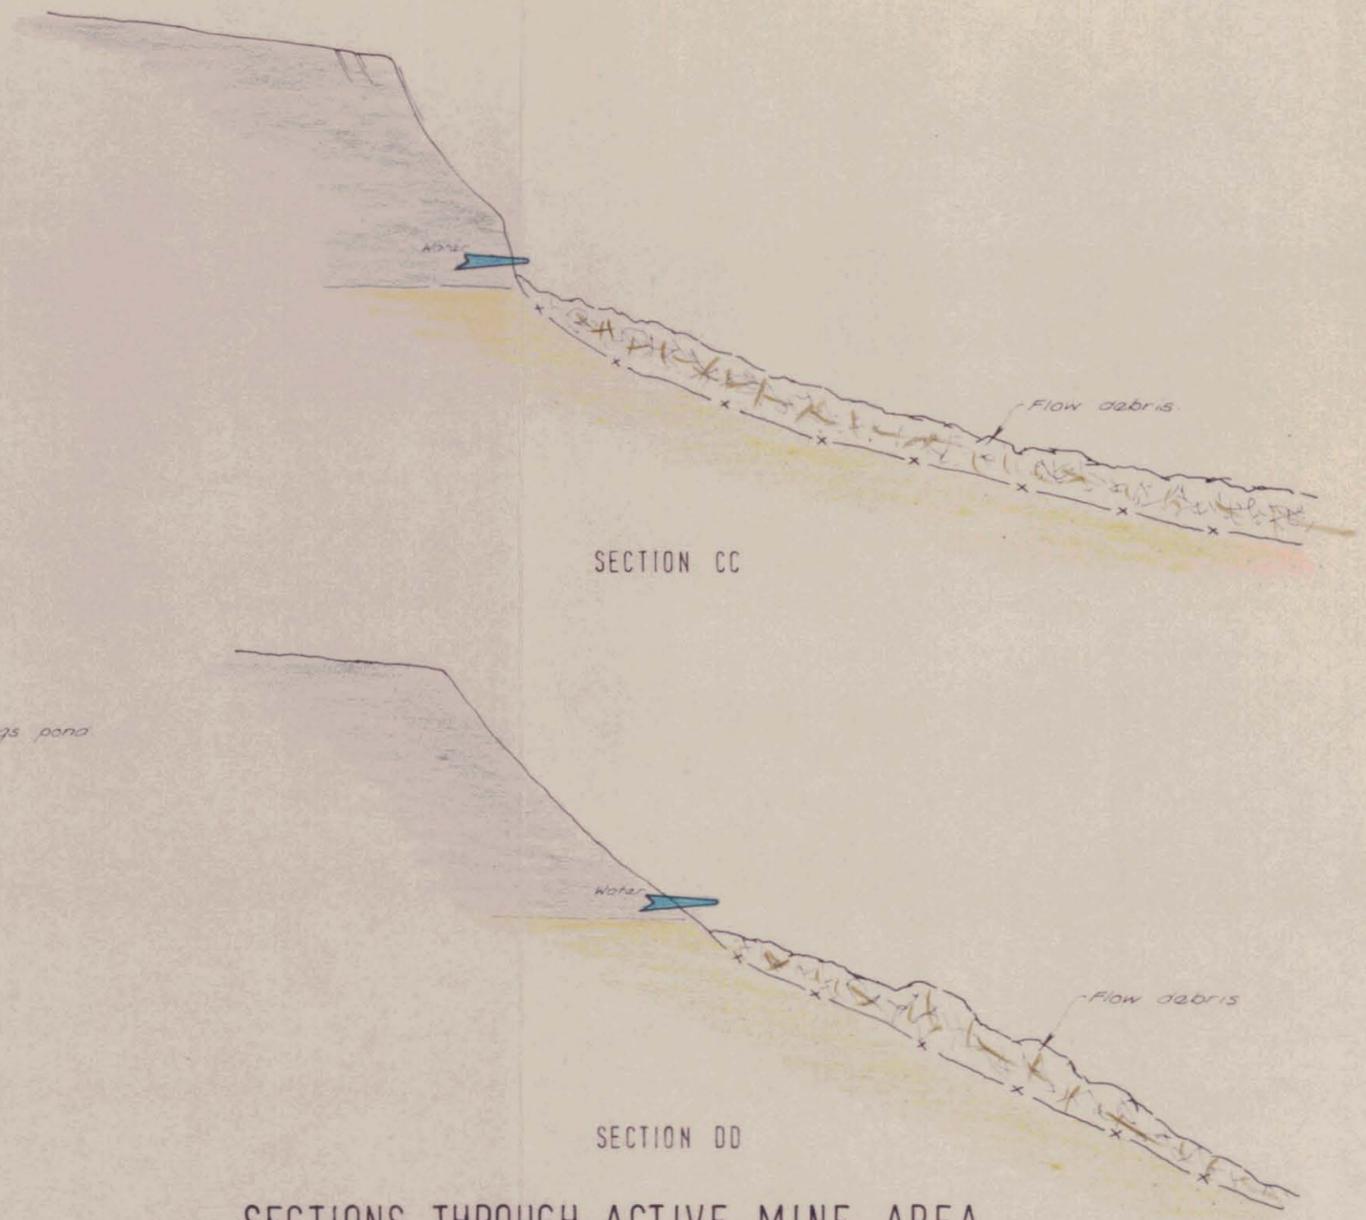
SECTIONS THROUGH PIT PIONEER TIN MINE, TASMANIA	Scale
	1: 250
AMDEX MINING Ltd	Drawing Number
	E-078/G3

- * The instability in the pit slopes is primarily caused by excavating the site materials in benches too high for the strength of the in-situ materials.
- * Partial failure of the newly excavated slopes can be expected at any time; such failures could occur without warning.
- * The present method of mining the overburden is unsatisfactory, and the prime cause of pit slope instability.

Provided that a proper planned method of excavating both overburden and ore is developed, technically acceptable and safe slopes should be able to be achieved in this mine. However, to achieve and maintain safe slopes it will be necessary to:

- * Carry out mining in accordance with a properly thought out plan.
- * Control stormwater and groundwater.
- * Mine overburden and ore separately.

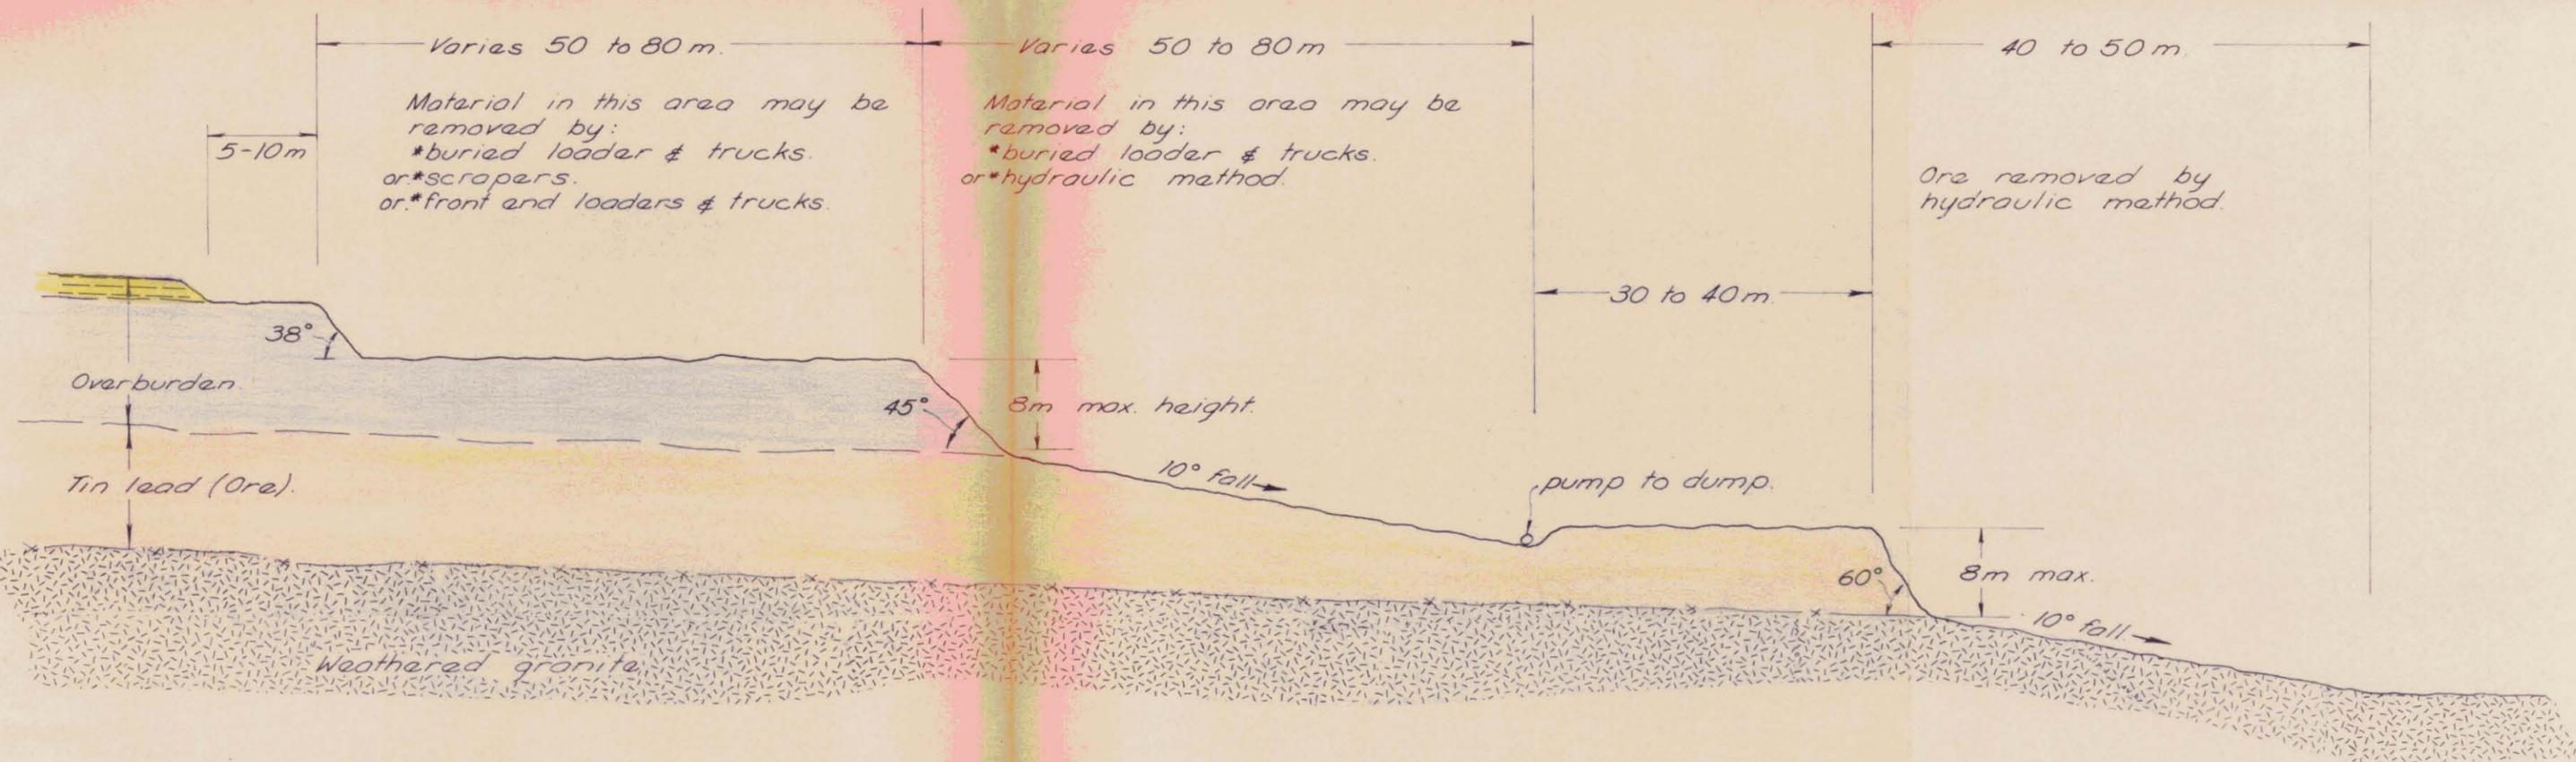
WORKING FACE ARRANGEMENT PIONEER TIN MINE . TASMANIA AMDEX MINING Ltd	Scale N.T.S. Drawing Number E-078 /G4
---	--

Drawing No. E-078/G4 has been prepared to illustrate a possible general arrangement of the mine working face, which would provide much greater stability of the mine area. In respect of this proposed method of excavating both the overburden and ore, it is to be noted that:

- * Near surface pit slopes in overburden are shown at a slope angle of 38 degrees, so that stability can be maintained for several months (possibly up to 9 months).
- * The majority of the overburden is excavated with a working face of approximately 45 degrees; a slope angle which site measurements indicate should maintain stability for several weeks (possibly up to 3 months).
- * The working face in the ore-bearing alluvium is restricted to a height of 8 metres, a height at which the site materials should be able to stand temporarily, and fail in a planned manner. It is our opinion that face heights greater than 9 metres are, theoretically, immediately unstable.

1. This drawing depicts a general arrangement of the mine working face which would achieve greater stability of the mine area.
2. The actual arrangement adopted should be varied in accordance with a detailed mine plan which takes into account lead dimensions and orientation, overburden characteristics and the mining method adopted.

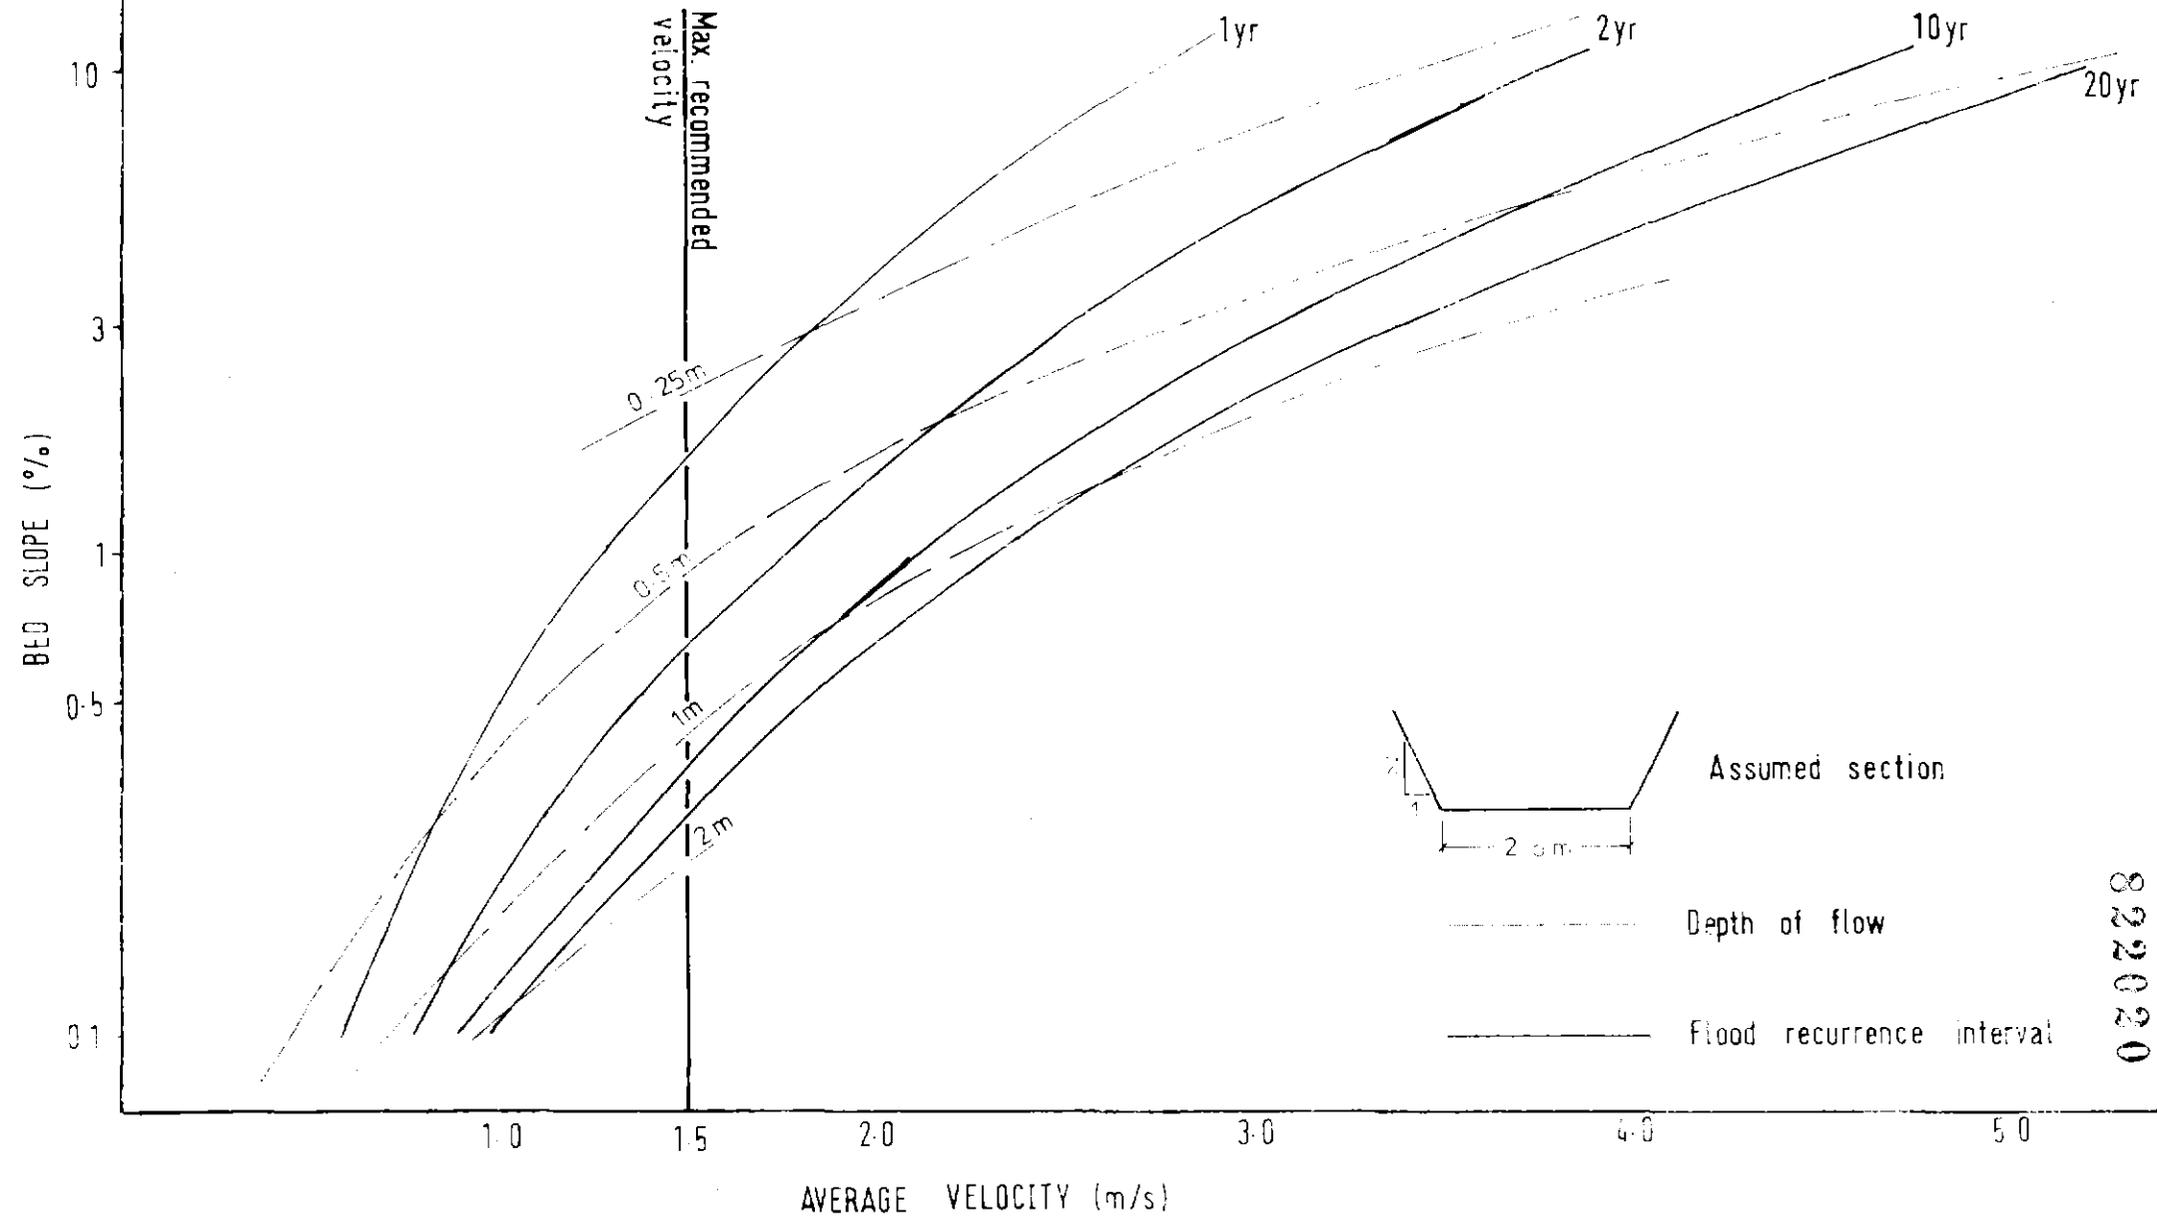
COMBINED DIVERSION CHANNEL Fig A1

Calculations upon the capacity of the new Diversion Channel for the combined Gilham and Bradshaw's Creeks, (Ref. Figures A1, A2 and A3 in the Appendix), have indicated that:

- * The portion of the channel with a bed slope of 10%, has streamflow velocities of approximately 4.0m/sec.
- * In those parts of the channel with a bed slope of 3%, streamflow velocities of approximately 2.5m/sec. can be expected.

It is established Engineering practice to limit flow velocity in earth channels of this type to a maximum value of 1.5m/sec, to reduce channel erosion to an acceptable level. Consequently, it is anticipated that severe erosion of both the channel bed and sides will occur in those section of the Diversion which have a grade of greater than 1% (water velocity approximately 1.5m/sec.).

It is also recommended that any new open channels should generally be constructed with trapezoidal sections having side slopes not exceeding $1\frac{1}{2}:1$ horizontal to vertical; also the invert of the drain should be excavated into the Tertiary Alluvial (hardpan) material where possible.

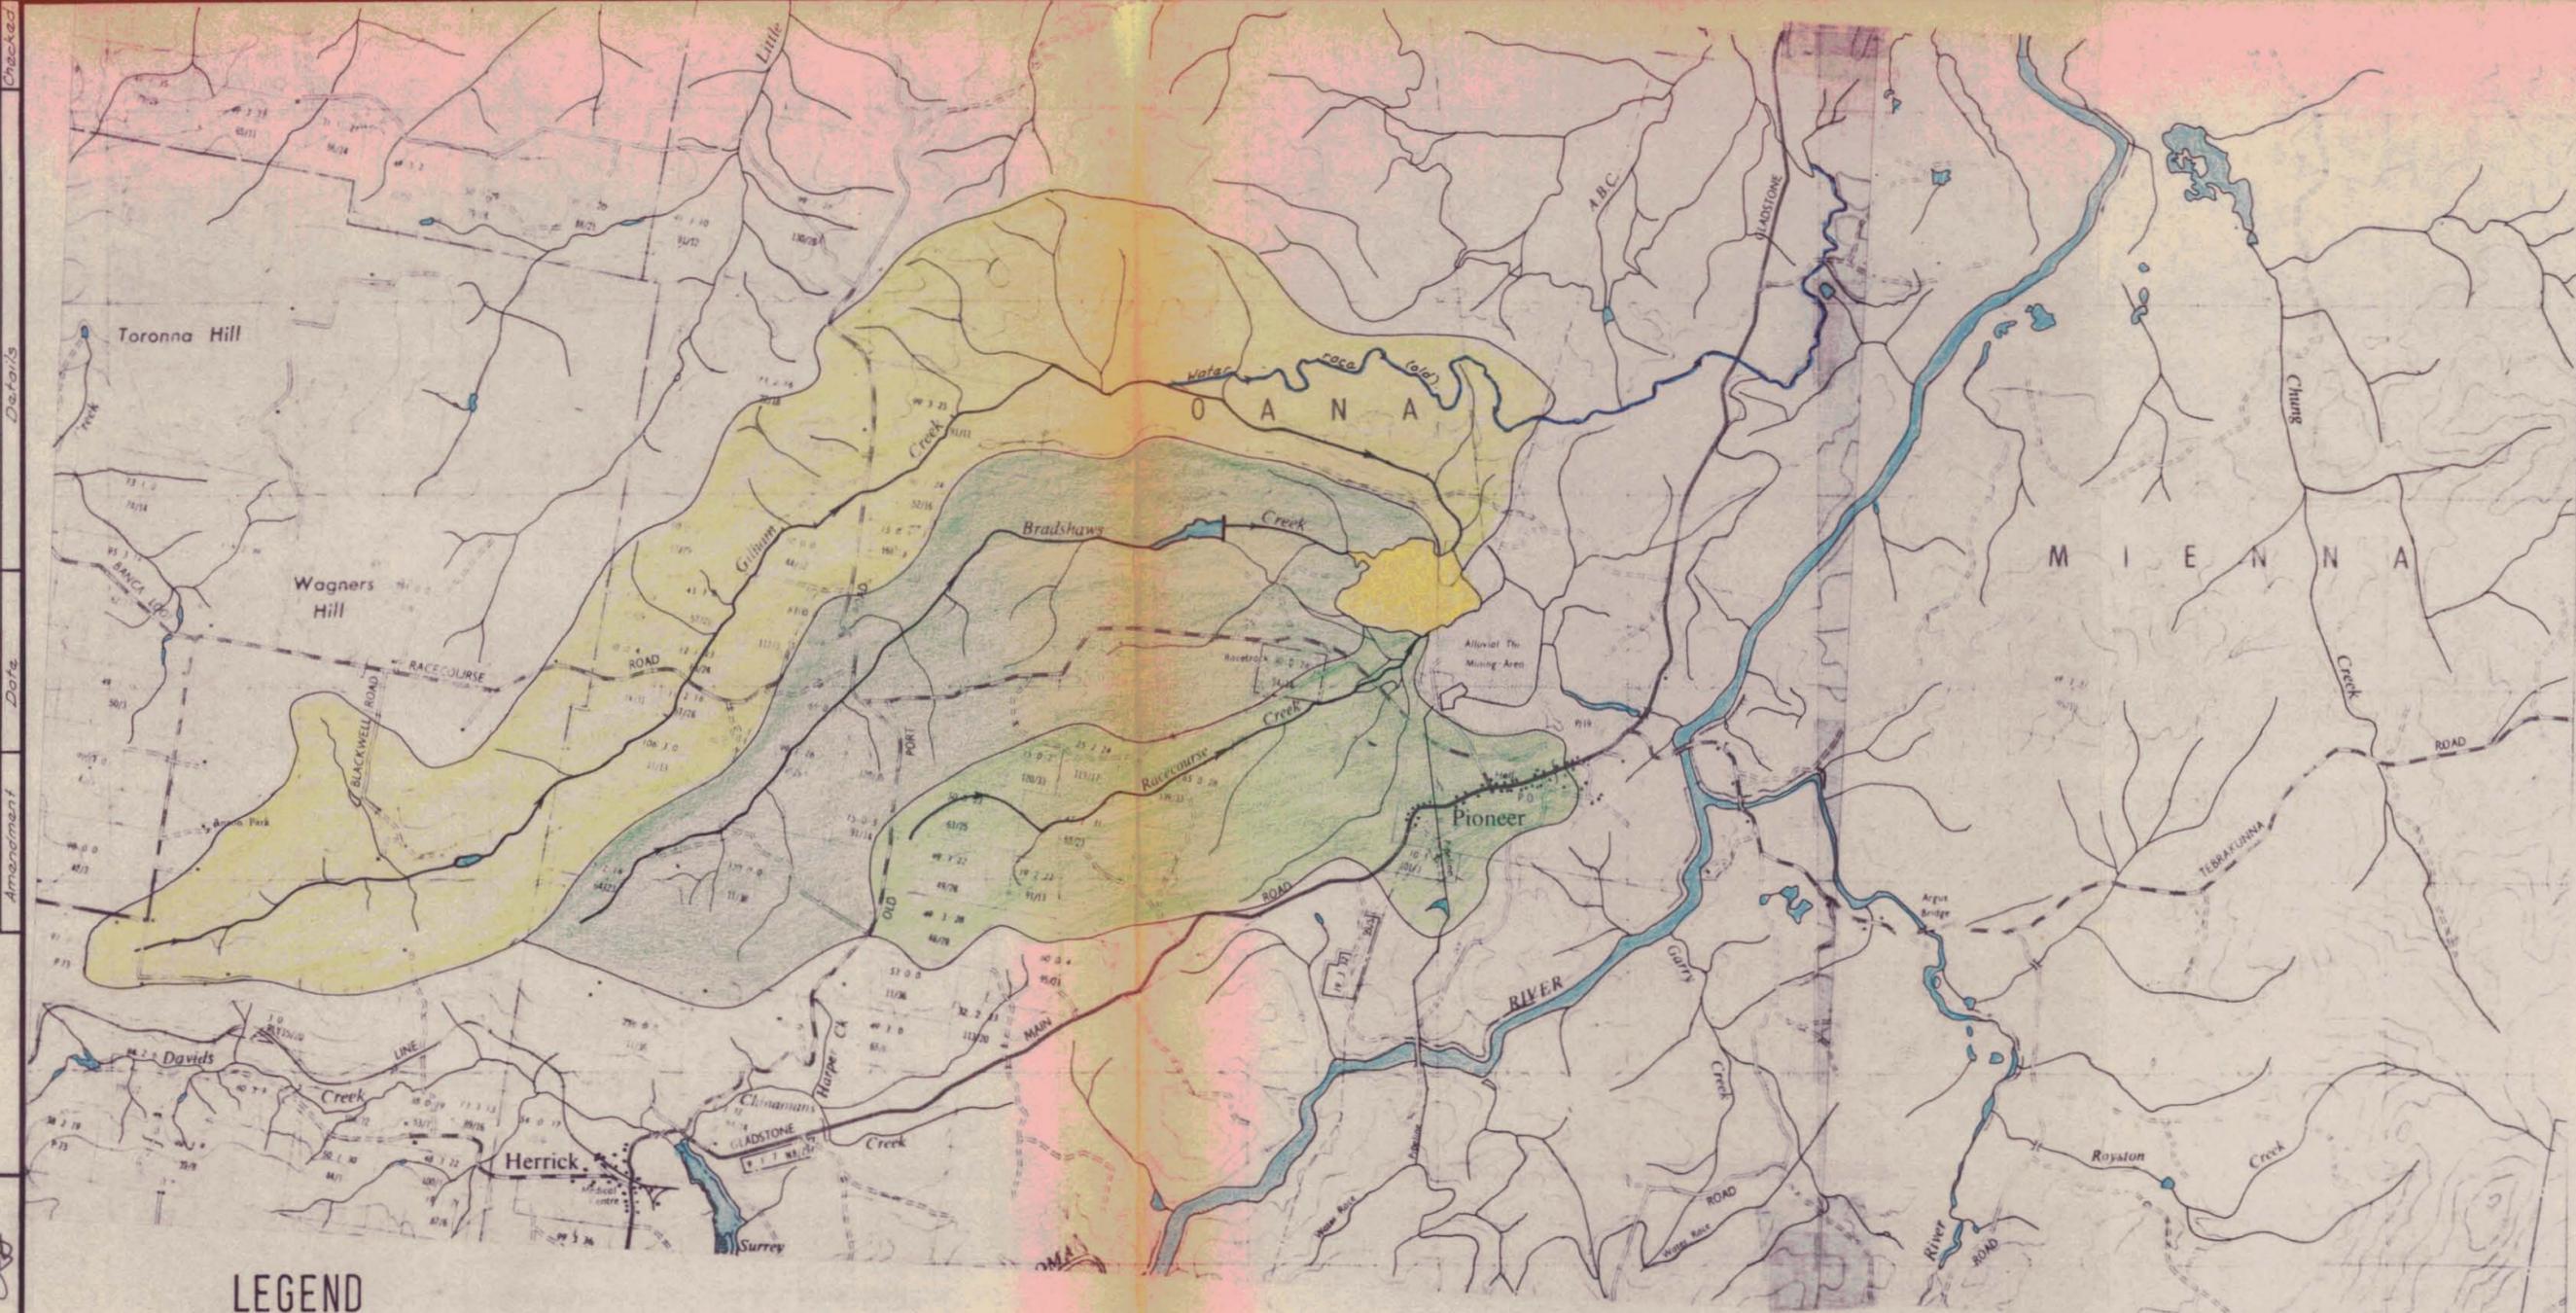
CATCHMENT AREAS & DRAINAGE	Scale
PIONEER TIN MINE TASMANIA	1: 13,680
AMDEX MINING Ltd	Drawing Number
	E-078 / G5

It is also to be noted that, the Pioneer Mine is located at the centroid of a substantial catchment area, into which three (3) creeks flow (viz. Racecourse Creek, Bradshaw's Creek and Gilham Creek). Reference to Drawing No. E-078/G5, will show how vulnerable the mine area is to flooding from these creeks; the plan also indicates the measures taken a number of years ago to prevent such flooding (ref. the 'Old Water Race' from Gilham Creek). It would appear that the reconstruction of such water races would materially reduce the vulnerability of the mine to stormwater flows, and flooding.
