R.L. 8810 MOINA TASMANIA - ANNUAL REPORT
for the period to 21.10.95

**R.L. 8810 SHEPHERD AND MURPHY MINE
MINE WORKINGS HAZARD AUDIT.**

By L.A. Newnham

26 August 1995

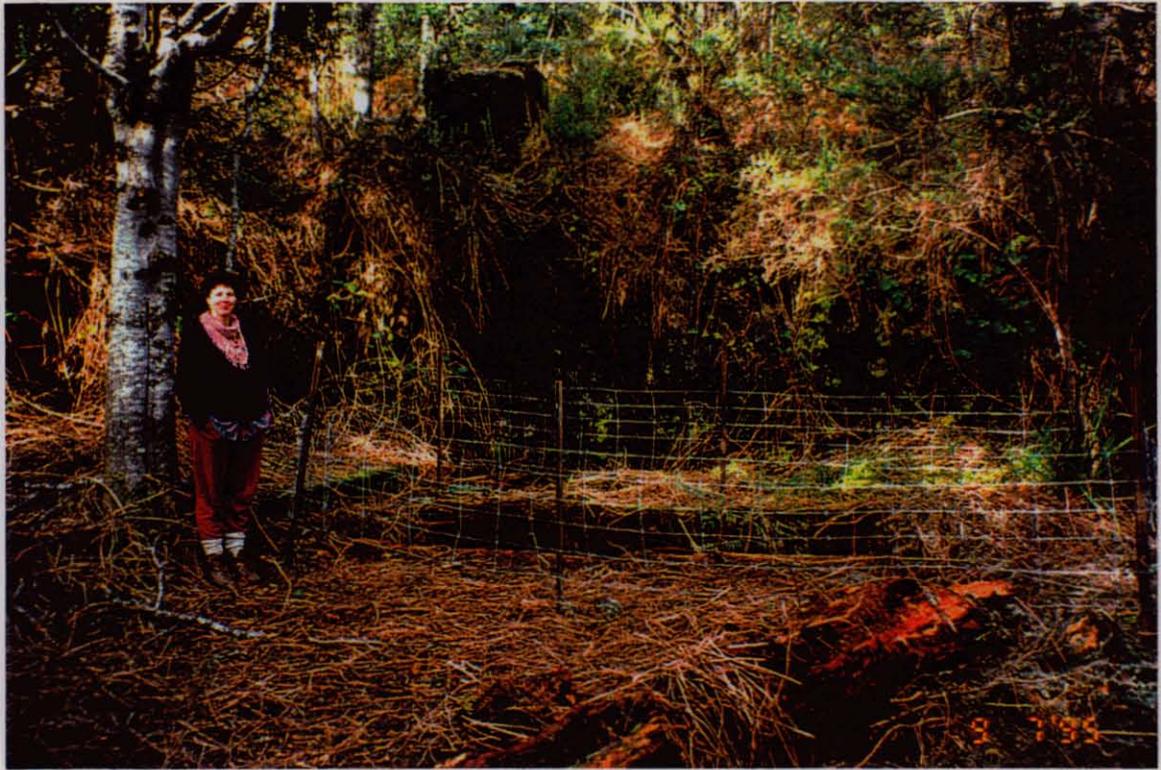
The **Main Shaft** is accessible and open (photos). It measures approximately 3000 x 1500 mm and is currently surrounded by a flimsy mesh wire fence. It was sunk on the No. 6 lode and stoping appears to have taken place right up to the brace.

Main Shaft - readily accessed and poorly fenced

This shaft is considered dangerous and a safety risk. It is recommended that it be capped with a large, heavy steel grate with mesh welded on top.

The area should then be fenced with barbed wire, with appropriate mine working warning signs attached. The fence should enclose the open stope (?) adjacent to the brace.

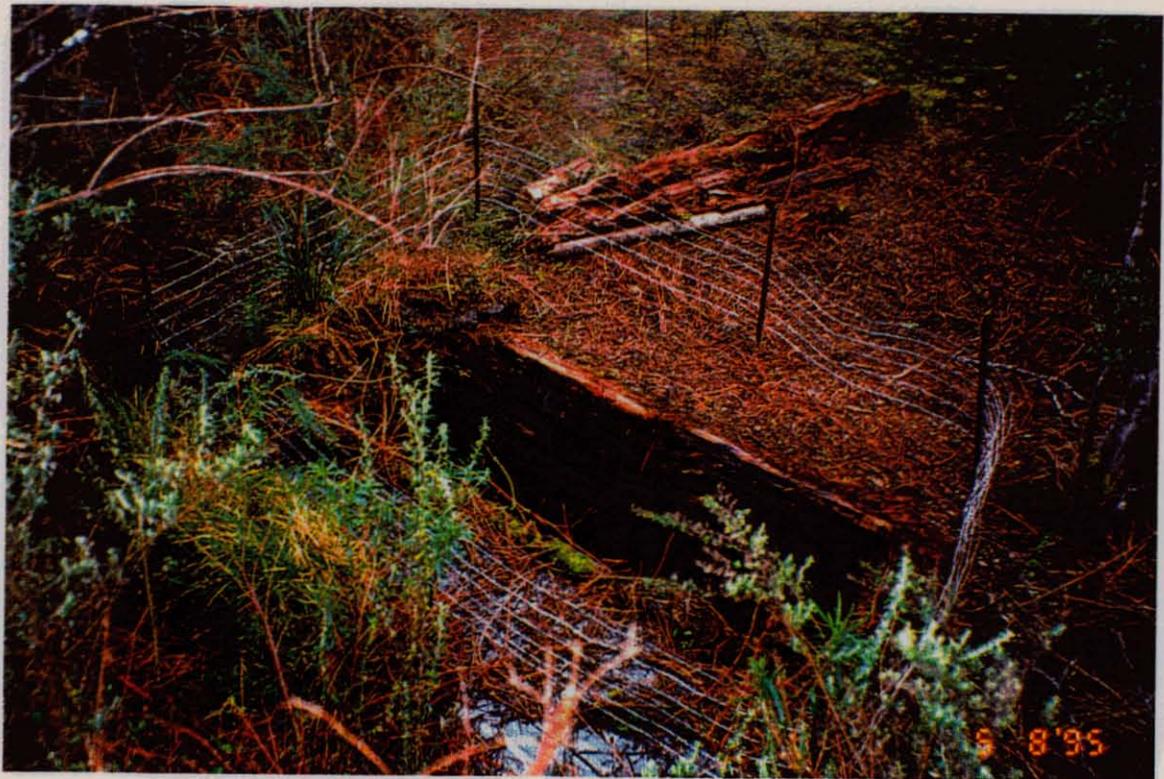
Main Shaft - open and considered dangerous

This shaft is considered dangerous and represents a significant safety risk.

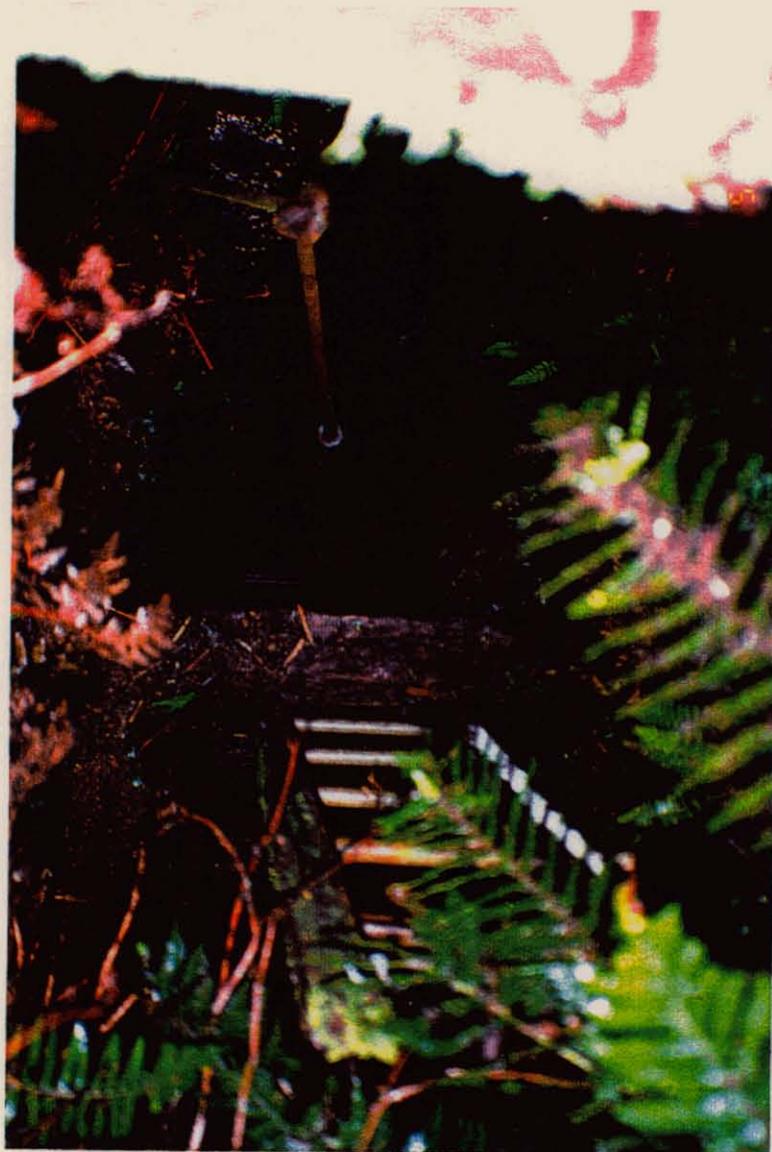
The **No. 5 Vent Shaft** (photos) is a small shaft, difficult to locate but lies in relatively open fern covered country. (This writer nearly fell down it!)

It is largely overgrown with water standing at about 10 metres. A steel rung ladder is installed in the shaft to surface thereby making it tempting and dangerous to visitors.

**Water filled shaft on No 5 Lode
with ladders in shaft -
accessible but largely concealed**

A steel grate made of heavy channel or railway iron with mesh welded on top should be placed over this shaft and a barb wire fence with appropriate signs erected around it.

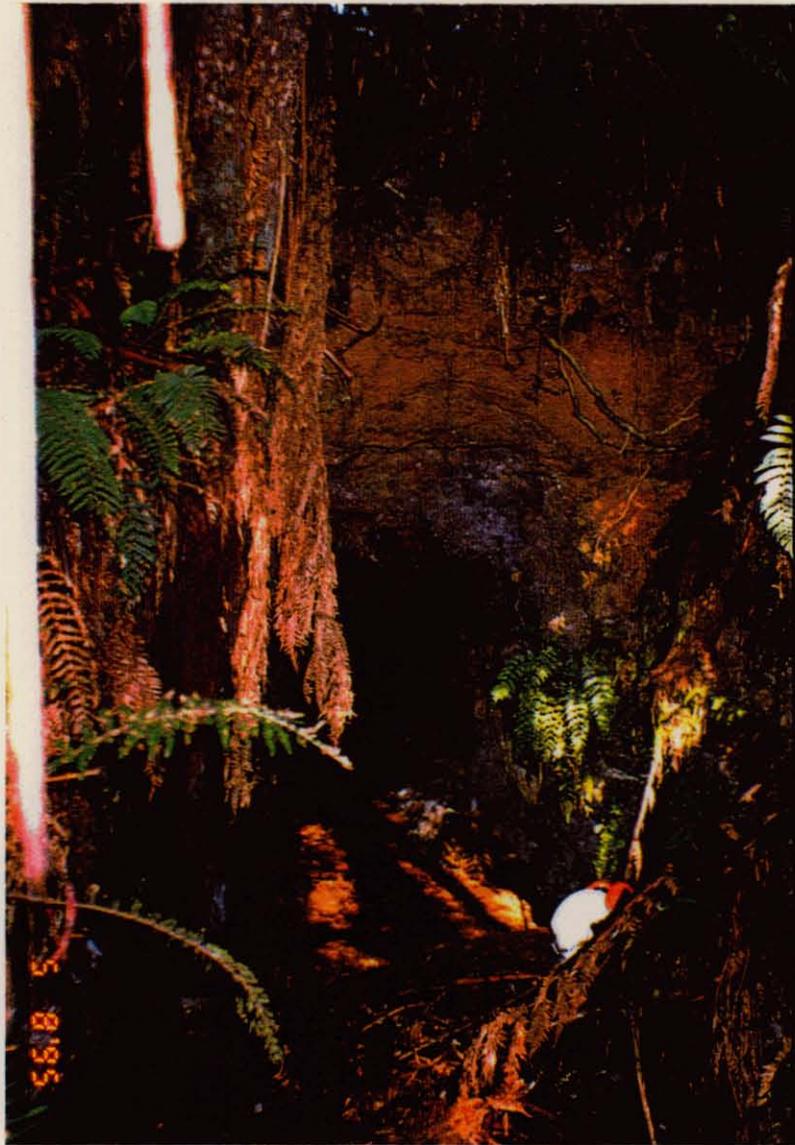
No 1 Adit

Driven south to intersect eastern end of No's. 2, 4 and 5 lodes. Difficult to locate above the main access road (walking track). Portal is open with some standing water. Adit is considered hazardous for entry by unskilled persons.

Short of blocking the adit with soil and rock, it would be difficult to prevent access. Fences are not particularly successful. To place a grid or gate over the portal would require reopening the access road to an excavator.

Recommended that an appropriate warning sign be placed at the portal:

<p>WARNING Old Mine Tunnel Because of unknown ground conditions and air quality, access to this tunnel is considered dangerous. DO NOT ENTER</p>

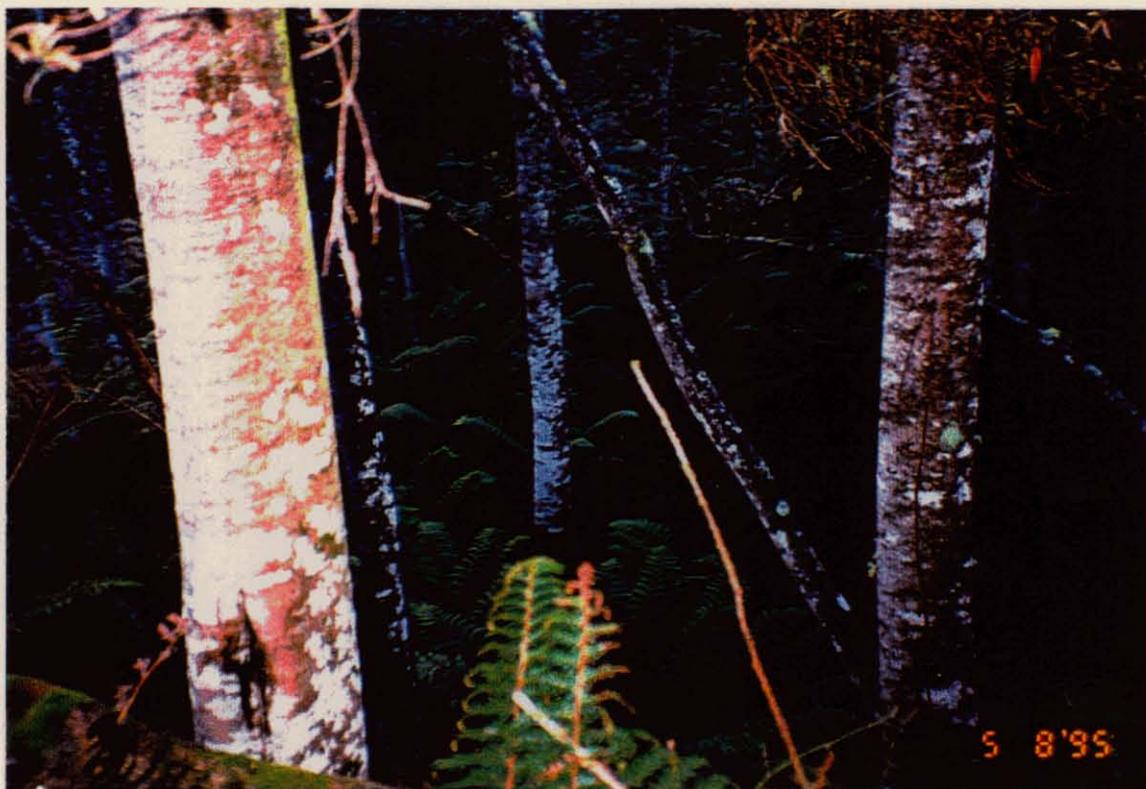
Open cut on No 6 Lode east of Main Shaft - heavily overgrown

This is an excavation which appears to be a combination of shallow alluvial workings and a portal cut for No. 2 adit. There are no benches as such and whilst the sides are steep, they are not regarded as more hazardous than a natural steep gully.

Recommended that no action be taken.

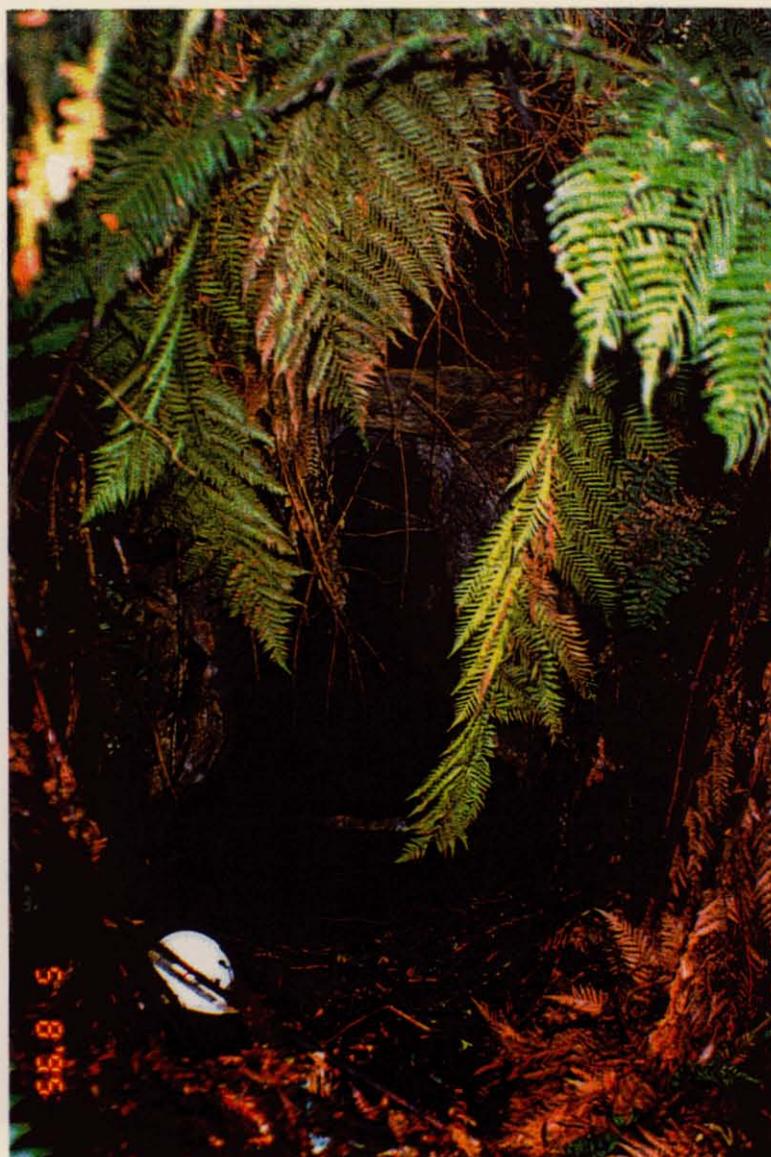
This adit was driven west along No. 6 lode from the bottom of a small overgrown open cut. The adit is relatively difficult to locate and the same comments and recommendations as for No. 1 adit apply.

**No 2 Adit - driven
from end of open
cut onto No 6 Lode**

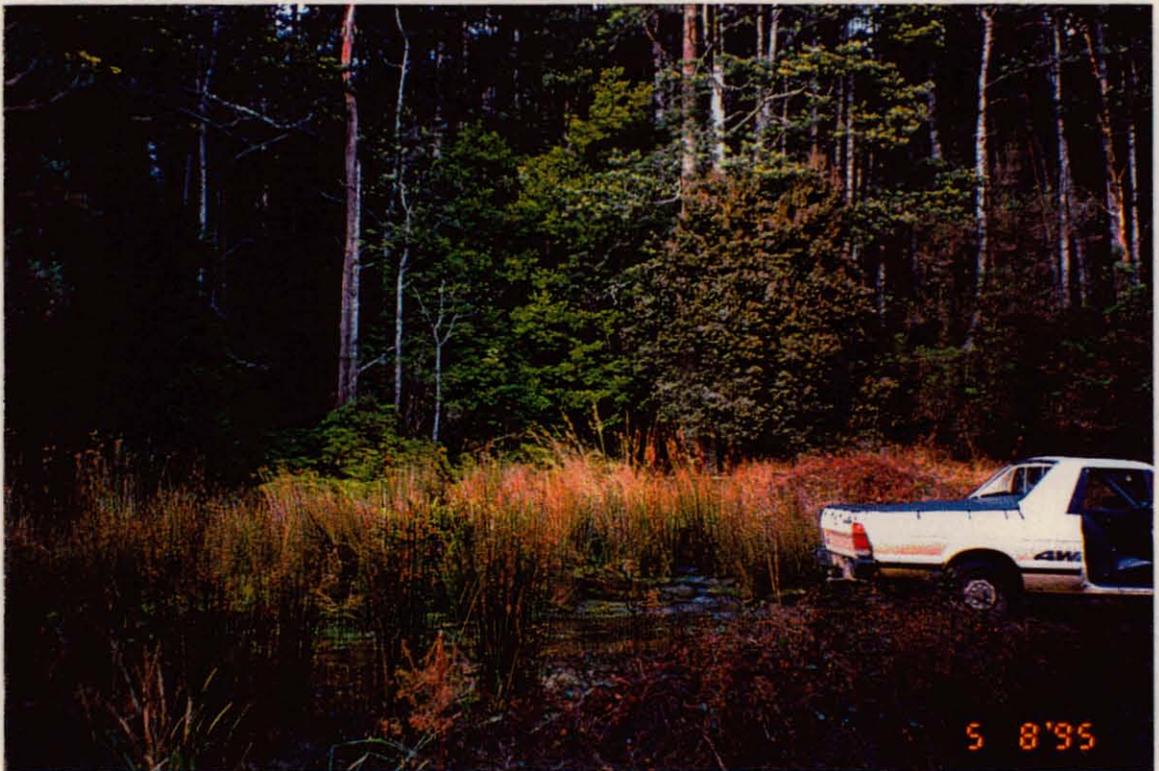
It is considered dangerous, firstly because it is very accessible being adjacent to the main vehicular access track, and secondly because of its rather peculiar portal construction, whereby a second shallow adit appears to have been driven above the main lower adit which contains deep water.

Entrance area to No 3 Adit - readily accessible

Recommended that this adit should be fenced with barbed wire and signs attached.

It may also be prudent to square up the portal of this adit with an excavator and place a vertical steel grid/mesh panel over the entrance.

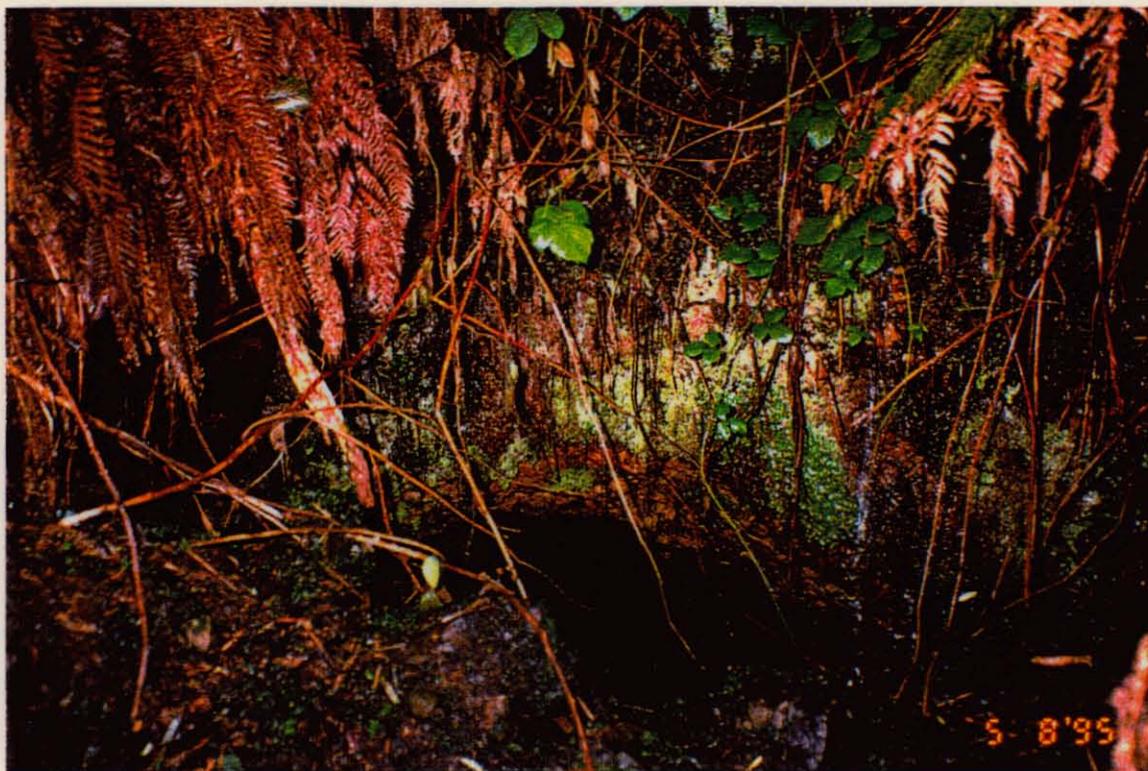
Goodwins Adit - portal largely collapsed

Short adit driven to explore for new lodes north of No. 6 lode. Portal now collapsed. Moderately difficult to locate and access. This adit is not considered particularly dangerous and no action is recommended.

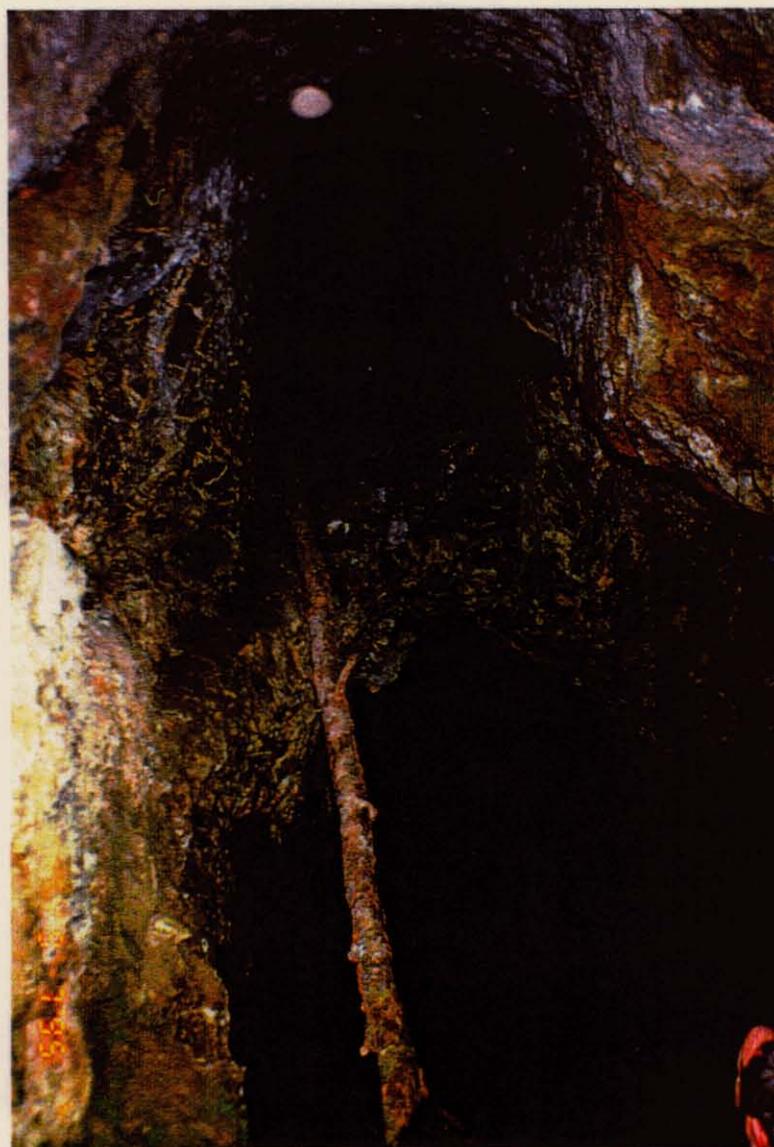
**No 3 Adit -
two adits,
one above
the other
very
accessible**

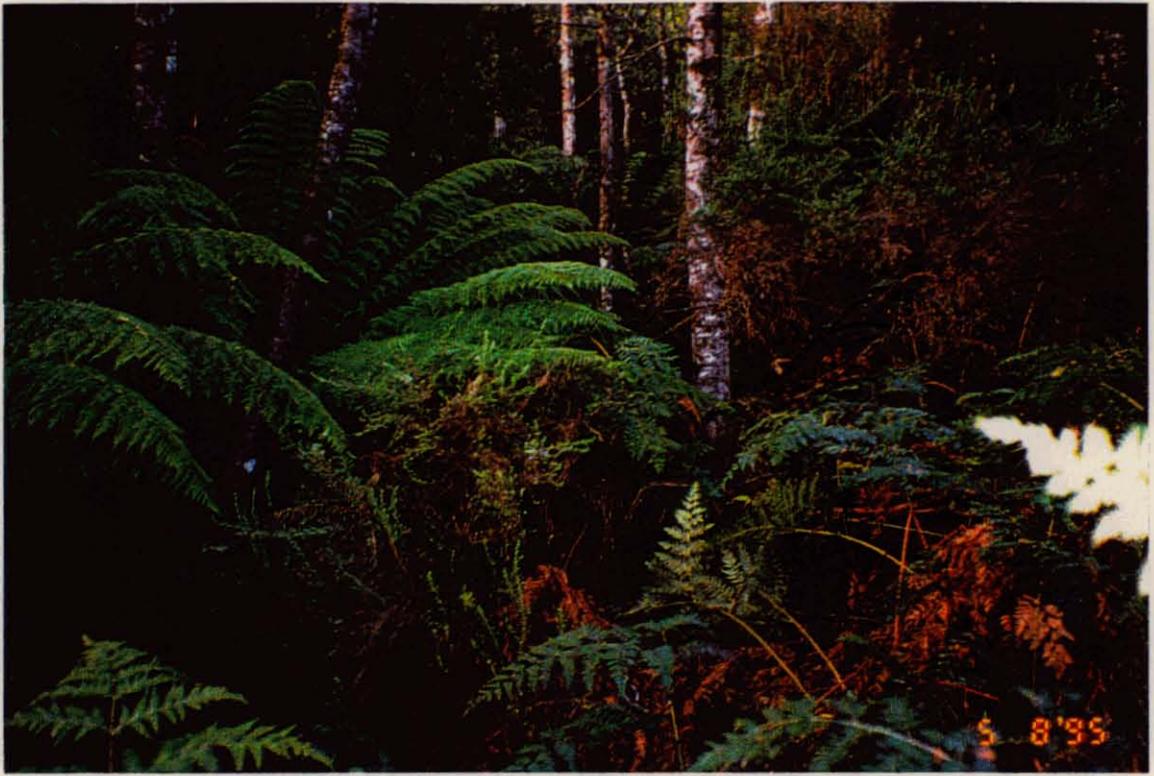
This adit was driven west along No. 4 lode. The portal lies on the banks of Bismuth Creek and it is very difficult to access and locate.

Any significant work here would diminish its inaccessibility and would probably impact on the creek.

No 4 Creek Drive Portal - behind ferns Adit is well concealed and difficult to access.

Recommended that a sign be erected near the portal as for No. 1 adit.

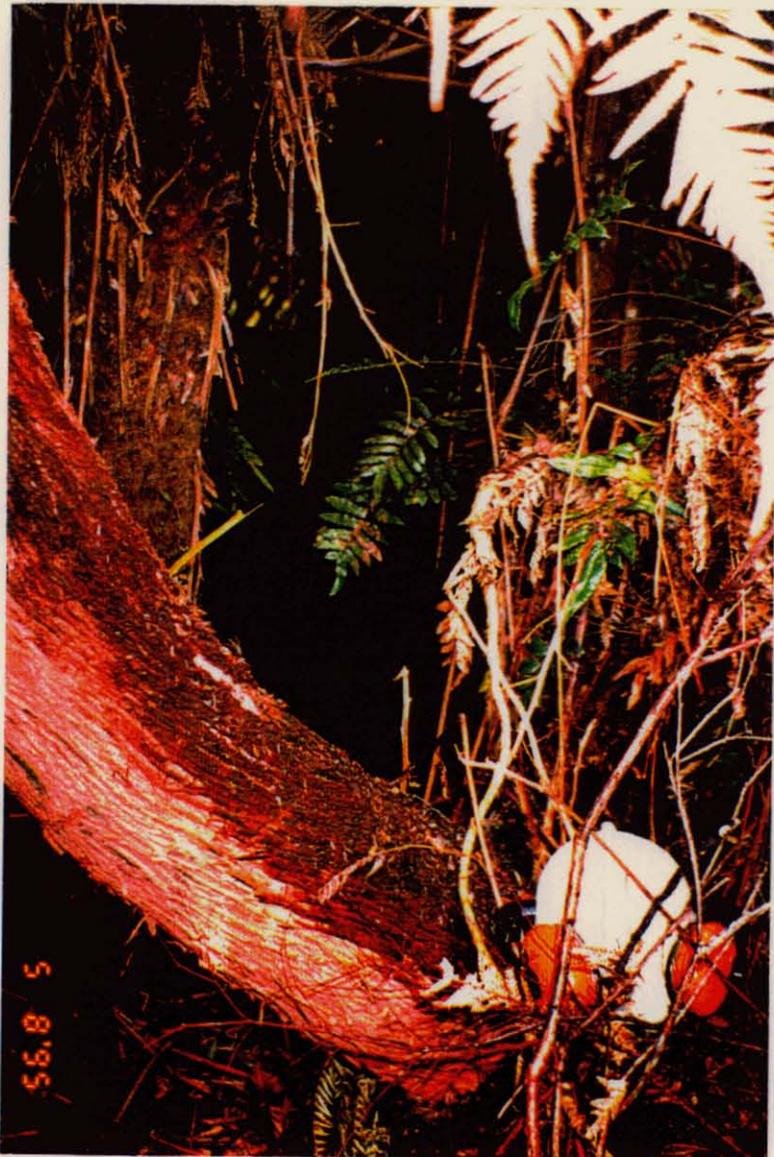
No 4 Creek Drive Portal is open

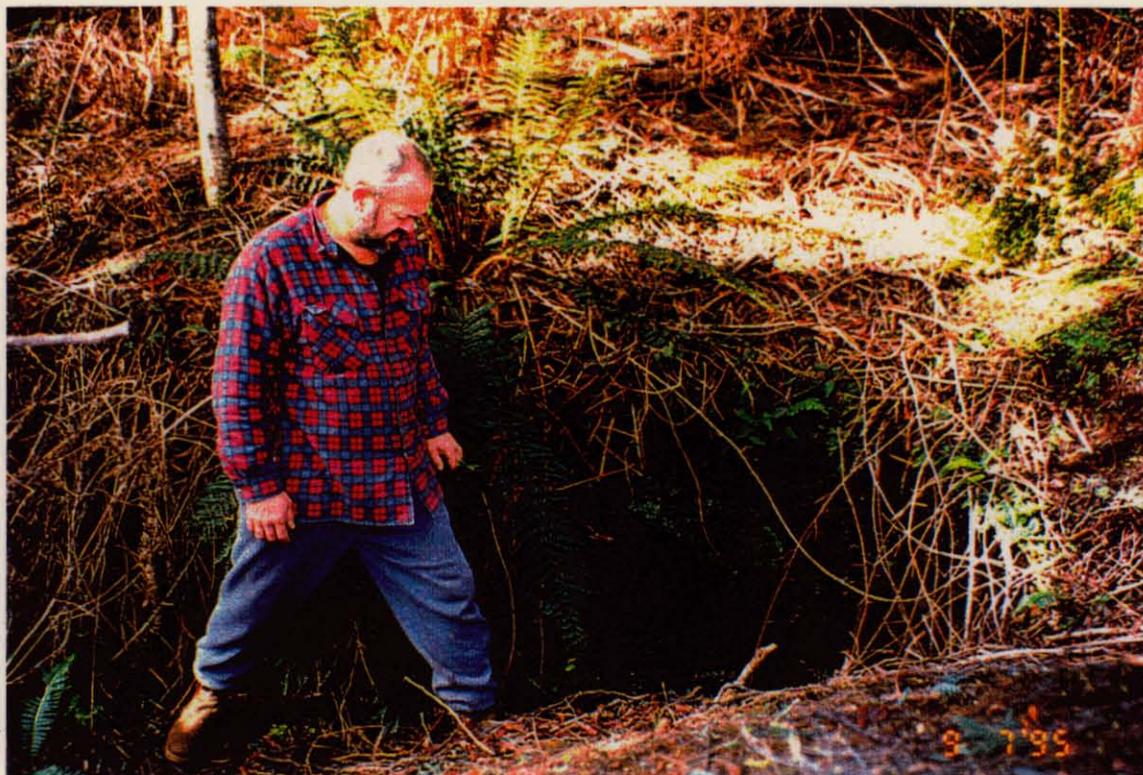
These appear to be mainly developed between the Main Shaft and No. 2 adit open cut area. As such, they are reasonably accessible and easy to locate. They are considered dangerous and a safety hazard.

However, to attempt to fill them would be quite difficult and would result in considerable local disturbance of the bush.

No 6 Lode open stope (?) adjacent to Main Shaft

Recommended the open stope area be fenced off and sign posted and a general warning sign be erected.

Some filling with an excavator should be considered. ?

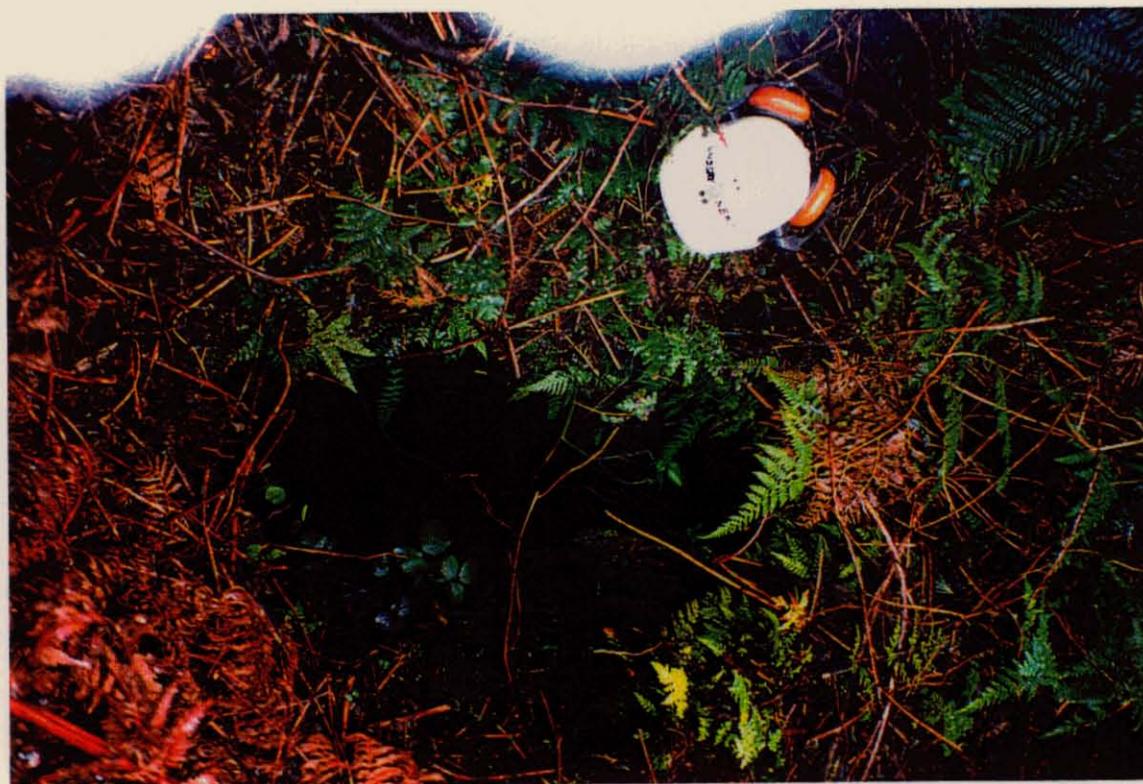
**No 6 Lode open stope east of Main Shaft
Accessible and considered dangerous**

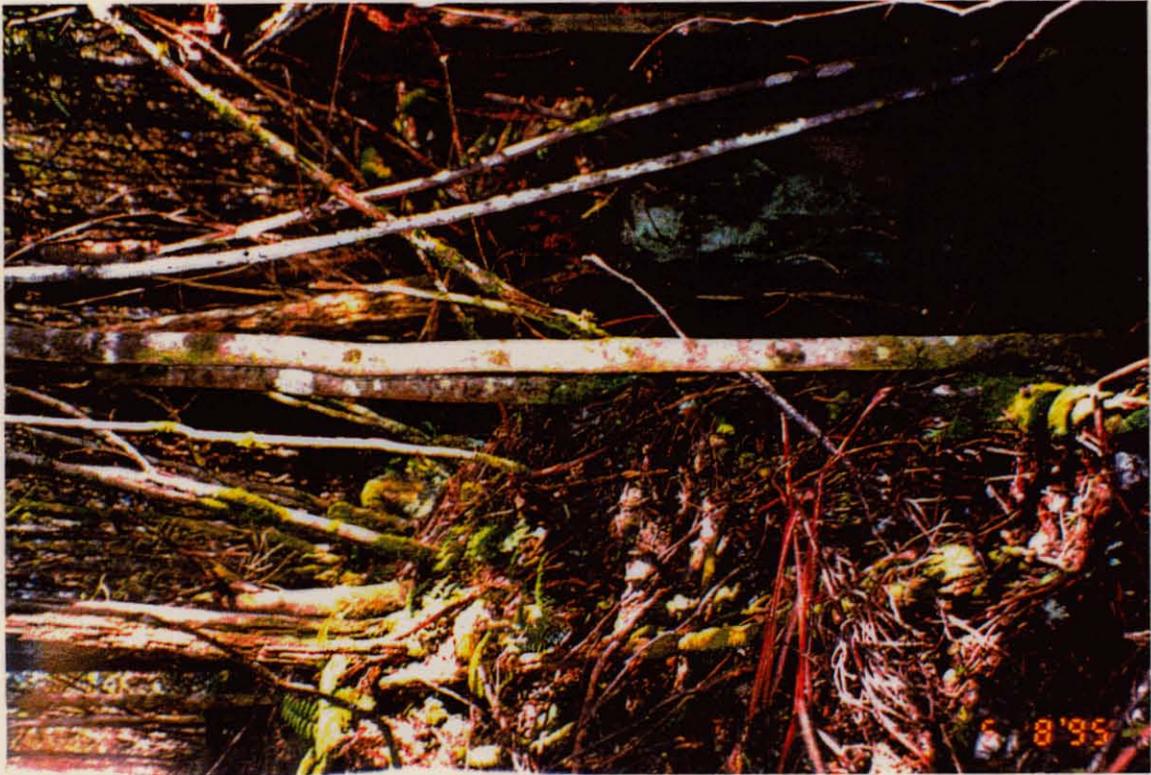
These are located on the side of a timbered hill south of the main access track, which can now only be accessed, with difficulty, on foot.

Open Slope - eastern end of No 4 lode

Recommended that a sign, similar to those erected in July near the main access, be erected on the access track.

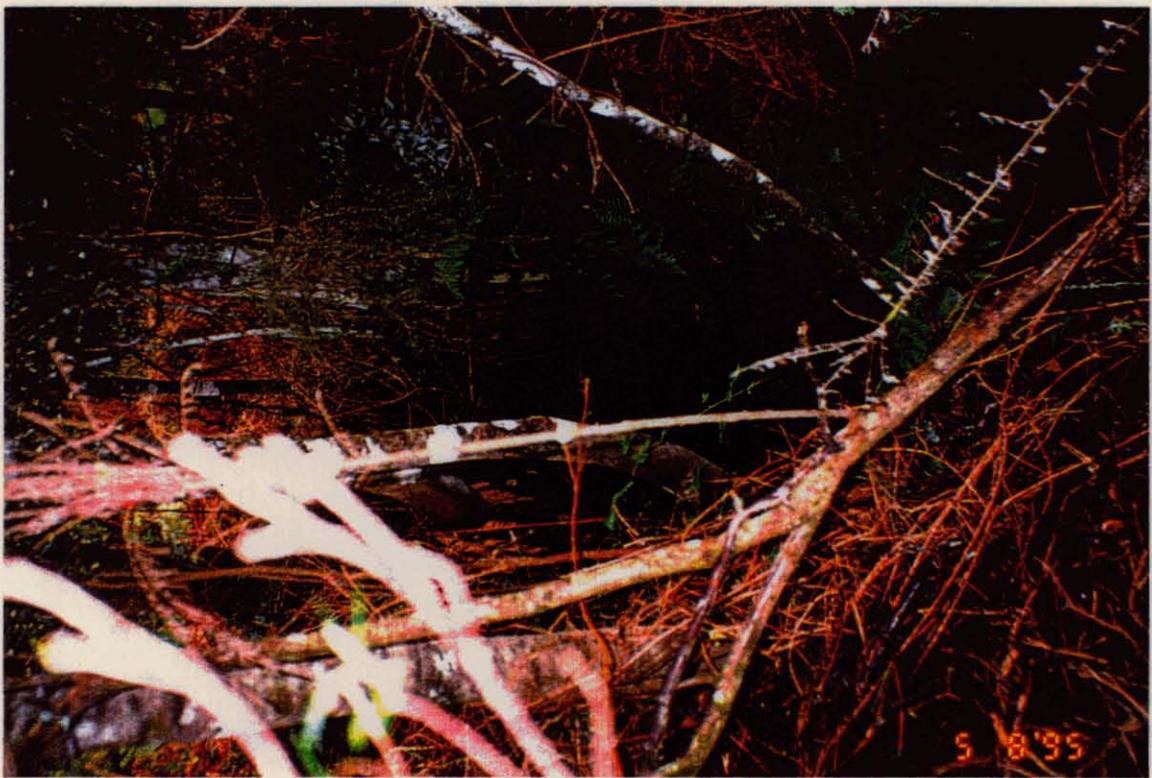
Narrow open Slope - eastern end of No 2 (?) lode

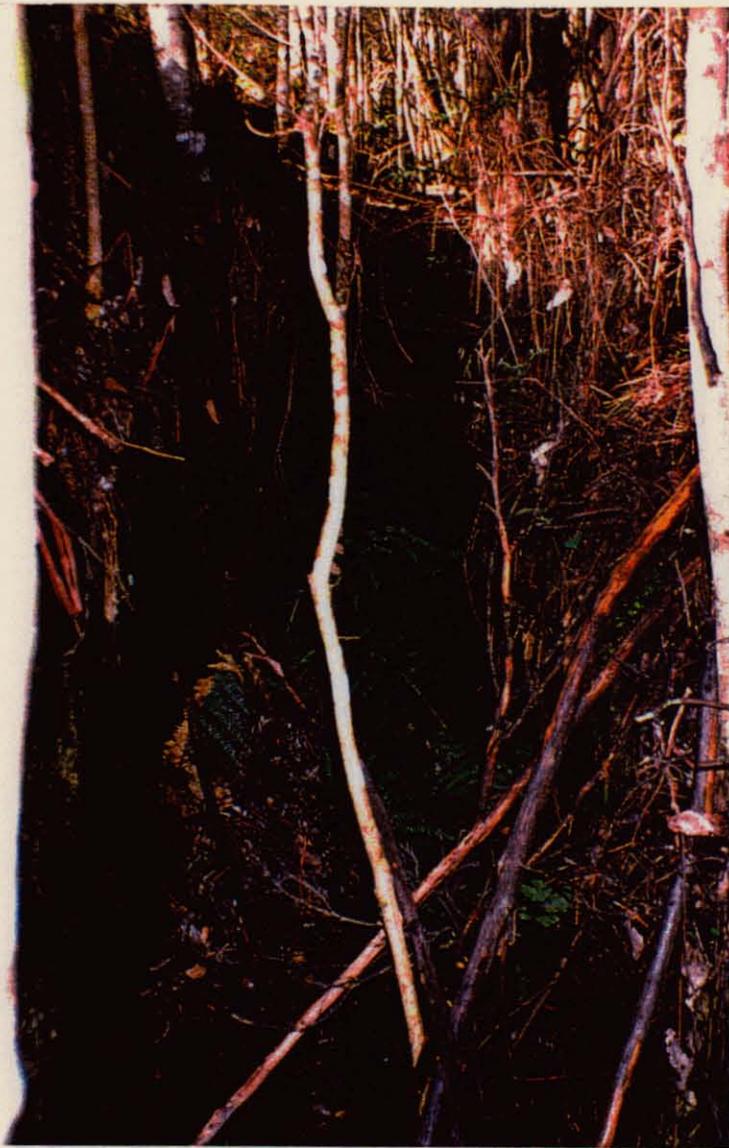
Adit driven into sub basaltic lead adjacent to alluvial workings. Moderately difficult to locate and access.

**Unnamed Adit in
sub-basaltic drift
open cut**

Recommended it be sign posted as with No. 1 adit.

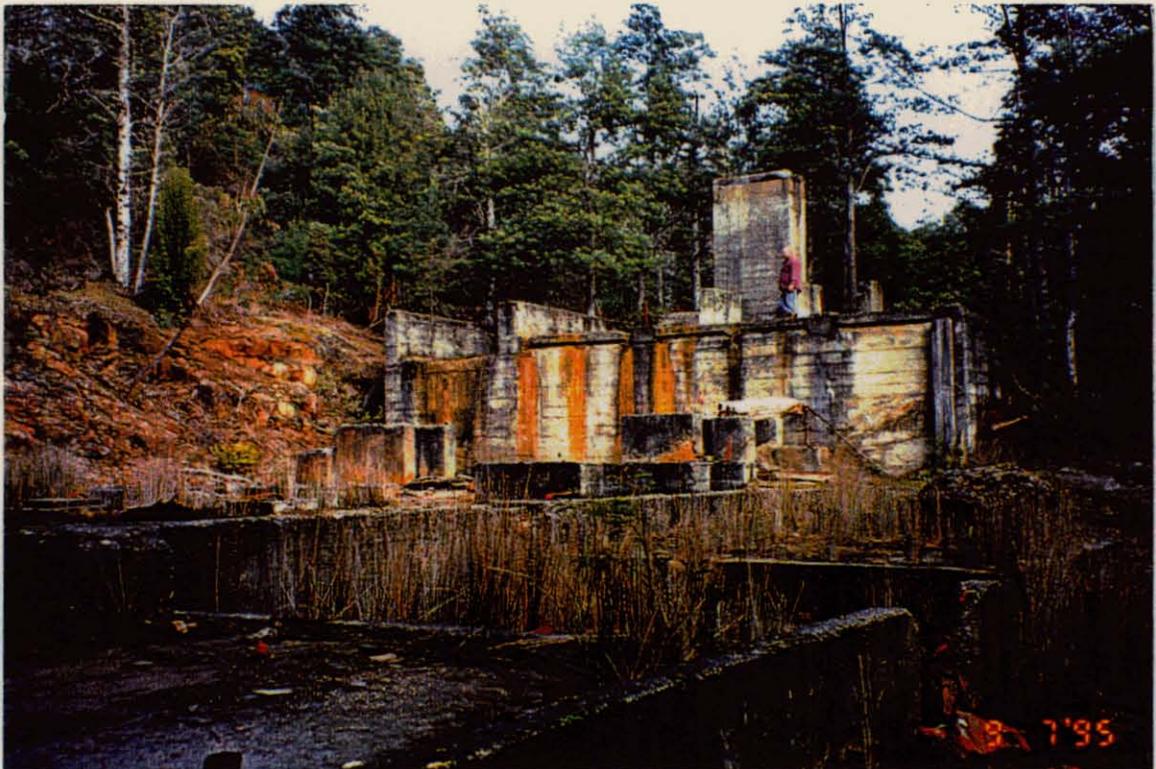
All that remains of the mill are the large concrete foundations. No buildings as such exist. These foundations are structurally stable but represent a hazard to anyone who might be climbing on them and fall. They are very easy to find and are vehicular accessible.

Treatment Plant remains - very accessible

Recommended that two warning signs be erected on the site:

<p>WARNING</p> <p>Old Mill Foundations</p> <p>Caution should be shown by any person climbing on these foundations.</p>
--

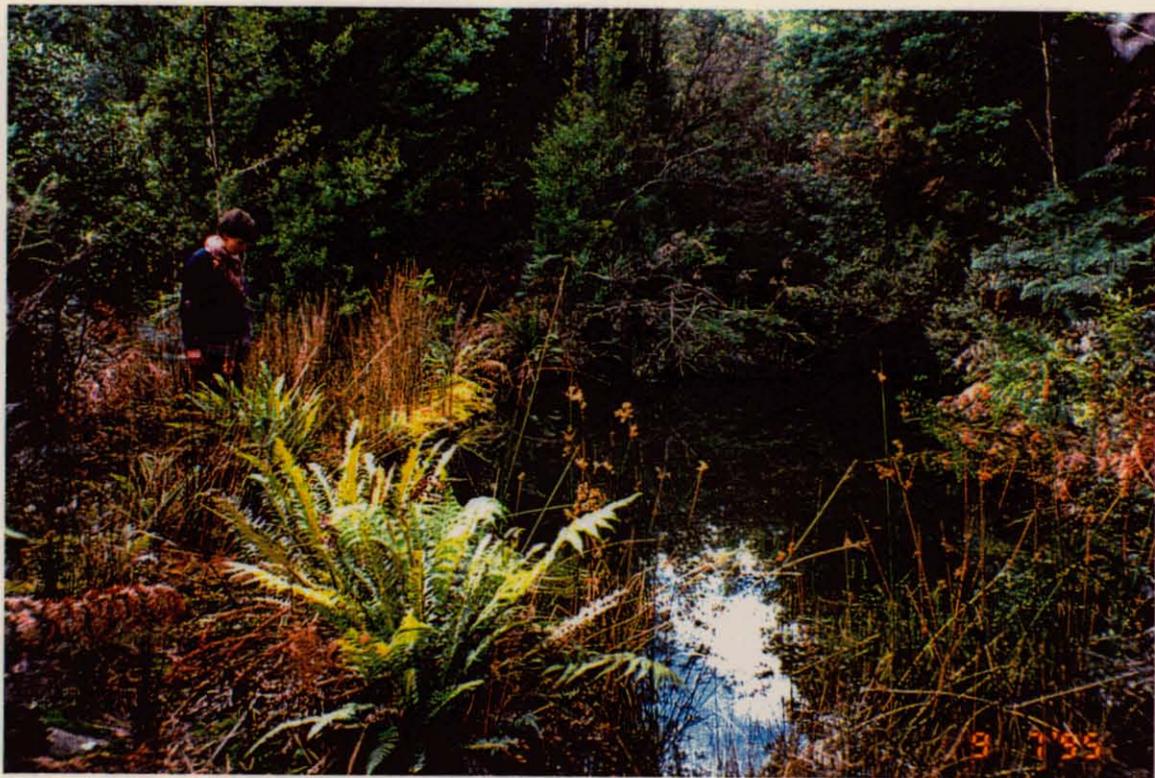
- ◆ Two other small dams exist, one to the immediate south, and one to the immediate east of the Main Shaft. They are very small, have low banks and probably not deep. They are accessible but not regarded as particularly hazardous.

Small dam east of Main Shaft

Recommended no action be taken.

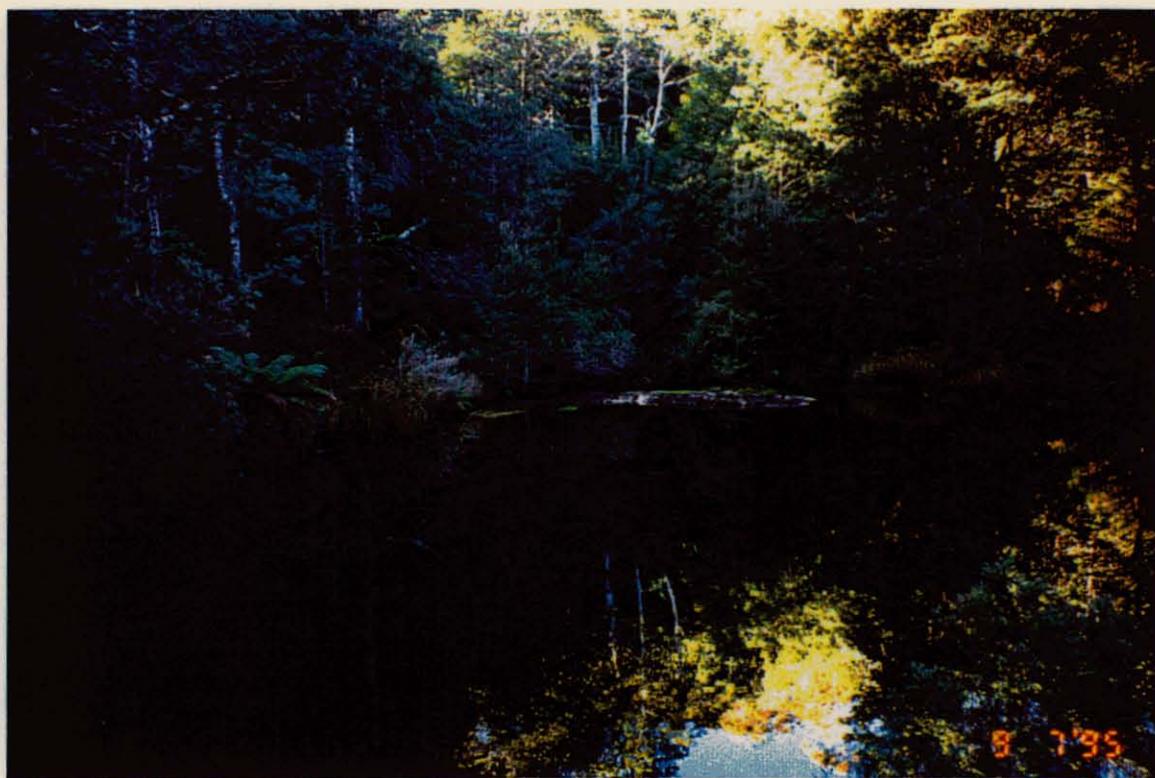
The dam is not particularly easy to find and is not frequented by casual visitors. It is not considered to be any more hazardous than other well constructed small dams.

Main water supply dam on Bismuth Creek

Recommended no action be taken.

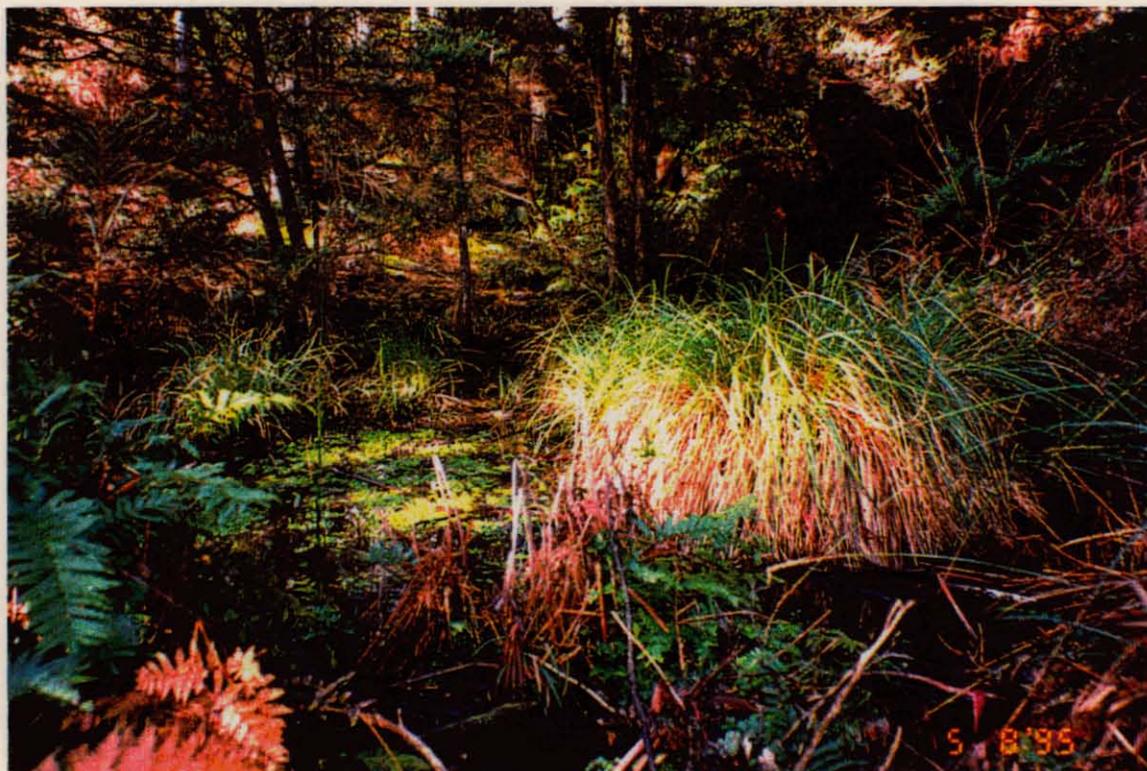
Small dam south of Main Shaft

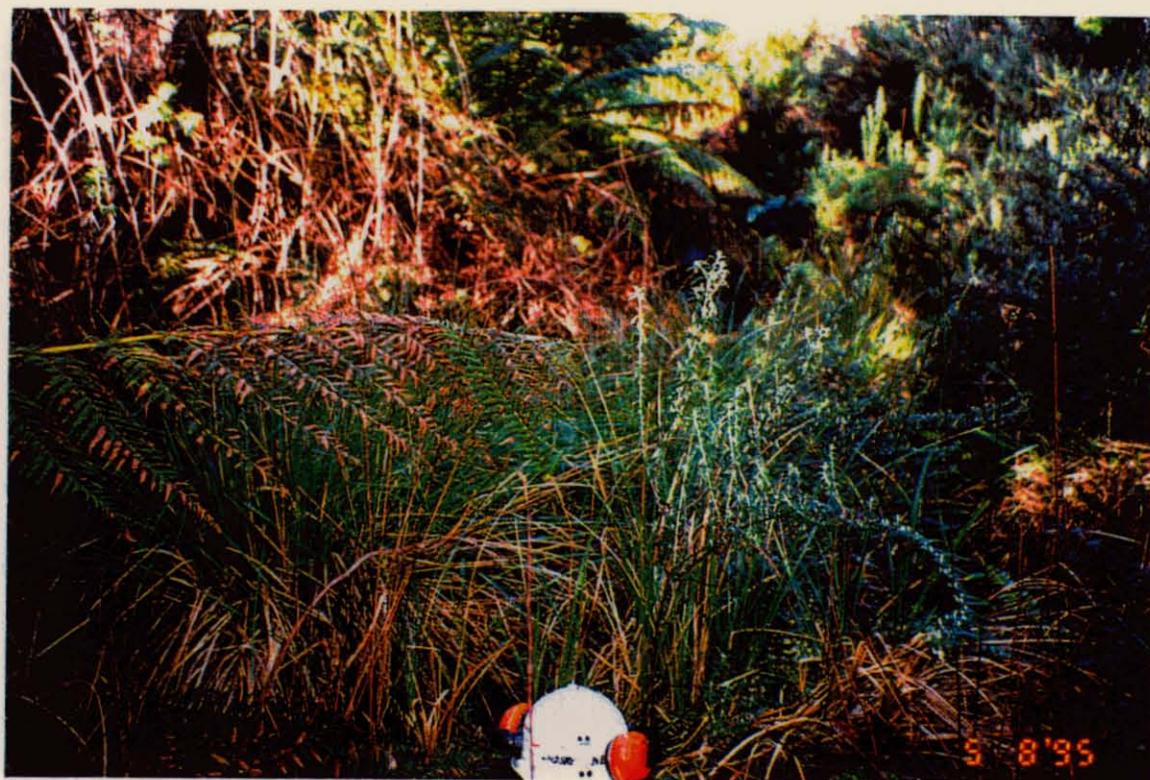
**Small dam southeast of Main Shaft -
inaccessible and not considered hazardous**
