SHEPHERD & MURPHY MINE

MINE WORKINGS HAZARD AUDIT

Prepared for:

26 August 1995

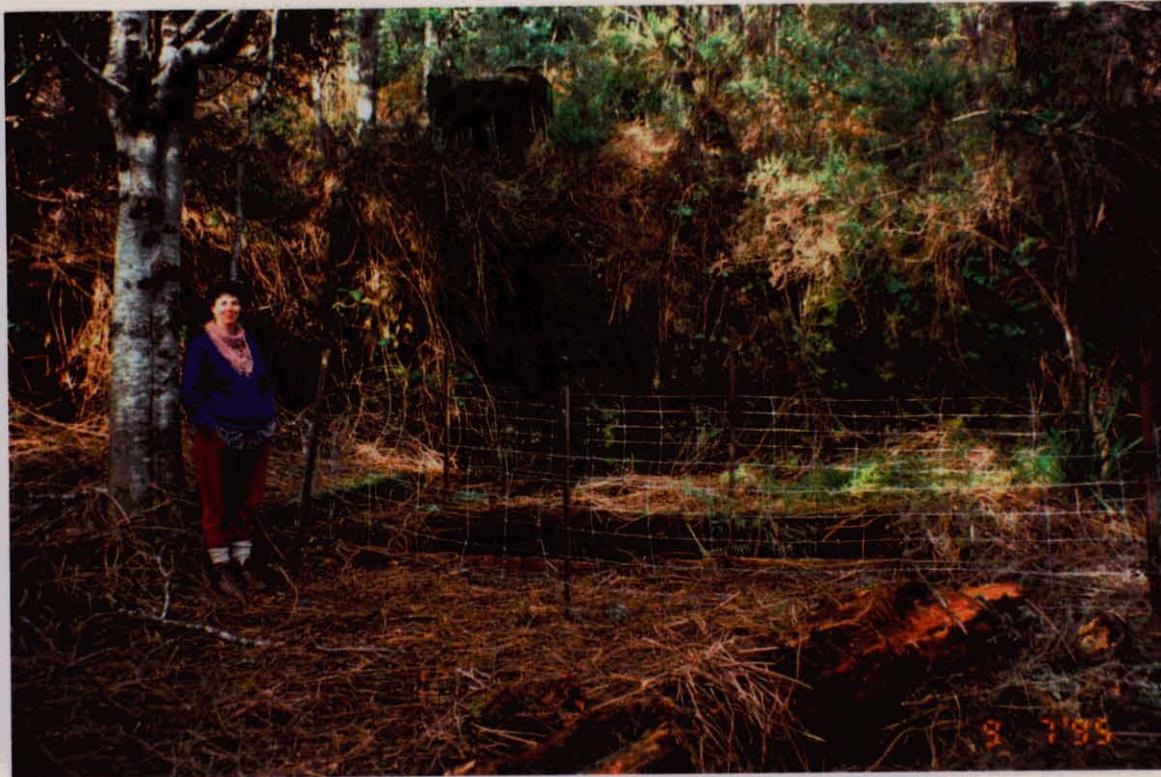
The **Main Shaft** is accessible and open (photos). It measures approximately 3000 x 1500 mm and is currently surrounded by a flimsy mesh wire fence. It was sunk on the No. 6 lode and stoping appears to have taken place right up to the brace.

Main Shaft - readily accessed and poorly fenced

This shaft is considered dangerous and a safety risk. It is recommended that it be capped with a large, heavy steel grate with mesh welded on top.

The area should then be fenced with barbed wire, with appropriate mine working warning signs attached. The fence should enclose the open stope (?) adjacent to the brace.

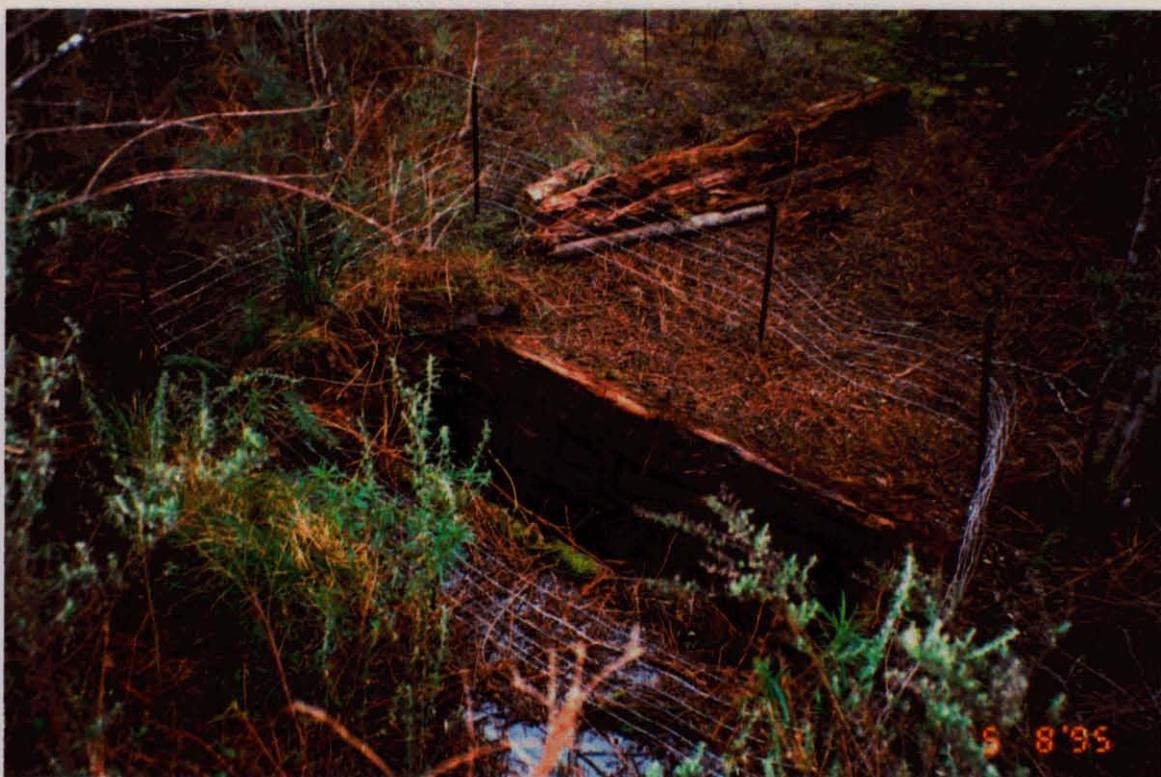
Main Shaft - open and considered dangerous

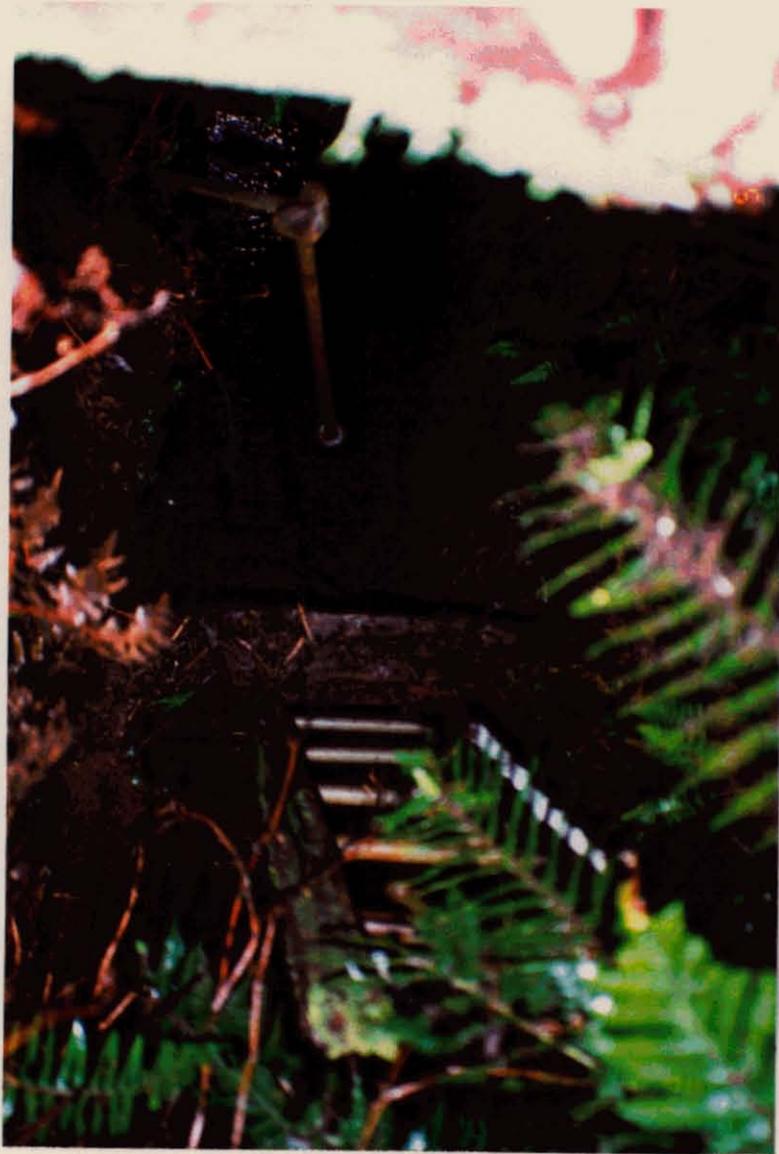
The **No. 5 Vent Shaft** (photos) is a small shaft, difficult to locate but lies in relatively open fern covered country. (This writer nearly fell down it!)

It is largely overgrown with water standing at about 10 metres. A steel rung ladder is installed in the shaft to surface thereby making it tempting and dangerous to visitors.

This shaft is considered dangerous and represents a significant safety risk.

**Water filled shaft on No 5 Lode
with ladders in shaft -
accessible but largely concealed**

A steel grate made of heavy channel or railway iron with mesh welded on top should be placed over this shaft and a barb wire fence with appropriate signs erected around it.

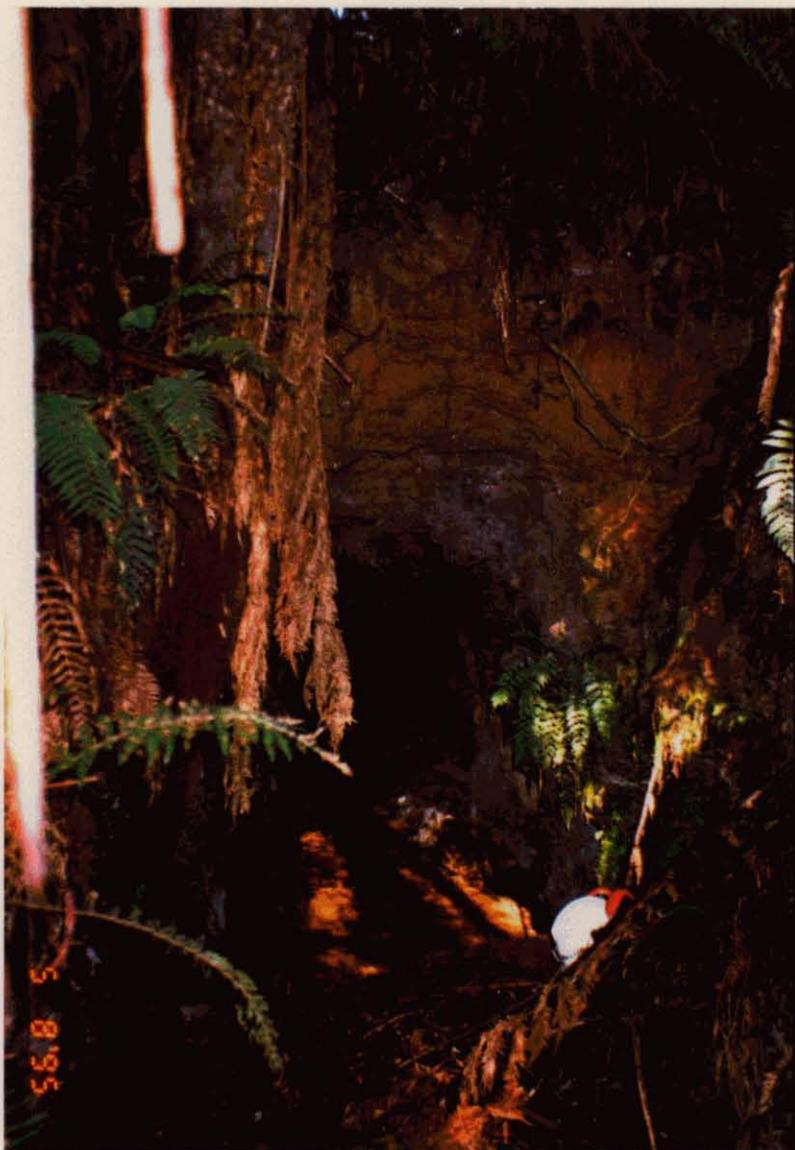
No 1 Adit

Driven south to intersect eastern end of No's. 2, 4 and 5 lodes. Difficult to locate above the main access road (walking track). Portal is open with some standing water. Adit is considered hazardous for entry by unskilled persons.

Short of blocking the adit with soil and rock, it would be difficult to prevent access. Fences are not particularly successful. To place a grid or gate over the portal would require reopening the access road to an excavator.

Recommended that an appropriate warning sign be placed at the portal:

<p style="text-align: center;">WARNING Old Mine Tunnel Because of unknown ground conditions and air quality, access to this tunnel is considered dangerous. DO NOT ENTER</p>
--

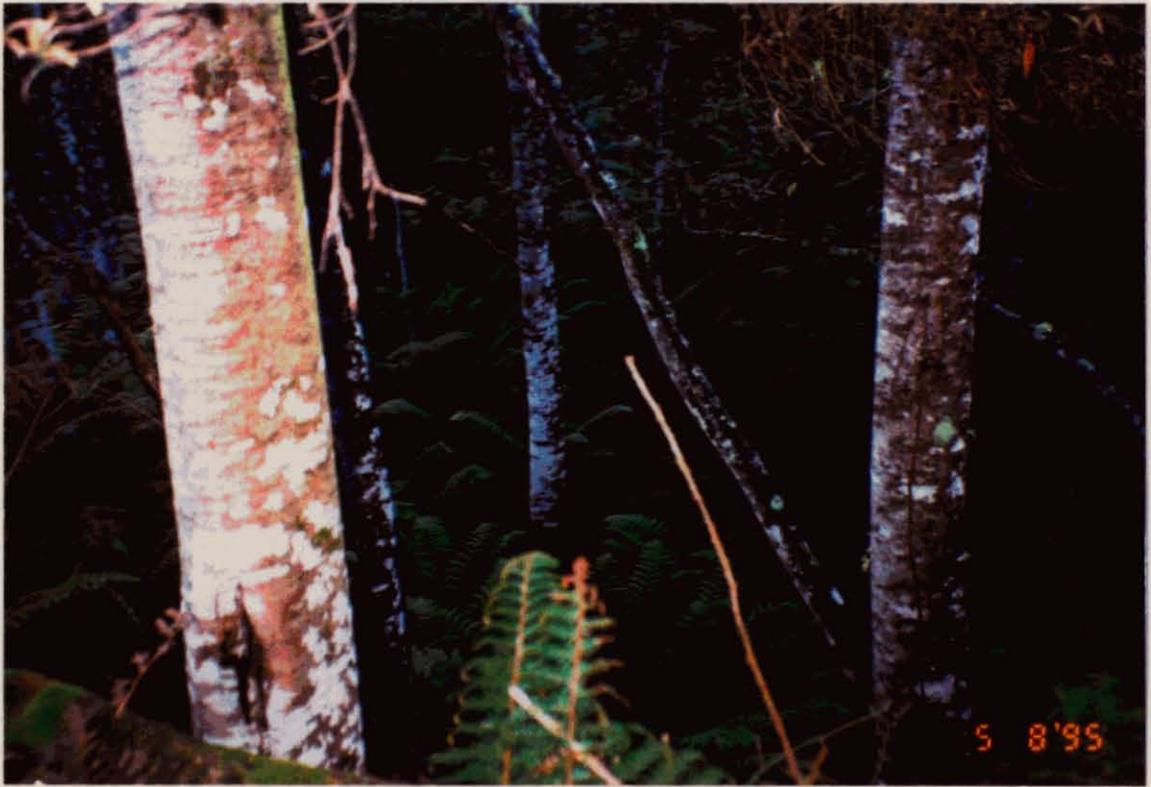
Open cut on No 6 Lode east of Main Shaft - heavily overgrown

This is an excavation which appears to be a combination of shallow alluvial workings and a portal cut for No. 2 adit. There are no benches as such and whilst the sides are steep, they are not regarded as more hazardous than a natural steep gully.

This area is moderately accessible but is not considered to be particularly hazardous to people accessing this type of bush.

Recommended that no action be taken.

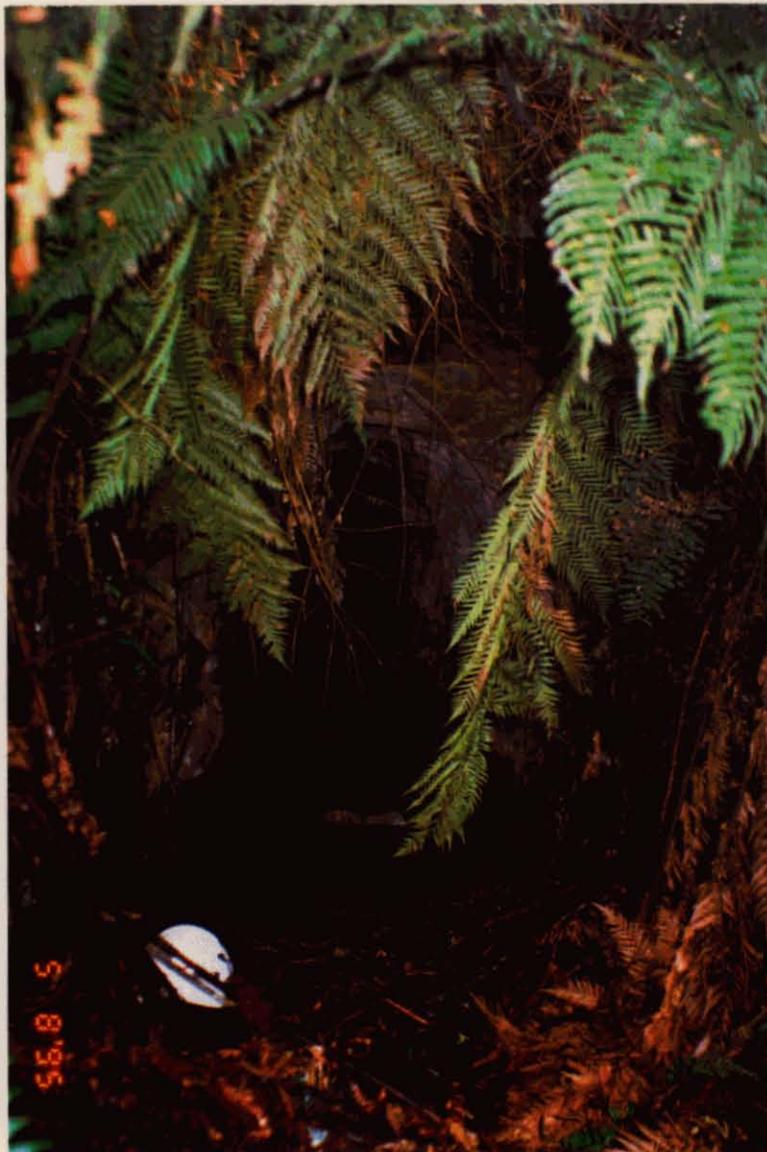
This adit was driven west along No. 6 lode from the bottom of a small overgrown open cut. The adit is relatively difficult to locate and the same comments and recommendations as for No. 1 adit apply.

No 2 Adit - driven from end of open cut onto No 6 Lode

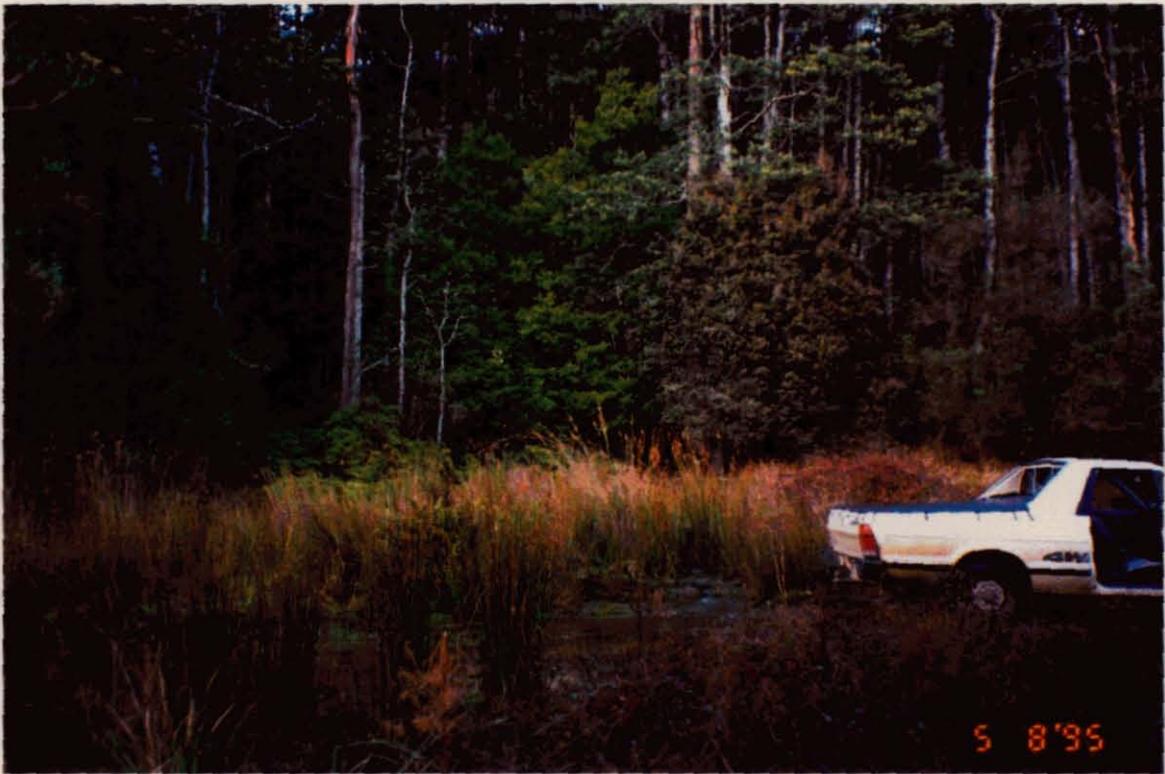
It is considered dangerous, firstly because it is very accessible being adjacent to the main vehicular access track, and secondly because of its rather peculiar portal construction, whereby a second shallow adit appears to have been driven above the main lower adit which contains deep water.

Entrance area to No 3 Adit - readily accessible

Recommended that this adit should be fenced with barbed wire and signs attached.

It may also be prudent to square up the portal of this adit with an excavator and place a vertical steel grid/mesh panel over the entrance.

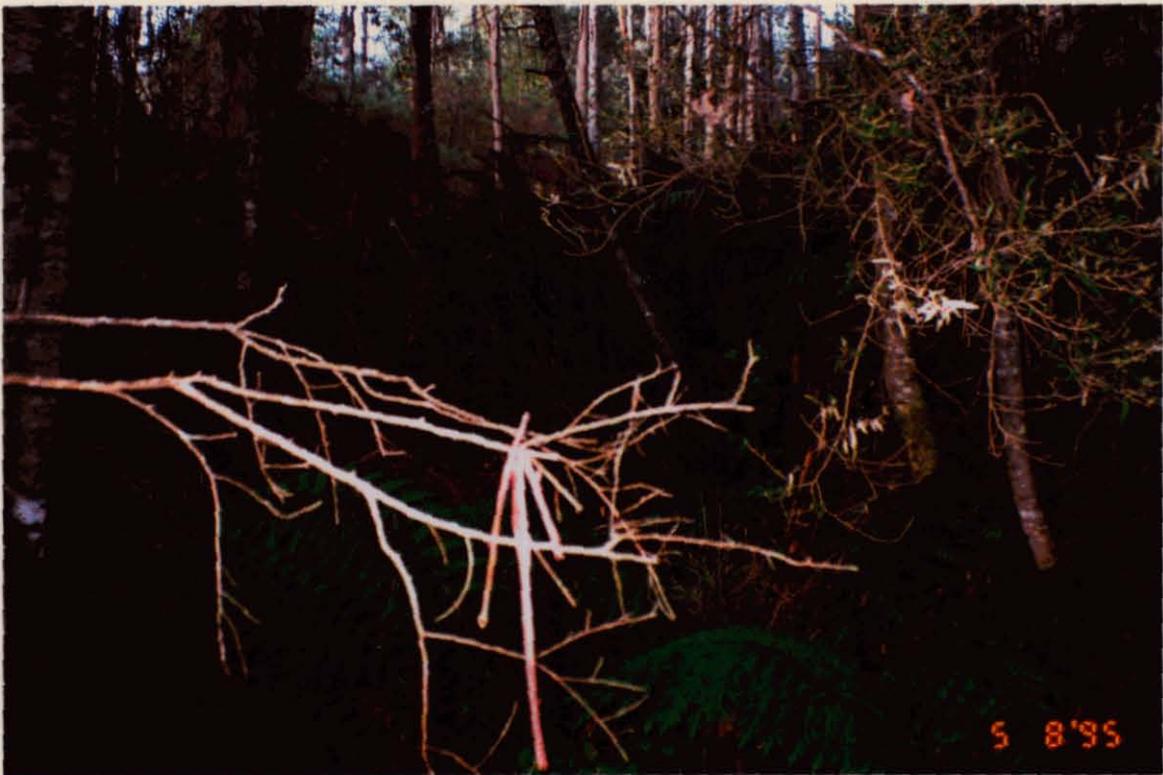
No 3 Adit - portal area

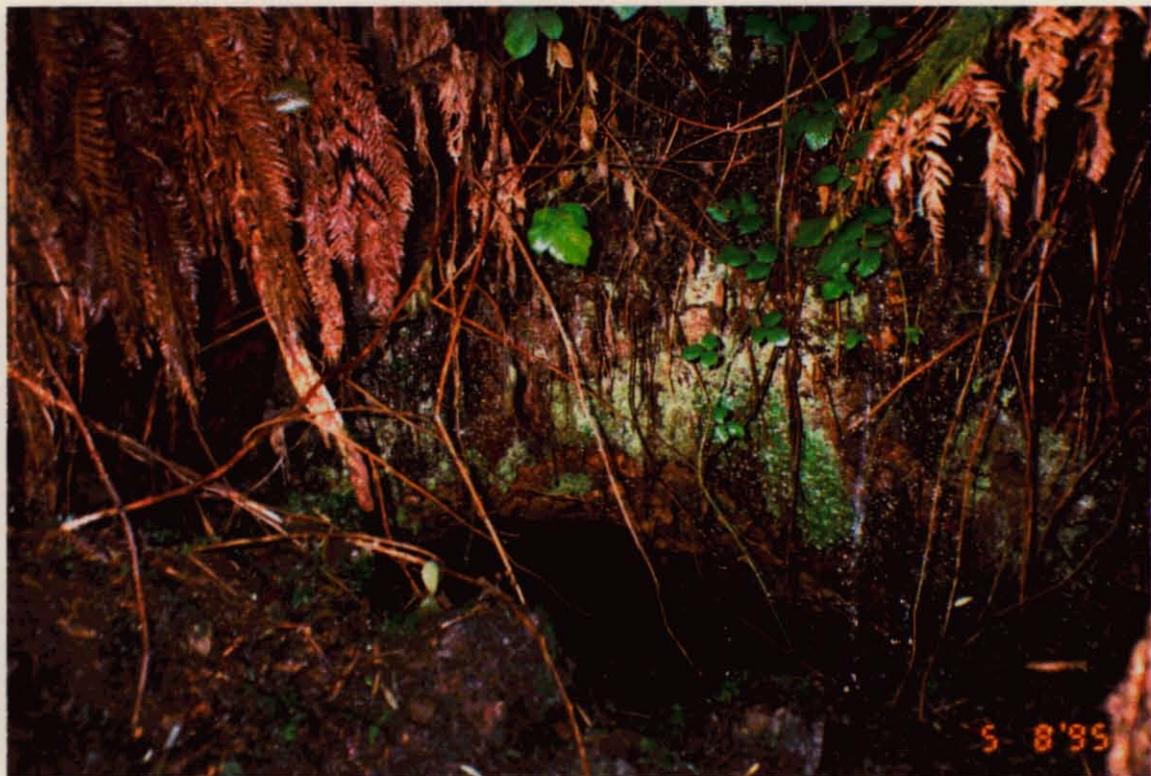
Goodwins Adit - portal largely collapsed

Short adit driven to explore for new lodes north of No. 6 lode. Portal now collapsed. Moderately difficult to locate and access. This adit is not considered particularly dangerous and no action is recommended.

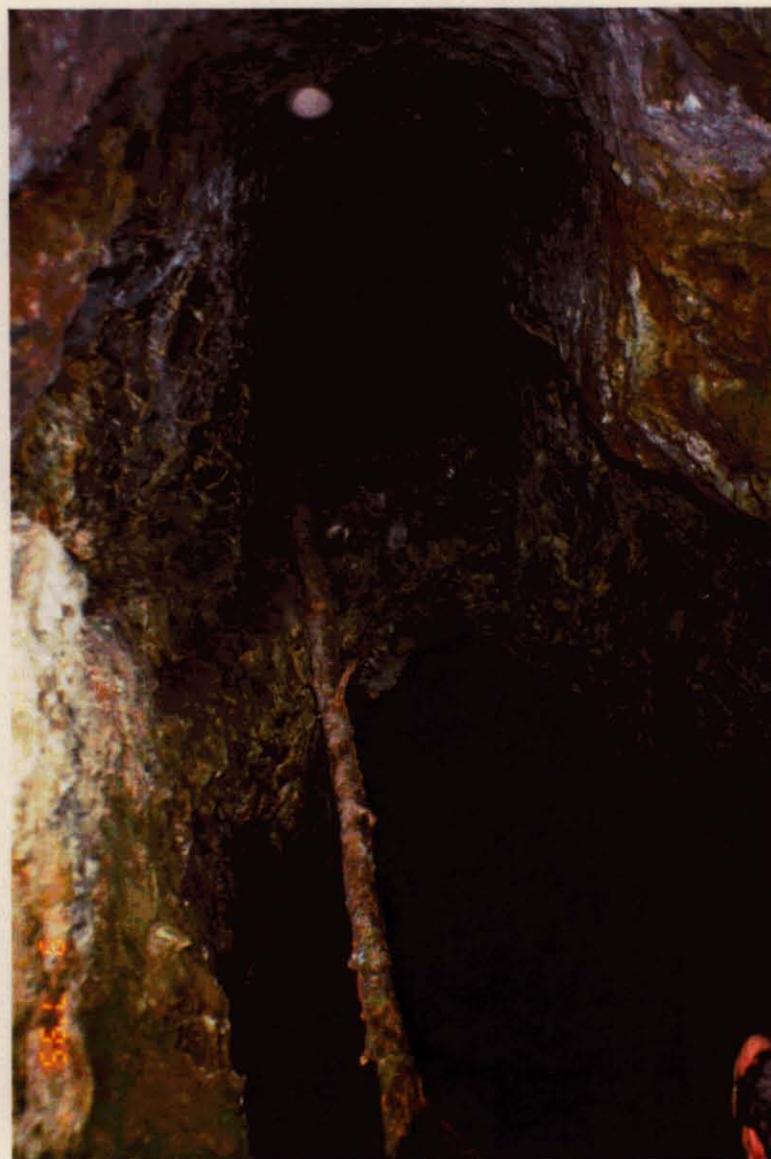
**No 3 Adit -
two adits,
one above
the other
very
accessible**

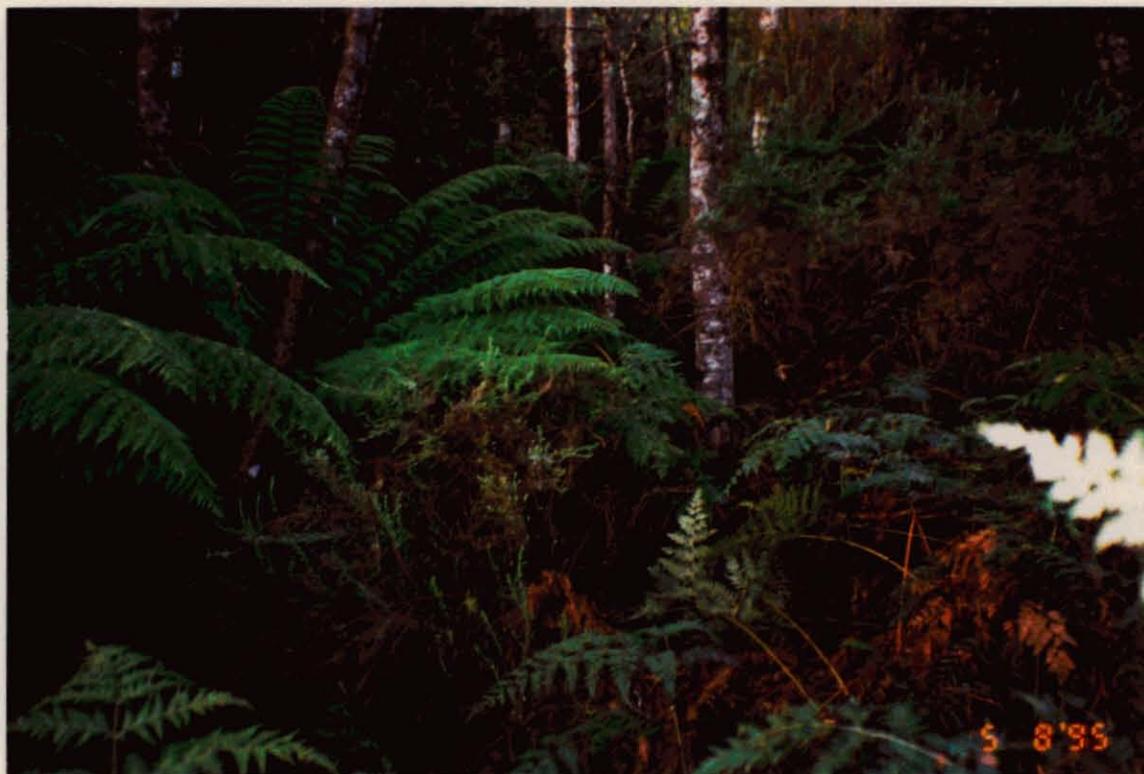
This adit was driven west along No. 4 lode. The portal lies on the banks of Bismuth Creek and it is very difficult to access and locate.

No 4 Creek Drive Portal - behind ferns Adit is well concealed and difficult to access.

Recommended that a sign be erected near the portal as for No. 1 adit.

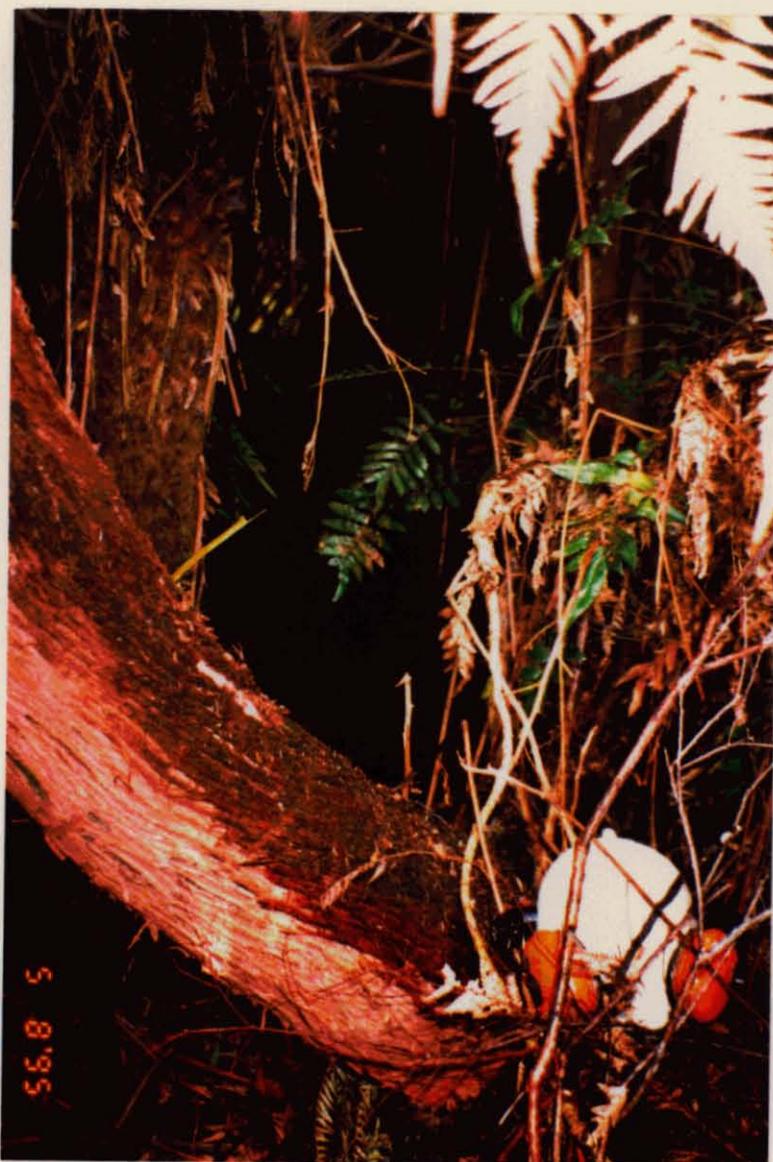
No 4 Creek Drive Portal is open

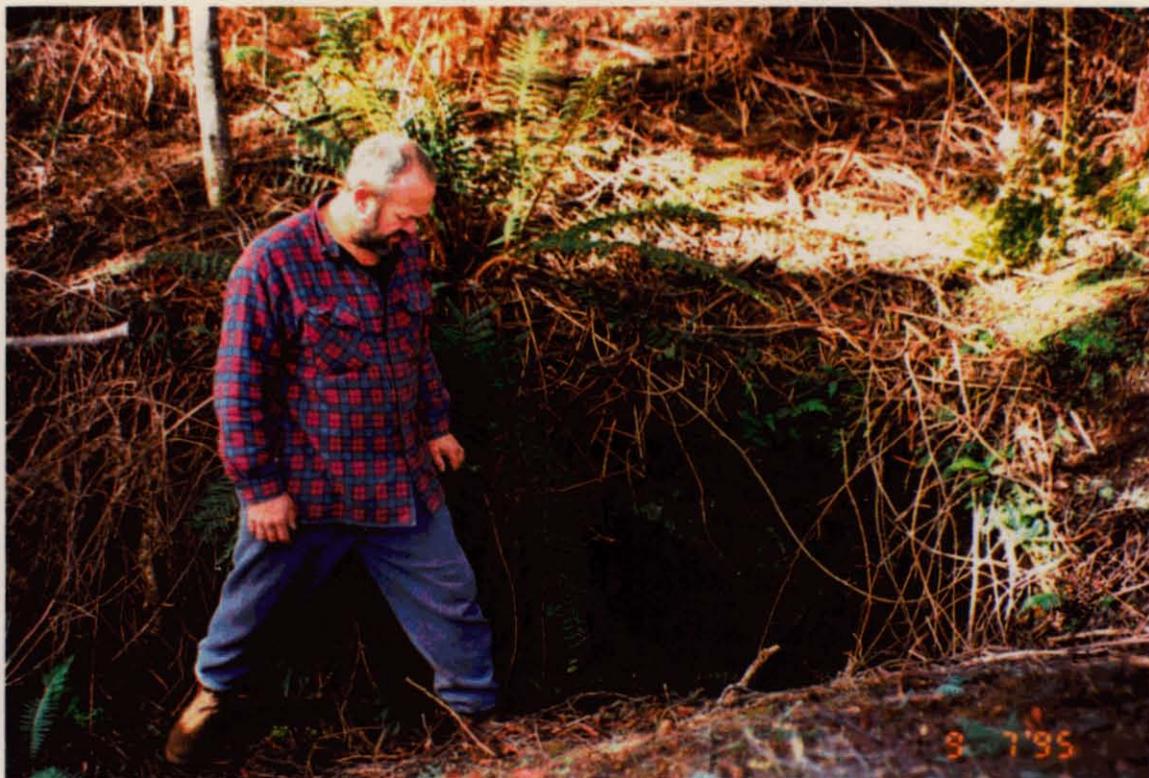
These appear to be mainly developed between the Main Shaft and No. 2 adit open cut area. As such, they are reasonably accessible and easy to locate. They are considered dangerous and a safety hazard.

No 6 Lode open stope (?) adjacent to Main Shaft

Recommended the open stope area be fenced off and sign posted and a general warning sign be erected.

Some filling with an excavator should be considered.

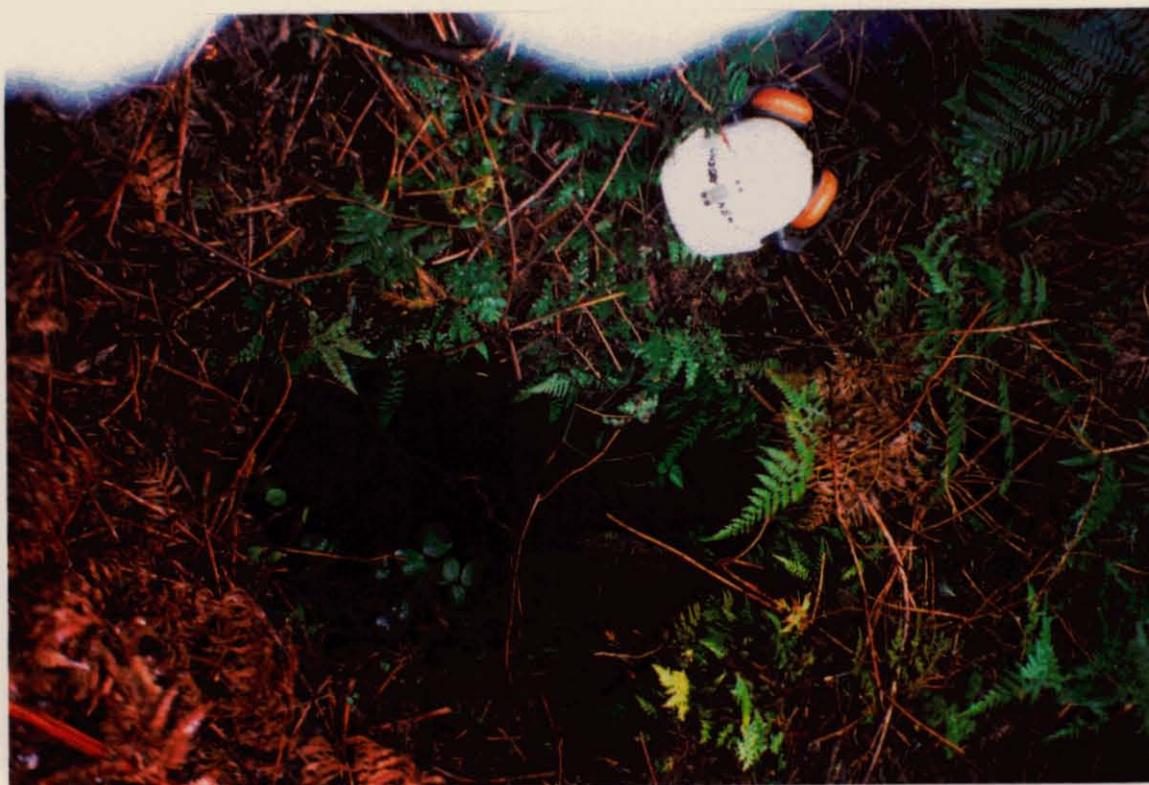
**No 6 Lode open stope east of Main Shaft
Accessible and considered dangerous**

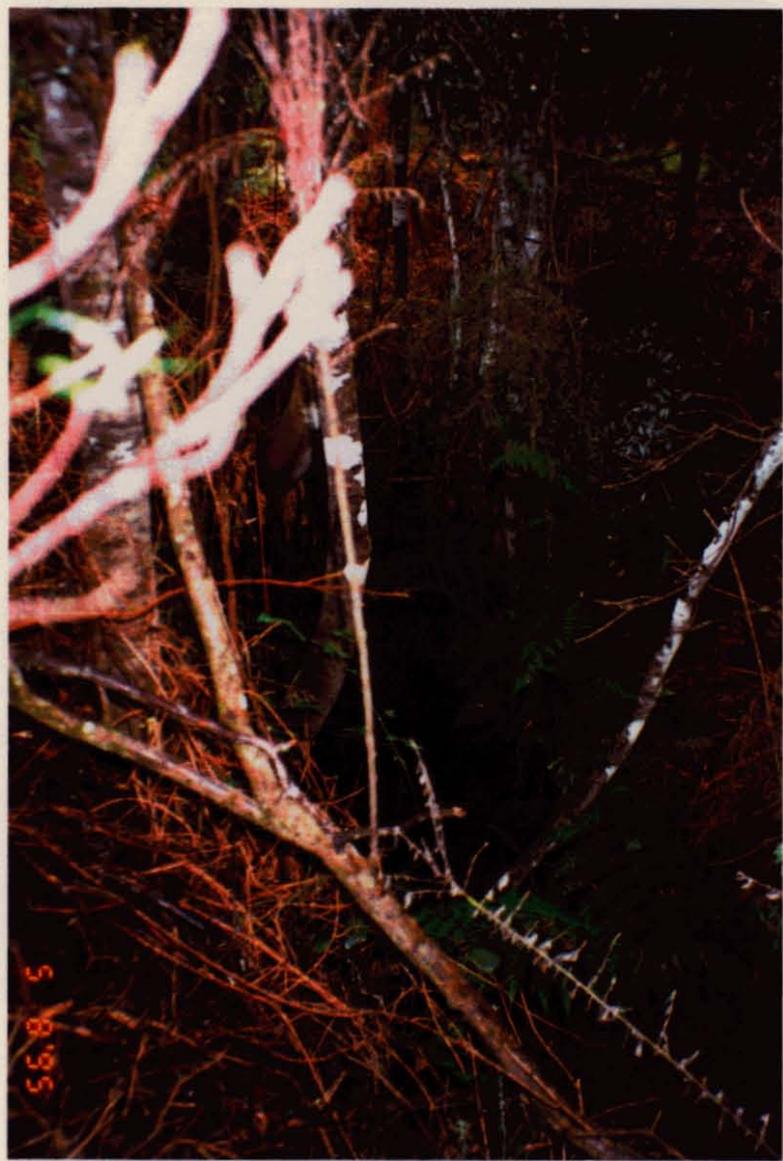
The stopes are certainly dangerous for anyone who comes across them. However, they are remote and relatively difficult to access. To attempt to fill them in seems impractical and the area affected is too large to fence.

Narrow open Stope - eastern end of No 2 (?) lode

Recommended that a sign, similar to those erected in July near the main access, be erected on the access track.

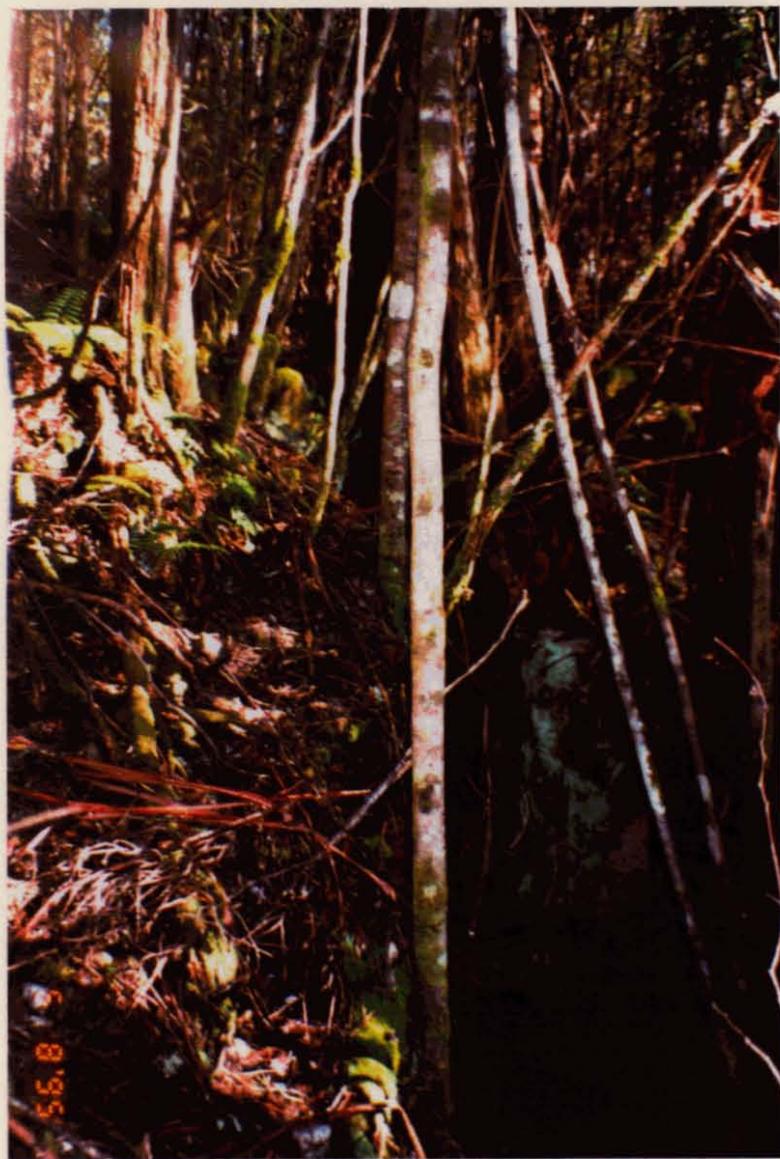
Open Stope - eastern end of No 4 lode

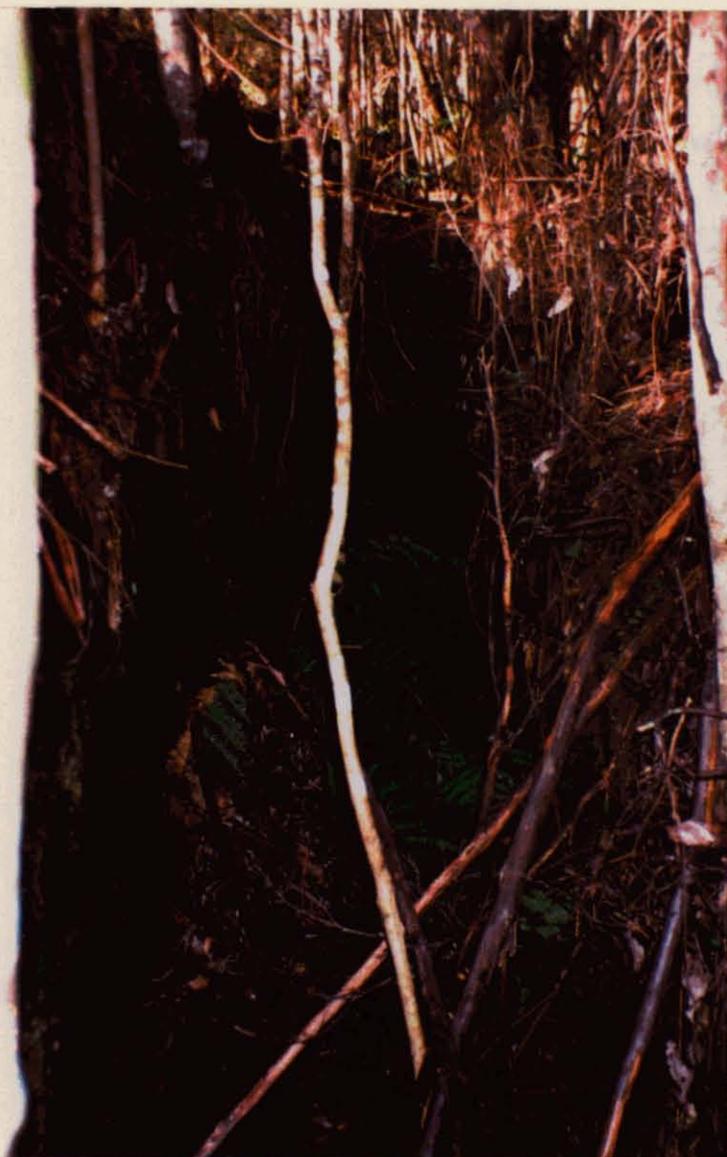
Adit driven into sub basaltic lead adjacent to alluvial workings. Moderately difficult to locate and access.

**Unnamed Adit in
sub-basaltic drift
open cut**

Recommended it be sign posted as with No. 1 adit.

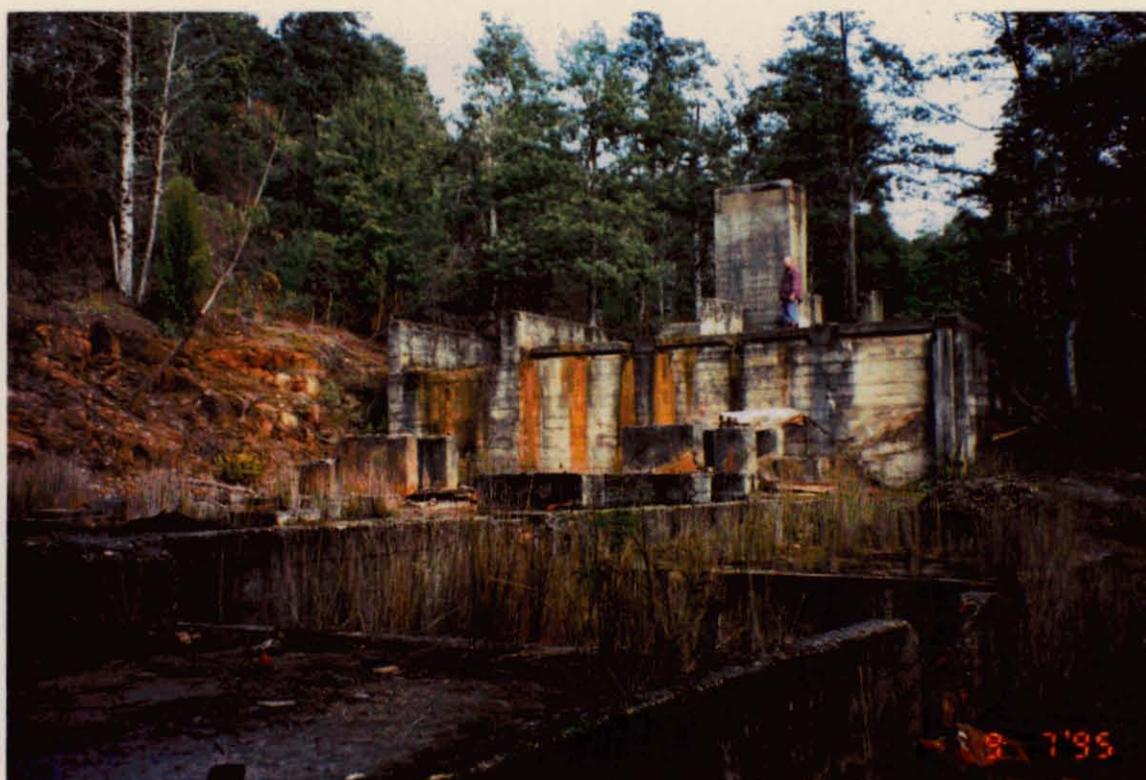
All that remains of the mill are the large concrete foundations. No buildings as such exist. These foundations are structurally stable but represent a hazard to anyone who might be climbing on them and fall. They are very easy to find and are vehicular accessible.

Treatment Plant remains - very accessible

Recommended that two warning signs be erected on the site:

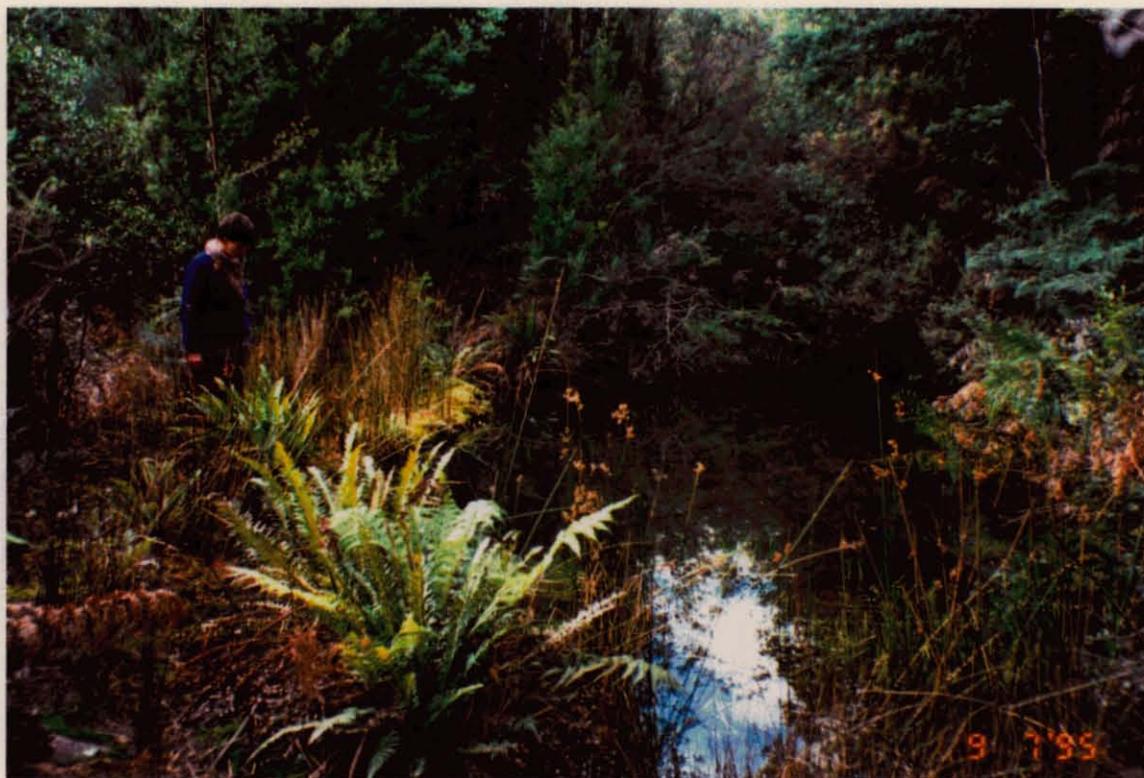
- ◆ Two other small dams exist, one to the immediate south, and one to the immediate east of the Main Shaft. They are very small, have low banks and probably not deep. They are accessible but not regarded as particularly hazardous.

Small dam east of Main Shaft

Recommended no action be taken.

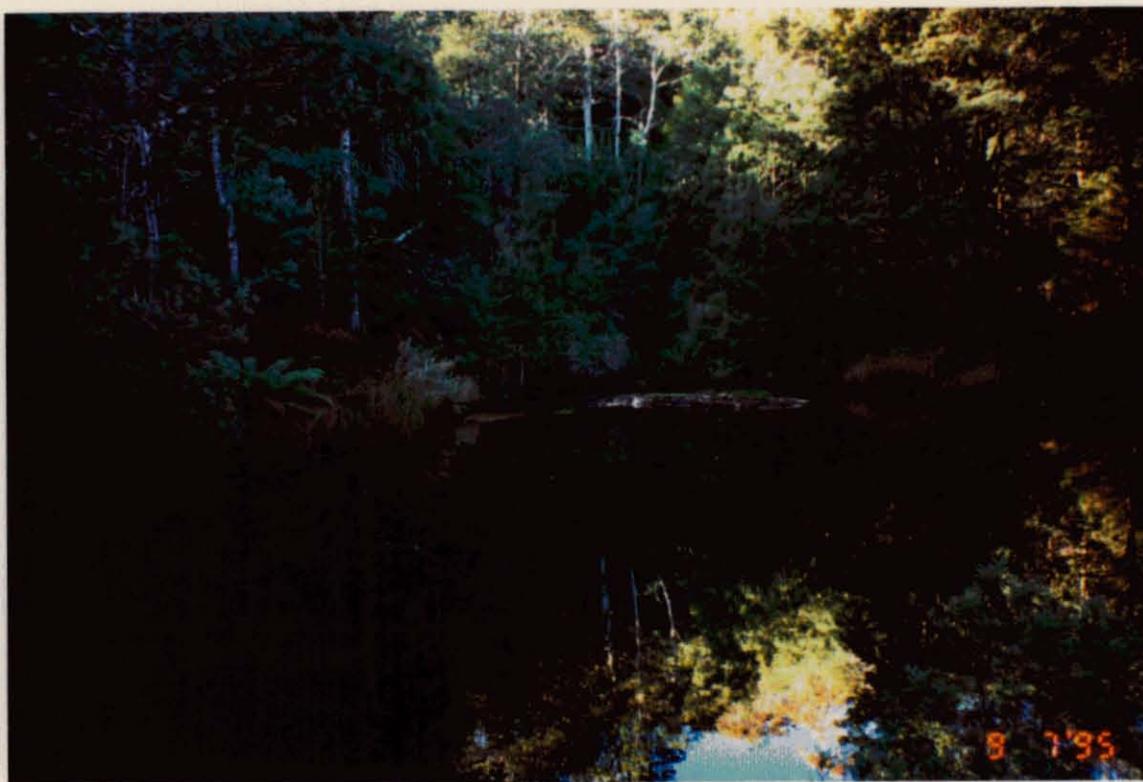
- ◆ The mine was fed by a water race from the Iris River. A number of small dams were located on the mine for various mining and milling needs. The most significant of these was developed on Bismuth Creek and consists of a rock wall and concrete spillway. It is well constructed and appears stable. The dam itself has shallow, low banks and is home to platypuses.

The dam is not particularly easy to find and is not frequented by casual visitors. It is not considered to be any more hazardous than other well constructed small dams.

Main water supply dam on Bismuth Creek

Recommended no action be taken.

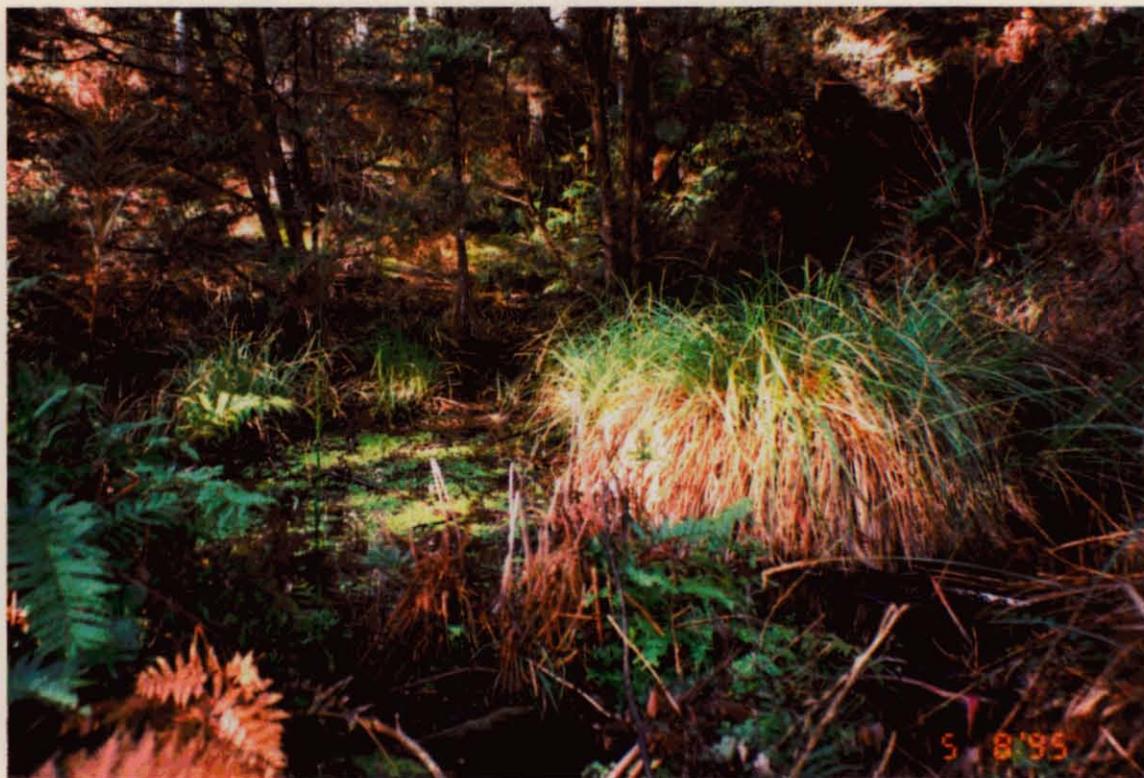
Small dam south of Main Shaft

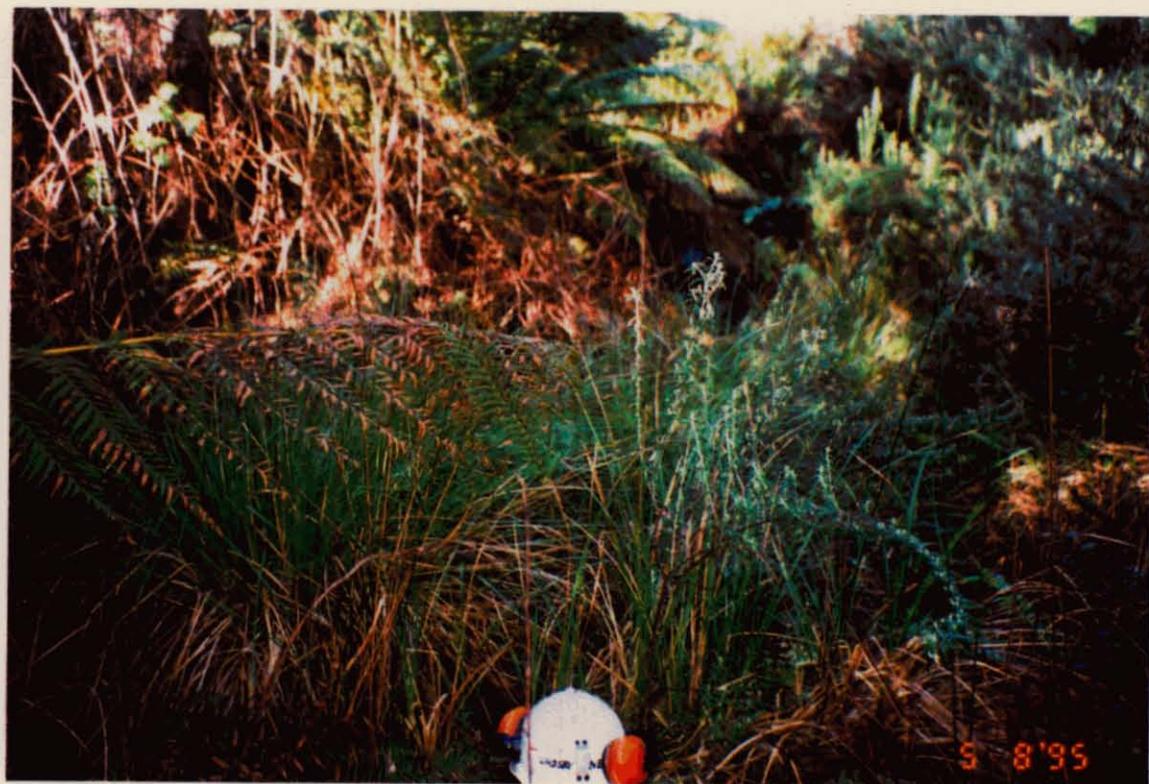
**Small dam southeast of Main Shaft -
inaccessible and not considered hazardous**
