**Aberfoyle Resources Ltd : site rehabilitation**  
plan Queen Hill, Zeehan / prepared by  
**Aberfoyle Resources Ltd 1997**

SITE REHABILITATION PLAN

QUEEN HILL

ZEEHAN

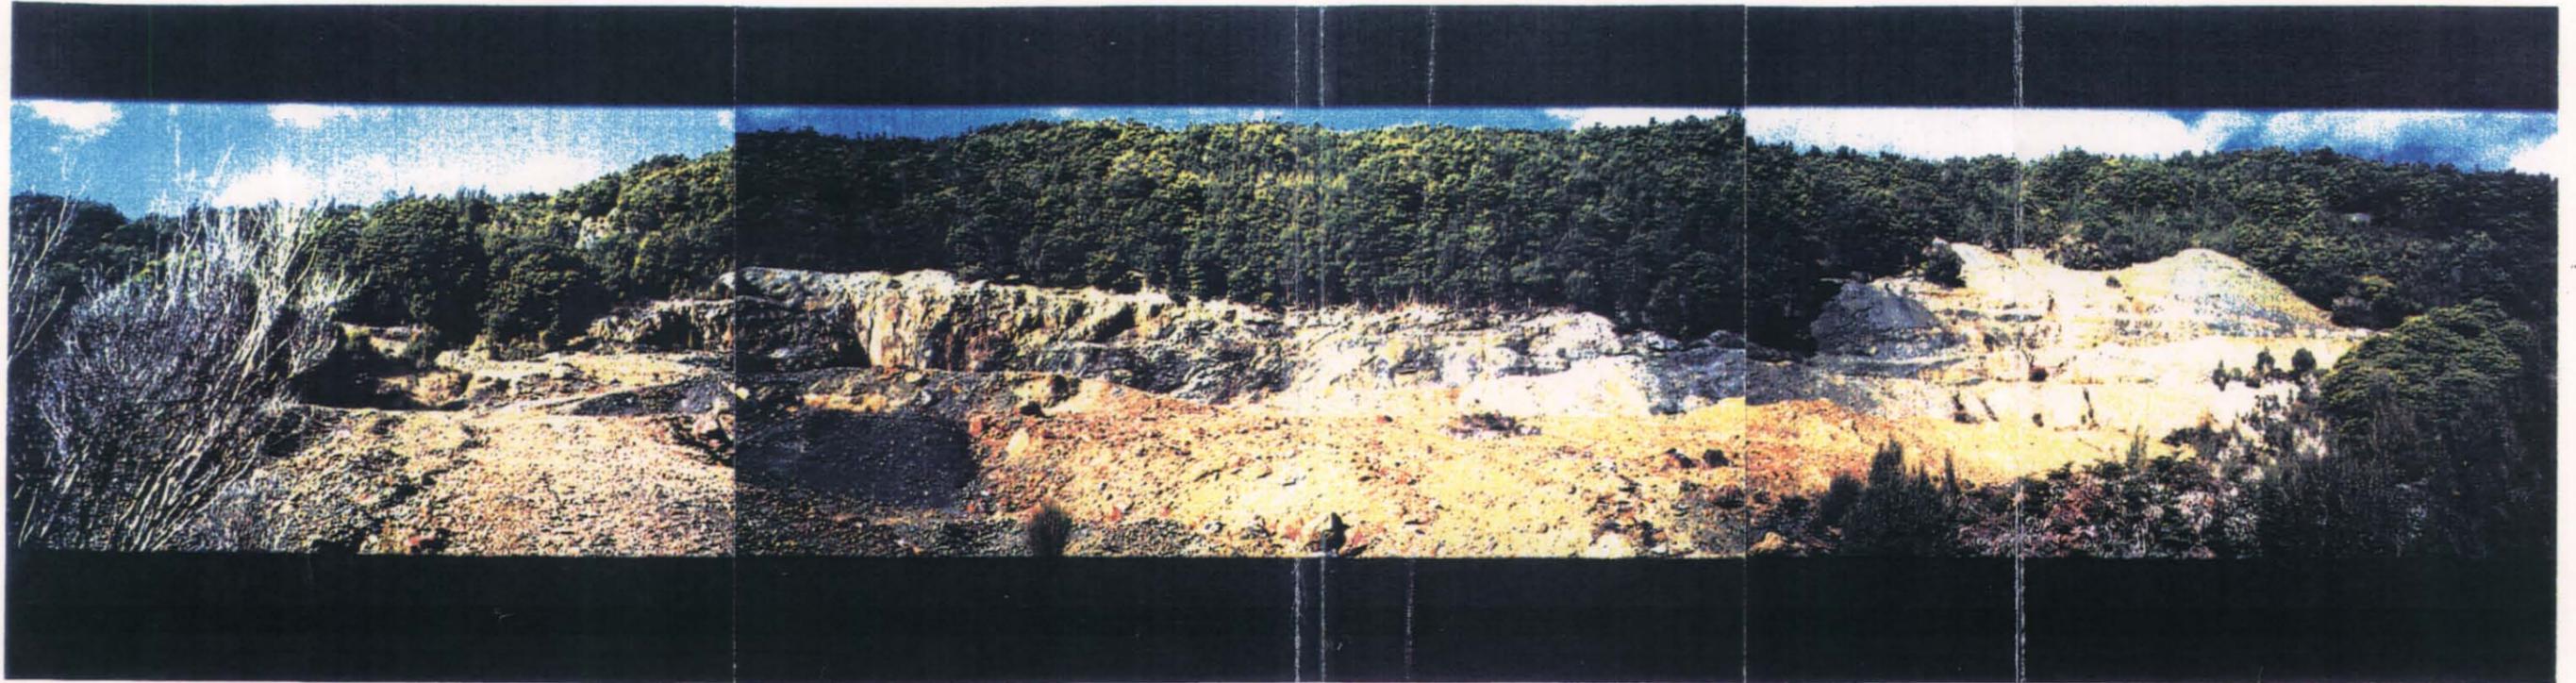
Figure 2.1 View of Benched Area of Hillside

The area is approximately 120m in length. The south end has six benches, each approximately 5m in width and 40m long. The total area to be rehabilitated is approximately 0.5 ha. The surface is barren rock or is covered with oxidised mullock containing sulphides. There is no soil and consequently revegetation is almost non-existent. Drainage is uncontrolled and causing erosion in places.

The slopes consist of broken rock fragments of varying sizes consisting for the most part of quartzite and black shale, which constitute the bedrock under the slopes. Apart from these relatively unreactive host rocks, blocks of mineralised rock containing sulfide minerals are present, which are in a state of advanced physical weathering. The fragmentary nature of this material increases the available surface area for oxidation and the production of acid drainage.<sup>1</sup>

**Drainage** for the area must be addressed. At present, there exist incisions made by small streams cutting through the waste. Steep slope angles and the absence of vegetation makes these slopes prone to fluvial erosion. In times of strong rainfall a lot of surface runoff occurs in a large number of small streams, some of which have cut quite deeply into the surface.<sup>2</sup>

**Recontouring** of the area will be undertaken. The benches will be recontoured to a slope fitting to the surroundings. This should also aid revegetation. On the disturbed area there remain several spoil heaps. A decision must be made whether it is more beneficial to push these over and risk exposing more sulphide material or to leave the piles. It would seem appropriate to push and spread the heaps over a small area to enable the placement of a clay cover as a growth medium.

**Application of growth medium.** Following the recontouring of the area a growth medium shall be applied. The disturbed area is a very harsh environment for plant establishment. The acid conditions and the associated presence of toxic levels of trace elements and low availability of major nutrients as well as the poor physical characteristics of the spoil are the major reasons for the lack of vegetation establishment. Topsoil is not readily available in the area and peat obtained from the Hellyer minesite has been considered for the area should no closer source be found.

**Seeding** with local provenance seed will ensure the stability of the site and limit visual disturbance. Some native vegetation reclamation has occurred around the disturbed area. This appears to have been restricted by the lack of soil and nutrients. Following the preparation of the area as described above, local natives should begin colonising the area and establishing themselves quite well.

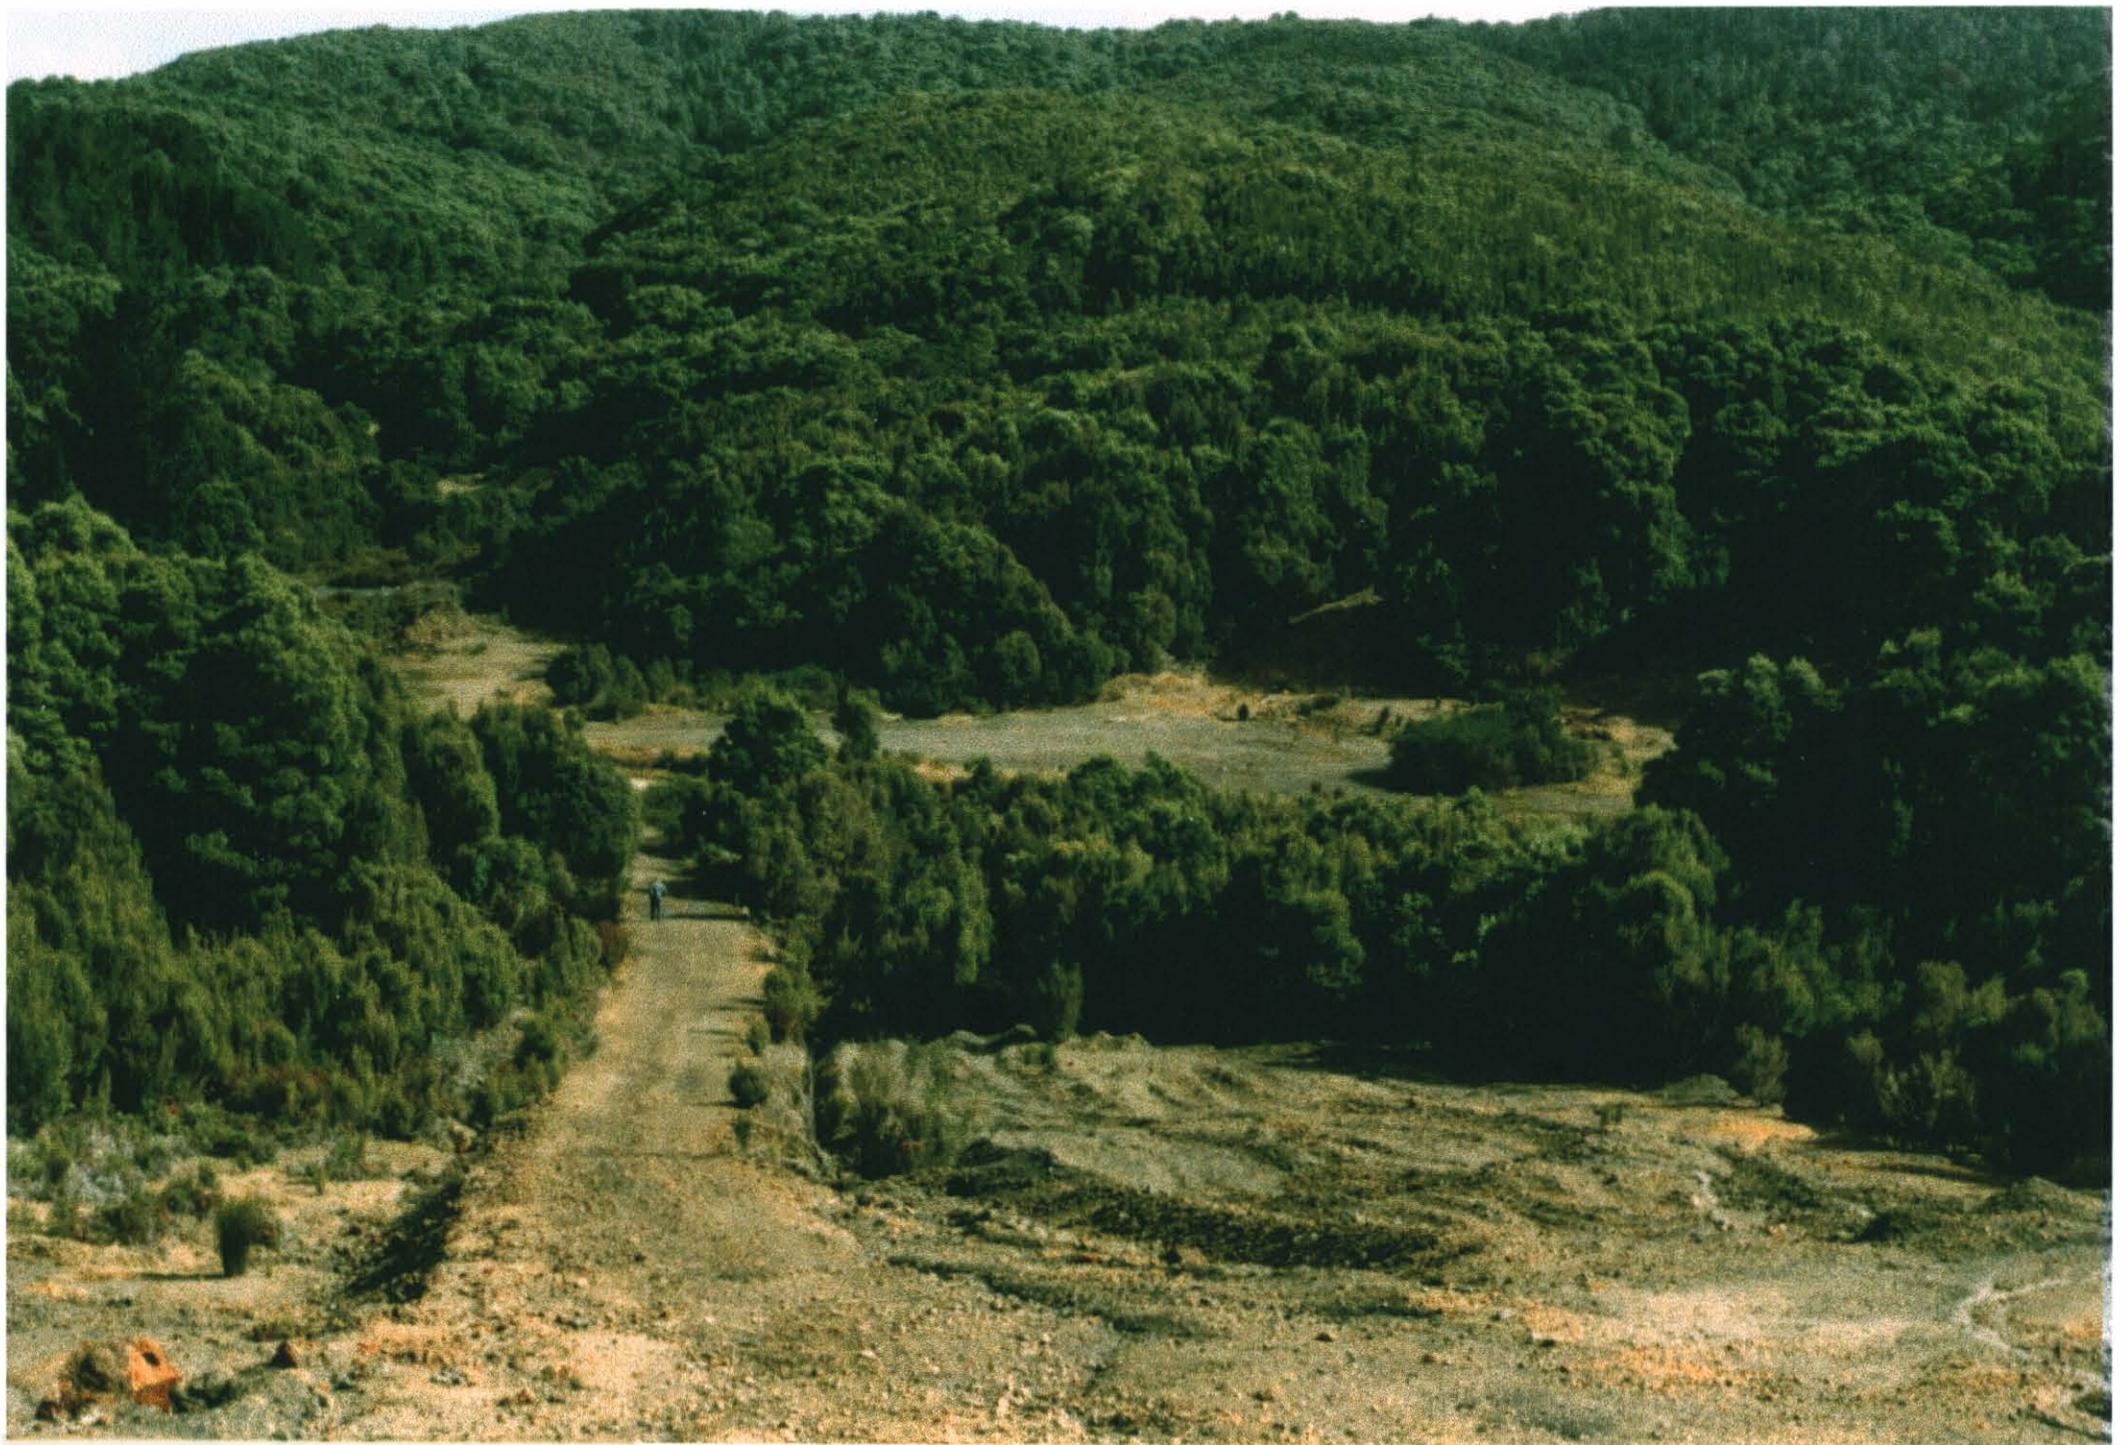
Figure 2.2 Stockpile Area (at base of hill)

The old stockpile area is roughly L shaped and covers about 0.5Ha. The ground is near flat and has one large and four small remnant mullock or ore dumps.

**Deep ripping** the area will be necessary. The ground has become quite compacted through trafficking and its use as a stockpile area. Ripping assists plant development by aerating the soil, increasing water infiltration and removing the physical barrier to the plant roots. Cultivation of the site should lead to less erosion as there will be no free running surface flows.

**Application of growth medium.** The stockpile area is nutrient and structurally poor. Peat or clay, as a growth medium will be applied to the area. Peat has a much greater capacity to support and sustain plant growth without continual maintenance. Clay may be obtainable locally. If not, this medium is likely to be obtained from the Hellyer site and trucked to Zeehan.

**Seeding.** Local native seed will be sown on the disturbed area. Some native vegetation reclamation has occurred around the disturbed area. The seed should be of the same mix as that applied to the hillside area. The seed will be collected from the area surrounding the disturbed site.

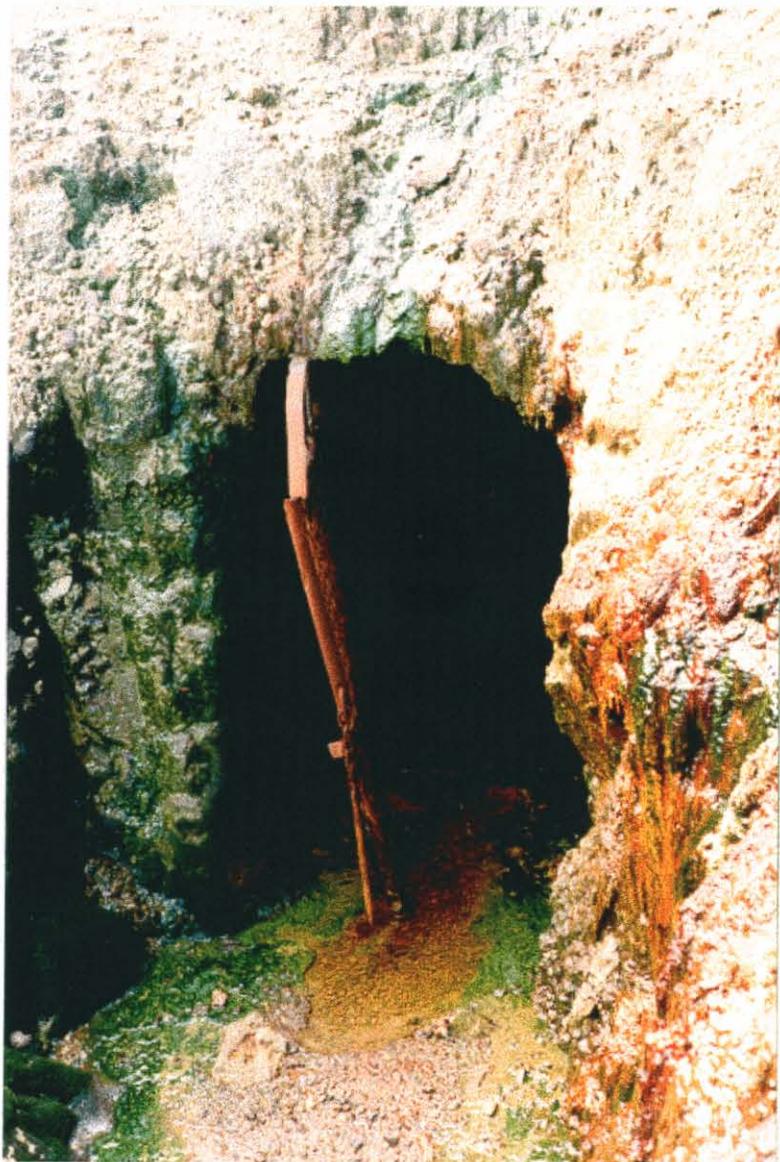
**Figure 2.4 Queen Hill Adit**

The entrance to the old adit is approximately 2 x 1.2m and is approached along a 20m long trench. The adit is discharging approximately 0.2L/s of clear but acidic water.

**Drainage.** Once it has been established the adit is not home to wildlife it is intended that this adit be filled in with inert free draining aggregate. Though the amount of water flowing from the adit is quite small it would seem more appropriate to continue to allow this water to flow rather than risk a build up of water behind an impermeable barrier.

**Recontouring.** The ground will be recontoured to blend with the surroundings. The fill will consist of approximately 50m<sup>3</sup> of free draining basalt.

**Application of growth medium.** Upon establishment of the final landform, the area shall undergo revegetation. This shall consist of the placing of a growth medium on the area to provide nutrients and an appropriate structure for root stability. Once again the growth medium is likely to be peat unless a local source of topsoil can be accessed.

**Seeding.** The area will be sown with local provenance seed to ensure the stability of the fill and limit the visual disturbance.
