Section 2 — Engineering Geology

TR 10-72-74

12. PROPOSED DAM SITE AT COLES BAY

by W. L. Matthews

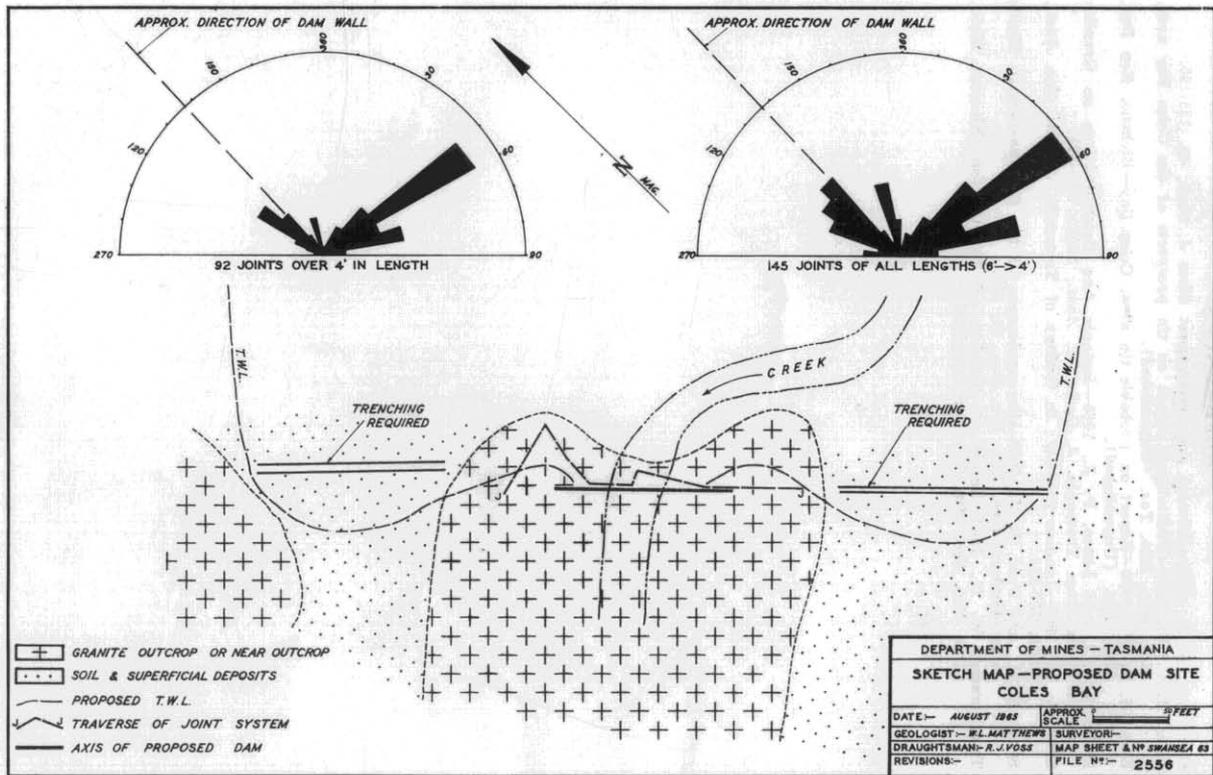
Figure 18.

Coarse-grained granite with large phenocrysts of feldspar is the only rock type occurring at the dam site and underlies the whole catchment area. At the dam site, granite outcrops on both sides of the creek constrict the valley making an ideal site for a low dam. Strong jointing is developed in the granite and 145 measurements of the orientation of joint planes were measured along a traverse across the creek. These have been plotted on rose diagrams to determine dominant directions. Two plots were made—one which included all joints and the other consisting of the 92 joints which could be traced for more than 4 feet. Two peaks appear in each diagram at strikes of about 310° (mag.) and 60° (mag.). The approximate direction of the dam wall is at about 317° . Most of the strong 310° direction joints occur on the W side of the creek, but the strong 60° direction joints occur generally throughout but are not quite so prominent on the W of the creek. Most of the joints dip at an angle between 70° and 90° with occasional dips as low as 30° .

The granite outcrops rise to a height of about 20 feet above creek level. Outside these outcrops the topography drops slightly to narrow saddles underlain by a grey soil. Upstream from the dam site, the creek runs along the E margin of the storage area with the main potential storage area separated from the creek by a small ridge of granite. A small flat of about 5 acres in area has developed here, where granite debris has accumulated while the creek has been cutting through the largely unweathered granite at the dam site.

The jointing developed in the granite is closely spaced with the strongest direction approximately perpendicular to the dam wall. In the joints examined, little weathering has taken place and in general they should not present large seepage problems. However, the two saddles where no outcrop occurs could possibly be a reflection of strong jointing and deeper weathering or small faults which would allow greater seepage. It is recommended that trenching be carried out to expose bedrock in these areas.

It is recommended that trenching be carried out adjacent to the granite outcrops along the creek at the damsite, to expose bedrock.
