TR12-69-71

## 15. REPORT ON DIAMOND DRILLING, PROPOSED TUNNEL, NUNAMARA

by D. E. Leaman

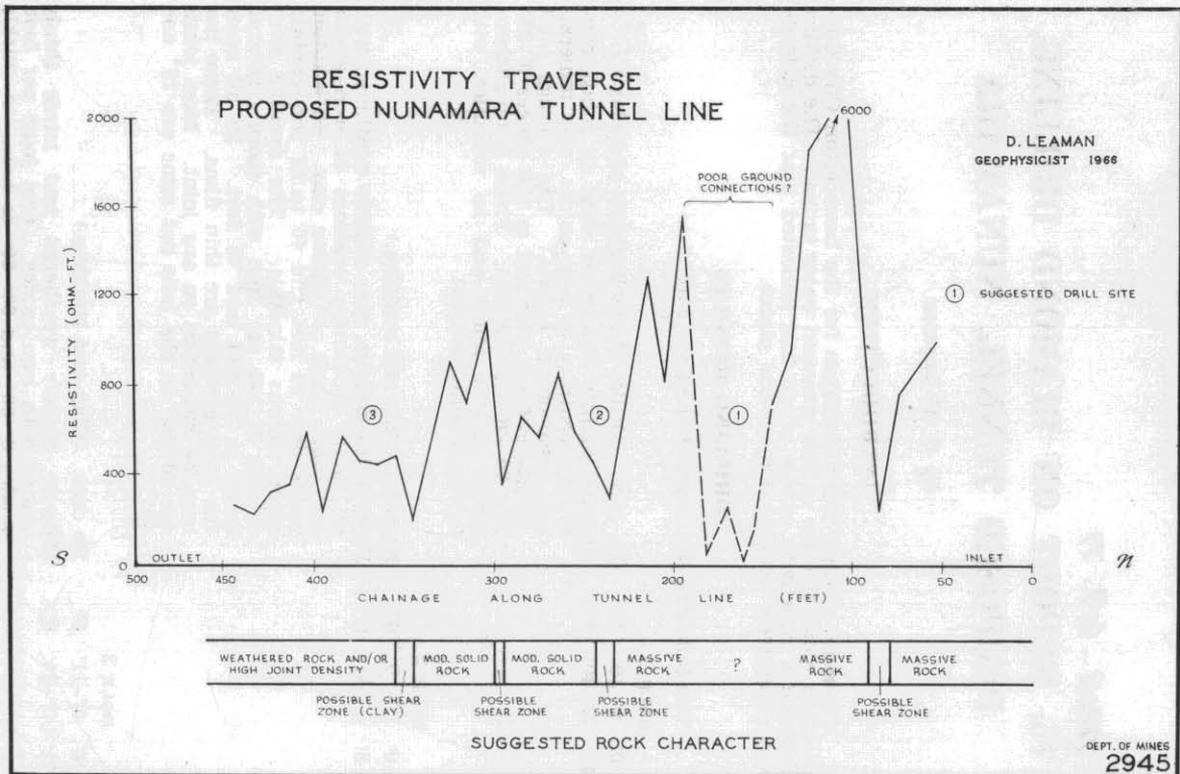
FIGURE 18

Only the rock in holes 2 and 4 is reasonably firm; that in holes 3 and 5 is soft. The shattered nature of the rock in the first hole would make it unsuitable for tunnel support. It would appear that the rock itself would be unable to support a tunnel and would need bracing and lining.
