TR12-74-77

18. GEOLOGICAL SURVEY - NICHOLLS RIVULET DAM SITE

by D. E. Leaman

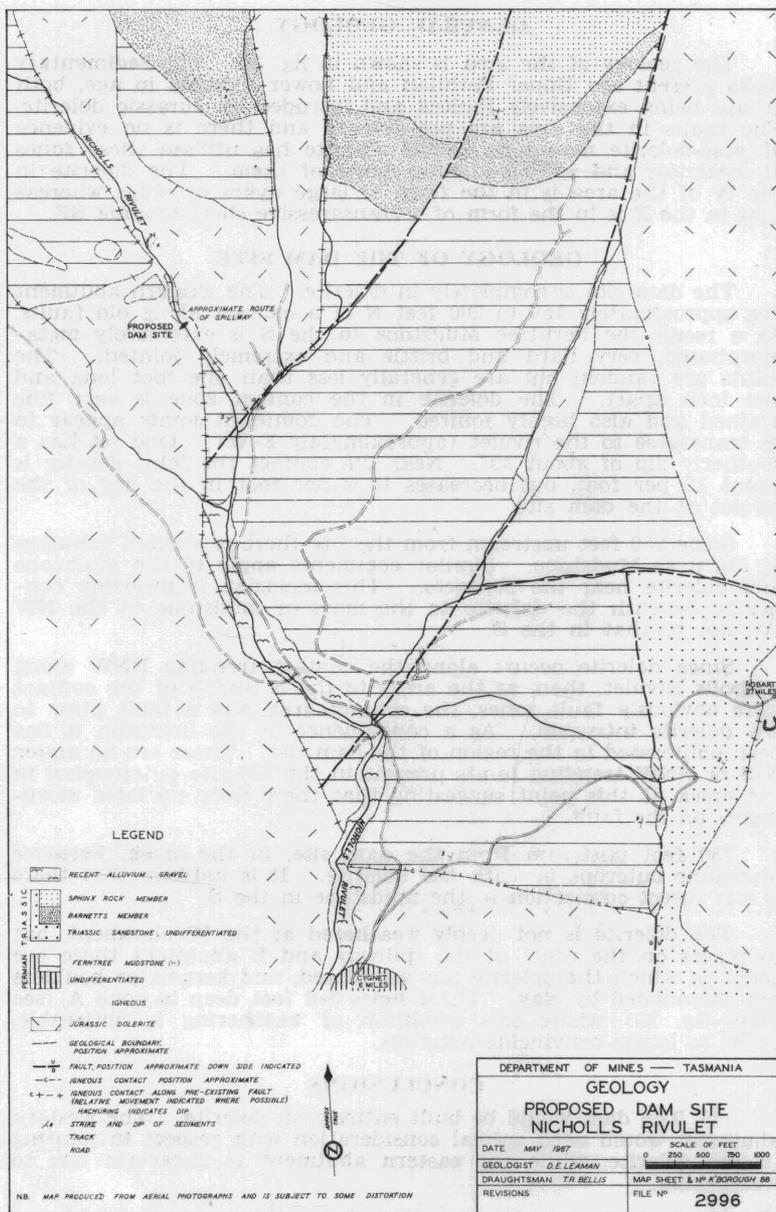
FIGURE 20

The geology of the area is shown in fig. 20. The sedimentary rocks present are Upper Permian and Lower Triassic in age, both groups being extensively faulted and intruded by Jurassic dolerite. The faults in the area are pre-dolerite and there is no evidence of post-dolerite movement. The dolerite has utilised these zones of weakness and intruded along many of them. The dolerite in the W of the area is in the form of large dykes or plugs whereas that in the E is in the form of a transgressive sheet dipping SE.

The dolerite is not deeply weathered at the W abutment, but in places on the route of the spillway and E abutment there are zones in which the dolerite has weathered, and kernels or boulders are surrounded by clay. Three holes 5-6 feet deep in zone A (see map—fig. 20) where this condition of weathering is noticeable, failed to locate convincing outcrops.

(1) The dam would be built entirely on dolerite. The western abutment would need special consideration with respect to jointing in the dolerite, while the eastern abutment is uncertain due to weathering.

(6) A significant quarrying job is expected along the route of the spillway, which will have a maximum depth of about 15 feet in dolerite. Only in zone A is there expected to be softer rock and odd clay zones.

(4) Wash down and test drill the route of the spillway, to fully determine the character of rock to be quarried. Three or four holes are required, one of which should be in zone A. Approximately one hole per 50 feet of spillway is required. As the route, depth and length of the spillway is undecided at present, no further specifications can be given as to tests required.
