TR13-103-106

15. GEOLOGICAL EXAMINATION OF THE LOWER DAM SITE ON BRADY'S CREEK, TRIABUNNA

by P. C. Stevenson

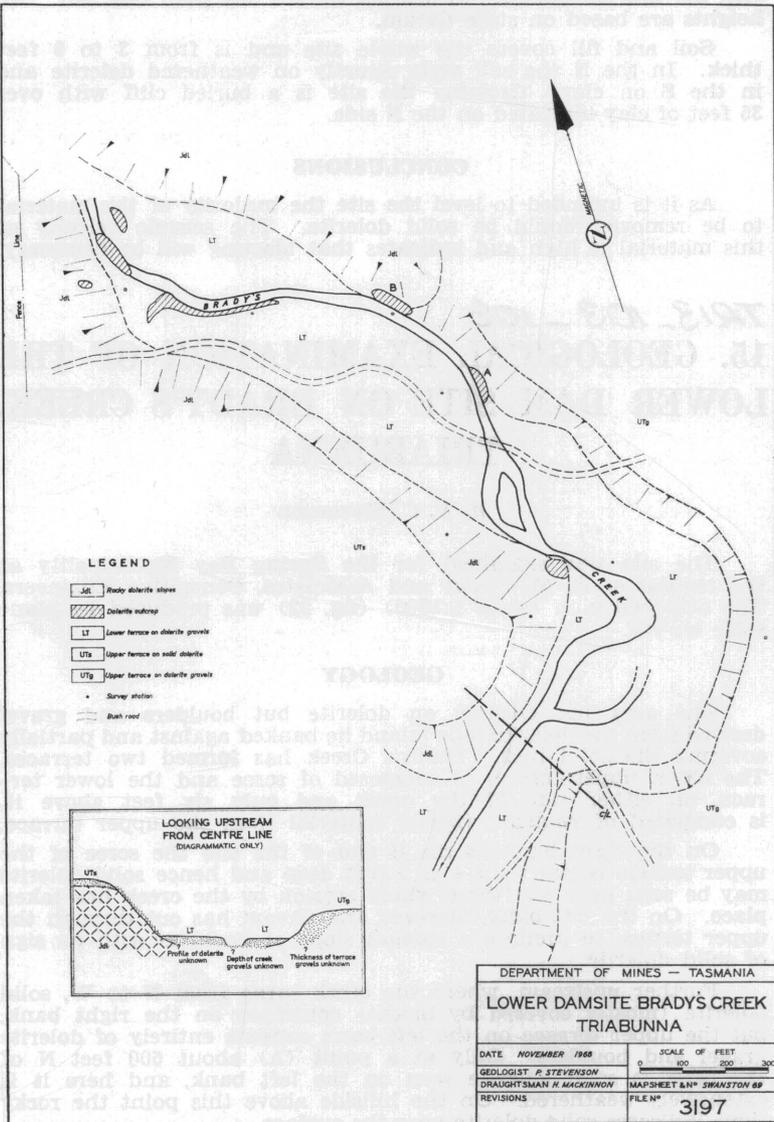
FIGURE 22.

On the right bank at the S end of the site the scree of the upper terrace is less than 4 or 5 feet deep and hence solid dolerite may be seen here and there where erosion by the creek has taken place. On the left bank, however, the stream has cut through the upper terrace to produce a smooth slope of boulders with no sign of solid dolerite.

Further upstream, where the creek turns from N to W, solid dolerite (mostly covered by blocks) continues on the right bank, but the upper terrace on the left bank consists entirely of dolerite gravel and boulders. Only at a point (A) about 600 feet N of the bend is solid dolerite seen on the left bank, and here it is extensively weathered. On the hillside above this point the rocky slope indicates solid dolerite near the surface.

A diagrammatic section in the vicinity of the dam site is provided (fig. 22). This shows that whereas solid rock exists on the right abutment, the position of solid rock under the dam centre line or on the left abutment is unknown.

In addition the position of the solid dolerite, under the dam and left abutment must be determined, and a seismic survey combined with the trenching is probably the most economical answer to this problem.

- (1) A seismic survey be conducted in an area along the centre line and at least 100 feet up and down stream to determine the position of the solid dolerite under the stream bed and under the left abutment.
- (2) Trenching by backhoe or similar machine be done to examine the nature and depth of the gravels of the lower and upper terraces along the centre line.
- (3) At least four *in situ* permeability tests be conducted in the gravels of the upper terrace near the left abutment to determine the magnitude of possible leakage. These tests would consist of measurements of the quantity of water lost in unit time from a vertical 4" polythene stand pipe cemented into the bottom of an augered hole at least four feet deep.
