TRIA-75-77

16. Geology around a proposed dam site, north-west of Bracknell

W. L. MATTHEWS

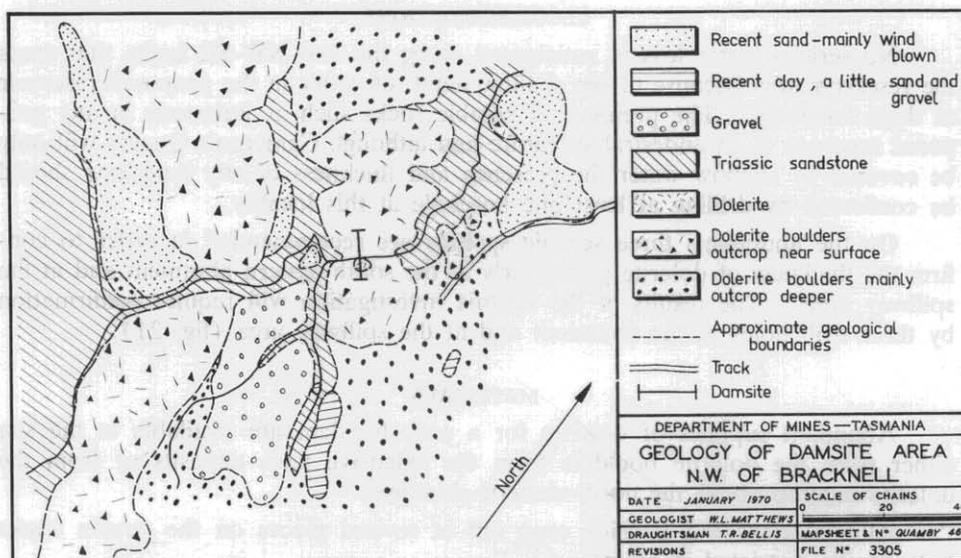
FIGURE 22

Most of the area around the dam site is underlain by dolerite boulders which probably overlie *in situ* dolerite. Only one small area of outcropping dolerite has been mapped and this is at the dam site itself. Areas have been marked on the plan where dolerite boulders are so common that *in situ* dolerite could be expected at shallow depth. Areas of sparse dolerite boulders with clay are also likely to overlie *in situ* dolerite; sand, quartz- and ironstone-gravel are associated with some of these areas but are of limited extent and thickness and have not been mapped separately.

Areas of baked sandstone of probable Triassic age are shown on the map (fig. 22). In a few places the sandstone may be *in situ*; elsewhere only sandstone boulders occur. Dolerite probably underlies these deposits.

An area of large sub-rounded boulders, composed mainly of quartzite, conglomerate, vein quartz and mudstone has been mapped to the S of the dam site, angular dolerite boulders can be found in a few places within this area, which is probably underlain by dolerite. The gravel deposit is probably of Tertiary age since in regional geological surveys similar gravels have been seen to underlie areas of basalt to the N and E of the dam site.

Seismic surveys should be used in selected places to determine areas of minimum overburden for the development of a quarry for the rock fill.
