TR14-90-108
22. Patersonia dam site

W. L. MATTHEWS

PART I. GEOLOGICAL SURVEY

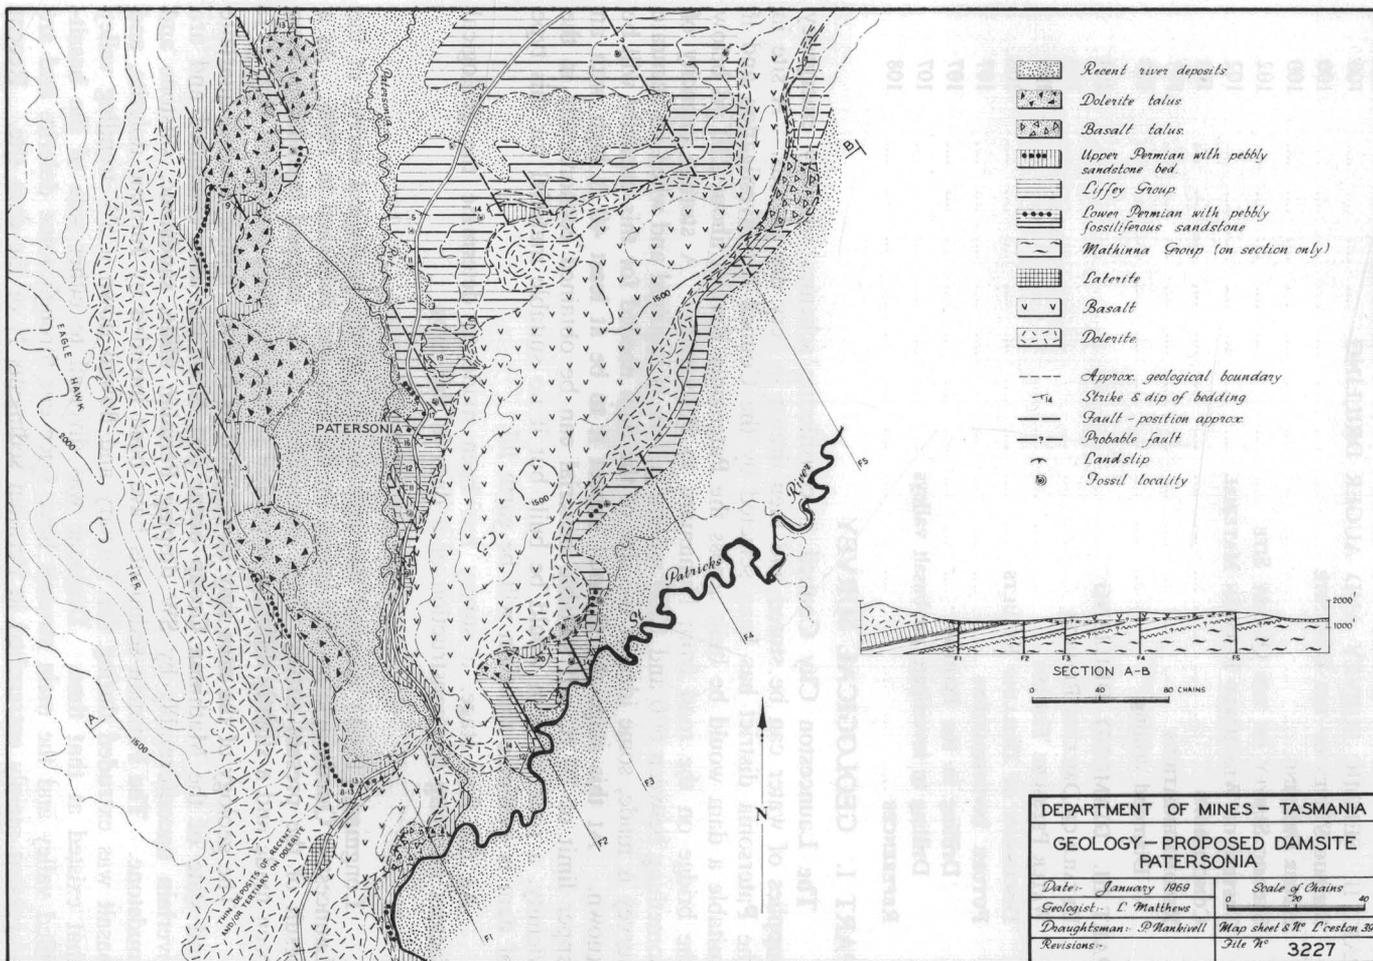
FIGURE 27

Longman (1964) mapped this area as part of the geological survey of the Launceston Quadrangle and his report on the area was published in 1966. As a result of the present survey, slight emendations to the mapped boundaries have been made and a slightly different structural picture has been postulated (fig. 27).

Detailed structure is difficult to determine because of the relatively poor exposure, however some major faulting has been deduced, mainly from displacements of the Liffey Group. Five NW trending faults, marked F1, F2, F3, F4 and F5 (fig. 27, 28) have apparently moved about 120 to 300 ft. Small faults in road cuttings with similar trends, have been noted in a number of places and no doubt many obscured minor faults occur. F2, F3, F4 and F5 probably predate the dolerite intrusion, as they do not appear to displace the dolerite in some cases, and where there are changes in the level of the dolerite, it does not seem to be of the same order as the apparent fault displacement. Around F1 however, the level of the base of the dolerite changes quite sharply and this could be a post-intrusive fault. Disregarding questions of age, the area has been subject to widespread faulting.

The Permian sediments have a regular dip to the SW of 10°-15°, which is no doubt related to the faulting. The strike of the beds is parallel to the faults. The sections show the dolerite unaffected by faulting—only one of the two possible alternatives.

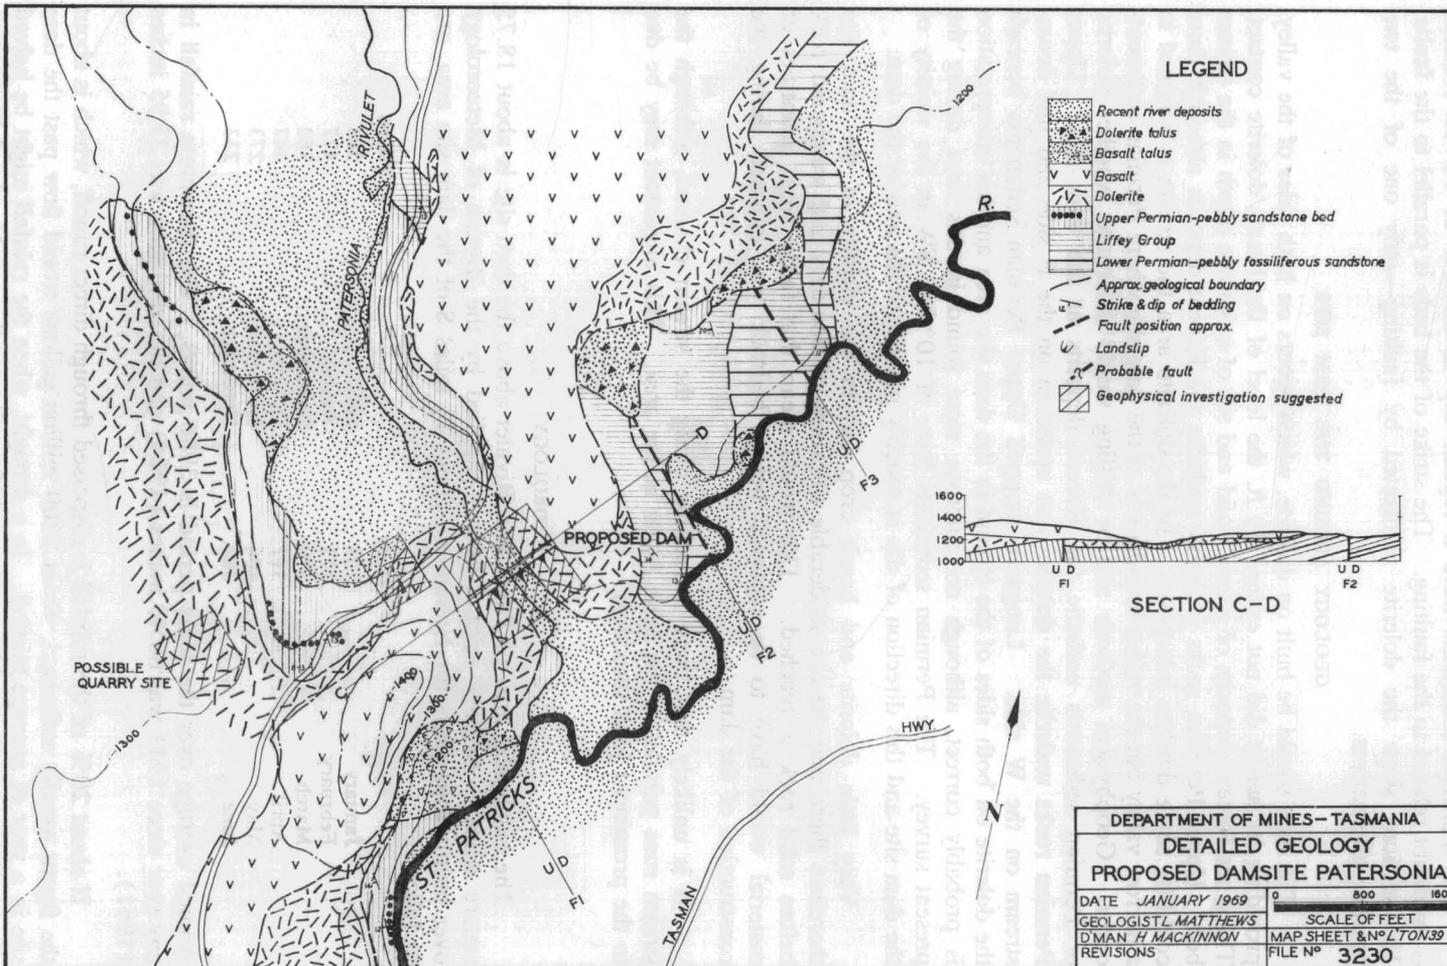
FIGURE 28

If successive dry years were to occur and heavy drawing on the dam was necessary, loss of water through leakage would become important. There are a number of factors that could contribute to leakage. A series of NW-SE trending faults cut across the area and although none has been mapped as passing through the dam site itself, there may be other small faults which cannot be determined because of the poor exposure. It is not expected that much faulting later than the intrusion of the dolerite is present in the area because the base of the dolerite is at about the same level on either side of the dam site. The nearest probable

fault of any size is W of the rivulet and this would have a fairly short leakage path. Faults mapped E of the rivulet are not expected to be the cause of excess leakage because of the longer leakage path.

Sandstone of the Liffey Group crops out E of Hole 3 (see geological map, fig. 28 and section fig. 31) and the top of the Liffey Group was struck in this hole. Examination of levels suggests that the Liffey Group dips from these surface outcrops to the bottom of Hole 3 at the regional dip with little or no displacement by faulting. If correlations between Holes 3 and 1 are correct, then there is little or no displacement between these holes.

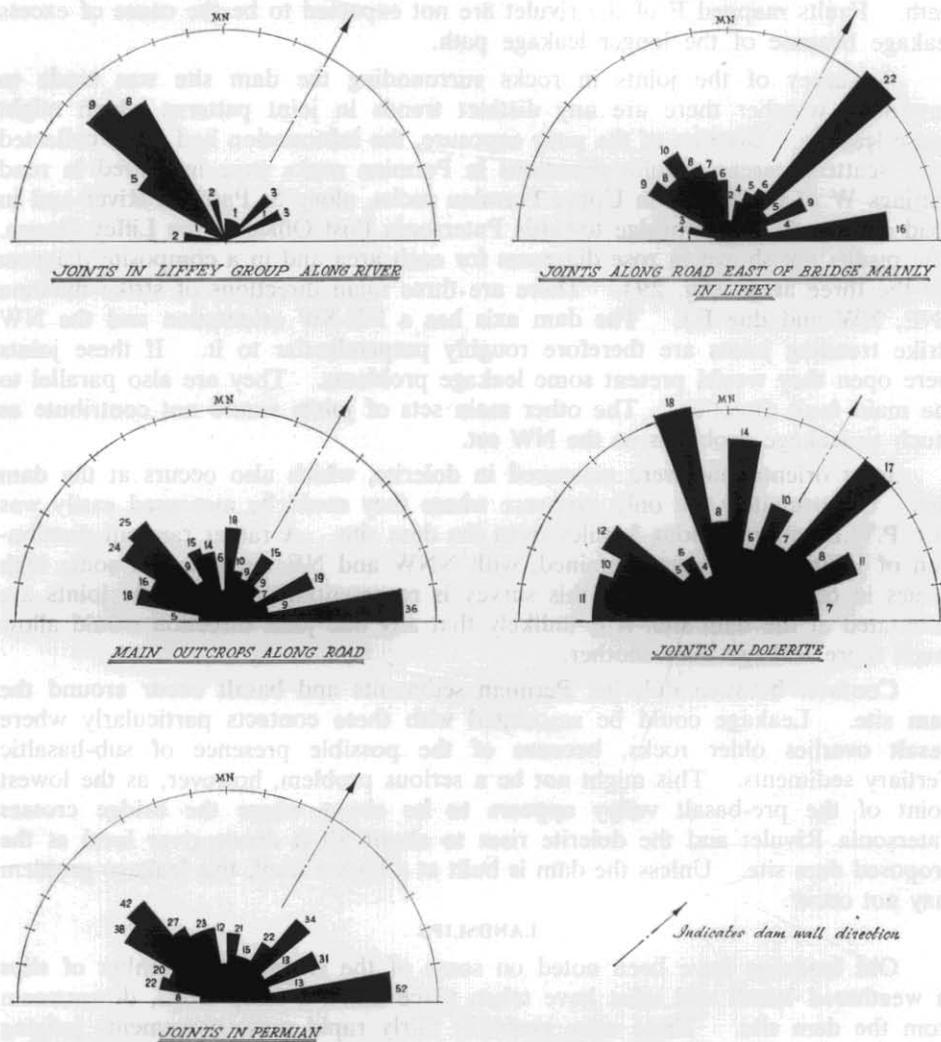
FIGURE 29. Rose diagrams of joint directions, Patersonia.

A survey of the joints in rocks surrounding the dam site was made to determine whether there are any distinct trends in joint patterns which might cause leakage. Because of the poor exposure, the information had to be collected from scattered areas. Joint directions in Permian rocks were measured in road cuttings W of the bridge in Upper Permian rocks, along St Patricks River and in road cuttings E of the bridge towards Patersonia Post Office in the Liffey Group. The results are shown in rose diagrams for each area and in a composite diagram for the three areas (fig. 29). There are three main directions of strike maxima (NE, NW and due E). The dam axis has a NE-SW orientation and the NW strike trending joints are therefore roughly perpendicular to it. If these joints were open they would present some leakage problems. They are also parallel to the main fault direction. The other main sets of joints would not contribute as much to leakage problems as the NW set.

Joint orientations were measured in dolerite, which also occurs at the dam site. Unfortunately the only exposure where they could be measured easily was in a P.W.D. quarry about 3 miles from the dam site. A rather random distribution of joint direction was obtained, with NNW and NE maxima and some high values in other directions. If this survey is representative of how the joints are orientated at the dam site, it is unlikely that any one joint direction would allow much more leakage than another.

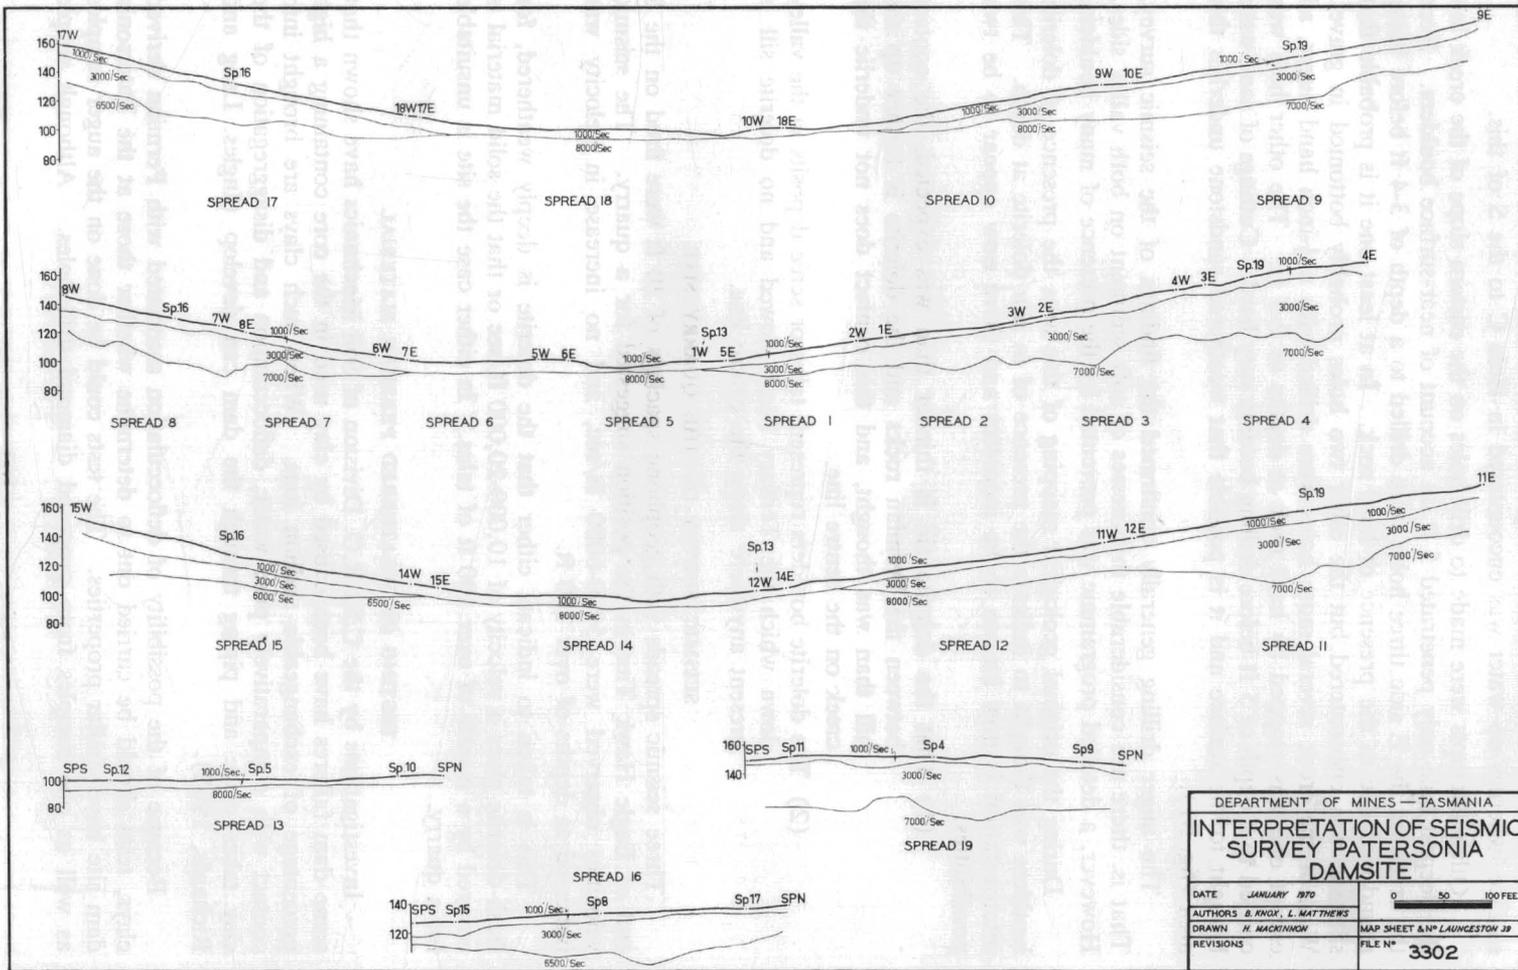
FIGURE 30

The results of this survey suggested that there were considerable depths of low seismic velocity material (about 1000-3000 ft/sec), underlying the slopes on either side of the rivulet (fig. 30). Depths of up to 30 ft of this material were indicated on each extremity of the centre line of the dam but thinning towards the creek to a depth of 4-8 ft. The bedrock underlying this low velocity material had a velocity of about 8000 ft/sec near the rivulet and decreased to about 6500 ft/sec away from the rivulet.

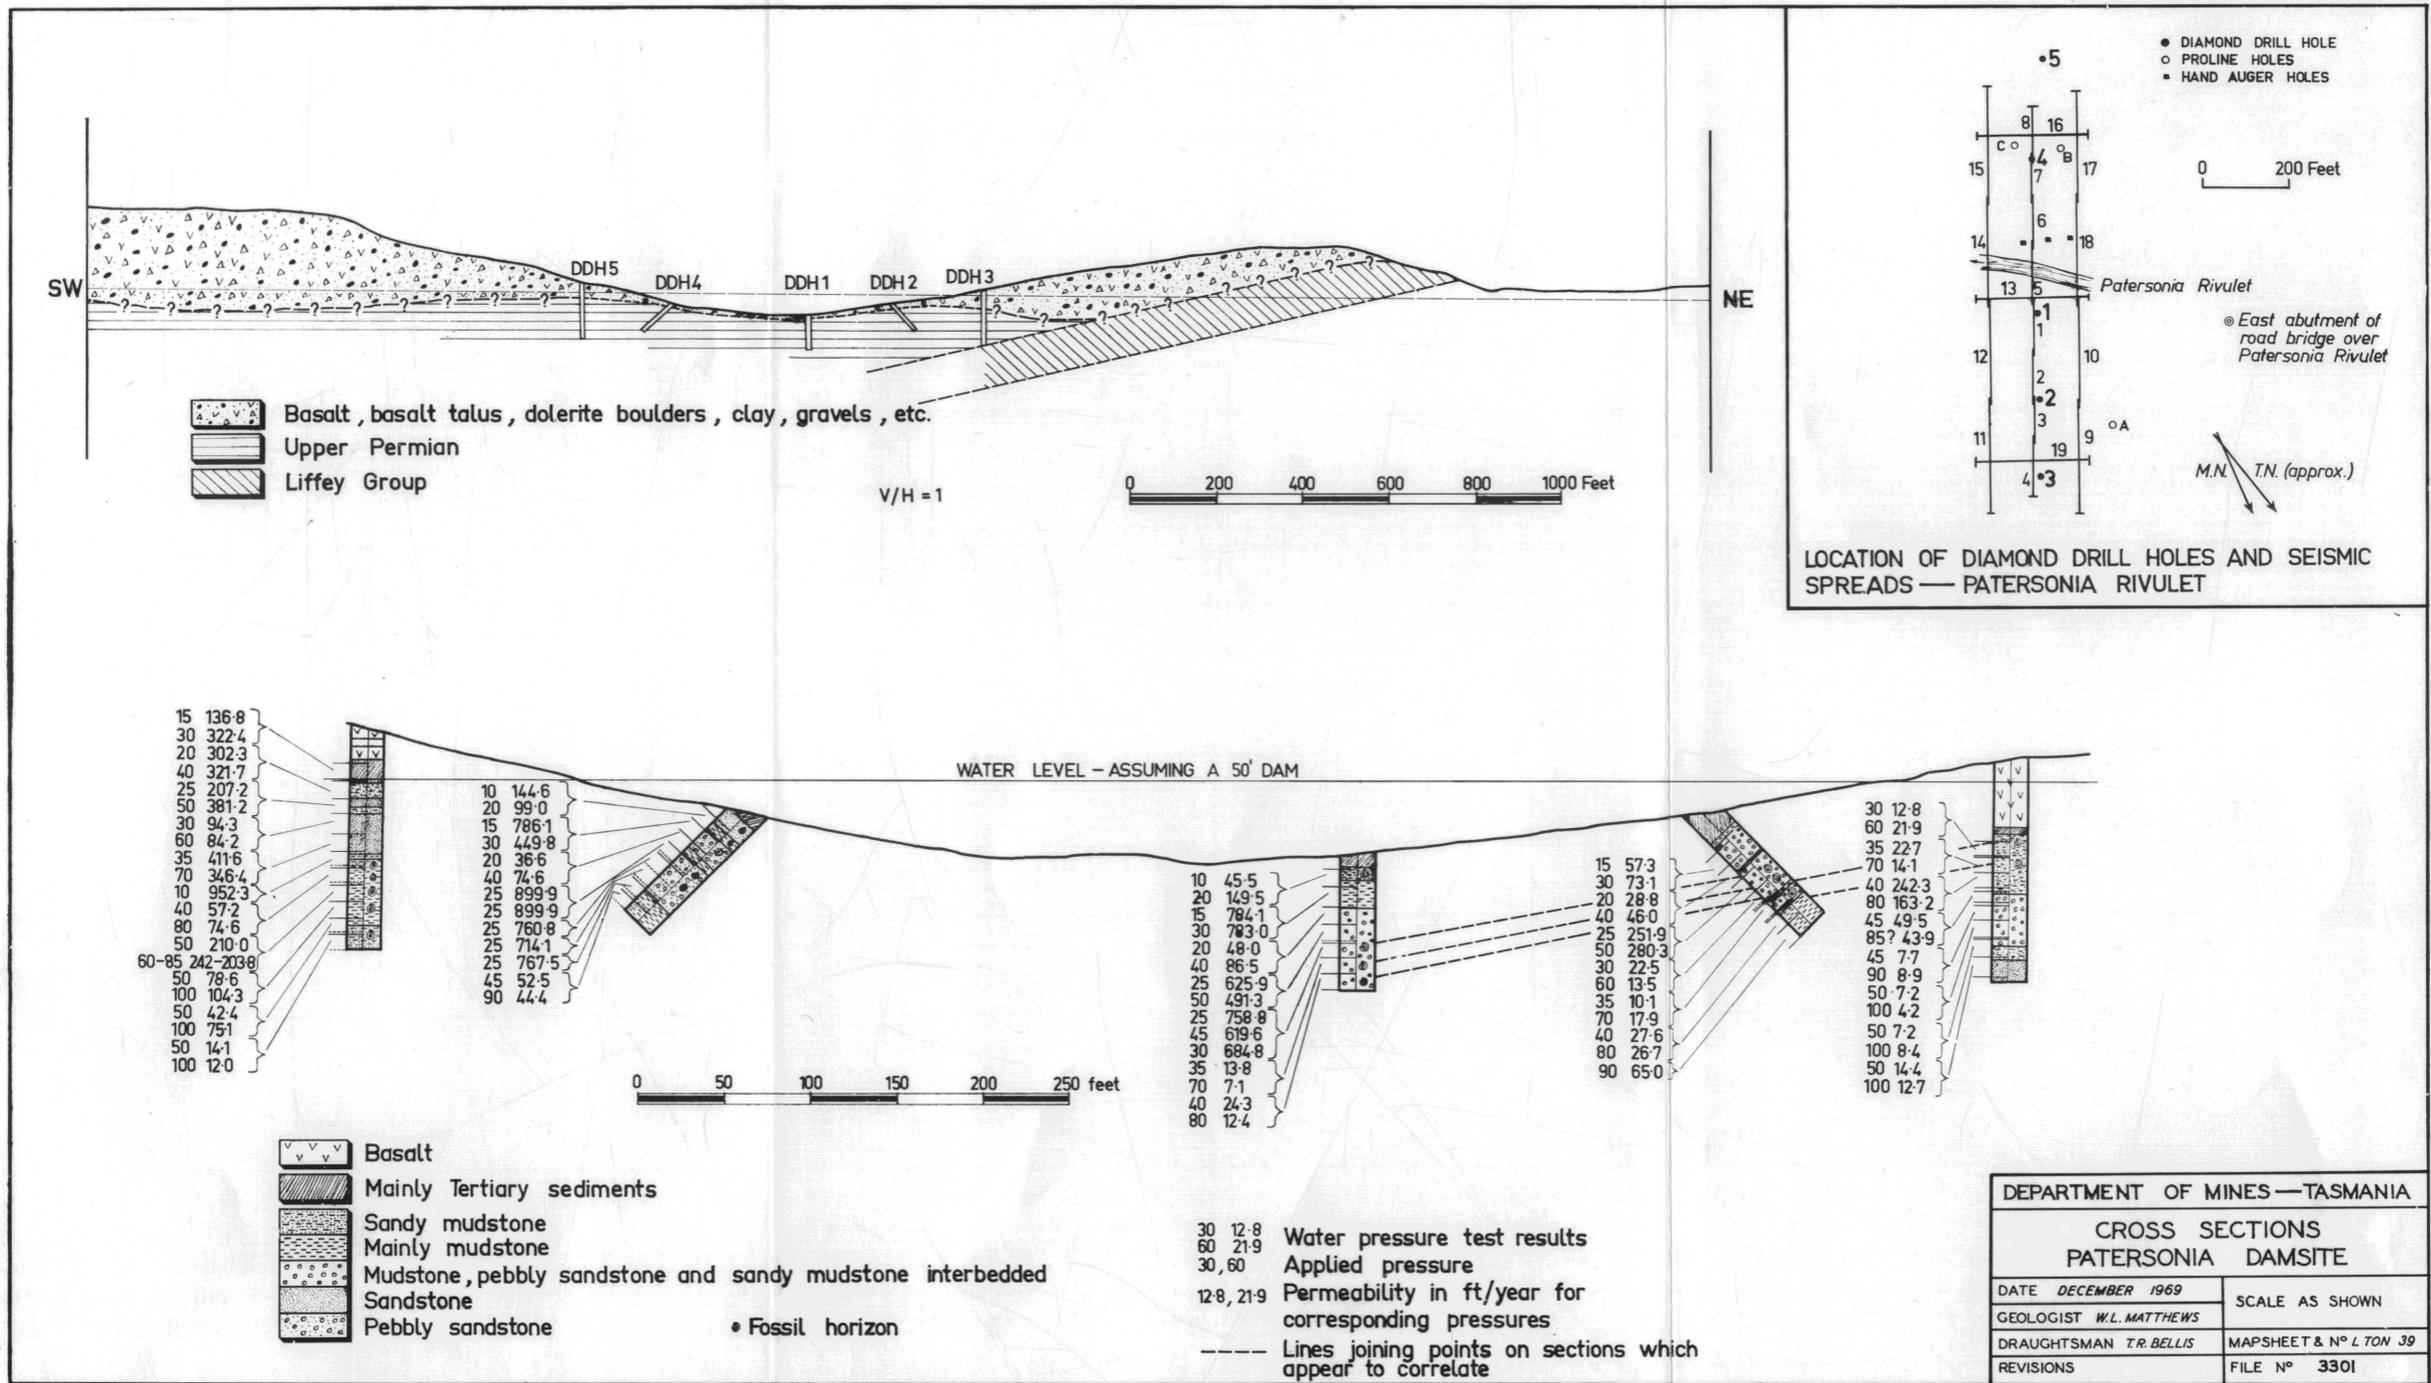
FIGURE 31

Following the discovery of the low seismic velocity zones it was apparent that the material underlying the abutments of the proposed dam was either very deeply weathered dolerite (as previously mapped) or else a soft sediment or talus. Auger holes were drilled to determine this. A number of holes were attempted but near-surface dolerite and basalt boulders (which would not affect the seismic velocities observed) prevented deeper drilling on many of the sites selected. However, three holes, one on the E side of the rivulet and two on the W bank were drilled to hard material at depth. Material that the auger drill was unable to penetrate would be expected to correspond with the 6000-8000 ft/sec material mentioned above. Each of these holes was sited about 30 ft above creek level. The hole on the E side was just N of the northernmost seismic traverse line and the two on the W of the creek were on either side of the middle traverse and about 105 ft apart (fig. 31). The following results were obtained:

Other attempts were made to drill holes on the eastern slope of the creek but the deepest hole only penetrated 5 ft on account of near-surface boulders. Near the creek on the E side three holes were drilled to a depth of 3-4 ft before being abandoned due to the presence of hard rock. In at least one it is probable that siltstone was encountered but the other two holes probably bottomed in gravel. West of the creek several more holes were drilled with a $\frac{1}{2}$ -inch hand auger, all except one was stopped by hard rock at depths of 2-3 ft. The other hole was carried to a depth of 5 ft before drilling became very hard. Cuttings of sand were brought to the surface and it is possible that weathered sandstone underlies this area (fig. 31).

The position of each drill hole is marked on Figure 31. Holes 1, 3 and 5 were drilled vertically, Holes 2 and 4 were inclined at 45° to the NE and SW respectively, along the axis of the dam.
