## 29. Engineering geology, Bellerive by-pass

D.E. Leaman

**GEOLOGICAL OBSERVATIONS ON THE ROUTE OF THE PROPOSED BELLERIVE BY-PASS**

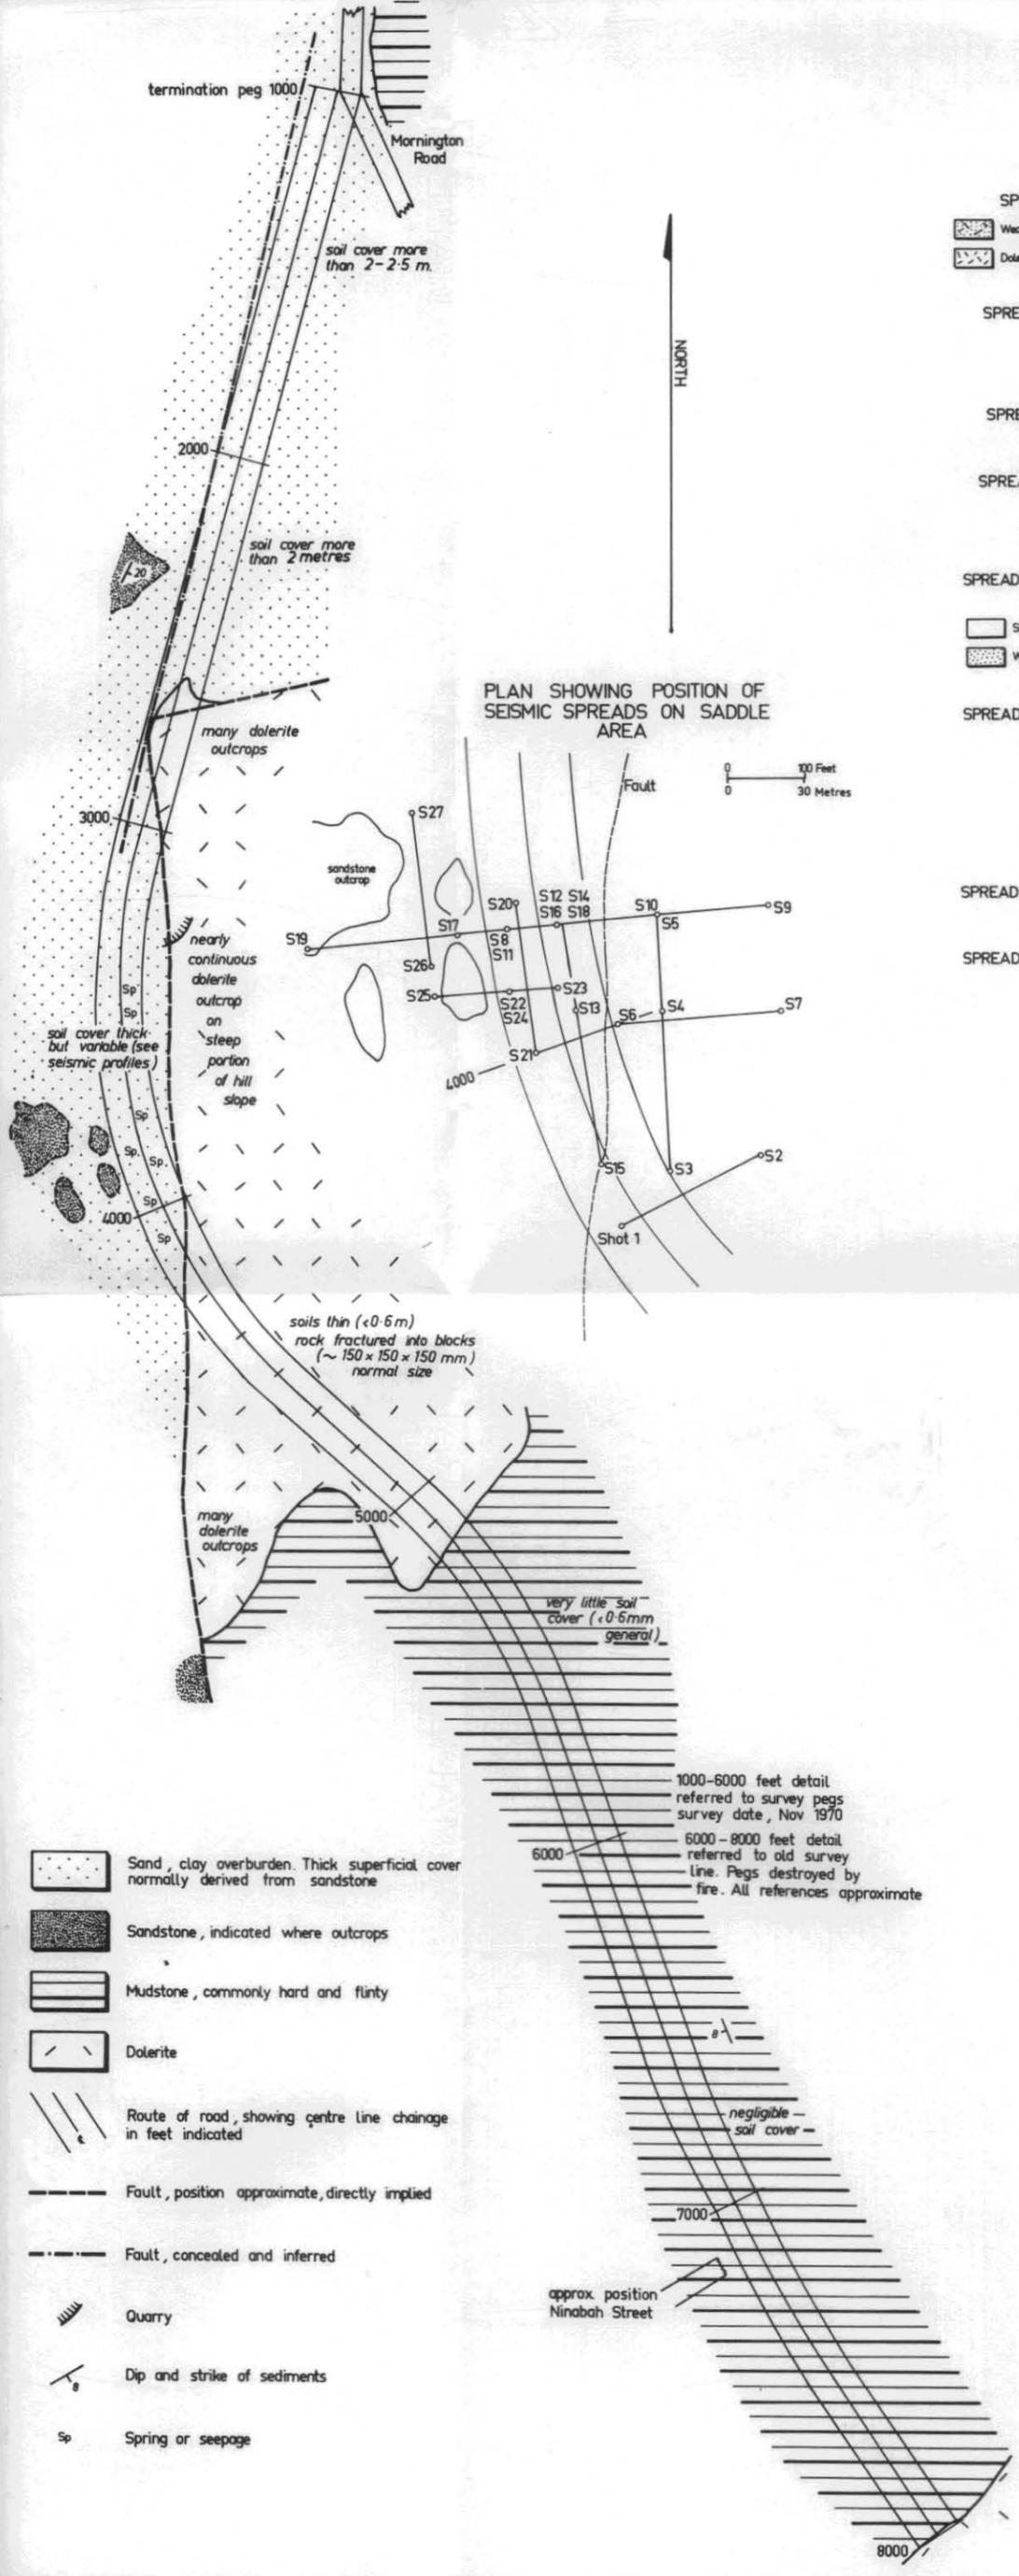
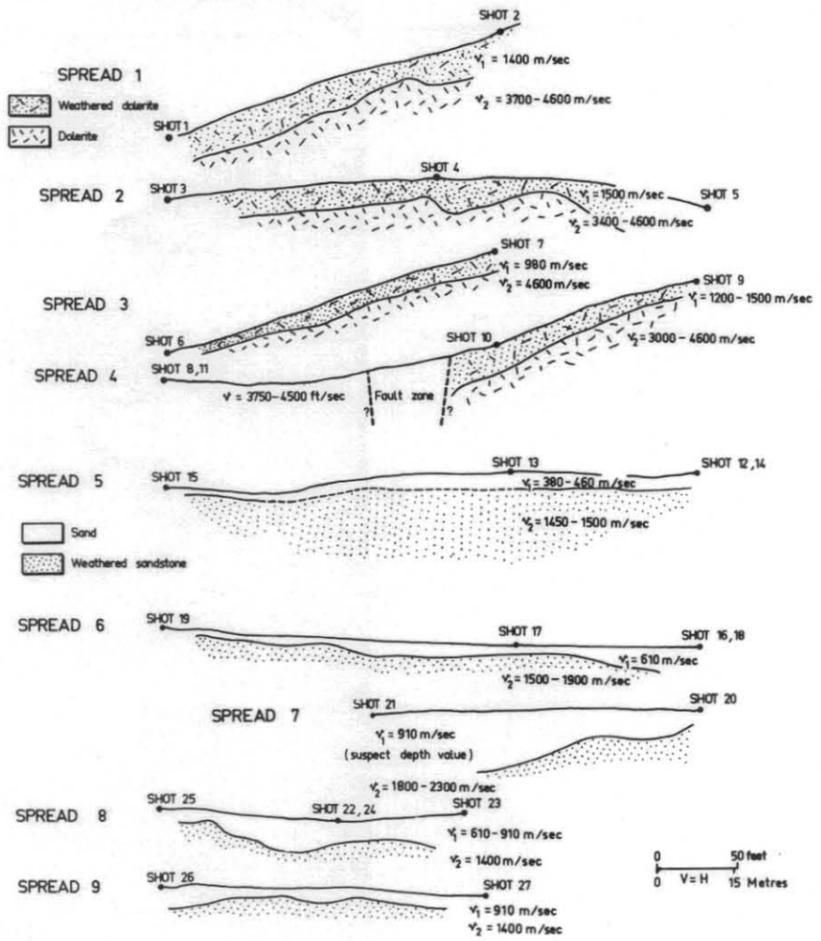
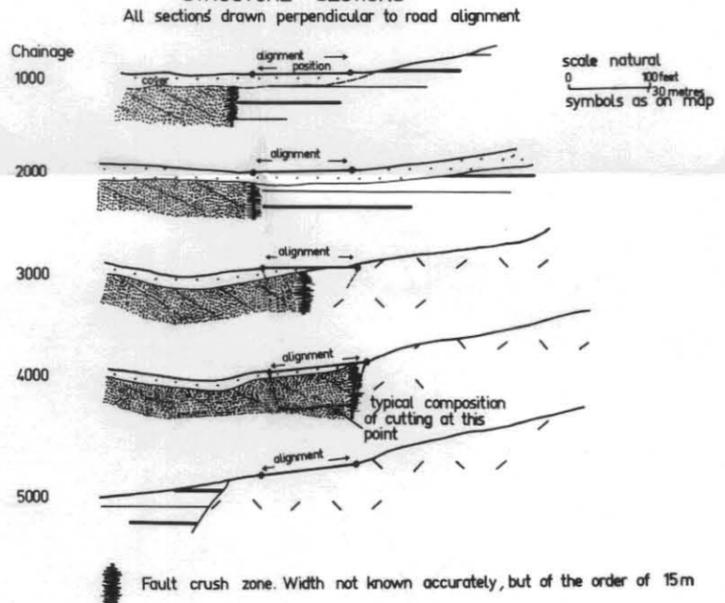
Figure 26.

Dolerite crops out over the hill, spur on the east side of the alignment in the region of the saddle. It is covered by thin, brown soils and normally about 3 m of very weathered and jointed dolerite (represented by a seismic velocity of about 1,500 m/s). The nature and depth of weathering is indicated in the seismic sections. The block size of the weathered dolerite is about 15 cm across. Distinct zones of oxide and calcareous weathering occur, for example near Ch. 5,000 ft (1.5 km).

**DETAIL OF SEISMIC INTERPRETATION**

**STRUCTURE SECTIONS**
