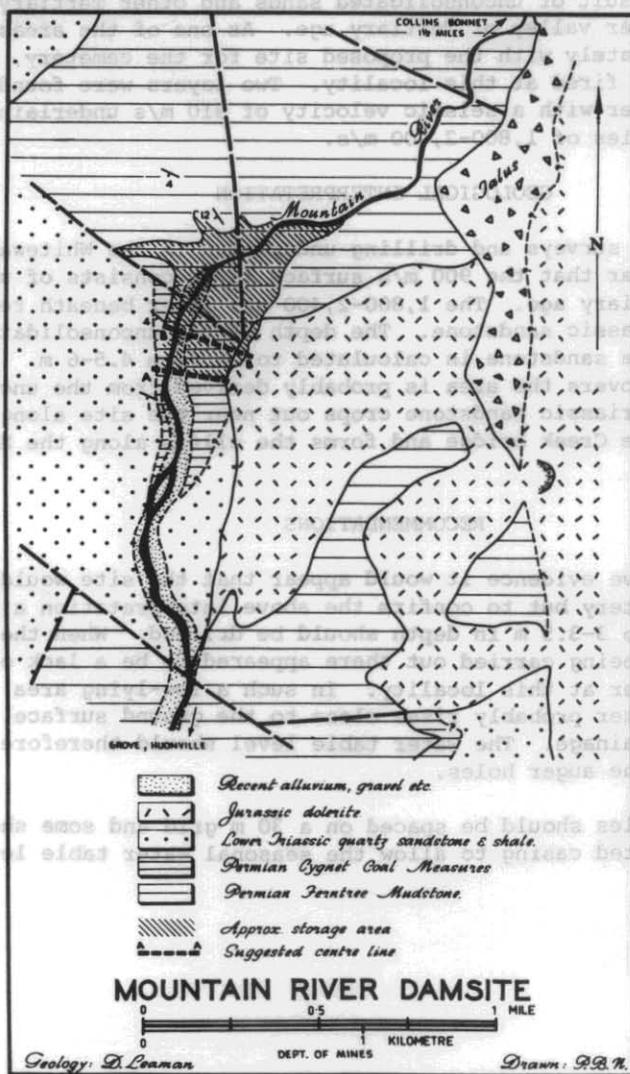
Figure 29.

A region in the middle reaches of the Mountain River, near Grove, has been examined as part of a preliminary study for a dam site. At this stage no definite sites have been selected by the Rivers and Water Supply Commission, at whose request this study was undertaken, although investigations have been restricted to a quarter of a mile stretch of the river. Two sites have been indicated which provide the best valley crossings with good abutments on the eastern bank (fig. 29). A dam of about 30 m in height has been assumed in the following discussion.
