TR/16-169-176

30. Subsurface investigations of proposed dam site, Nunamara.

W.L. Matthews

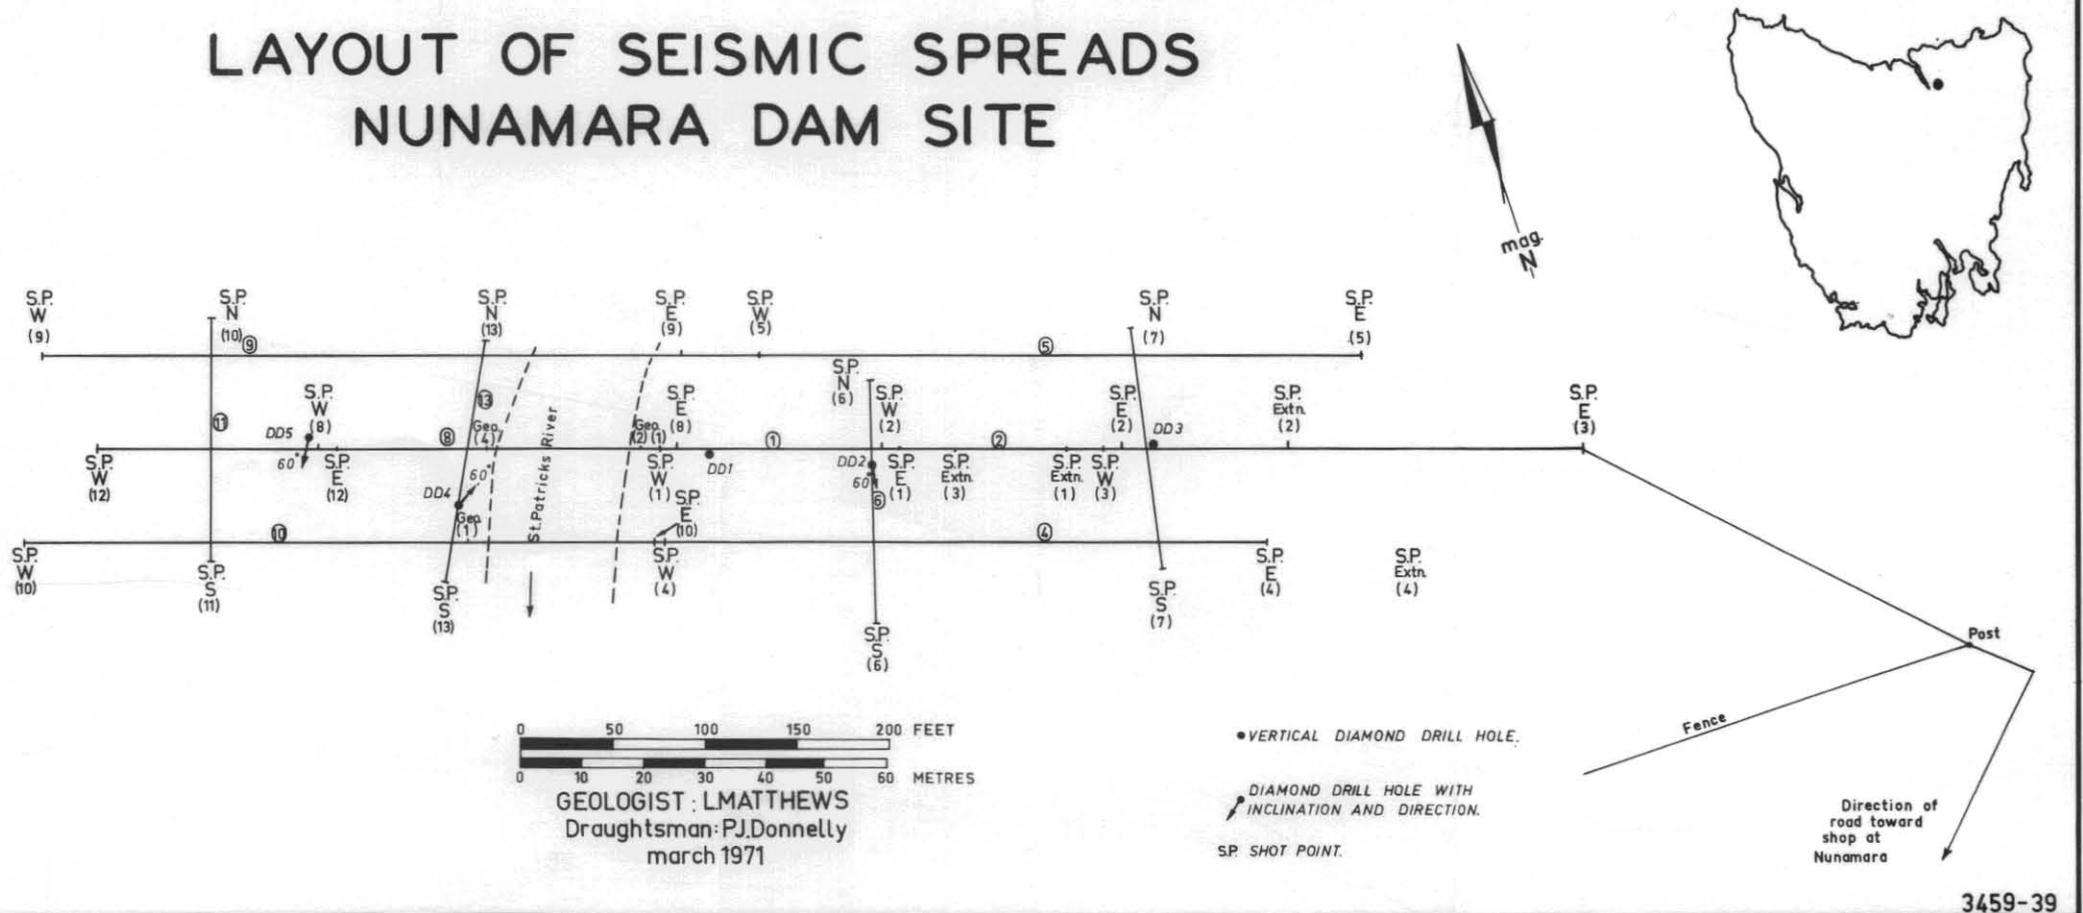
Figure 49.

Nine seismic spreads were fired along three approximately parallel traverses, across the proposed dam site area and four cross spreads were fired at right angles to these. The traverse lines were 15 m apart. Geophone spacings were 3 m and 6 m for the central traverse, 7.5 m for the traverses on either side and 3 m for the cross spreads (figs. 49, 50, 51).

The seismic survey indicated 2 layers of material exhibiting seismic velocities of about 300 m/s and 3,000-5,000 m/s. Spread 7, a cross spread, gave strong indications of material with an intermediate velocity of about 900 m/s which was not obvious from the results of any of the other spreads. Drawing on a knowledge of the geology of the area, the material having the lowest velocity was interpreted as being weathered dolerite and dolerite talus and the material with the highest velocity was thought to be unweathered dolerite, the variation in velocity in this being due to different degrees of jointing. The material with the intermediate seismic velocity of about 900 m/s was interpreted as being clay derived from the weathering of dolerite *in situ*. Spread 7 is crossed by Spreads 4 and 5 at its ends and by Spread 3 about the middle. Although each of these spreads suggests slightly higher velocity than the 300 m/s figure used in the interpretation, a 900 m/s layer is not obvious. This could be due partly to the closer geophone separation used in Spread 7 (*i.e.* 3 m compared with 6 m for Spread 3 and 7.5 m for Spreads 4 and 5) and also partly due to the fact that the seismic traverses are approximately parallel to the principal faults in the area whereas Spread 7 a cross spread is at right angles to the fault directions. If weathered and unweathered zones of dolerite have a linear form then the directions of these lineations could be expected to parallel the fault directions.

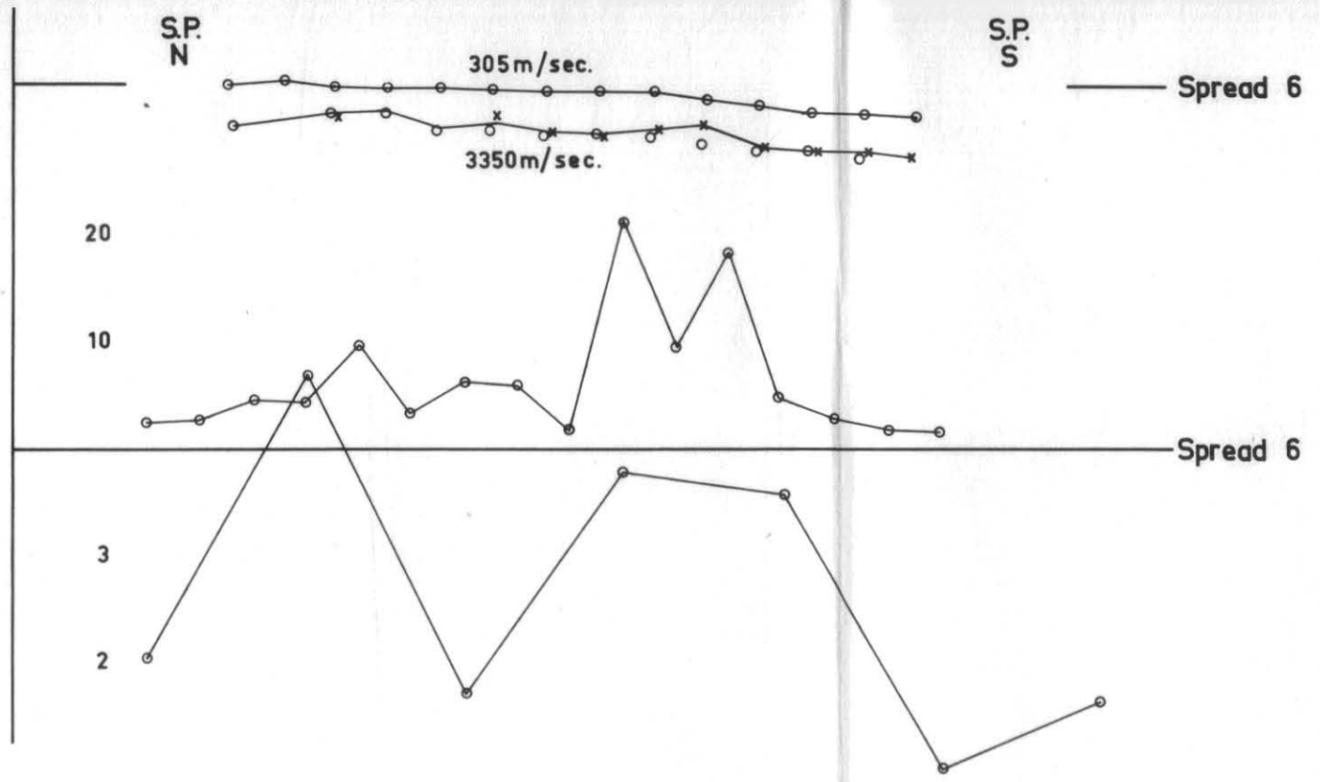
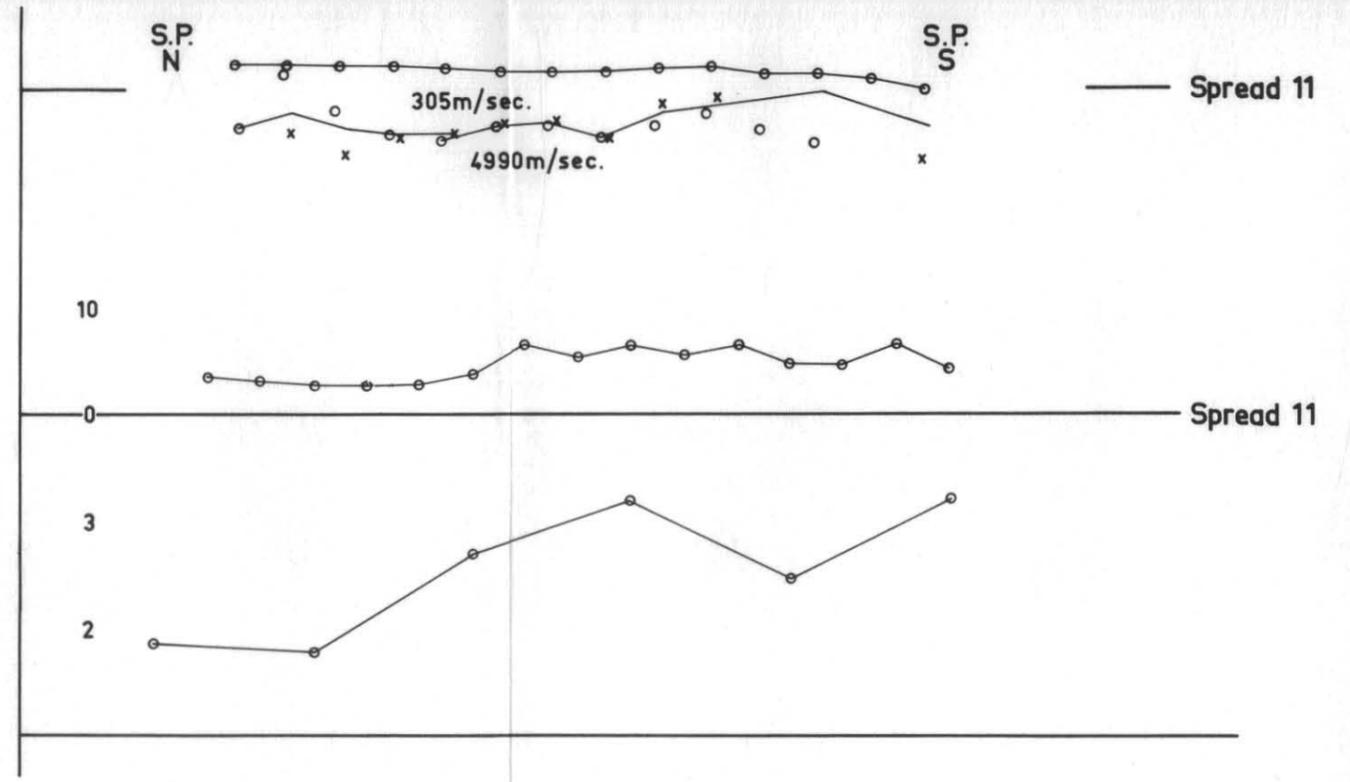
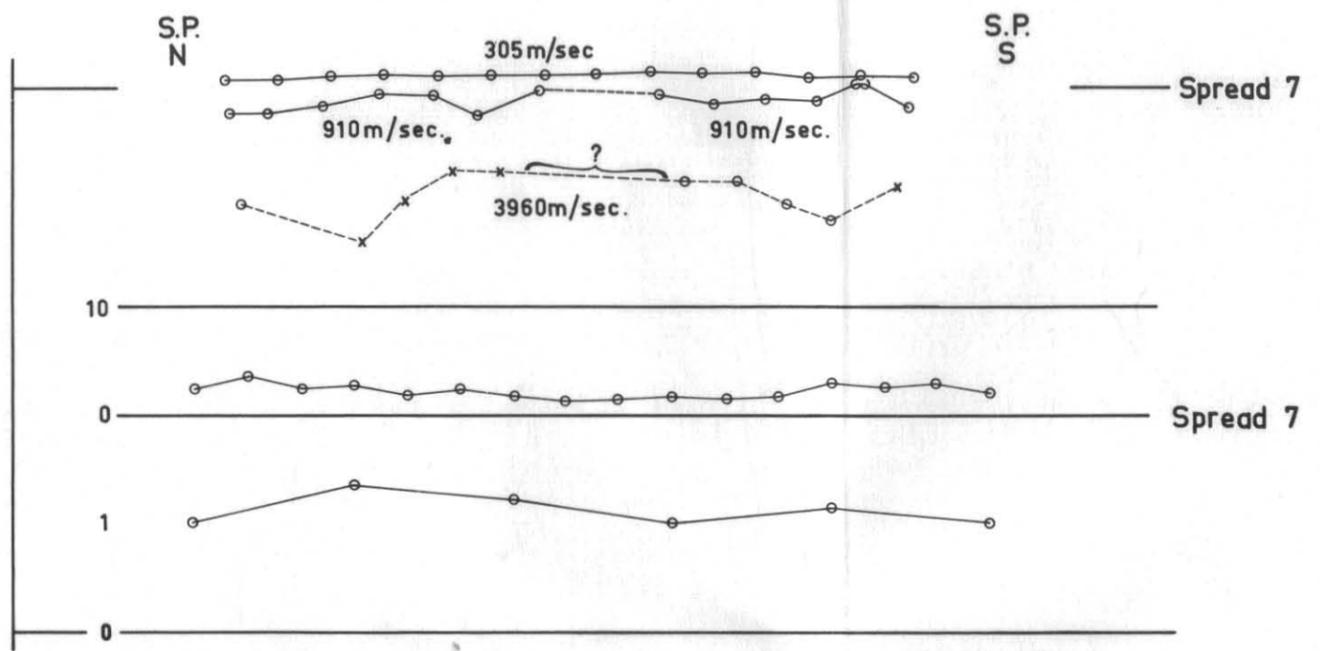
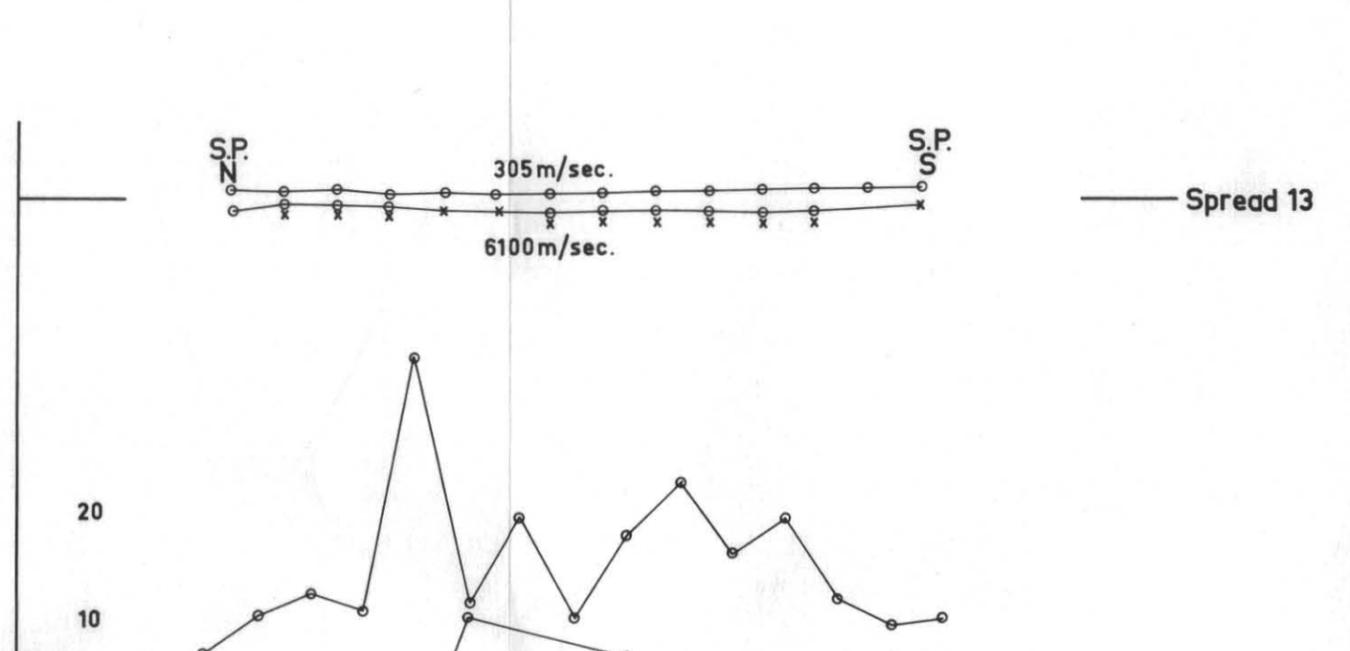
Figure 50.

The resistivity traverses indicated zones where resistance is high and other areas where it is much lower. The high zones were interpreted as being where unweathered dolerite is near surface and the zones where the resistivity profile is low and relatively flat were regarded as areas where the near-surface dolerite is weathered. In general, the profiles of the resistivity traverses support the occurrences of near-surface unweathered dolerite suggested by the seismic data.

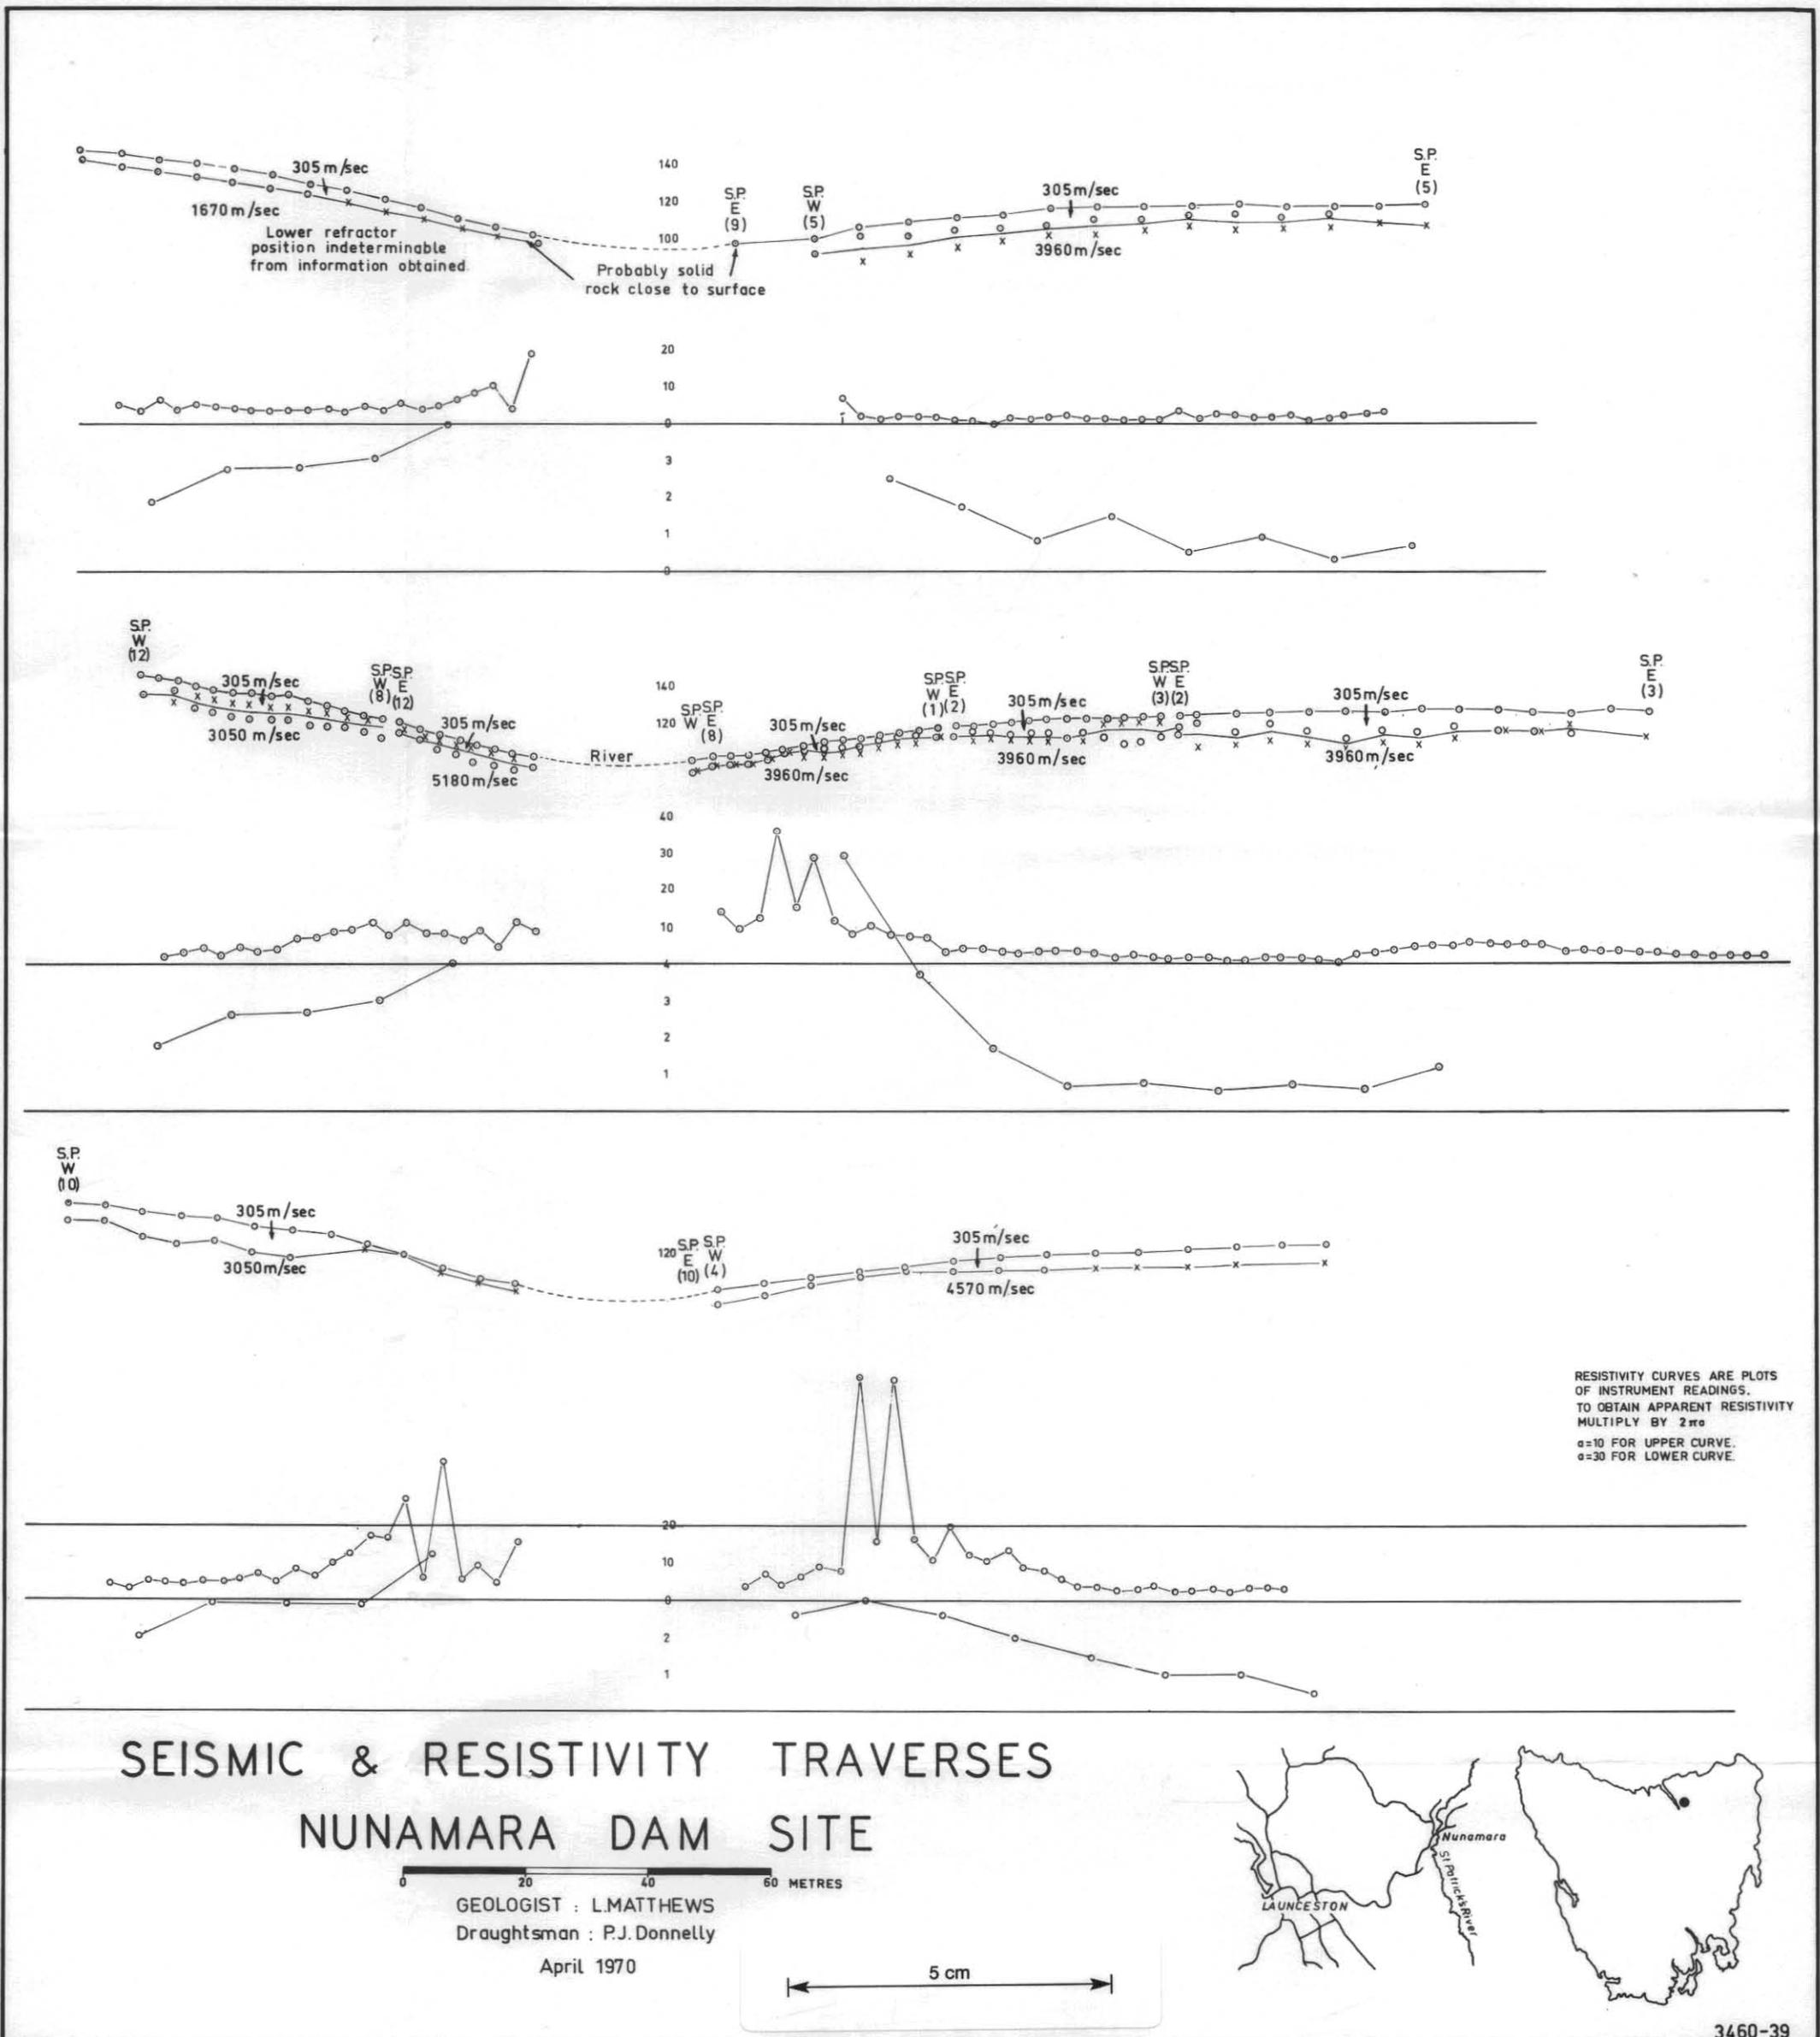
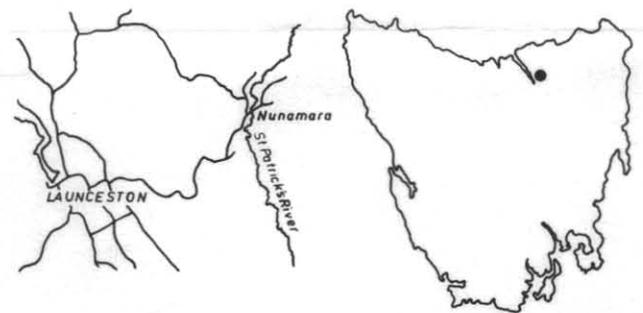
Figure 51.

The middle seismic traverse appears to be along the line where unweathered dolerite is nearest the surface and this line would be the most suitable centre-line for the dam.

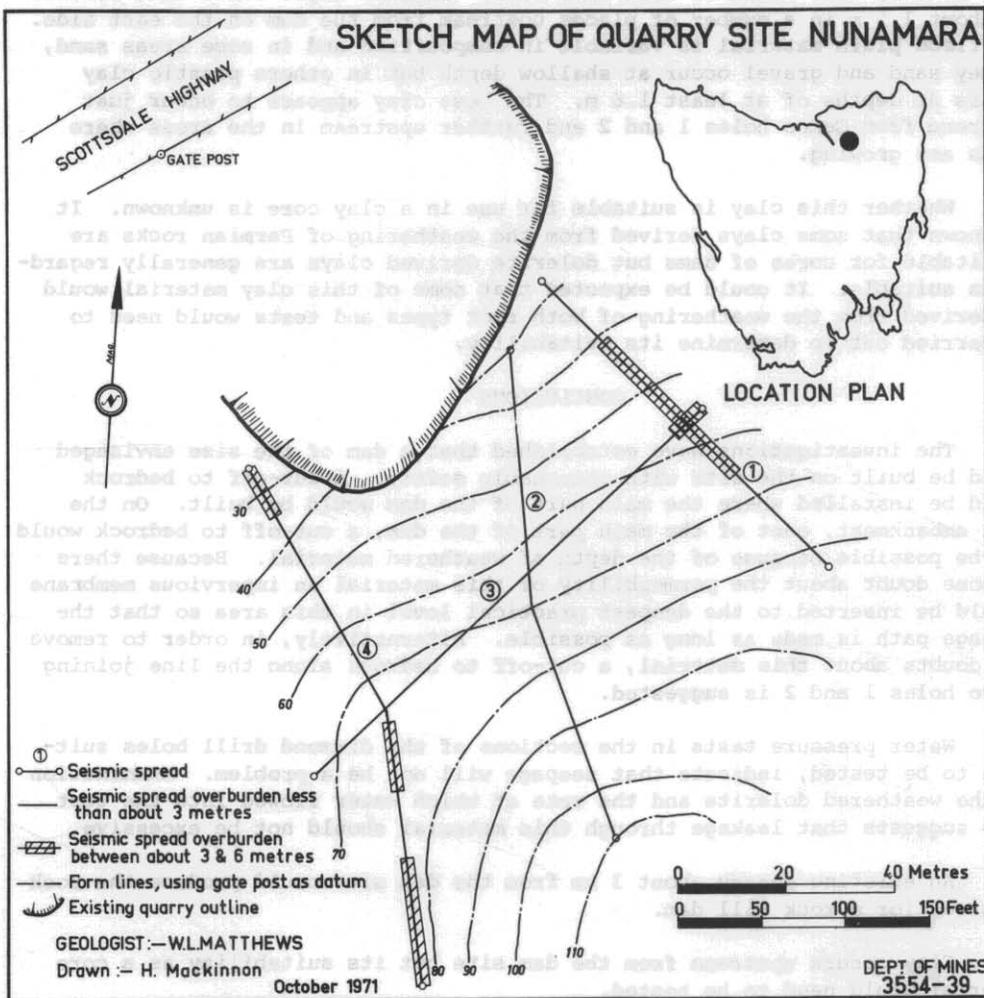
Figure 53.

An existing quarry about 3 km south-west of the dam site could be used as a source of rock if a rock fill dam is built. The quarry at present has a face of up to about 10 m and the country behind it is steep so that with further working, a higher face would quickly develop. There are widespread outcrops uphill from the quarry and it could be expected that good rock could be found at shallow depth over extensive areas. The best rock, with least weathering, is in the southern part of the quarry (fig. 53).

Four seismic spreads covering land from 80-100 metres south of the quarry, were fired and the results suggest that there are areas where weathered material and boulders of dolerite extend to about 6 m below the surface but in general this material is less than 3 m thick. The most continuous unweathered rock, from the seismic spreads, appears to extend towards the highest point on the hill.

Because the overburden is fairly thin where dolerite is not exposed, there is little doubt that adequate supplies of rock could be obtained from the area. The one drawback of the site appears to be the wide opening of the joints in the dolerite since more explosives would be required than if the joints were closed.
