## 23. Geological observations and seismic survey, Department of Mines site, Mornington.

D.E. Leaman

WEST PORTION , DEPARTMENT OF MINES SITE ,  
MORNINGTON  
SCHEME 2 LAYOUT

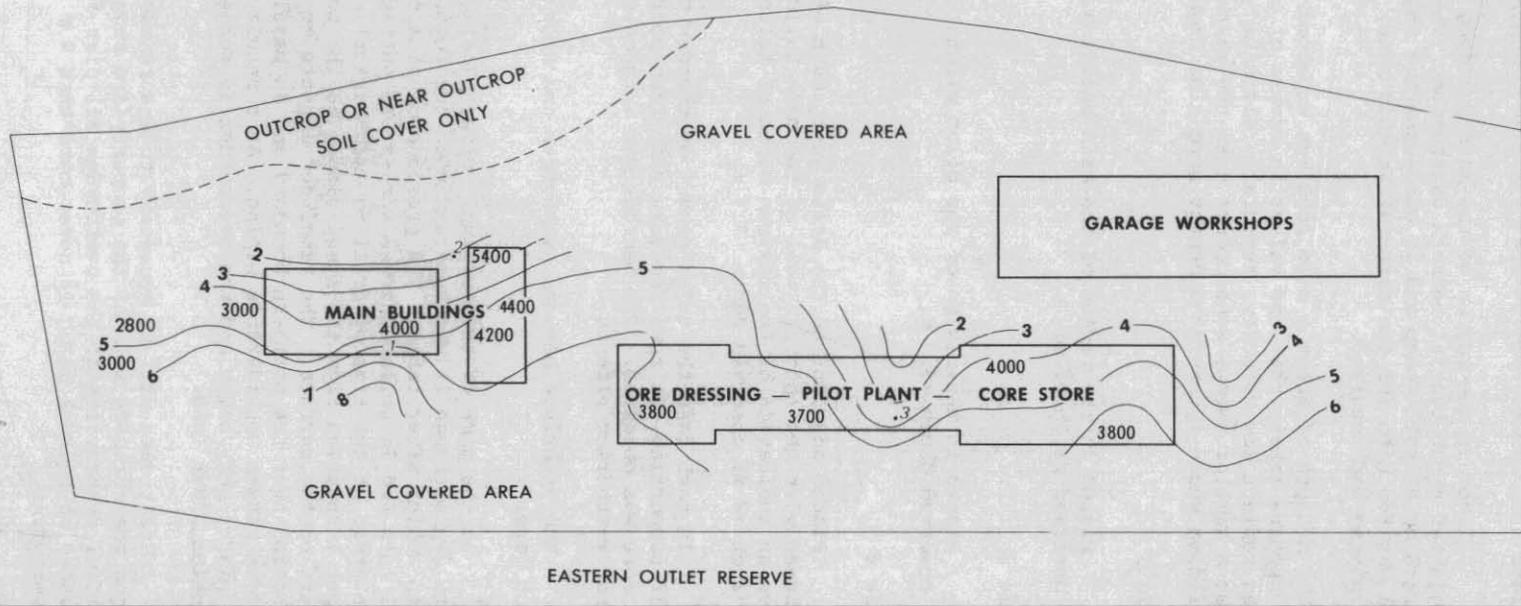
The geology of the property is indicated in Figure 79 which also shows the general location and the siting of the buildings. In general only three materials occur at the site.

In the area of main building definite bedrock (seismic velocity 3000-4200 m/s) occurs at depths ranging from 3-7 m. The interface is very irregular but appears deepest towards the south side of the proposed building. It may be coincidental that a small swampy depression occurs nearby. This could imply either lower velocity distortion of the interpretation or a more permeable, deeper, water path. This section of the site should be drilled. At least one other hole should be placed in this region, preferably on the north-eastern corner of the site so as to confirm the general interpretation and demonstrate whether the interpreted interface represents the gravel/rock interface or a fractured rock/rock interface.

In the region of the core store building site the thickness of the gravel ranges from 2.5-6.5 m. The interface is again very irregular and its exact nature should be confirmed by at least one drill hole. At the western end of the proposed building the thickness of gravel is estimated at 6.5 m and at the eastern end, 5.5 m. The average thickness is about 5m with a localised thin cover zone about half way along the site from the western end.

Four holes were subsequently drilled to evaluate the reliability of the seismic survey (fig. 79).

Placed in the region of the main building where the seismic results suggested a substantial bedrock depression. The particular region is also marked by a small swamp and it was suspected that the velocity presumed overall was too high for the material in this zone. This would be especially so if piping had occurred.

A depth of about 6 m to rock was expected but only 3.7 m was recorded. It appears likely that the values in excess of 5 m as shown in the original plan reflect low velocity, texturally disturbed material. It is significant that a similar swampy zone occurs near the eastern end of the core store building where interpreted depths were also high.

At the time of the original surveys (late summer) the property was very dry although it was apparent that two regions were generally swampy with a high water table. The presence of piping features was also noted in all cuts and in collapse zones across the surface. All these features were confirmed at the time of drilling (mid-winter). The property is subject to sheet inundation from the steep slopes to the north and much of this runoff stays on the surface. The remainder appears to pass into the rock/talus junction near the northern boundary and in passing through the variable overburden causes considerable piping. As a result the property is very wet, in places very boggy and the overburden is subject to collapse and compaction under load.

Footings for the main building should be placed on bedrock (positively identified by excavation). This will be necessary because of variable strength, cohesion and compaction of the gravel and the ever present risk of the removal of fine material by the piping process which could result in the undermining of the foundations unless these are rock founded. Two to four drill holes at the locations suggested are advisable so as to confirm the form and depth to bedrock indicated in Figure 79.

Great care will be necessary to ensure adequate drainage, and drains along the northern side of the property are suggested. As a result of the partial destruction of the overburden all pier footings should be properly founded on bedrock which is never more than 4 m deep in the area marked for development.
