TR 5. 95-98

## ALLUVIAL GOLD PROSPECT, BESSELLS CREEK, LISLE

by R. Jack.

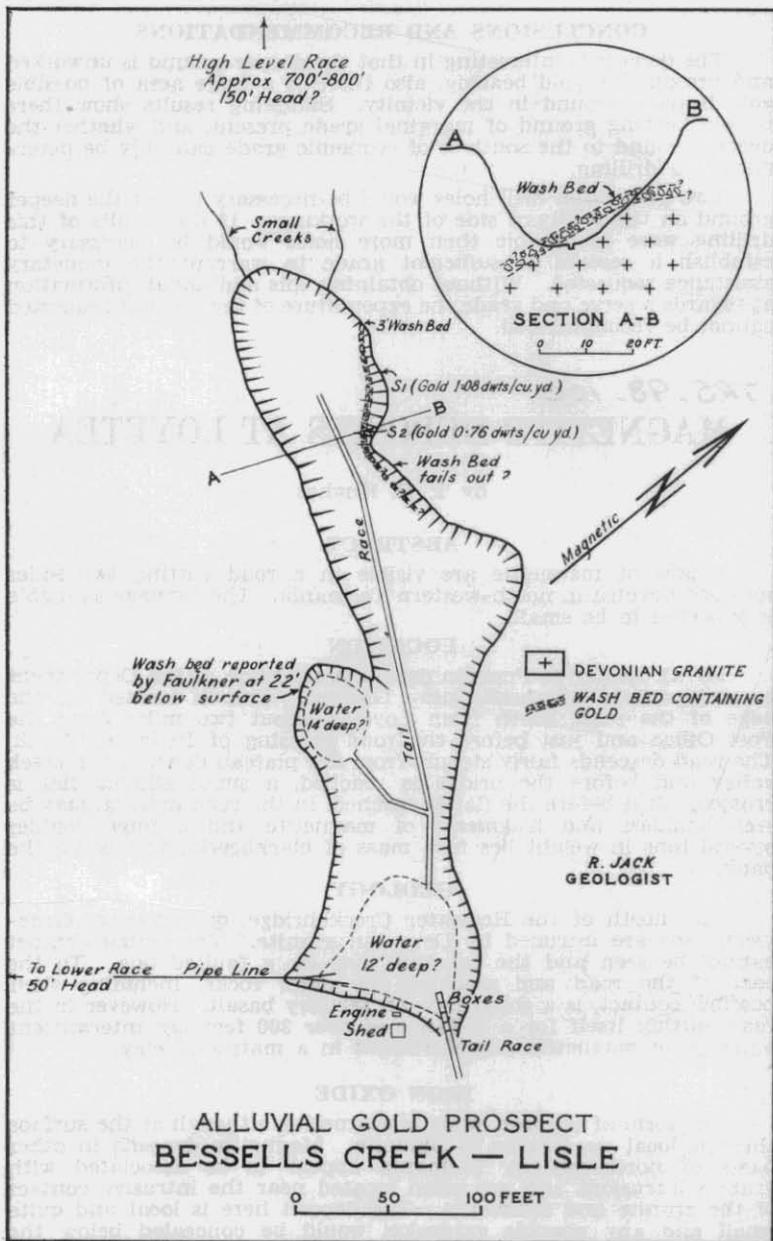
FIGURE 19.

Proper sampling was impossible owing to the collapse of the steep banks, but gold bearing wash was sampled in two places on the northern bank where the collapsed material had been cleared away.

- S1—1.08 Dwt. per cubic yard; three feet thickness of wash.
- S2—0.76 Dwt. per cubic yard; three feet six inches thickness of wash.
