## Geological survey of a proposed dam site on Nicholls Rivulet

*by D. E. Leaman*

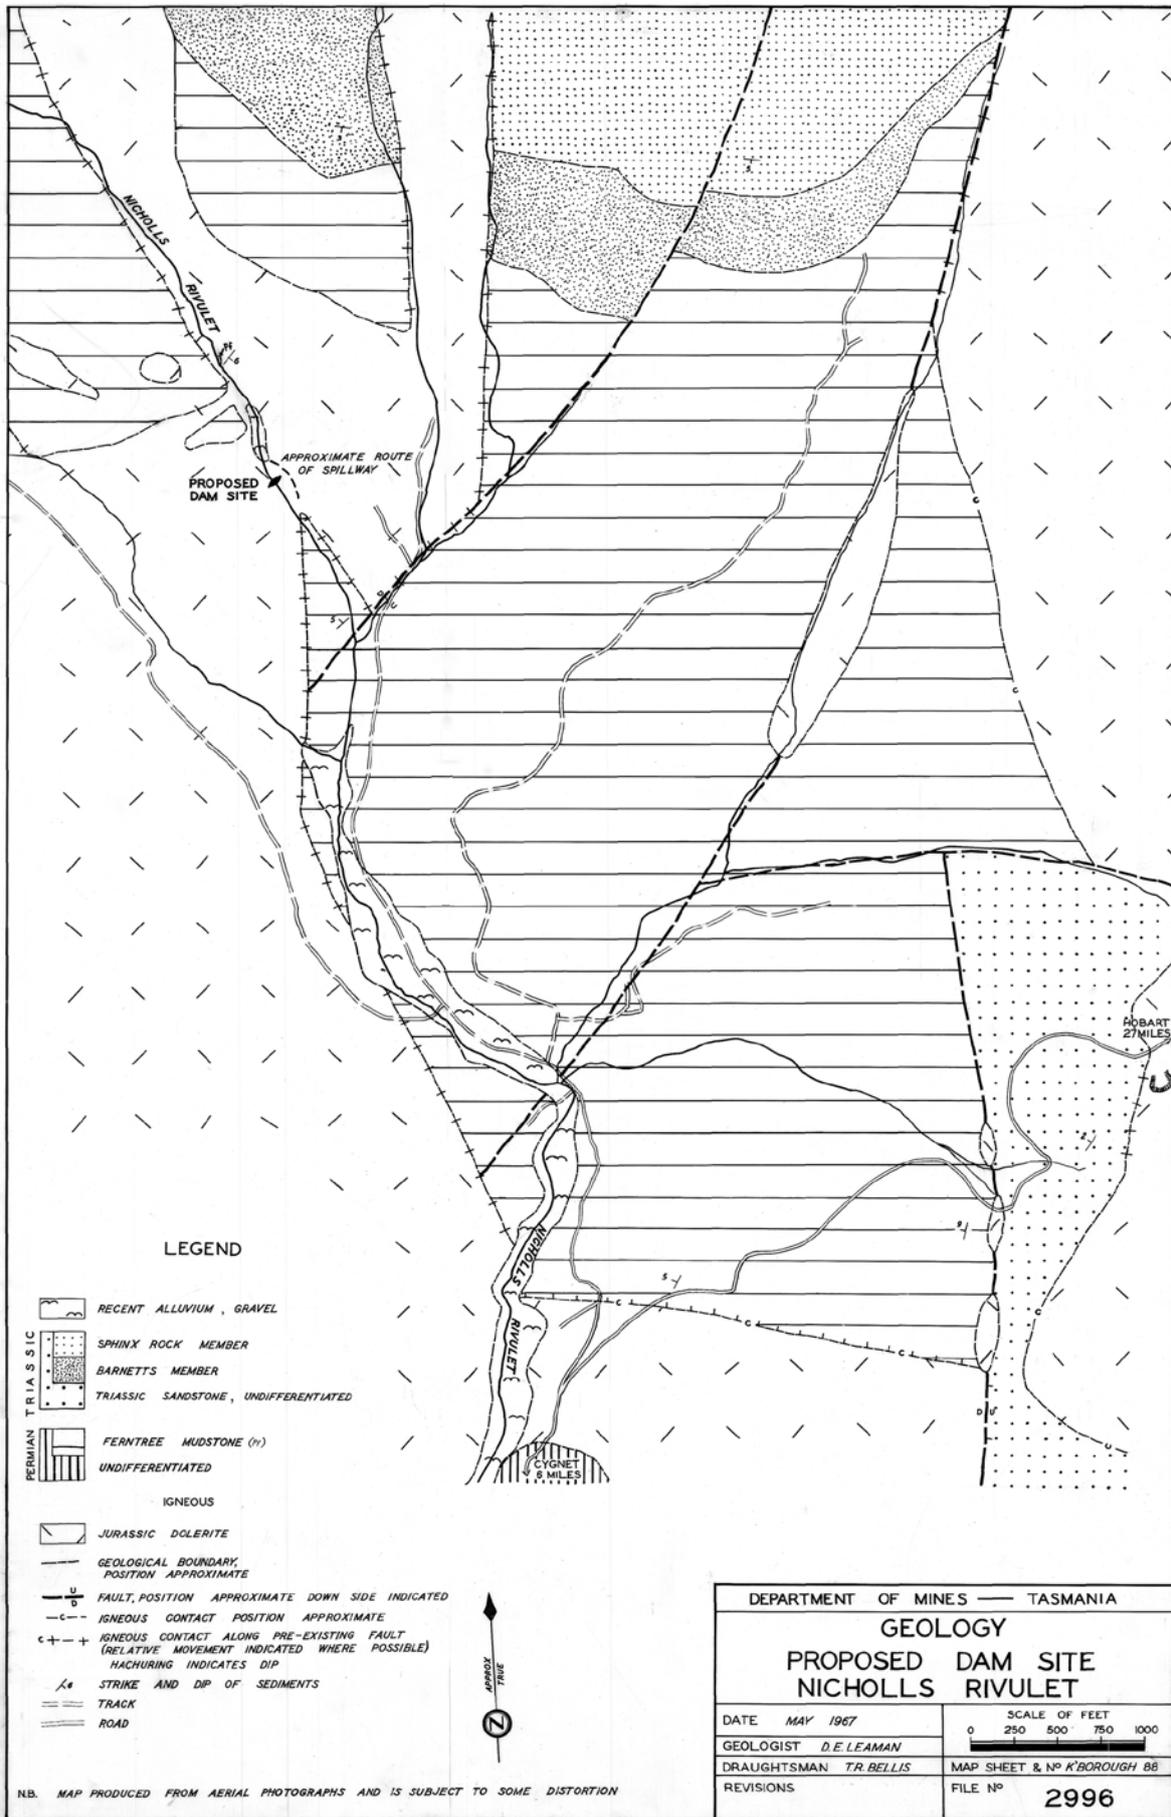
Figure 1

The geology of the area is shown in Figure 1. The sedimentary rocks present are Upper Permian and Lower Triassic in age. Both groups are extensively faulted and intruded by Jurassic dolerite. The faults in the area are pre-dolerite in age and there is no evidence of post-dolerite movement. The dolerite has utilised these zones of weakness and intruded along many of them. The dolerite in the west of the area has the form of large dykes or plugs whereas that in the east has the form of a transgressive sheet dipping southeast.

The dam site is completely in dolerite. The western abutment lies approximately 150 to 200 feet north of a contact along old faults. As a result the Ferntree Mudstone to the south is extensively metamorphosed, very hard and brittle, and much jointed. The joints in the mudstone are random but are generally less than one foot long and one inch apart. The dolerite in the contact zone is very fine grained and also highly jointed. The dominant joints appear to be transverse to the rivulet (approximately E-W). One set has a southerly dip of about 30°. Near the contact the joint density is about 12 per foot, but decreases to 2 per foot in the bed of the rivulet at the dam site.

The dolerite is not deeply weathered at the west abutment, but in places on the route of the spillway and eastern abutment there are zones in which the dolerite has weathered, and kernels or boulders are surrounded by clay. Three holes drilled to 5-6 feet deep, where this condition of weathering is noticeable, failed to locate convincing outcrops.

1. Quarry a small amount of the western face to check joints and fully expose the dolerite, particularly with respect to the southerly dipping joints.
2. Wash down to bedrock on the eastern abutment, again to check jointing and weathering.
3. Determine the thickness of gravel in the flat upstream of the dam, either by completing the trench or by blasting.
4. Wash down and test drill the route of the spillway, to fully determine the character of rock to be quarried. Three or four holes are required, one of which should be in zone A. Approximately one hole per 50 feet of spillway is required. As the route, depth and length of the spillway is undecided at present, no further specifications can be given as to tests required.
5. If rock, other than that recovered from the spillway, is required there should be at least two to three holes to check any likely quarry site.
