Results of diamond drilling at the Patersonia Rivulet dam site

by W. L. Matthews

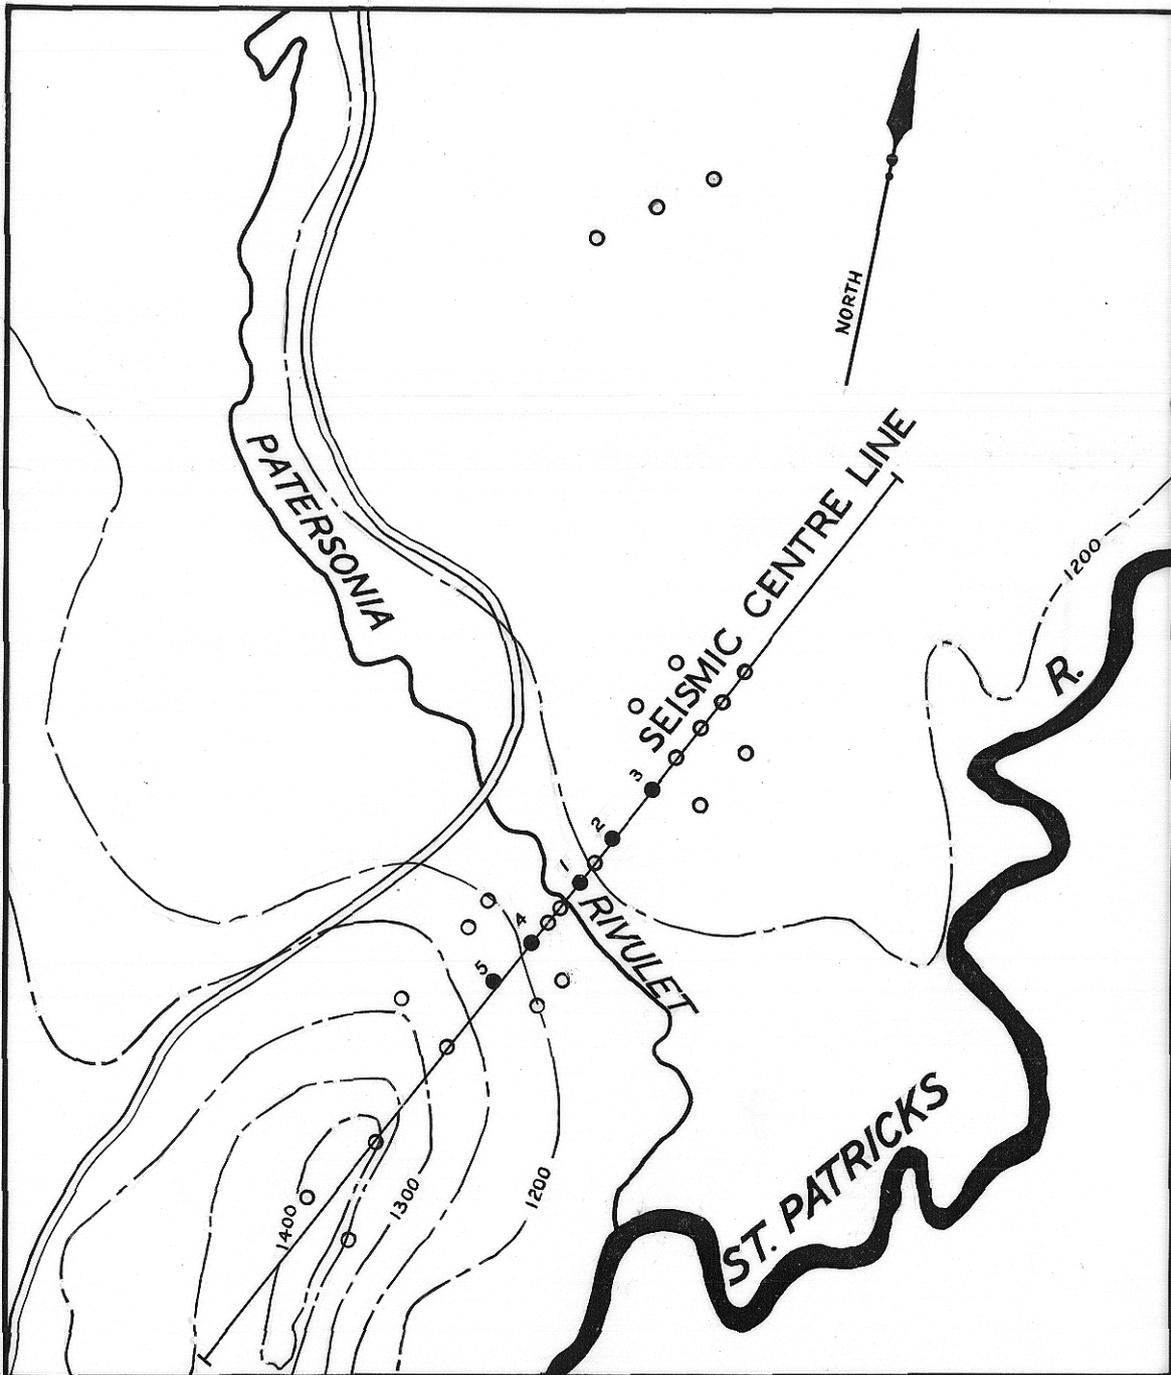
Figure 1

The position of each drill hole is marked on Figure 1. Holes 1, 3 and 5 were drilled vertically, while holes 2 and 4 were inclined at 45° to the NE and SW respectively, along the axis of the dam.

The section between holes 1 and 4 is incomplete and in order to determine whether faulting is present two holes, each 80 to 100 feet deep, are suggested; one vertical and one inclined at 45° SW along the axis of the dam.

Further investigation is required upstream and downstream of holes 4 and 5 because of the presence of faulting in this area. Two holes upstream and two holes downstream from the centre line, all inclined at 45° SW, are suggested. These should be deep enough (100–150 ft) so that definite correlations between boreholes can be made in this area.

Some fairly high water losses occurred in Hole 1 and a hole (say 80–100 feet deep), drilled east of Hole 1 and at 45° NE along the axis of the dam, is suggested in order to determine the extent of this leakage.

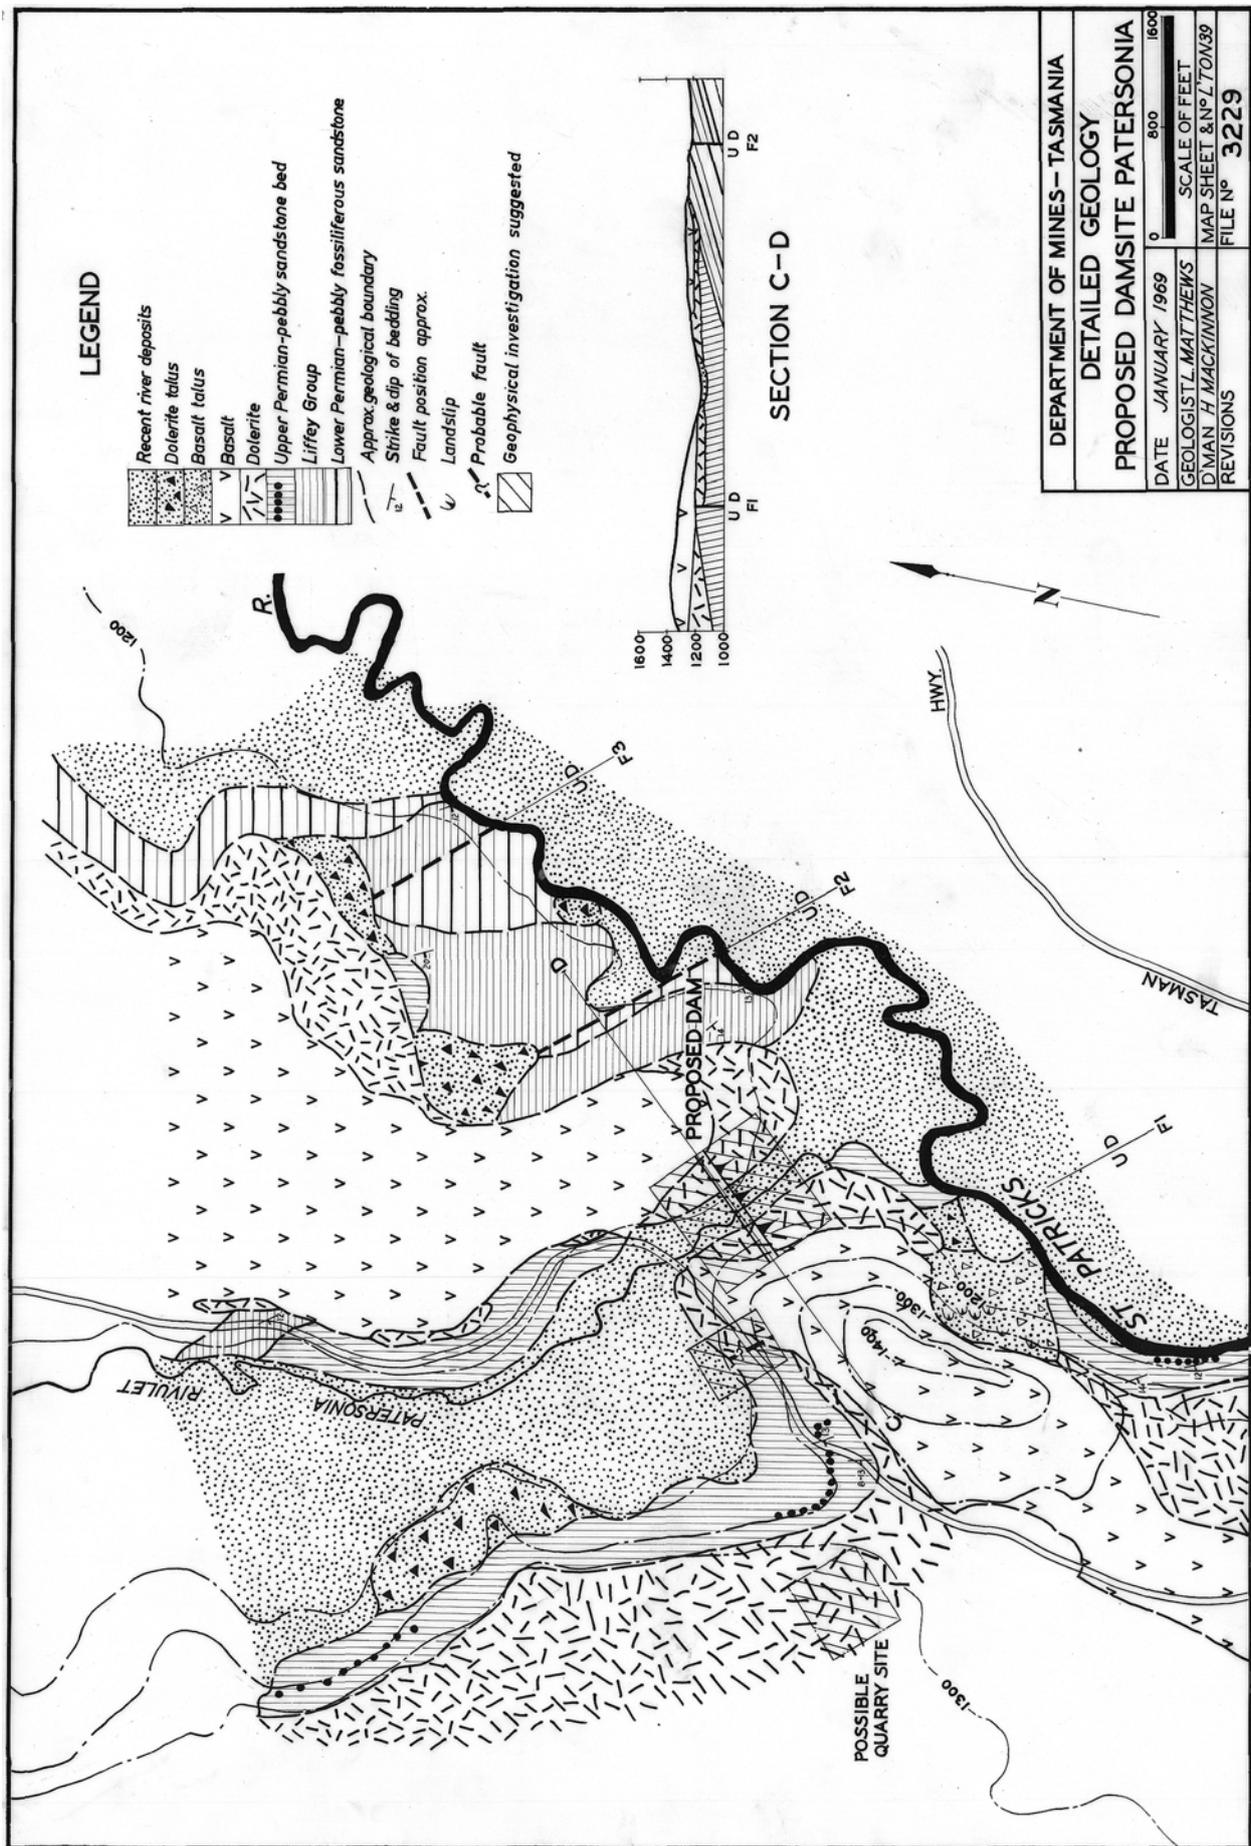
Figure 2

There is a possibility that a valley was eroded into the Permian rocks around the fault east of the dam site (F2 on Figure 2). Although the leakage path would be comparatively long, two or three holes are suggested to test whether such a valley exists and whether significant leakage would occur.
